ACCIDENT

Aircraft Type and Registration:	Piper PA-38-112 Tomahawk, G-BNDE	
No & Type of Engines:	1 Lycoming O-235-L2C piston engine	
Year of Manufacture:	1979 (Serial No: 38-79A0363)	
Date & Time (UTC):	20 August 2014 at 1834 hrs	
Location:	Near Padbury, Buckinghamshire	
Type of Flight:	Private	
Persons on Board:	Crew - 1	Passengers - None
Injuries:	Crew - 1 (Fatal)	Passengers - N/A
Nature of Damage:	Aircraft destroyed	
Commander's Licence:	Commercial Pilot's Licence	
Commander's Age:	60 years	
Commander's Flying Experience:	3,027 hours (of which more than 80 hrs were on type) Last 90 days - 28 hours Last 28 days - 13 hours	
Information Source:	AAIB Field Investigation

Synopsis

The aircraft was flying in the vicinity of the town of Buckingham when it entered a spin from which it did not recover. The pilot sustained fatal injuries in the impact.

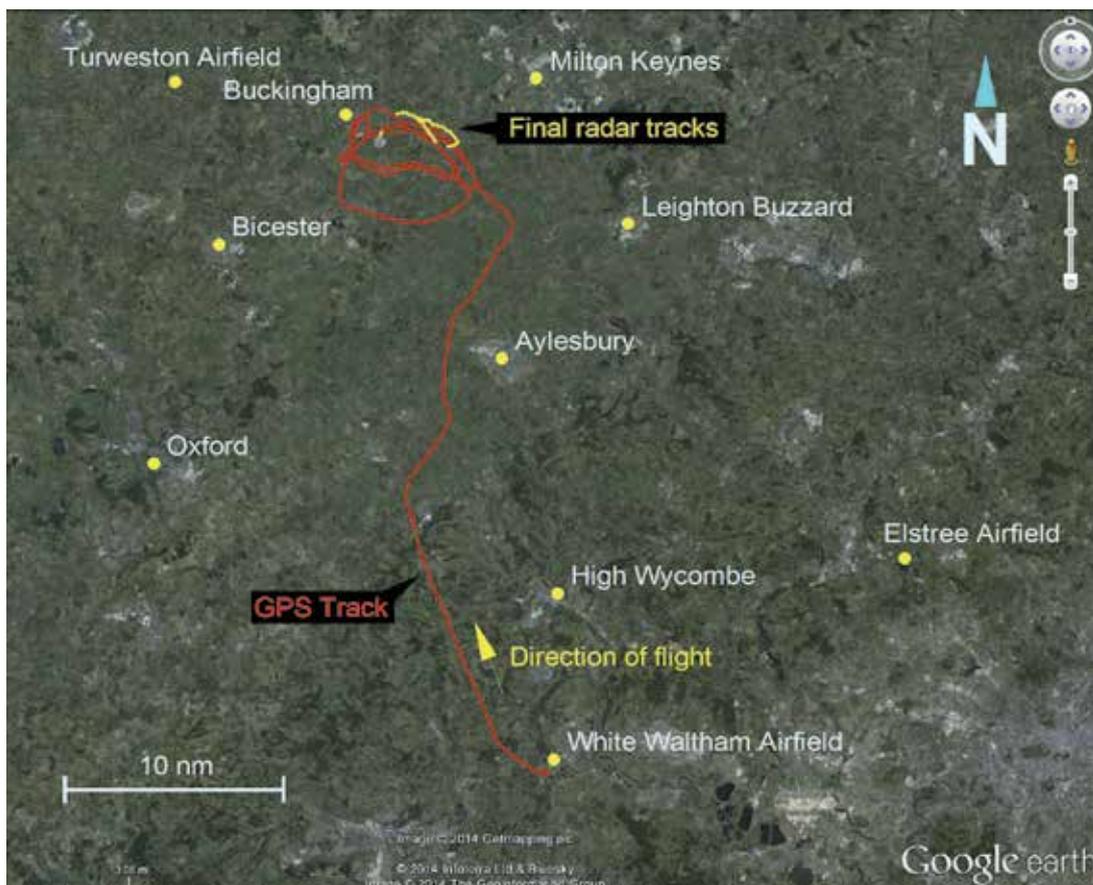
Figure 1

The pilot took off from White Waltham at 1708 hrs and headed in a northerly direction. South of Buckingham he started flying in an approximately circular pattern with a 2 nm to 3 nm radius and continued for almost an hour, remaining between 2,500 ft and 4,700 ft amsl (the base of controlled Class A airspace in the area is 5,500 ft amsl). During this time the pilot made a number of calls on his mobile telephone. A plot of the track of the aircraft, from White Waltham to Buckingham, is shown in Figure 1.

Combined GPS and radar track of flight from White Waltham

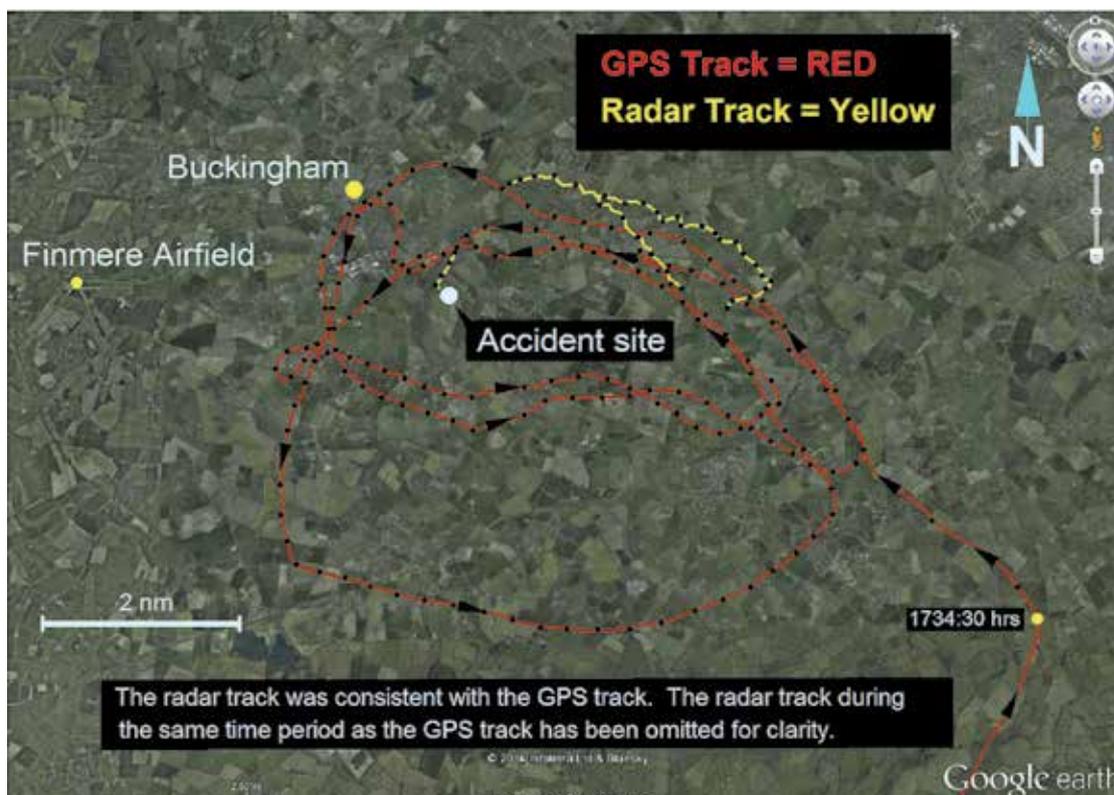
Figure 2

Shortly after takeoff from White Waltham the pilot had attempted to make a phone call, but no network connection was available. Several minutes later, at an altitude of 2,200 ft amsl, he made several phone calls lasting a total of about two minutes. At 1734 hrs the aircraft was about 5 nm west of Leighton Buzzard and had climbed to an altitude of about 2,800 ft, when it started to manoeuvre in a series of turns, predominantly to the left (Figure 2).

GPS and Bovingdon Radar track to the south and south-east of Buckingham

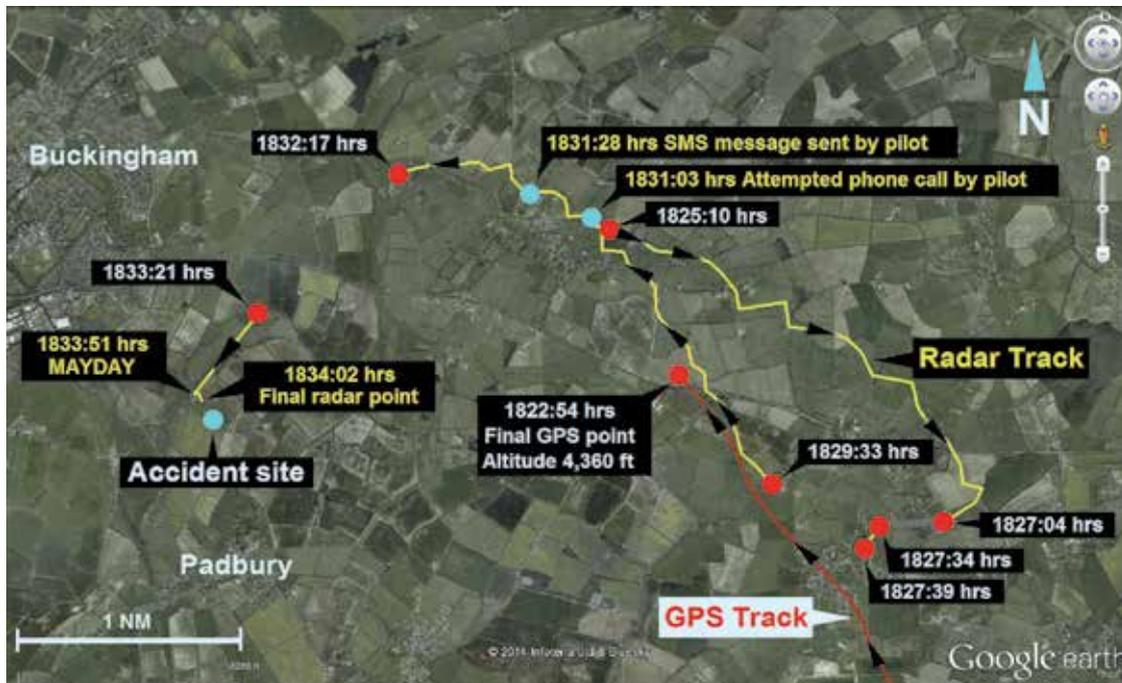
Figure 3

At 1822.54 hrs, the track log ended (Figure 3), with the aircraft recorded at an altitude of 4,360 ft and on a track of 319° T. Its airspeed based on an estimated wind at 5,000 ft of 280° at 12 kt would have been 52 kt. About 30 seconds prior to this the radar record had also stopped, probably due to a computed groundspeed below 50 kt. At 1825:10 hrs the radar record was re-established. Shortly after, at 1831:03 hrs, the pilot attempted to phone a relative's mobile phone, but the outgoing call failed⁸ to connect with the mobile network⁹.

Final GPS and Bovingdon Radar track

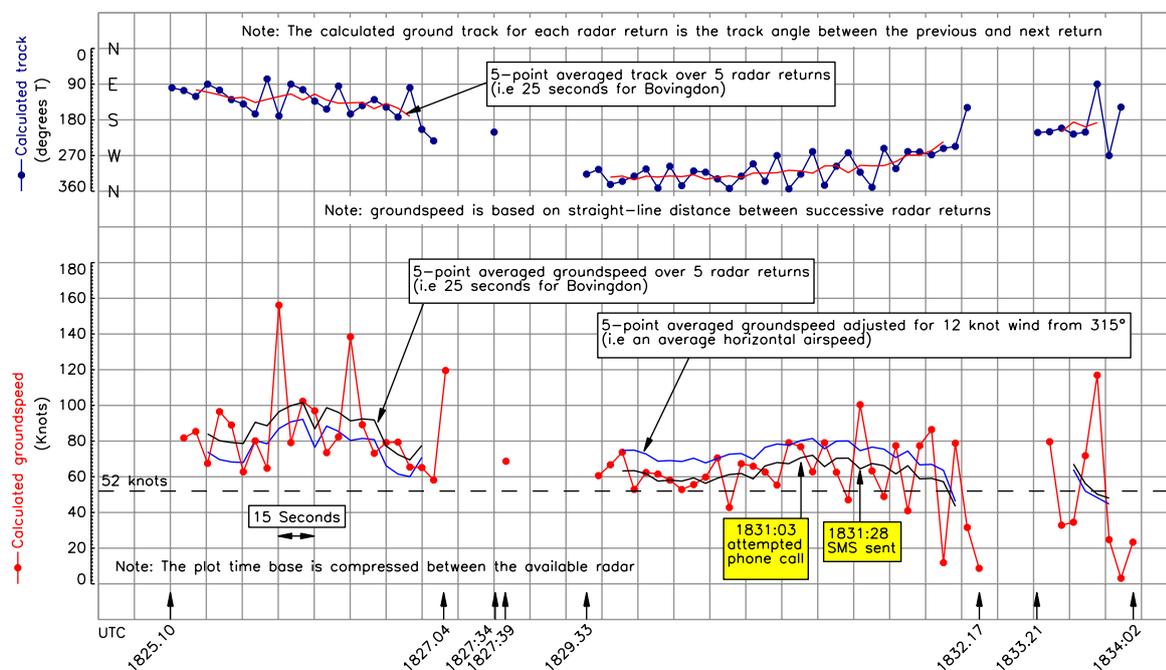
Figure 4

To estimate the airspeed of the aircraft during the final phase of flight, the radar data was corrected for the effect of the wind. This data is presented in Figure 4, which plots both the variation in calculated groundspeed and the corresponding aircraft track as individual points and five-point averages. The plot shows the estimated horizontal component of the aircraft's airspeed, based on the five-point average groundspeed, corrected for a wind from 315° at 12 kt. Given the lack of altitude information, a vertical speed component could not be included because there was no information as to whether the aircraft was climbing, descending or in level flight. Due to the variation in the recorded data, a consequence of the limitations of primary radar, the calculated airspeeds are not accurate enough to demonstrate airspeed at any specific point, but do show that, in general, the aircraft was flying at airspeeds below typical cruise speeds.

Calculated airspeed of G-BNDE based on radar data from Bovingdon
