Report on the investigation of
the loss of the yacht
Cheeki Rafiki
and its four crew
in the Atlantic Ocean,
approximately 720 miles east-south-east of
Nova Scotia, Canada
on 16 May 2014

SYNOPSIS

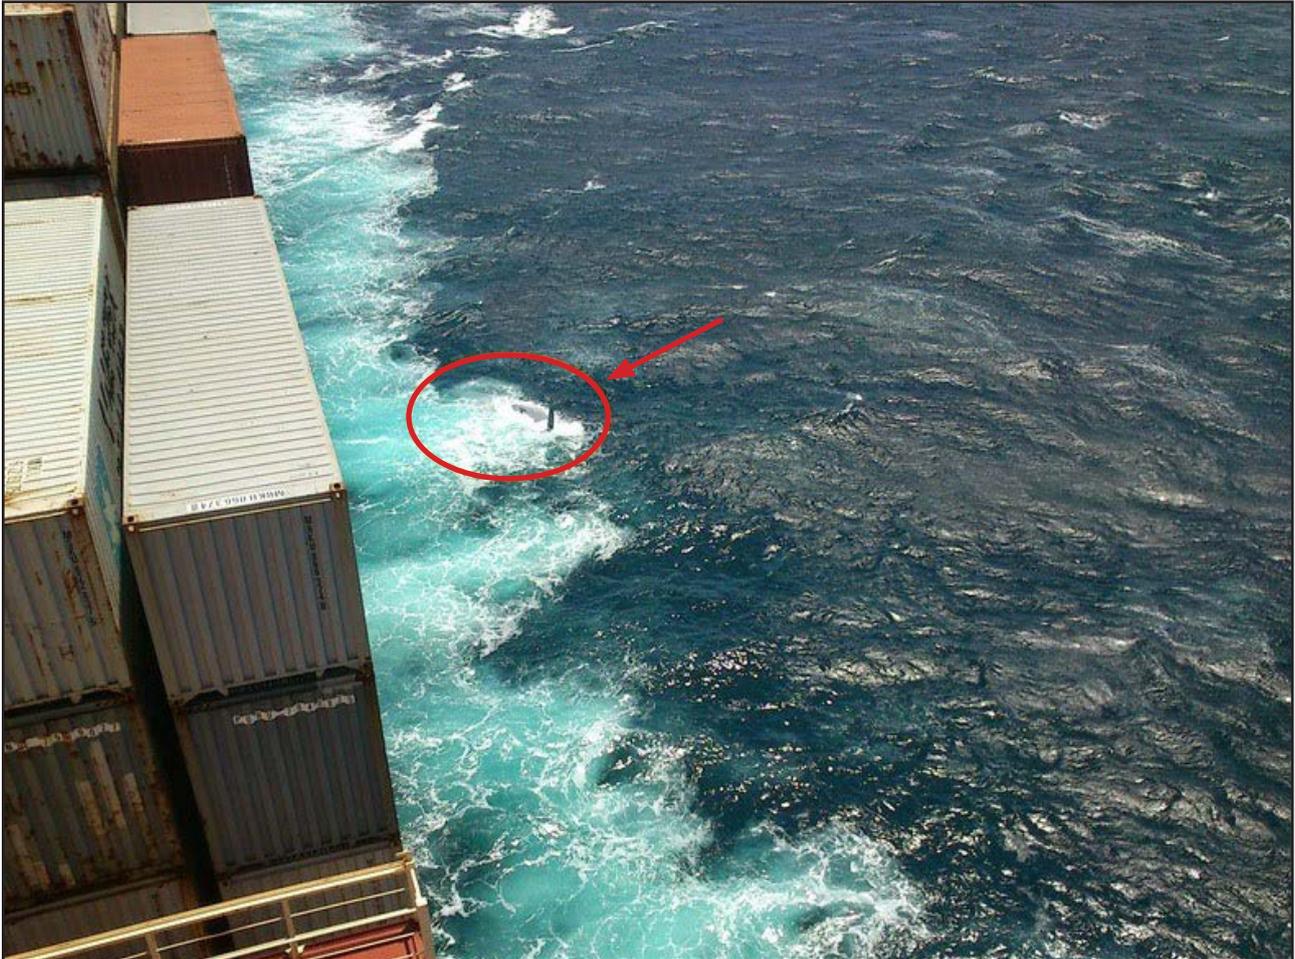
At about 1400 on 17 May 2014, the container ship *Maersk Kure* located the upturned hull of a small boat, which was believed to be *Cheeki Rafiki*. Adverse weather conditions prevented launching the ship's lifeboat or rescue boat (**Figure 6**) to carry out a closer inspection.

Figure 6: Photograph showing the upturned hull of a small boat alongside the container vessel *Maersk Kure* taken on 17 May 2014 at about 1400

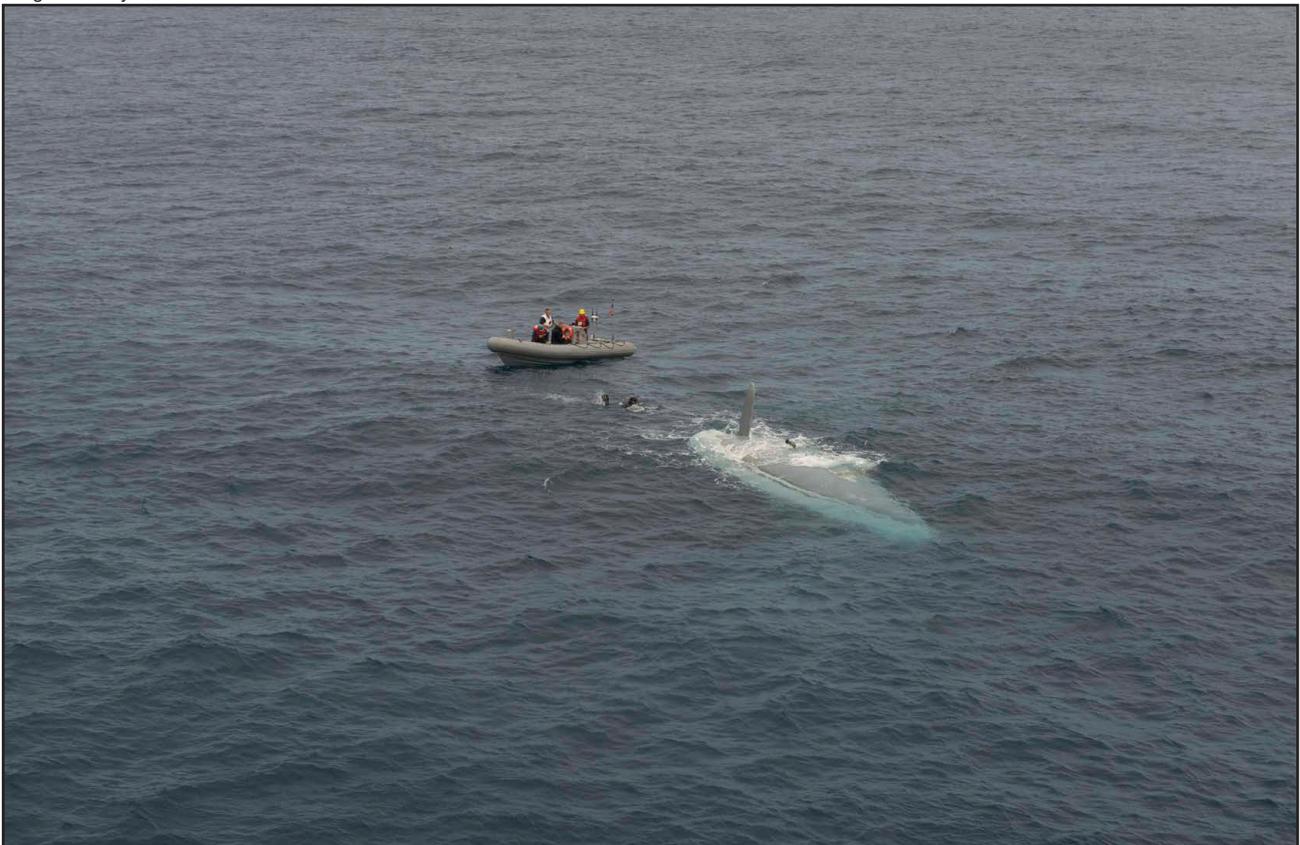
Figure 7: Photograph of Cheeki Rafiki's upturned hull being inspected by the US Navy

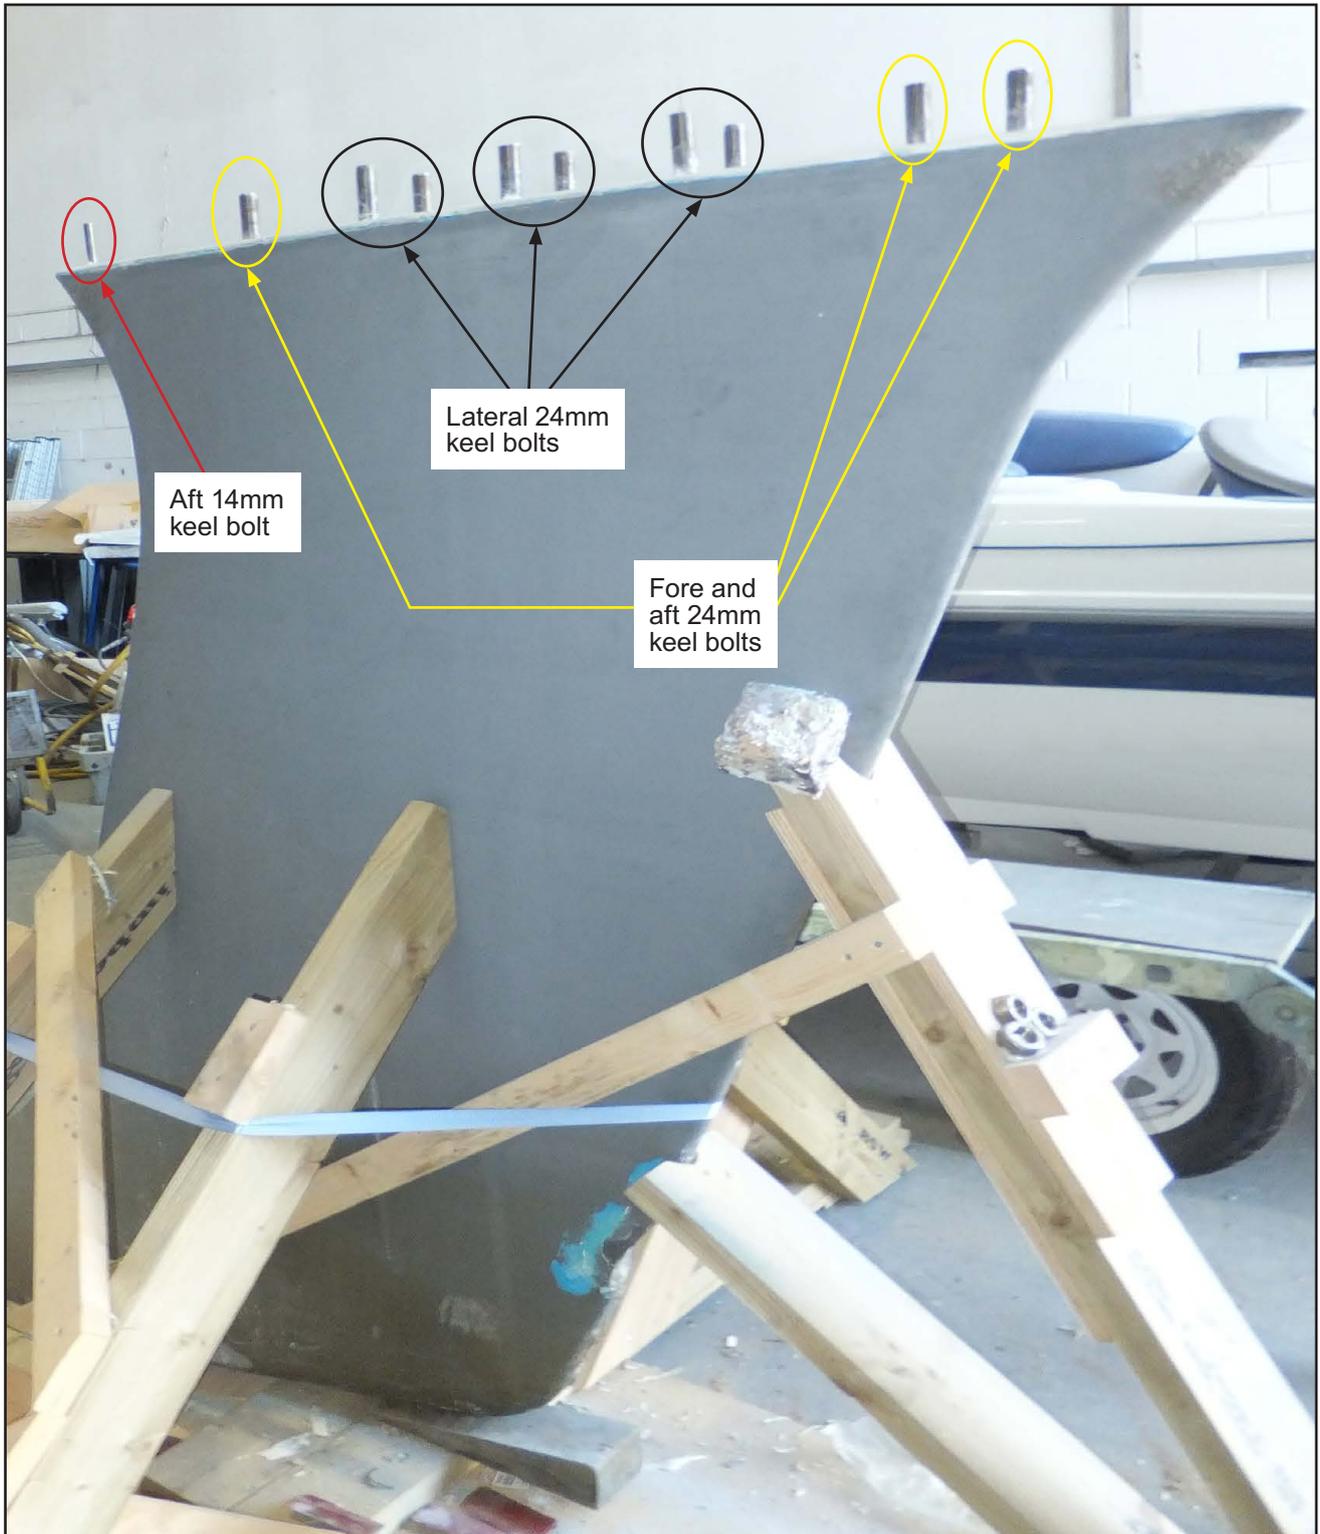
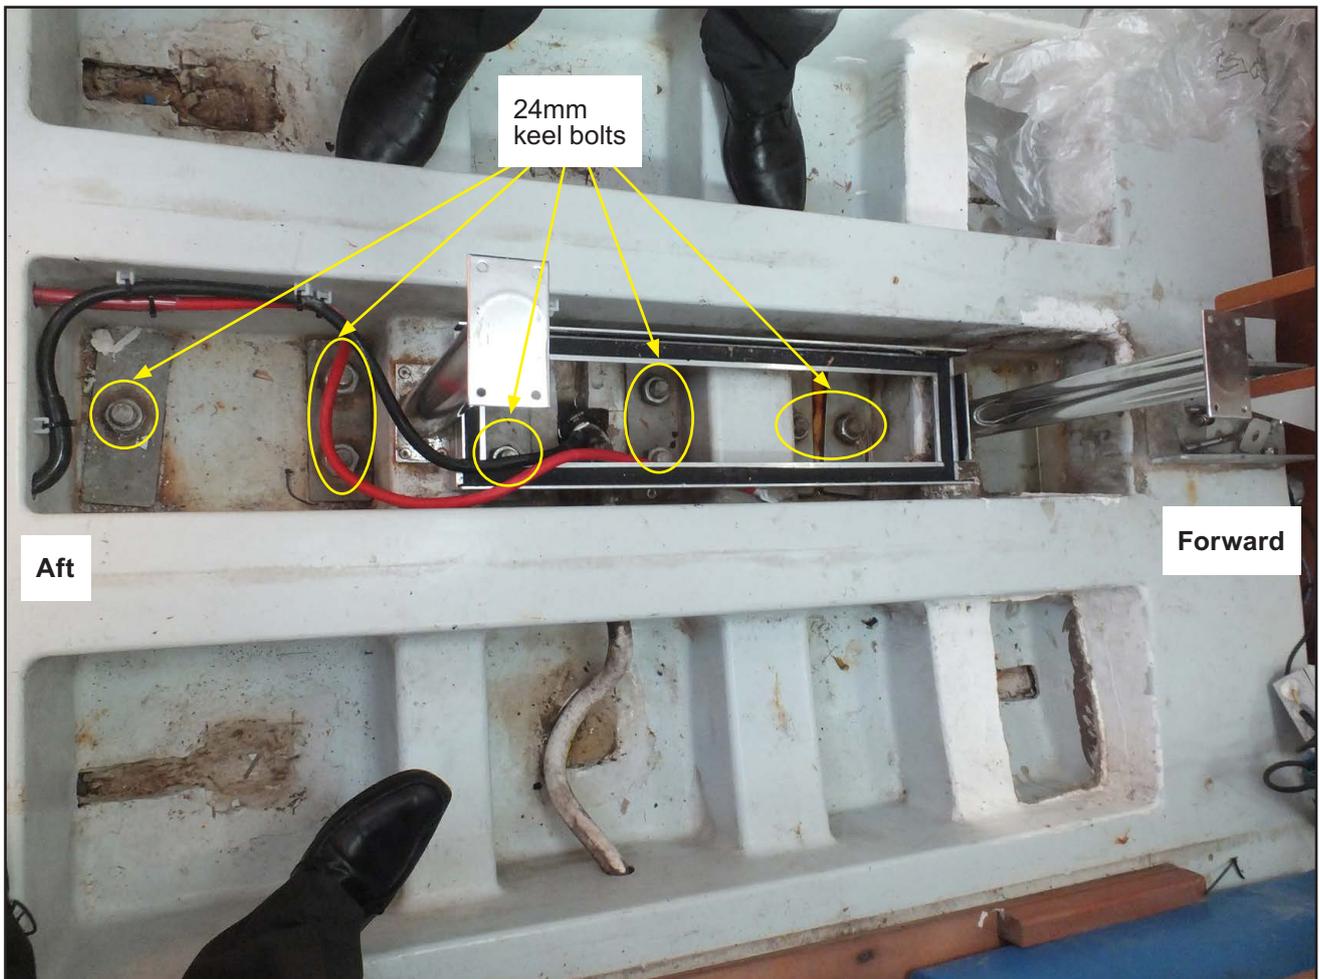
The Beneteau First 40.7 was available with two keel options: a shorter cast iron bulb type keel and a more popular deep fin cast lead keel. The lead keel was manufactured with stainless steel bolts cast into it. There were nine 24mm bolts: three designed to carry the fore and aft loading on the keel, and six primarily to carry the lateral loading (**Figure 9**). The three bolts carrying the fore and aft loading were arranged with two single bolts at the forward end of the keel and one single bolt aft. The six bolts designed to carry the lateral loading were arranged in pairs. All of the 24mm bolts were secured to the glass reinforced plastic (GRP) hull with a washer (i.e. backing) plate and nut (**Figure 10**).

In addition, the design provided for a 14mm bolt at the extreme forward end and at the after end of the keel, to prevent the GRP flexing away from the top of the keel. However, only the aft bolt was installed in the manufactured product owing to insufficient material being available in which to effectively install the forward bolt (**Figure 9**). The Wolfson Unit's assessment of the keel structure (**Annex C**) was based on a Beneteau First 40.7 design incorporating only the aft 14mm bolt.

Figure 9: Typical Beneteau First 40.7 keel bolt arrangement (not *Cheeki Rafiki*)

Figure 10: Typical Beneteau First 40.7 keel bolt arrangement (not *Cheeki Rafiki*)

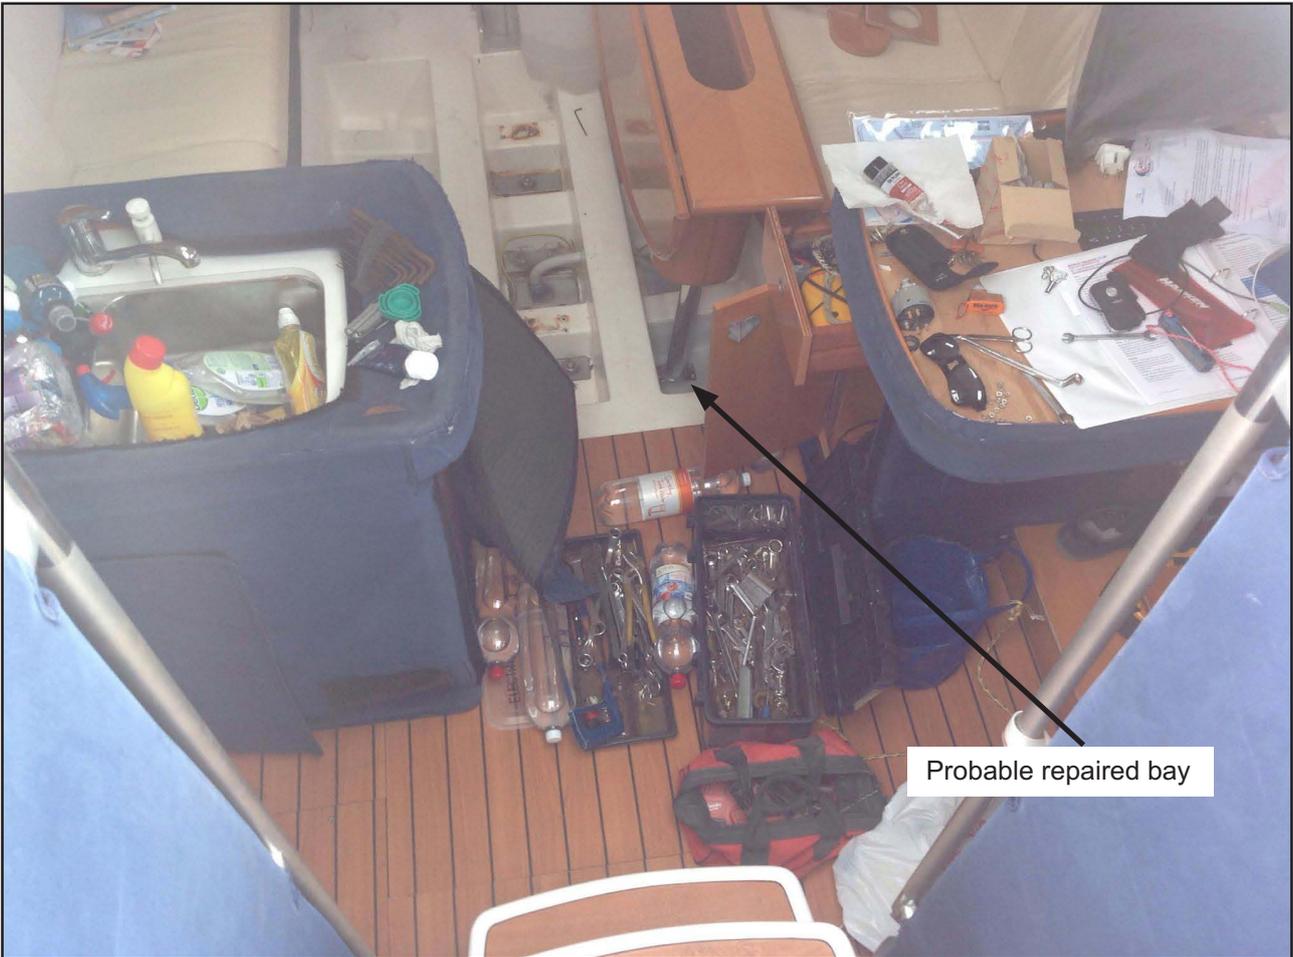
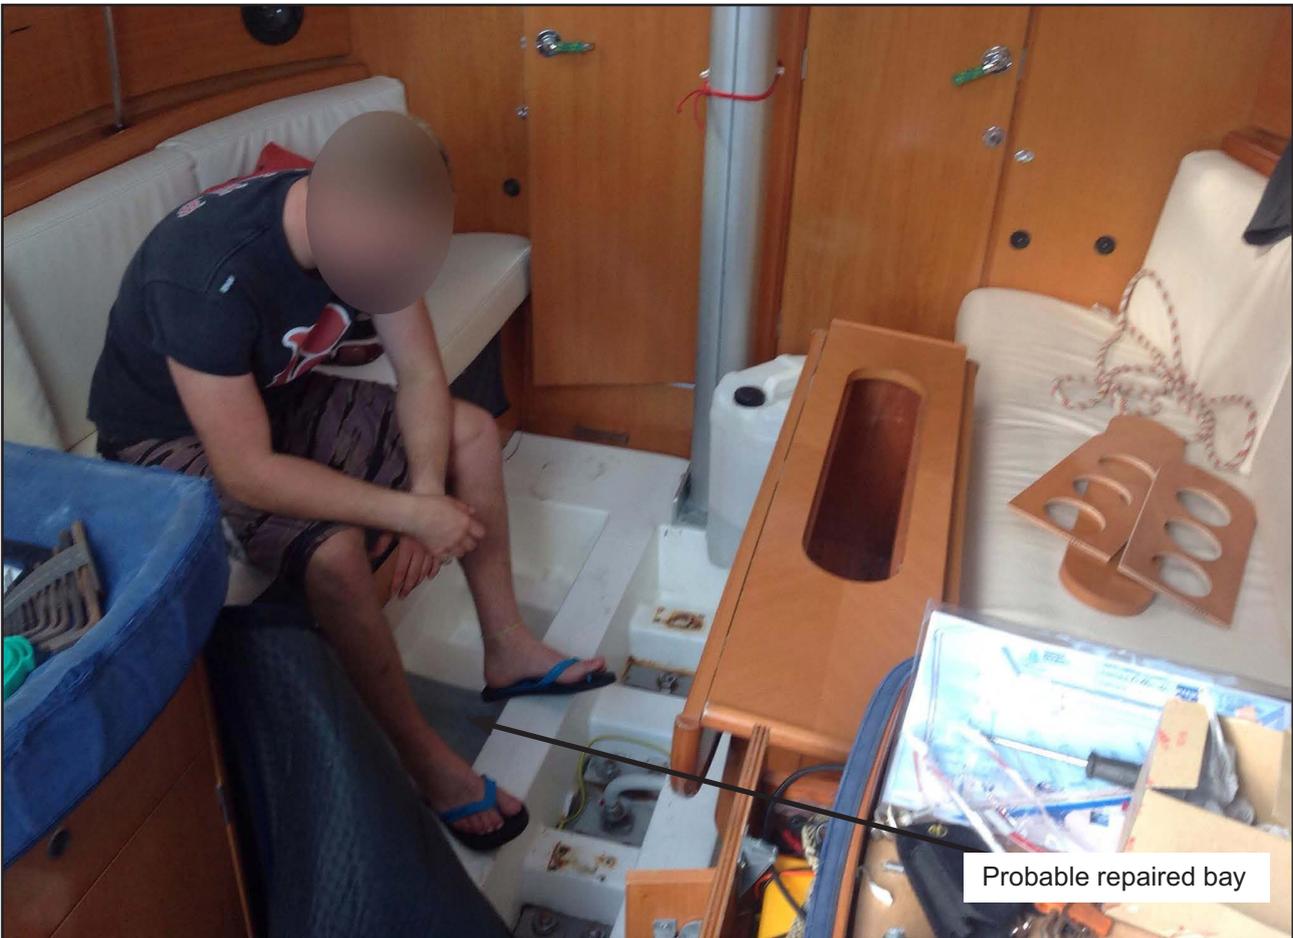
The repair invoice also indicates that the repair was not carried out in accordance with Beneteau's recommended method contained in the advice to its after sales and dealer network. Of the repairers visited by MAIB inspectors, there was divided opinion as to the appropriate repair method and, again, there is currently no industry-wide guidance on this matter.

Figure 16: *Cheeki Rafiki's* keel bilge area prior to departure on the ARC 2013, with table temporarily removed

Figure 17: *Cheeki Rafiki's* keel bilge area prior to departure on the ARC 2013, with table temporarily removed

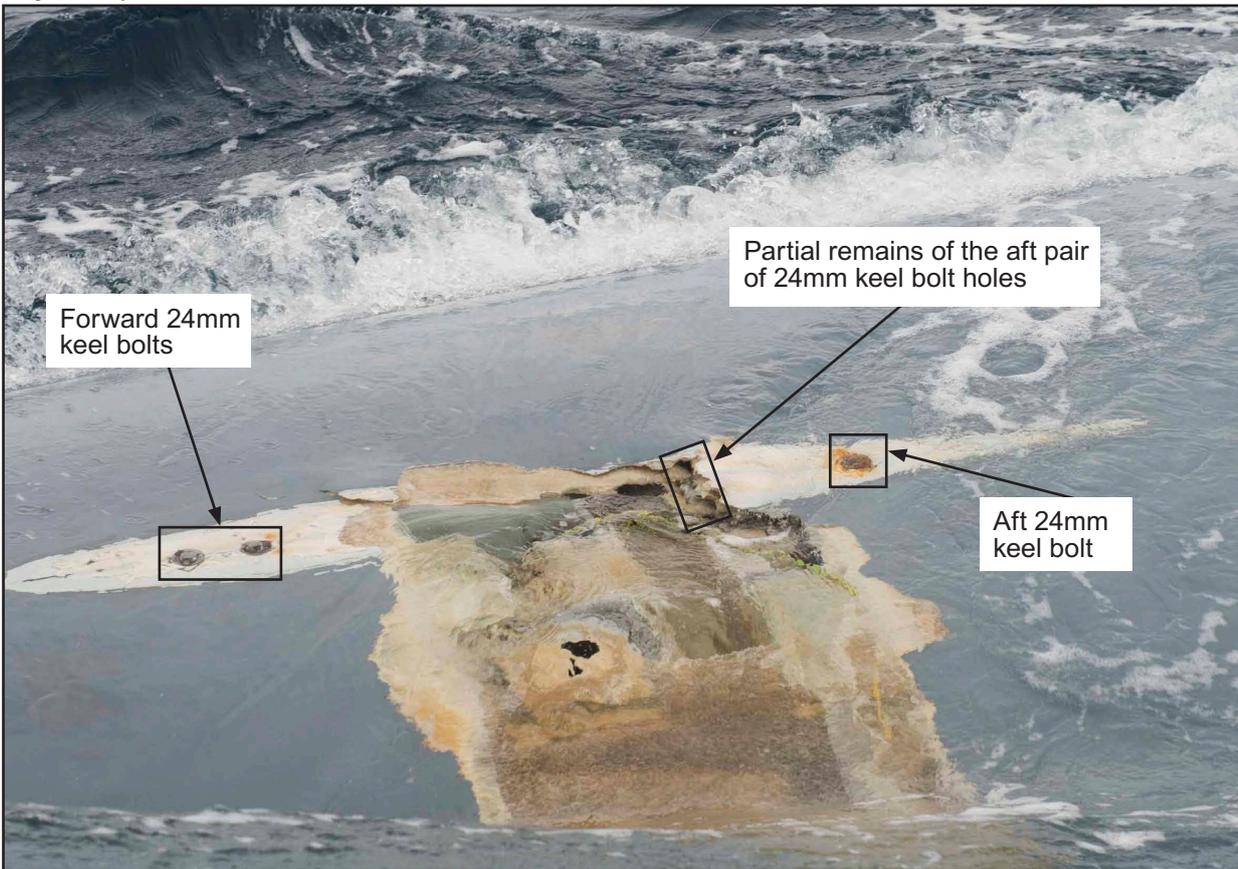
Figure 18: Photograph of *Cheeki Rafiki's* upturned hull taken by the crew of USS *Oscar Austin* in the afternoon of 23 May 2014

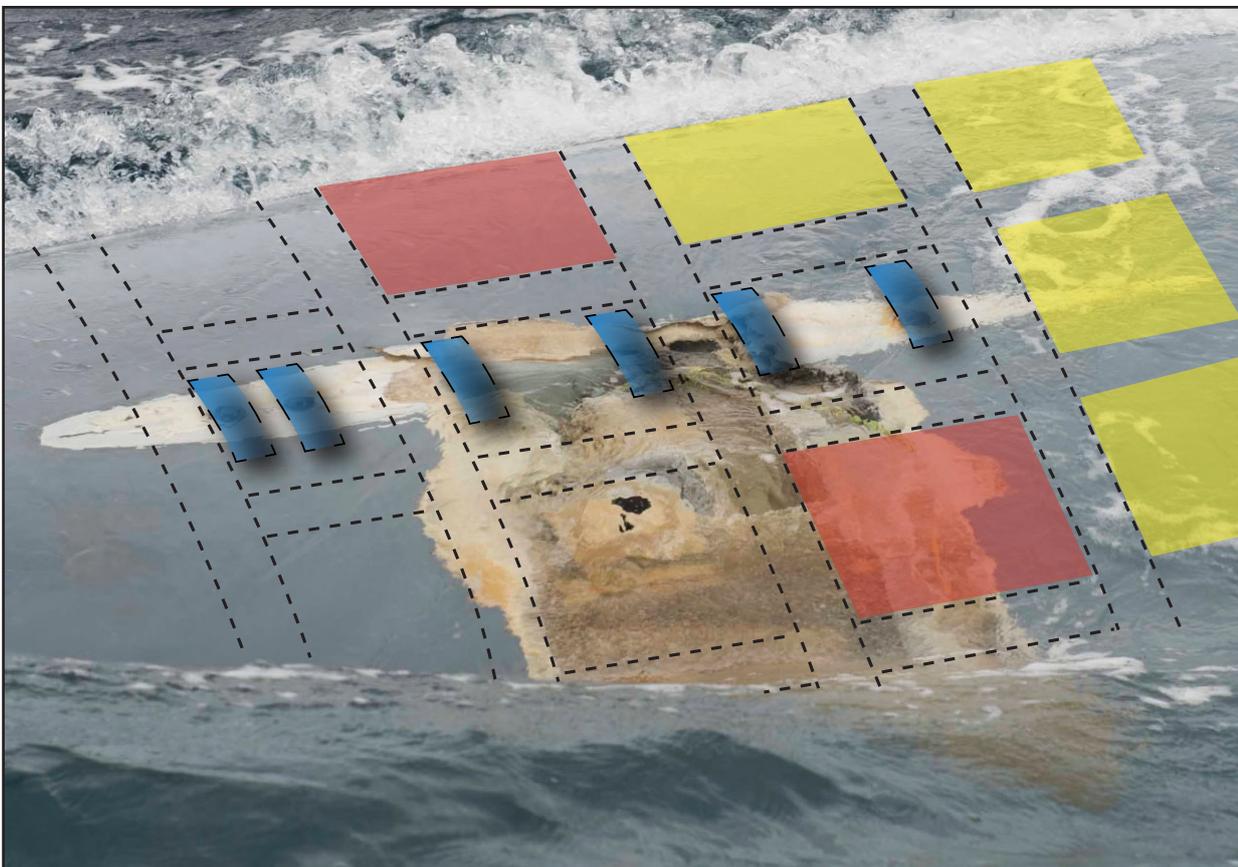
During Cowes Week in August 2007 *Cheeki Rafiki* suffered what was described as a 'light grounding' in Stanswood Bay, in The Solent. It was subsequently inspected by a GRP repairer who had the vessel lifted out of the water and temporarily rested it on its keel to enable inspection for signs of hull deflection. The matrix was then hammer tested in an attempt to identify detached areas. Repairs to the vessel were completed in September 2007.

'Remove floor boards and pipe work in way of damaged areas. Cut flanges off six bays, grind back hull, laminate and sides of structural floors. Bond structural floor to hull with GRP, lightly rub down and apply wax gel. Drill off limber holes, refit pipes and floors. Clean vessel. Lift plate washers and re bed'.

Cheeki Rafiki's keel was not removed to carry out these repairs.

Figure 19: Figure 18 superimposed with the approximate position of the matrix frames and location of the bays probably (red) and possibly (yellow) repaired in 2007
