Wolfson Unit report following its assessment of the keel structure of the Beneteau First 40.7 yacht *Cheeki Rafiki*

Report No. 2542

Assessment of the Keel Structure of the Beneteau 40.7 Yacht - Cheeki Rafiki

Loss of the yacht Cheeki Rafiki and its four crew

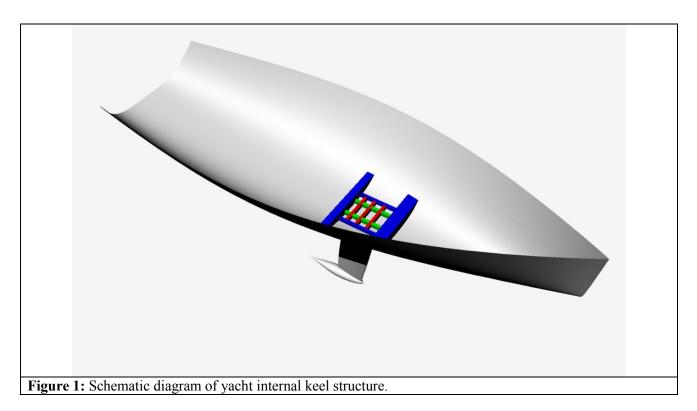
Figure 1 shows a schematic representation of the internal keel structure of the Beneteau 40.7 Yacht. The hull is constructed of a solid hull laminate, with a separate stiffening structure which is laminated and then bonded to the hull. Figure 1 shows only the structure surrounding the keel.

The elements coloured blue are the significant stiffeners in the hull, and are the parts of the structure at which the boundary conditions of the structural analysis are applied. The keel floors are coloured red and the keel longitudinal girders are coloured green. This form of construction is common within the mass produced yacht sector. The floors and girders provide stiffness to the surrounding area of hull laminate, and the keel is attached to the hull via 9×24 mm and 1×14 mm through bolts.

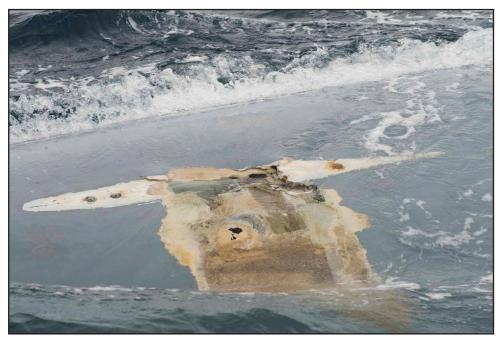
On 16 May 2014, an alert was received from the personal locator beacon of the skipper of the United Kingdom (UK) registered yacht *Cheeki Rafiki*, which was on passage from Antigua to the UK, and located approximately 720 miles east-south-east of Nova Scotia, Canada. Despite a major search effort, during which the yacht's upturned hull was located but not recovered, *Cheeki Rafiki*'s four crew remain missing.

In the absence of survivors and material evidence, the causes of the accident remain a matter of some speculation. However it is concluded that the yacht capsized and inverted following a detachment of its keel. In the absence of any apparent damage to its hull or rudder other than that likely to have been directly associated with keel detachment, it is concluded unlikely that the vessel had struck a submerged object. Instead, a combined effect of previous groundings and subsequent repairs to its keel and matrix had possibly weakened the vessel's structure where the keel was attached to the hull. It is also possible that one or more keel bolts had deteriorated. A consequent loss of structural strength may have allowed movement of the keel which would have been exacerbated by increased transverse loading through sailing in worsening sea conditions.
