Report on the investigation of  
the accidental release of a lifeboat on

***Nagato Reefer***

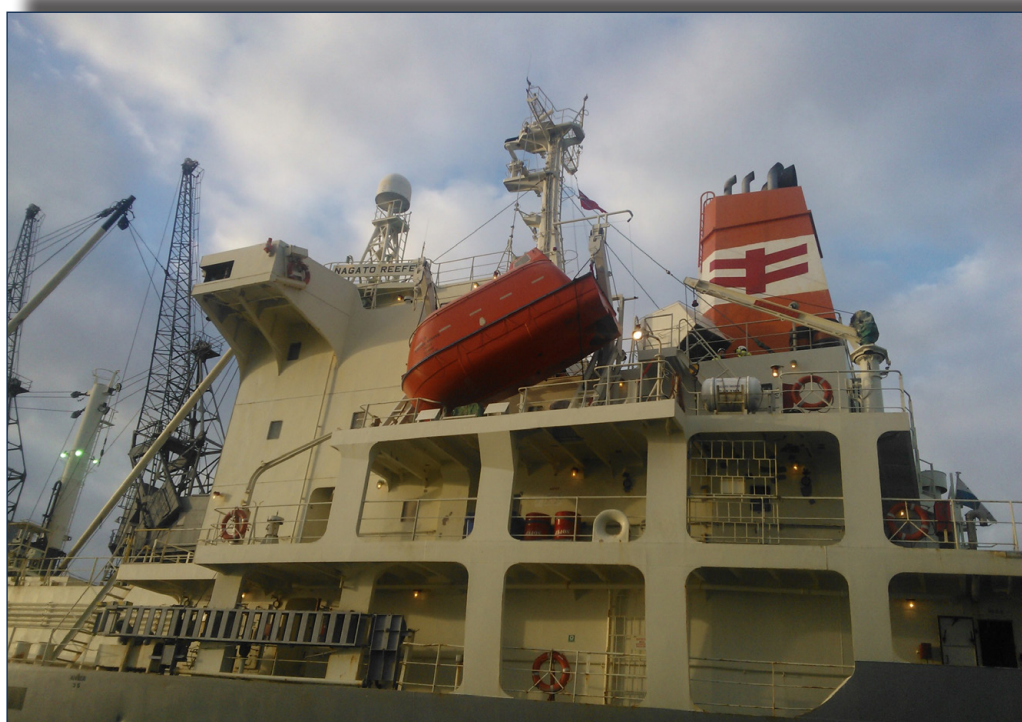
**Extract from**  
**The United Kingdom Merchant Shipping**  
**(Accident Reporting and Investigation)**  
**Regulations 2012 – Regulation 5:**

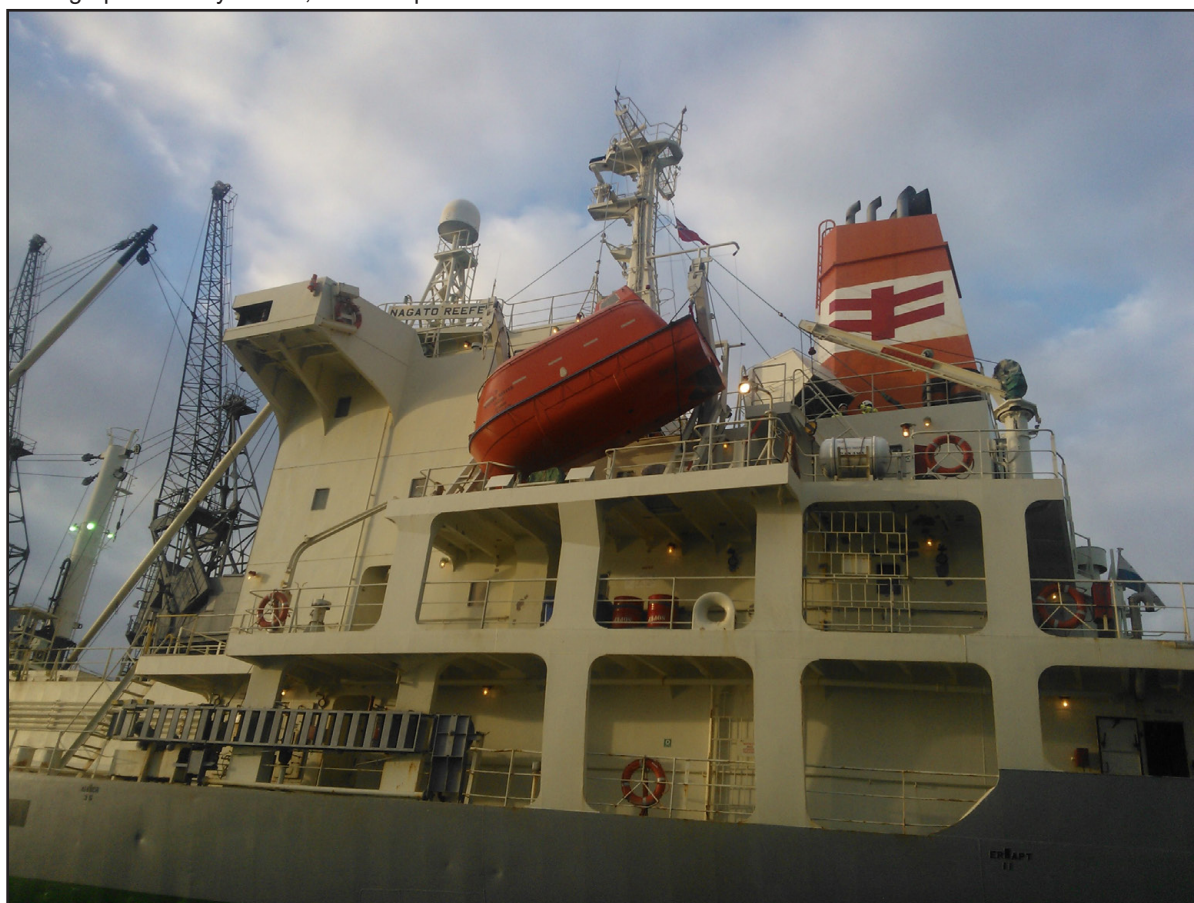
Photograph courtesy of ABP, Southampton

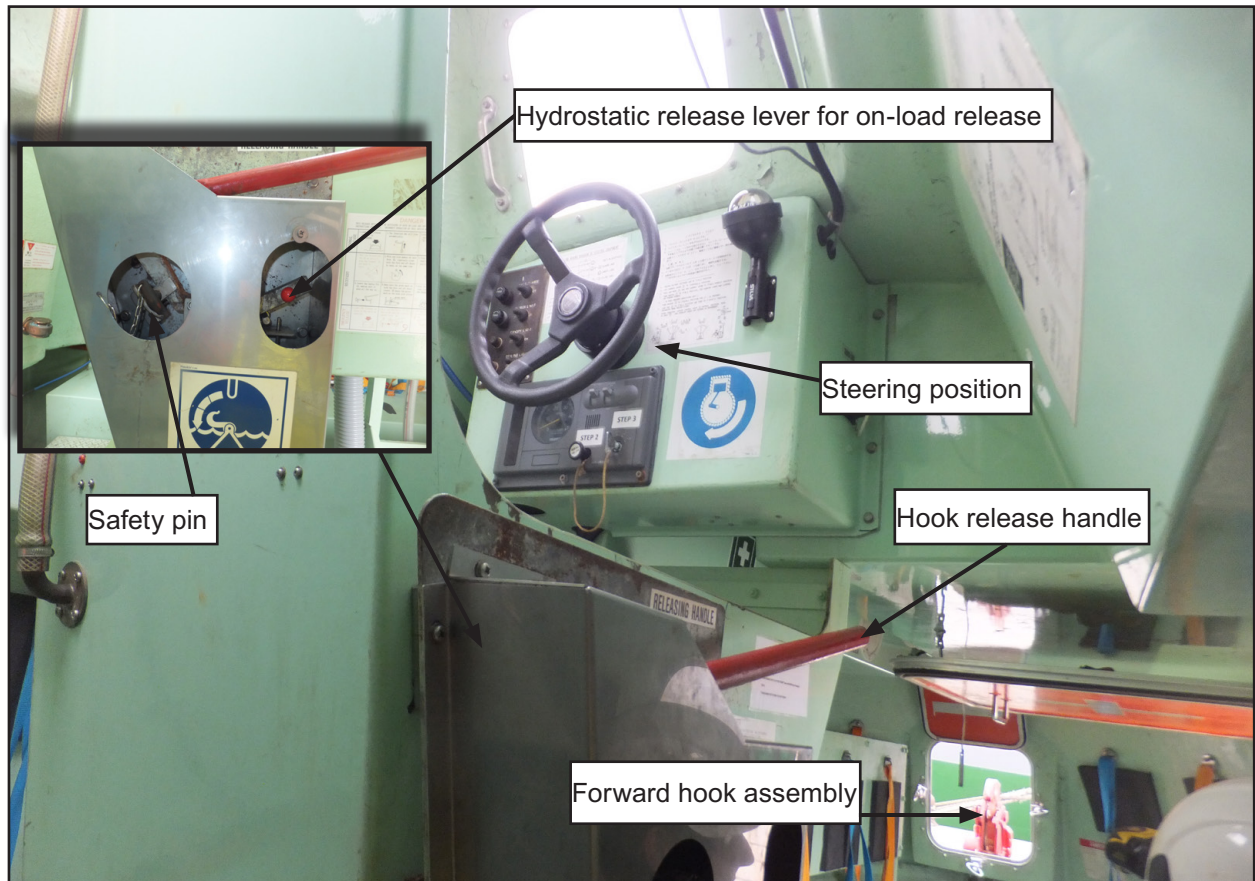
**Figure 2:** Lifeboat interior - steering position and hook release handle

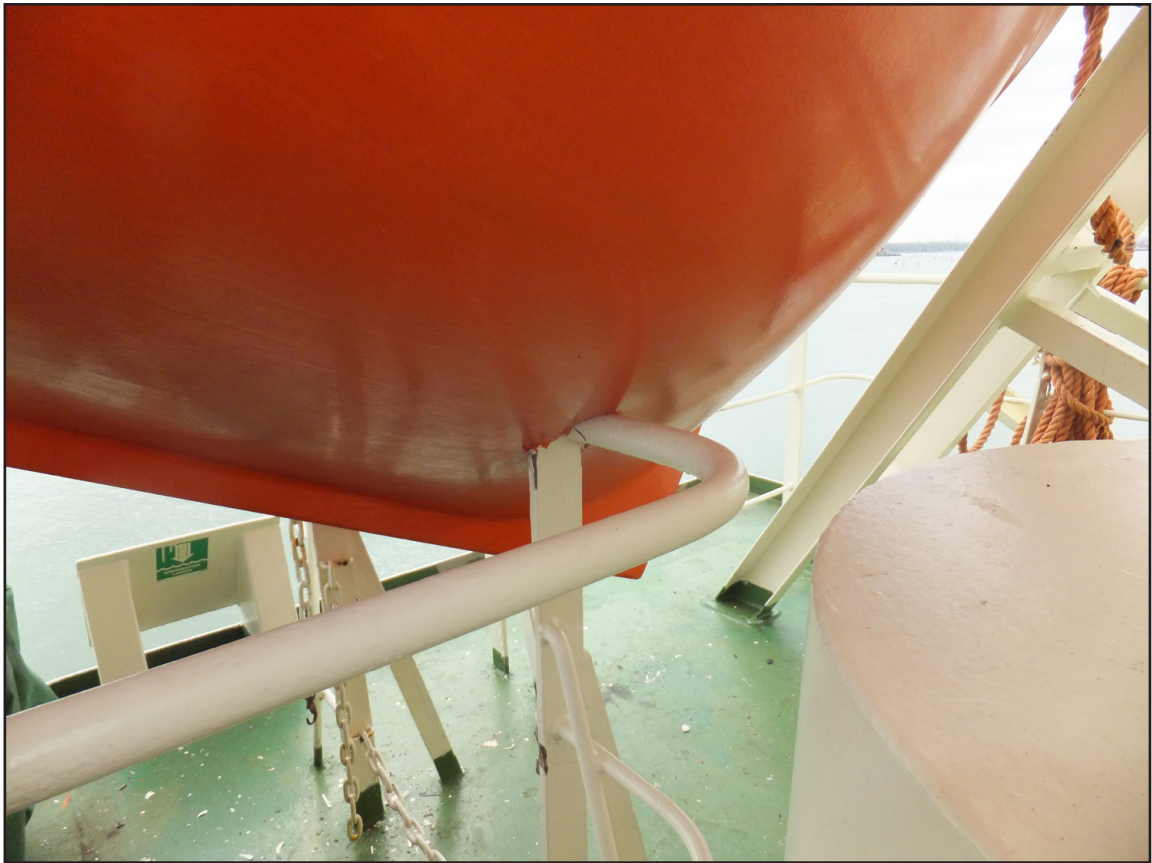
**Figure 6:** Lifeboat hull damage

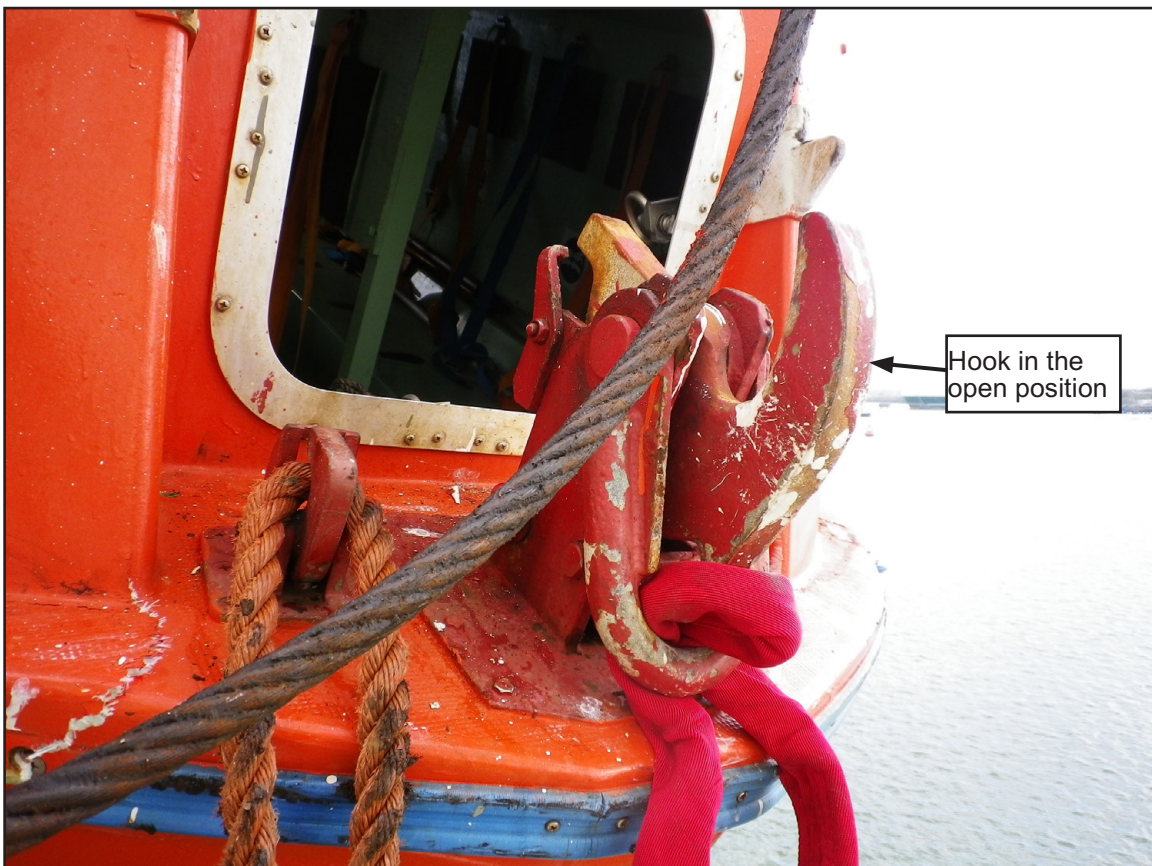
**Figure 7:** Forward hook as photographed post accident at 1608

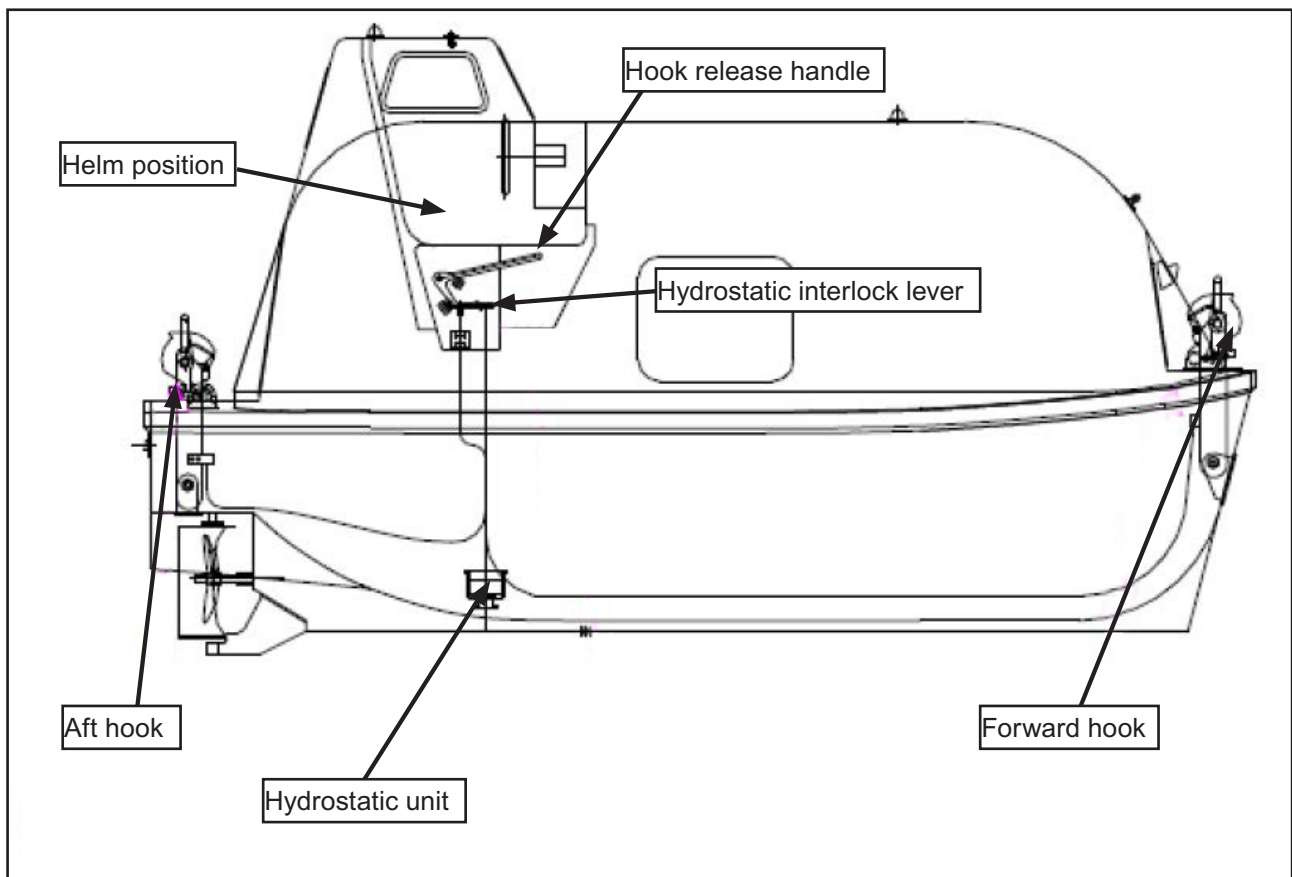
**Figure 8:** Lifeboat hook release gear arrangement

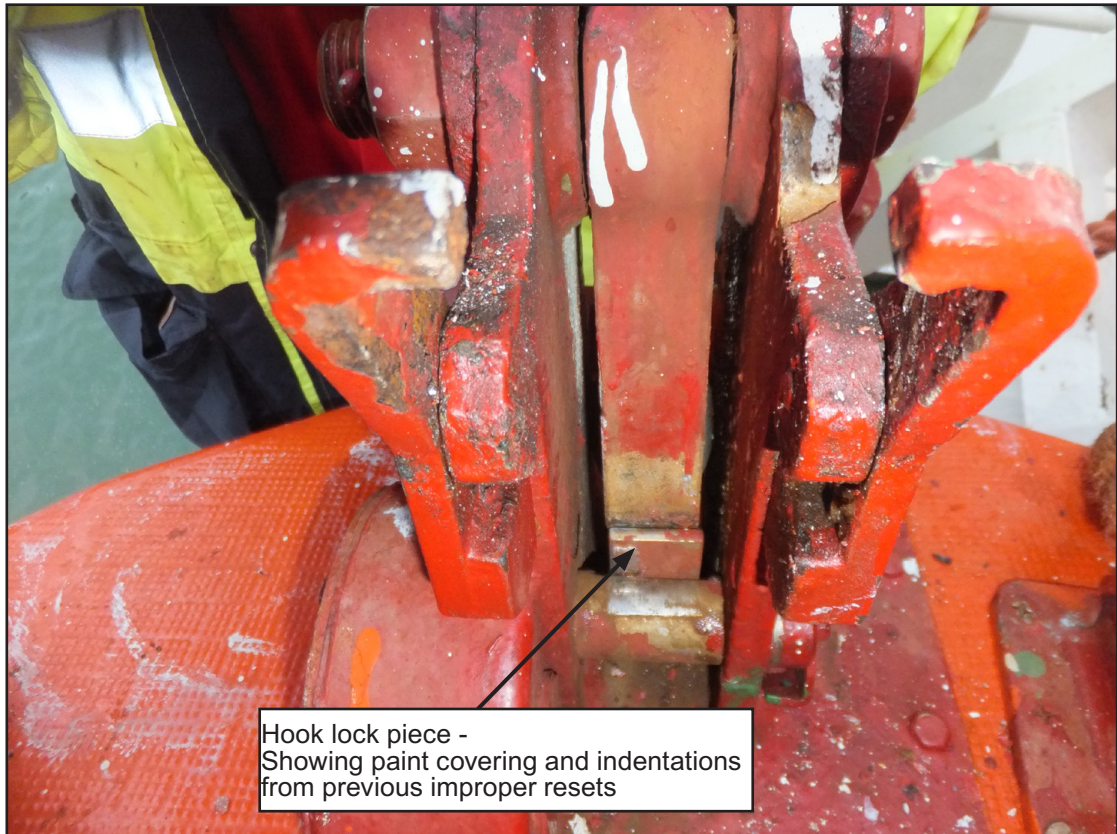
**Figure 12:** Port lifeboat - forward hook assembly

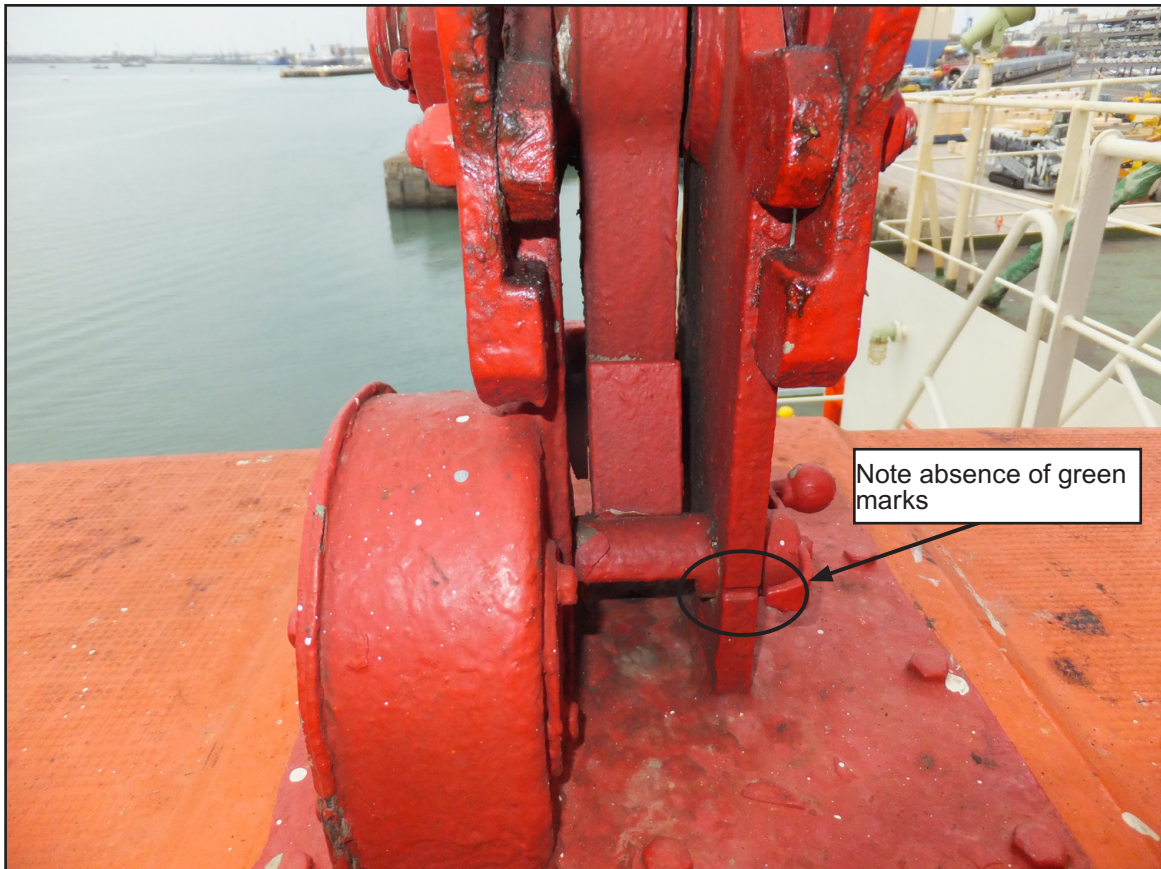
**Figure 13:** Starboard lifeboat aft hook assembly (as found)

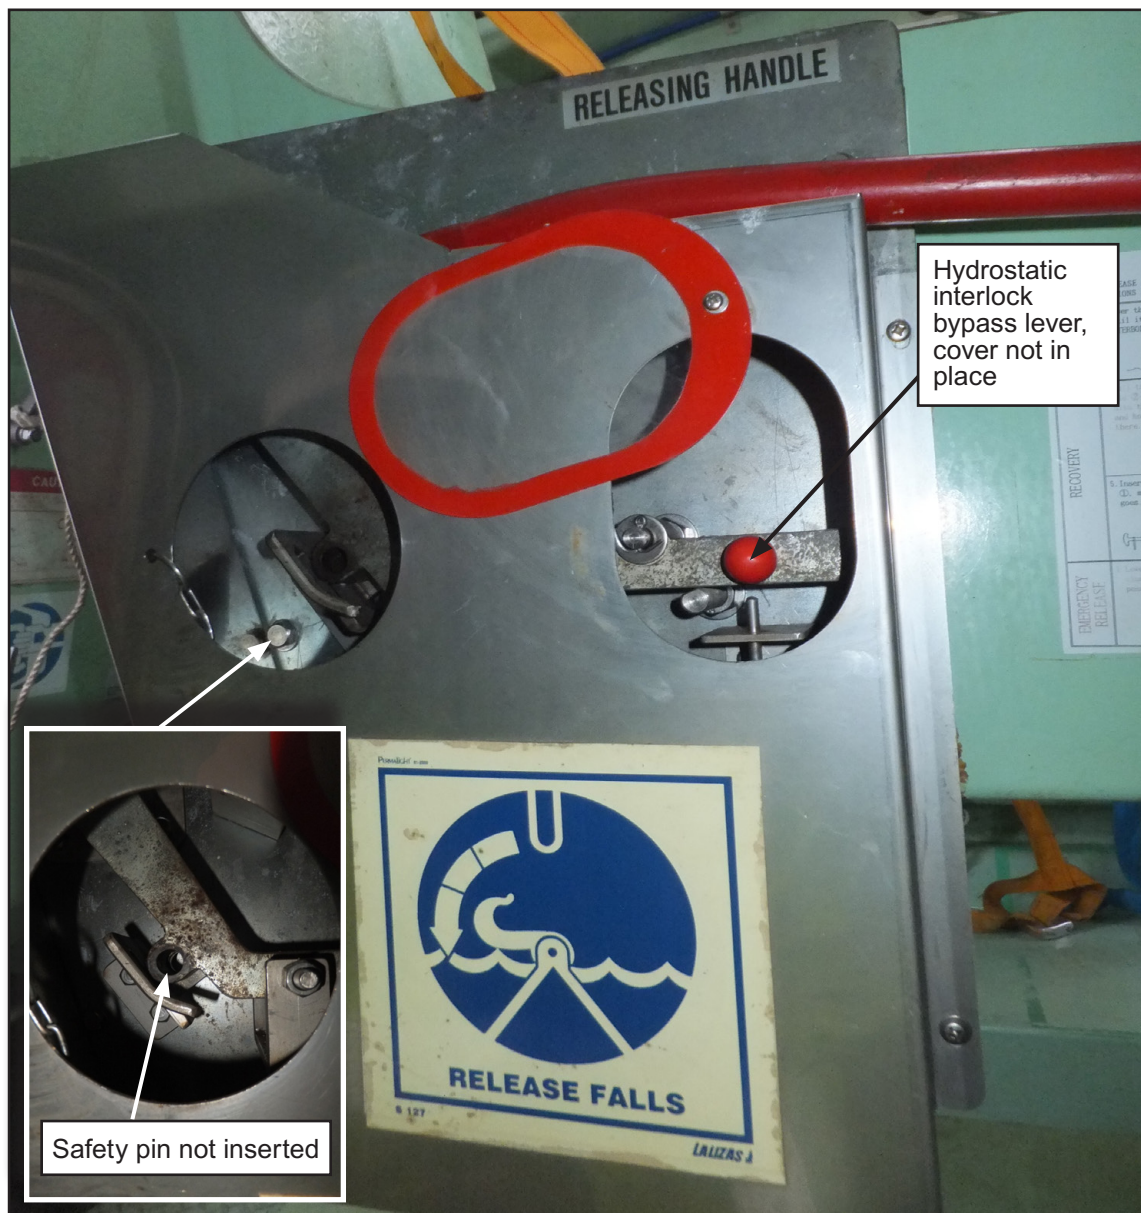
**Figure 14:** Starboard lifeboat - release lever (as found)
