## ACCIDENT

<b>Aircraft Type and Registration:</b>	CZAW SportCruiser, G-EWZZ	
<b>No &amp; Type of Engines:</b>	1 Rotax 912 ULS piston engine	
<b>Year of Manufacture:</b>	2010 (Serial no: LAA 338-14815)	
<b>Date &amp; Time (UTC):</b>	9 August 2014 at 1440 hrs	
<b>Location:</b>	Kingarth, Isle of Bute, Scotland	
<b>Type of Flight:</b>	Private	
<b>Persons on Board:</b>	Crew - 1	Passengers - 1
<b>Injuries:</b>	Crew - 1 (Serious)	Passengers - 1 (Fatal)
<b>Nature of Damage:</b>	Aircraft destroyed	
<b>Commander's Licence:</b>	National Private Pilot Licence	
<b>Commander's Age:</b>	53 years	
<b>Commander's Flying Experience:</b>	555 hours (of which 100 were on type) Last 90 days - 29 hours Last 28 days - 1 hour	
<b>Information Source:</b>	AAIB Field Investigation

## Synopsis

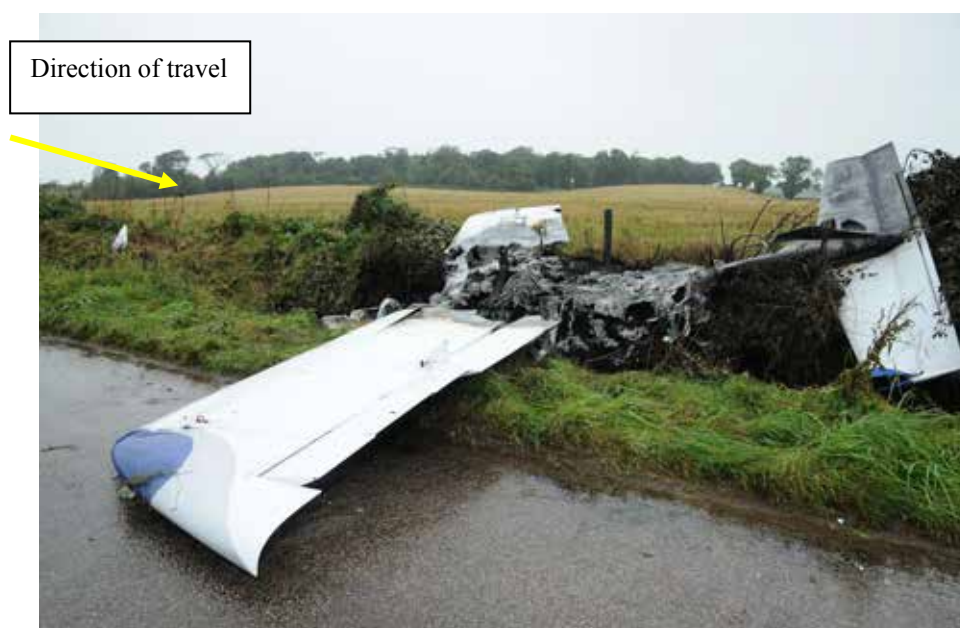
**Figure 2**  
Accident site

The accident site was approximately 590 m north of Bute Airstrip along the line of a fence and ditch that ran parallel to the A844. With the exception of the field to the north of the road, which contained a crop of corn approximately 0.4 m high, there were no other suitable areas in the immediate vicinity in which to land. See Figure 2.

Ground marks and paint flakes from the right wingtip show that the aircraft touched down on the right mainwheel and nosewheel at a relatively shallow angle, banked to the right on a heading of approximately  $115^{\circ}(T)$ . The nosewheel broke off and the aircraft continued to slide forward with the inner section of the left wing striking and knocking over several fence posts. After approximately 10 m the front section of the aircraft dropped into a ditch and the aircraft turned over onto its back with the fin coming to rest in a hedge. Propeller cut marks in the ground indicated that the engine was still producing power when it struck the ground.

Foliage in the ditch, the fence posts and foliage on the north side of the ditch were all badly burnt, whereas the grass on the south side of the road was not. This burn pattern was consistent with the direction of the wind.

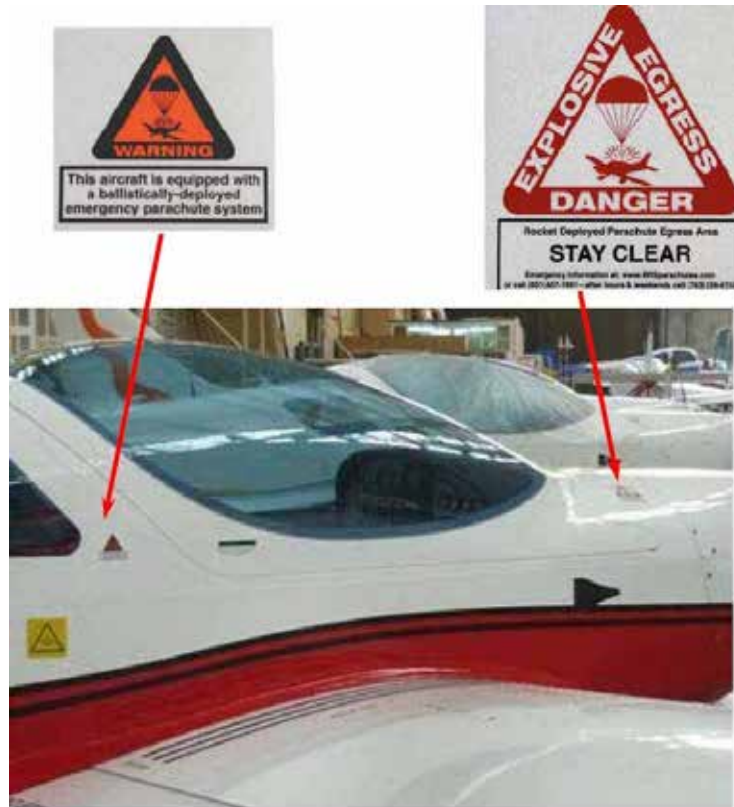
**Figure 5**

The manufacturer of the system, BRS, required the SportCruiser to have three warning placards attached to the airframe. An orange and black 'Ballistic Warning' placard attached aft of the canopy on each side of the fuselage and a red and grey 'Stay Clear' placard attached on the right side of the parachute egress panel, Figure 5.

Warning labels required by BRS for the SportCruiser installation

The markings on the fin and side of the fuselage warning that a ballistic system was fitted to the aircraft had all burnt off in the post-crash fire. Due to the fire damage to the aircraft it was difficult to identify many of the components in the BPRS system.

It is recommended that the European Aviation Safety Agency review the requirement for the placarding of aircraft fitted with a Ballistic Parachute Recovery System so that the warning placards contain information on the location of the rocket launcher and the actuating device, and can be read from a safe distance regardless of the stationary attitude of the aircraft.

It is recommended that the Civil Aviation Authority review the requirement for the placarding of aircraft referred to in Regulation (EC) 216/2008 Annex II, fitted with a Ballistic Parachute Recovery System, so that the warning placards contain information on the location of the rocket launcher and the actuating device, and can be read from a safe distance regardless of the stationary attitude of the aircraft.

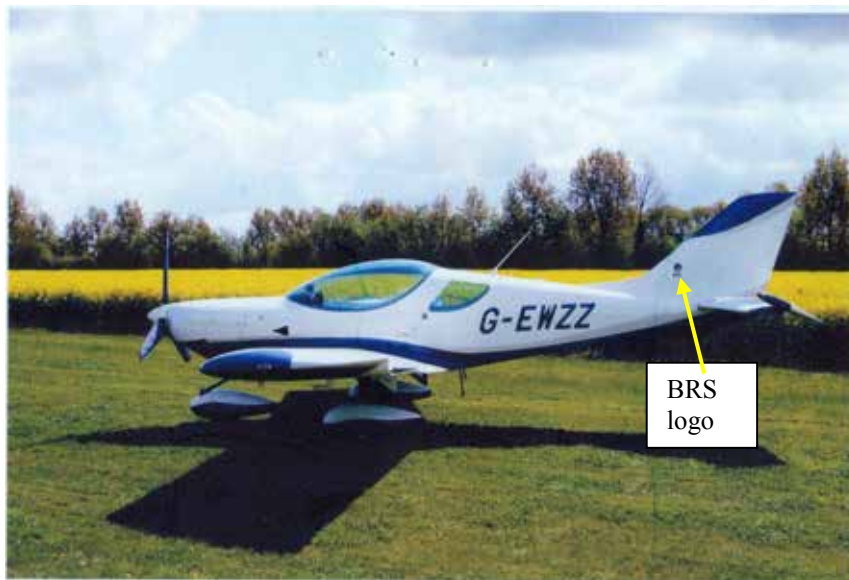
**Figure 6**

G-EWZZ also had a BRS logo attached near the base of the left side of the fin, Figure 6. There were no other placards or logos on the outside of the aircraft to indicate that the aircraft was fitted with a BPRS.

BRS logo on left side of fin
