Report on the investigation of  
a fatal accident to the skipper of fishing vessel

***Ronan Orla***

3 miles north-east of Porth Dinllaen

on 30 March 2014

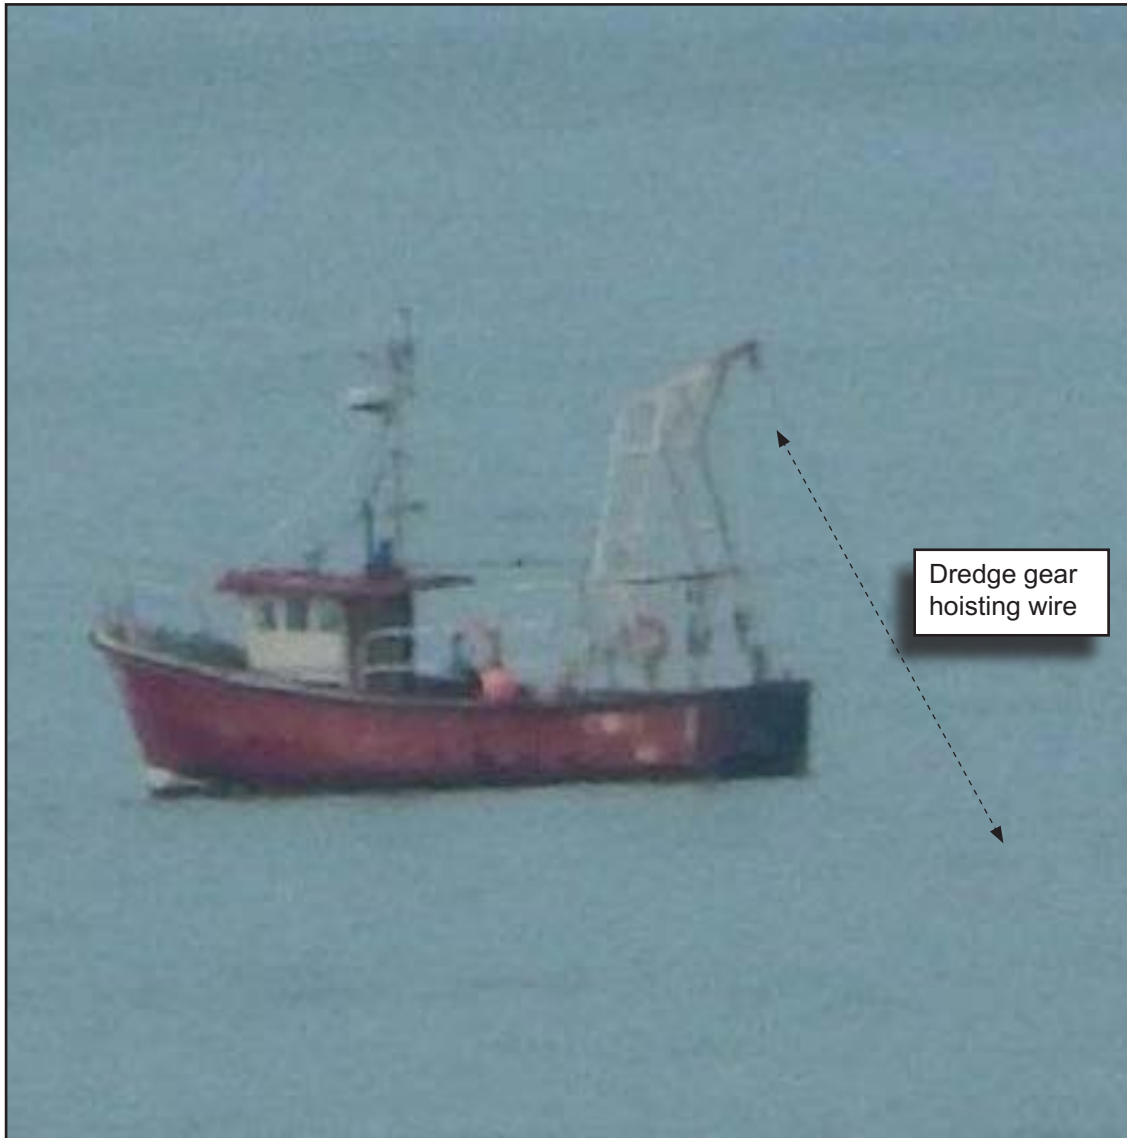
**Figure 3:** Photograph of *Ronan Orla* taken from a beach at 1348

When the crewman of *Integrity* boarded *Ronan Orla*, it was anchored to the seabed by its dredge gear hoisting wire (**Figure 3**), its engine was running, and the pull-down rope was missing. The winch's directional control valve was in its hauling position, the warping drums were rotating and its towing and hoisting drums were declutched and stationary. The hoisting drum band brake was loosely applied and the towing drum band brake was released.

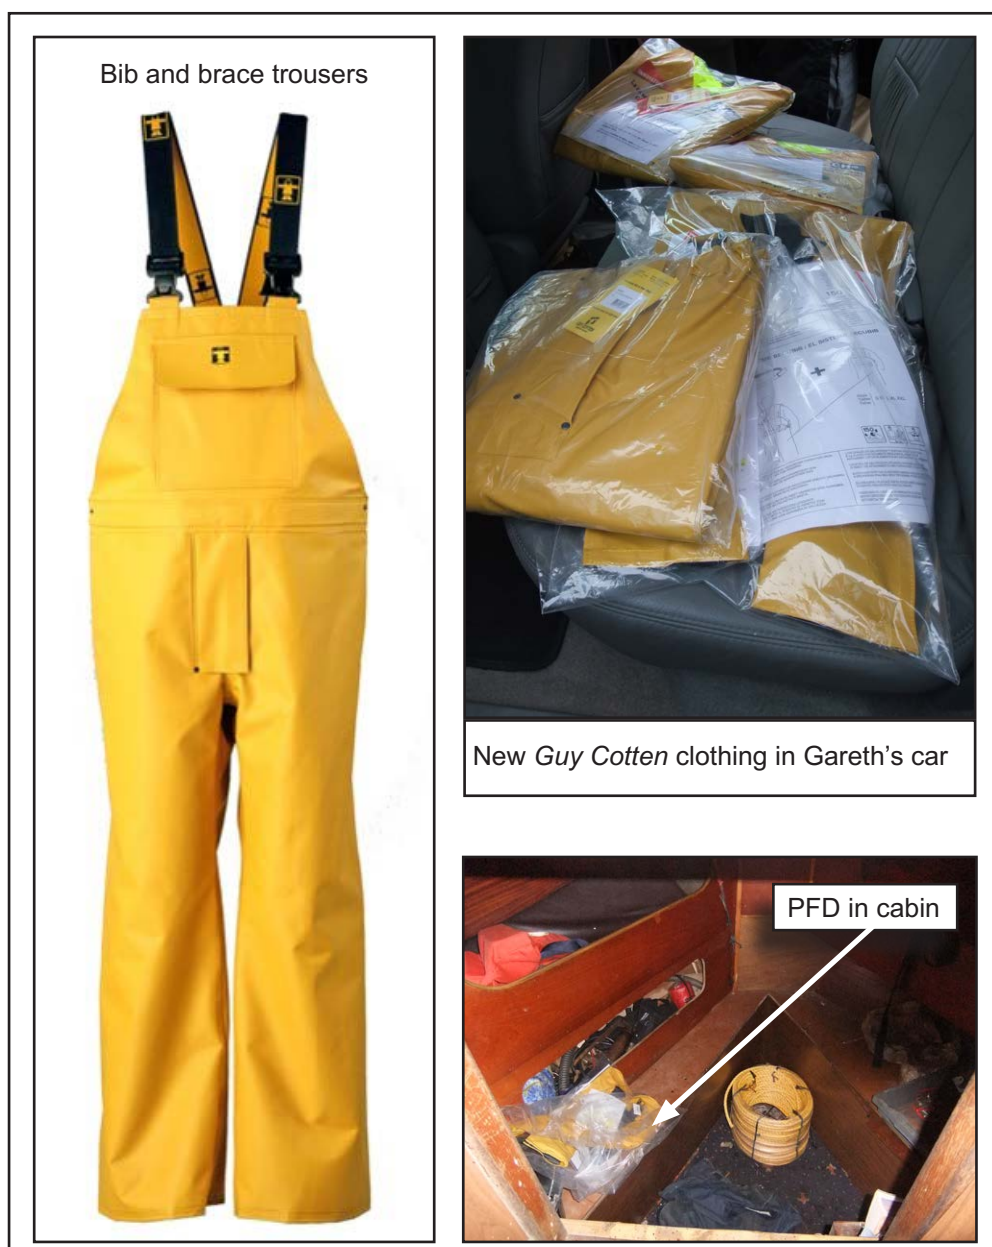
**Figure 11:** Foul weather bib and brace trousers

After the accident, the skipper's bib and brace trousers were found to be tightly wound around the warping drum. As the trousers were carefully wound off the drum, it was noted that the shoulder straps were the last part of the garment to be released. They had been stretched tight and had formed many turns on the drum.

At the time of the accident, *Ronan Orla*'s skipper was wearing a new pair of waterproof bib and brace trousers, which were found to be tightly wound around the warping drum when his body was released from the winch. The last part of the trousers to be wound off the warping drum was the shoulder straps. Without witnesses, the investigation was unable to determine conclusively the exact mechanism by which the skipper became entangled on the warping drum. The evidence strongly indicated that one of the elasticated shoulder straps from his bib and brace trousers had snagged on the warping drum and pulled him onto it.

If the bib and brace trousers had been worn correctly, and the straps been adjusted and secured properly, the risk of snagging would have been low. However, had one of the shoulder straps come loose from its chest buckle, or if one or both had not been worn correctly, a significant snagging hazard would have been introduced.

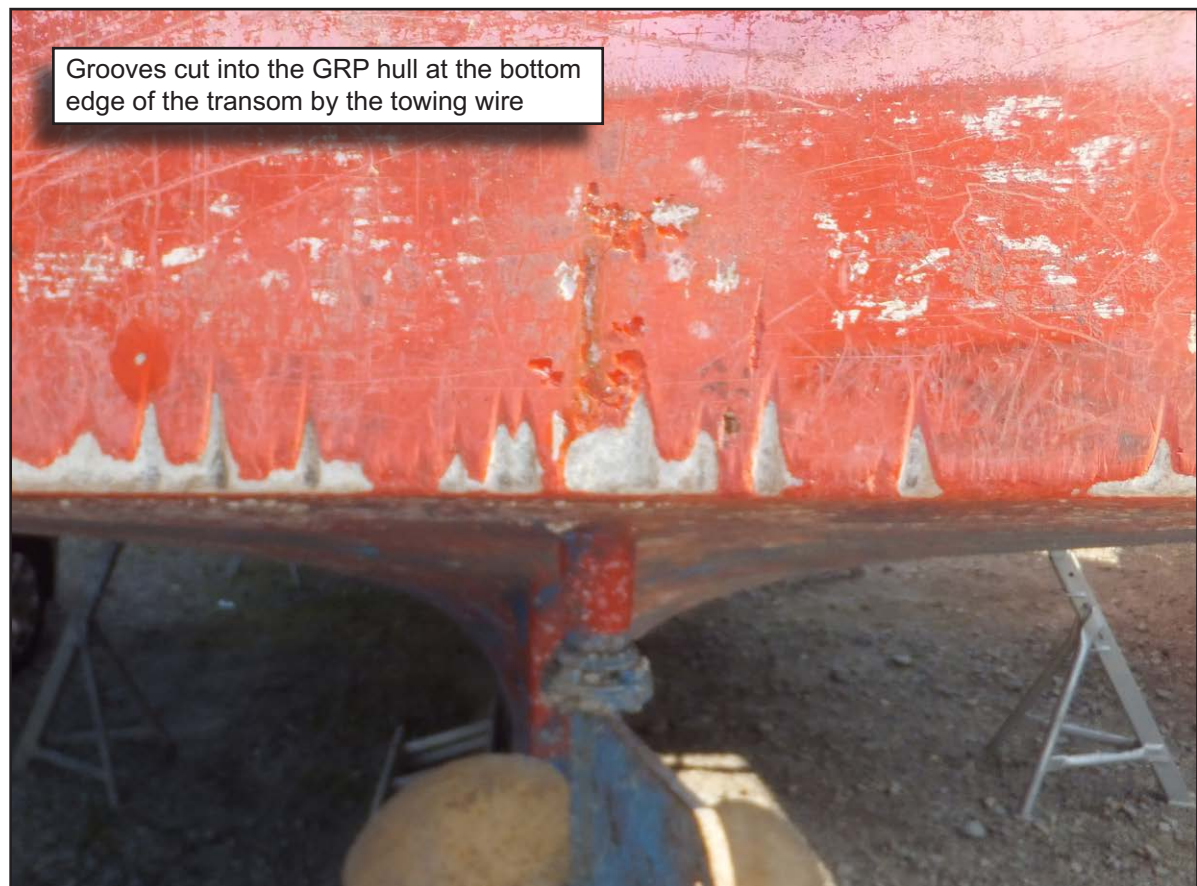
Externally, the hull was covered in a considerable amount of marine growth below the waterline and its zinc sacrificial anodes were heavily wasted. Deep grooves were found in the GRP hull below the waterline at the bottom edge of the transom (**Figure 12**). The grooves were so deep that light could be seen passing through the GRP from inside the hull when the vessel was lifted out of the water.

**Figure 12:** Damage caused to the hull by the towing wire

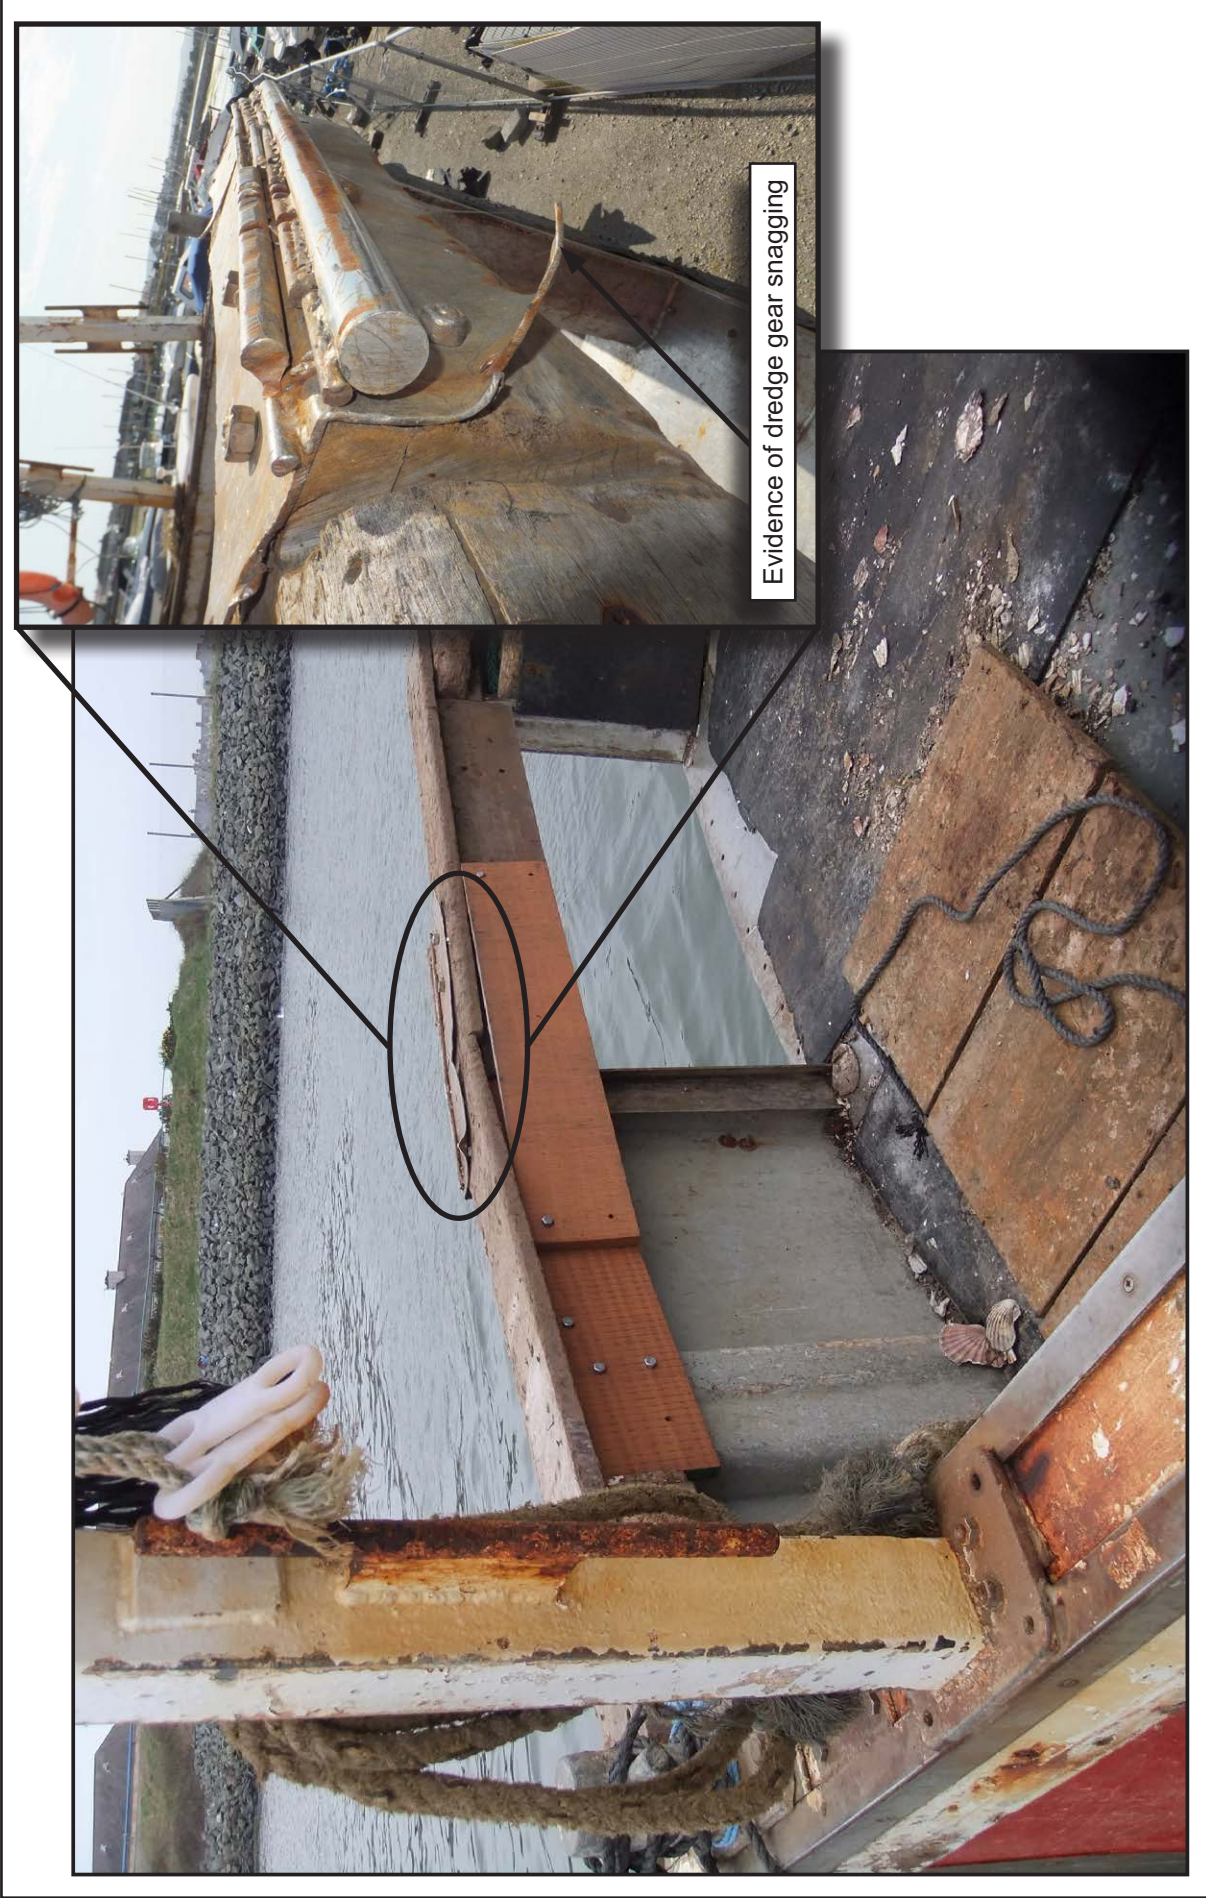
The upper part of the transom had suffered a considerable amount of damage and several ad-hoc repairs had been carried out (**Figure 13**). A steel plate with steel bars welded to it had been bolted to the top of the bulwark in an attempt to protect it from the dredge gear. Other identified shortfalls included:

Figure 13: Ad-hoc repairs to damaged transom bulwark

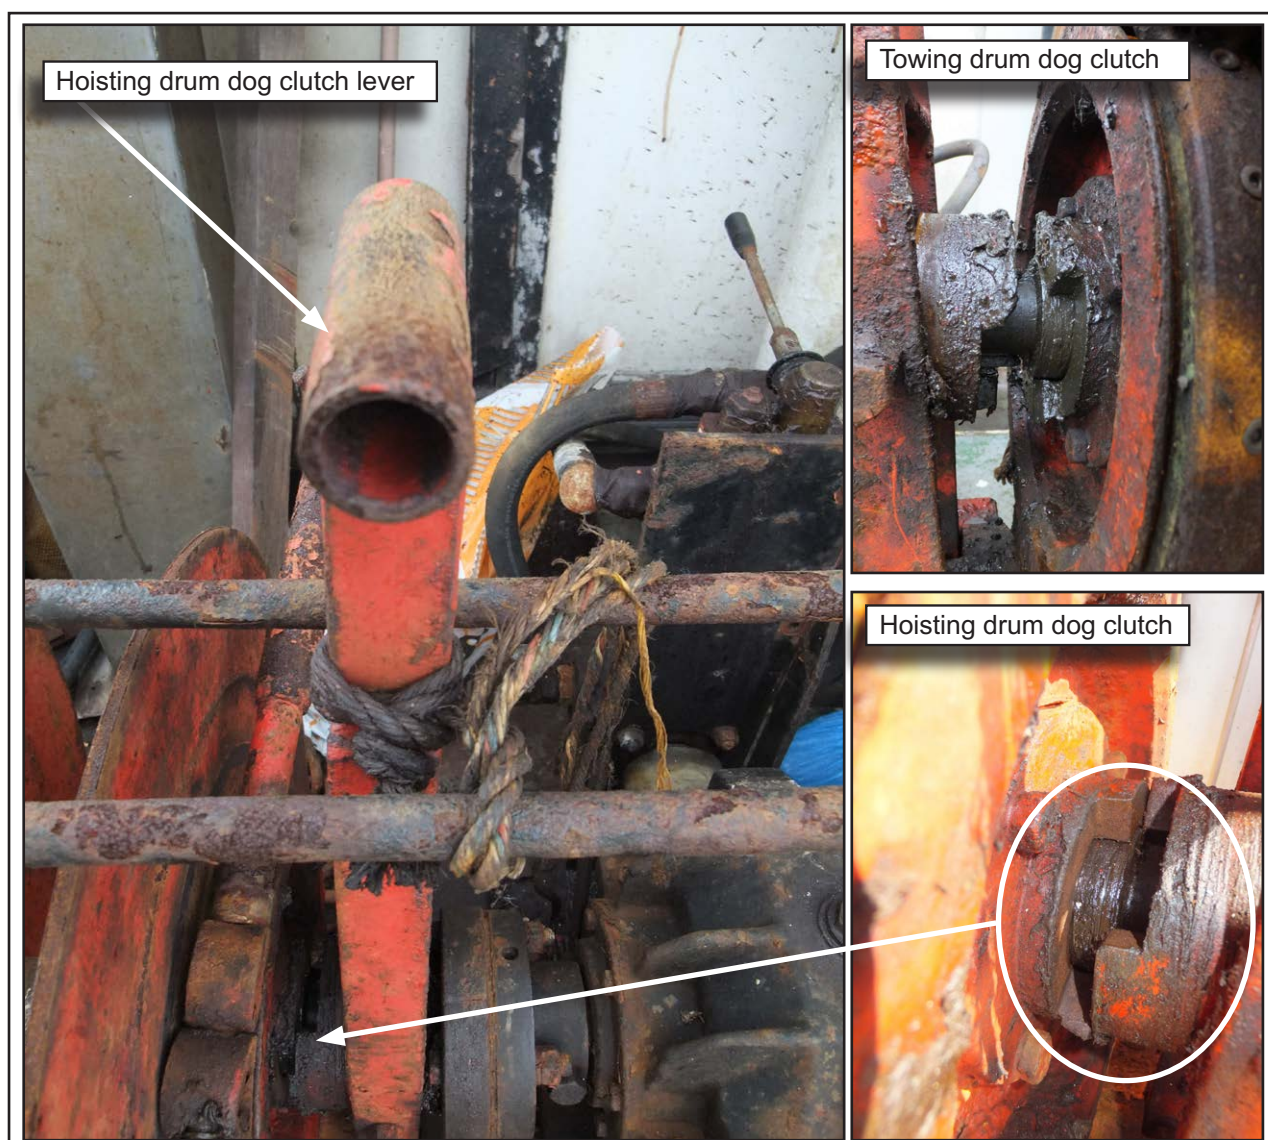
During the initial post-accident inspection of the hauling winch, both dog clutches were found to be disengaged. The hoisting drum band brake appeared to be on, but its tensioning screw was not fully applied. The towing drum band brake was off. The hoisting drum's dog clutch lever appeared to be secured in the disengaged position by a rope (**Figure 14**). When disengaged, the clearance between faces of the hoisting drum dog clutch was minimal. A plank of wood (**Figure 15**) was found wedged between the outboard flange of the hoisting drum and the winch drive shaft support frame. Several grooves were found to have been worn into the face of the wooden plank. A chunk of the outer rim of the starboard warping drum had broken away (**Figure 16**), but this damage had been caused prior to the skipper purchasing the winch.

- The winch drum bearing bushes had worn and there were significant levels of play between the hauling drums and the winch drive shaft.
- The port and starboard dog clutch teeth were heavily worn (**Figure 14**) and during operational trials one of the dog clutches unintentionally disengaged.
- There were numerous cracks in the band brake linings.
- The hoisting drum band brake had varying thicknesses of brake lining material and, when fully applied, there were gaps of up to 0.6mm between the drum and band brake lining. When the winch was operated with the brake fully tensioned, the drum rotated.

**Figure 14:** Towing and hoisting drum dog clutches in disengaged position and hoisting drum dog clutch lever

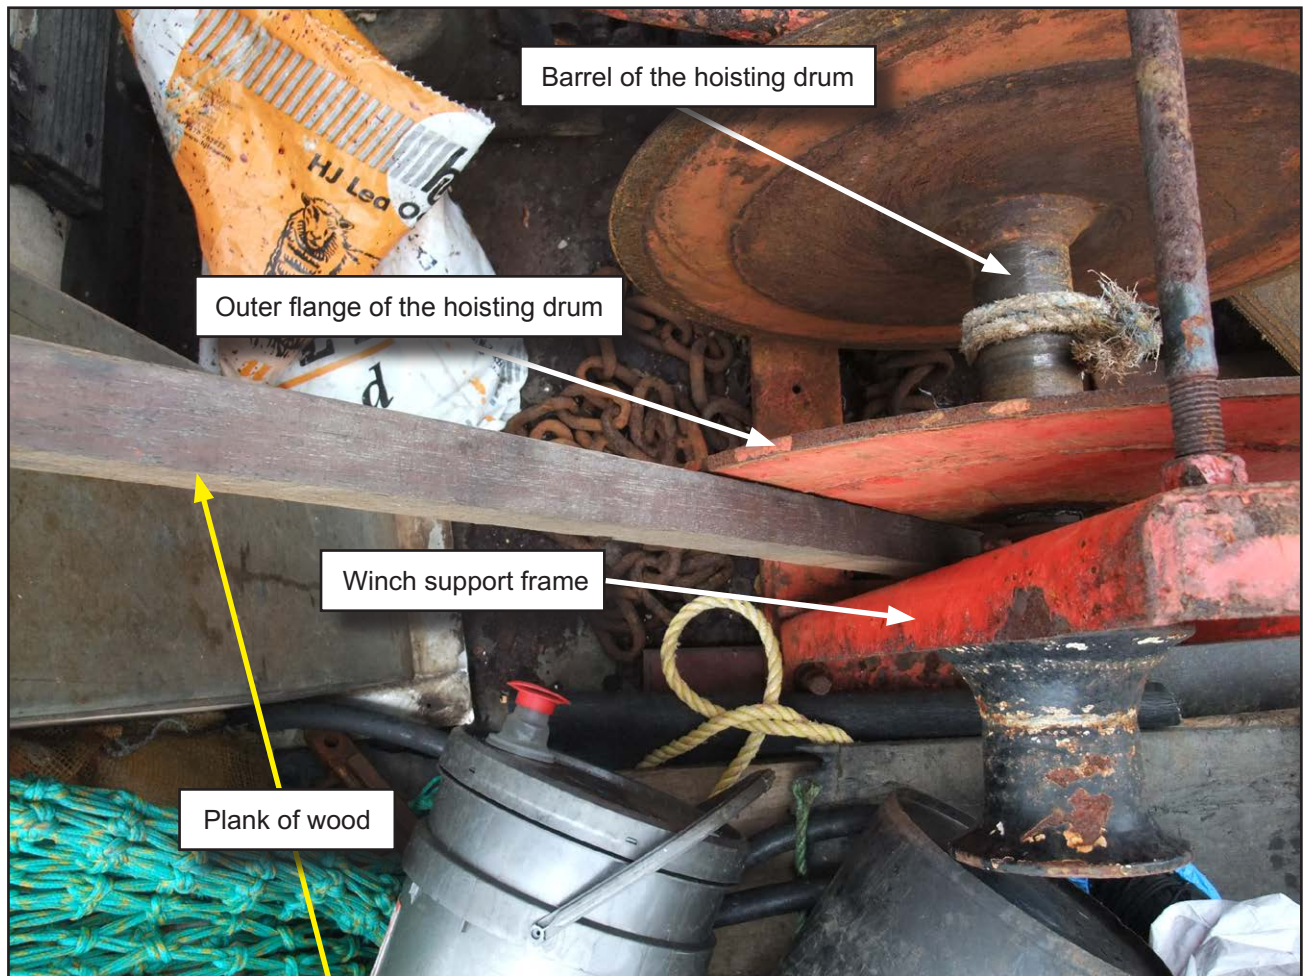
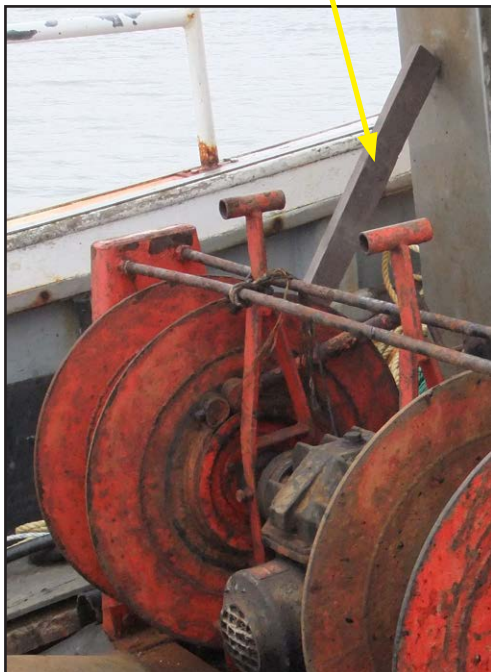
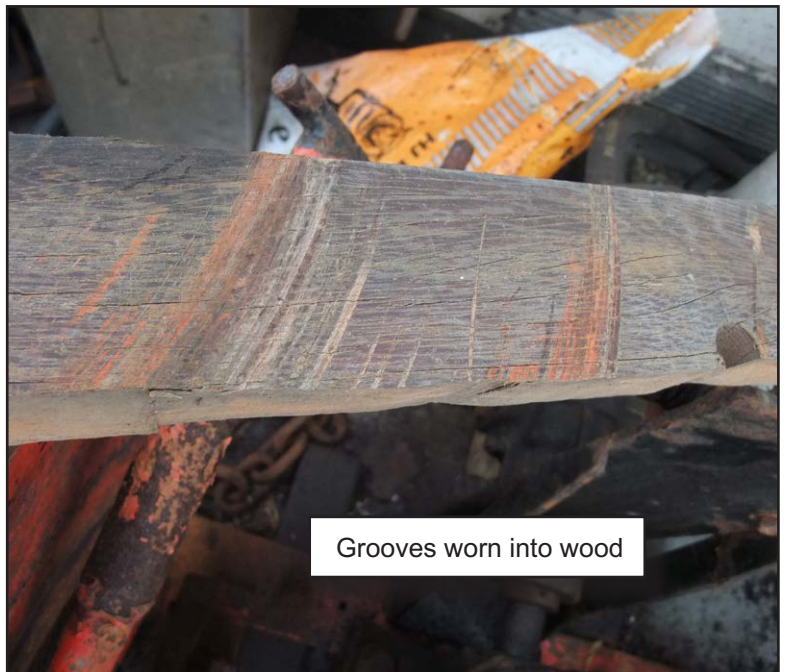
**Figure 15:** Plank of wood wedged between the hoisting drum flange and the winch support frame

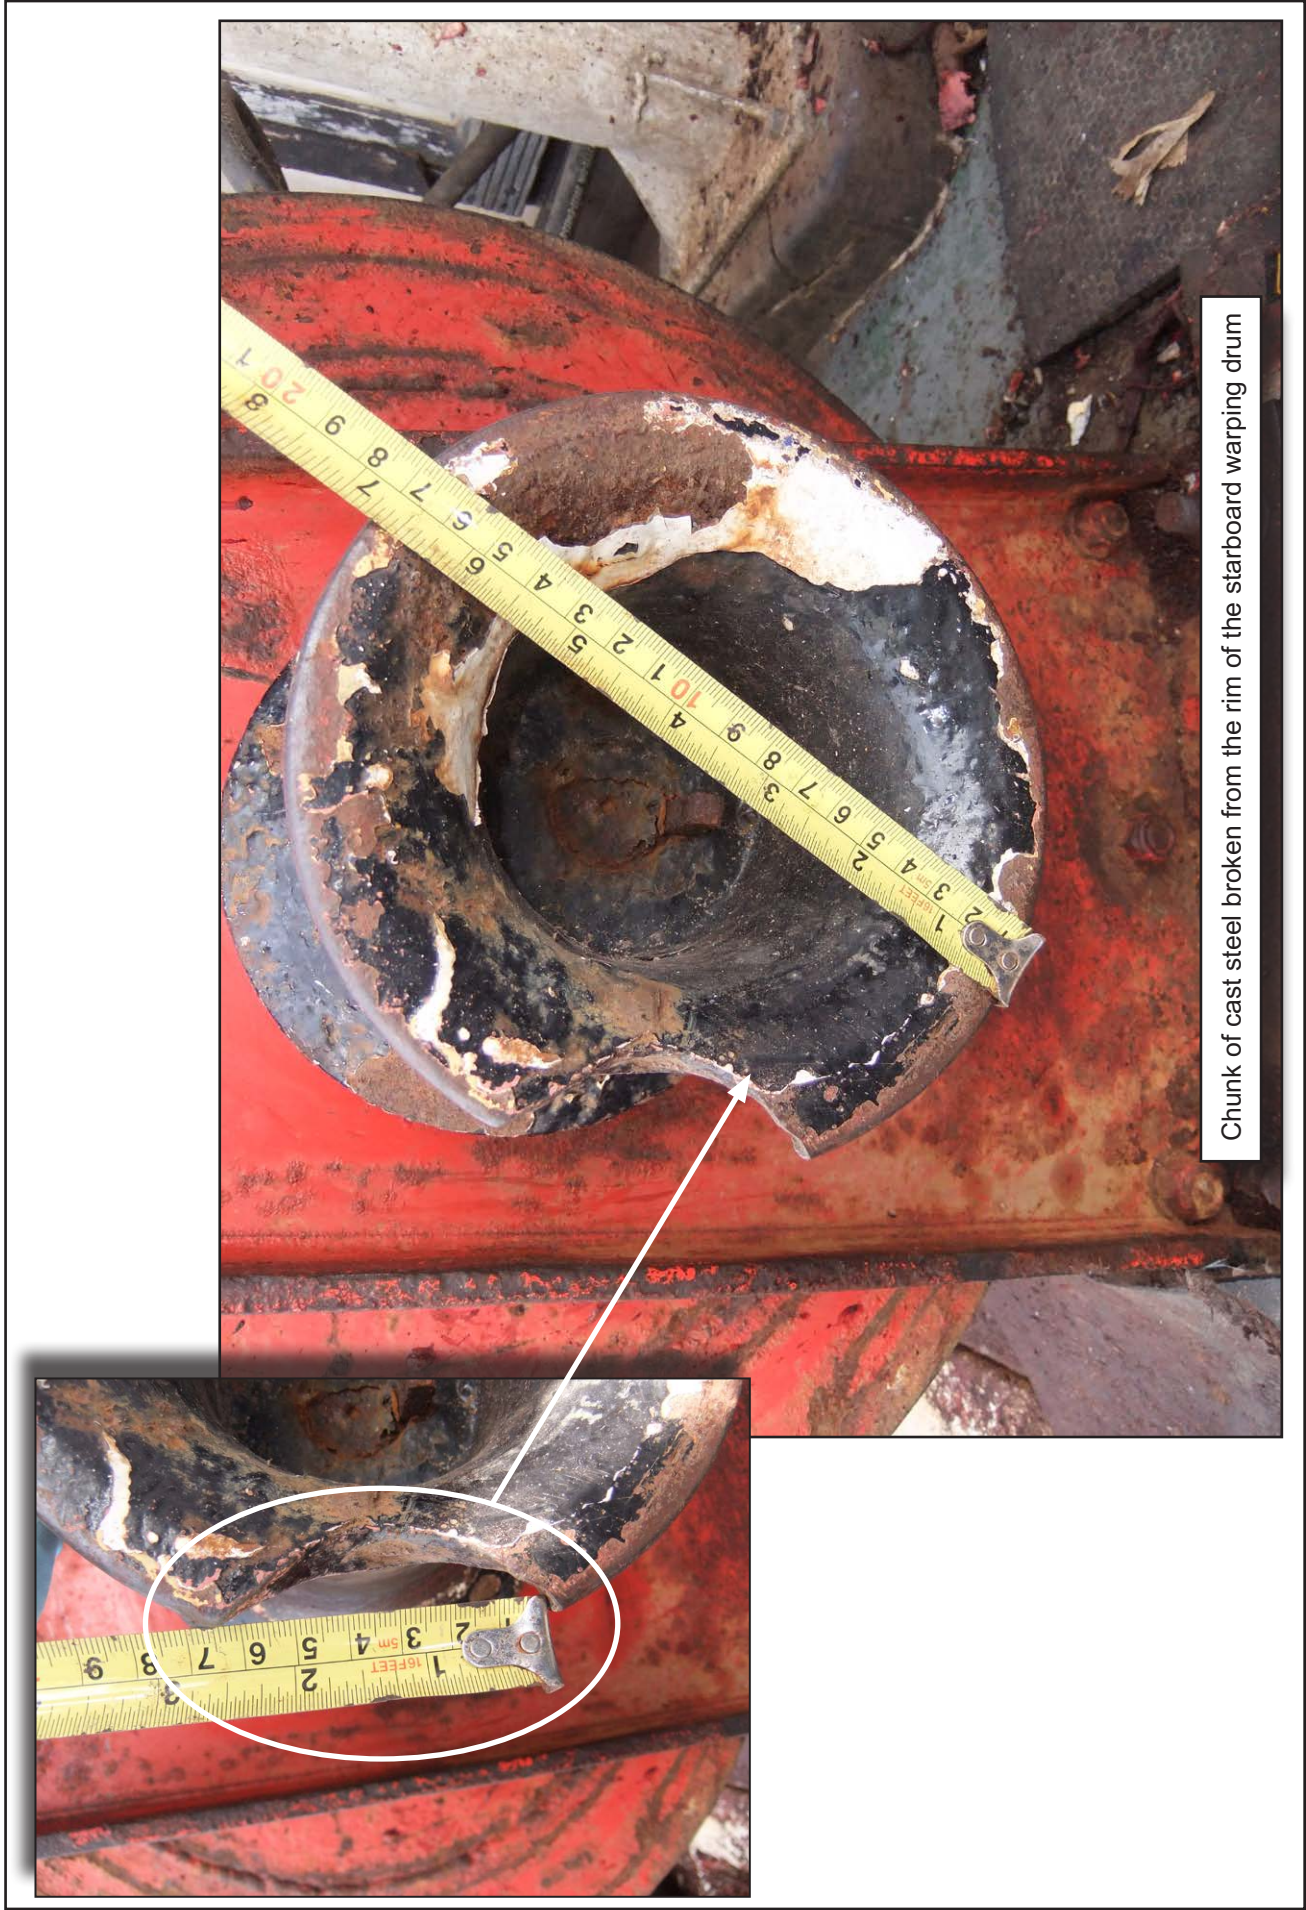
Figure 16: Damaged outer rim of the starboard warping drum

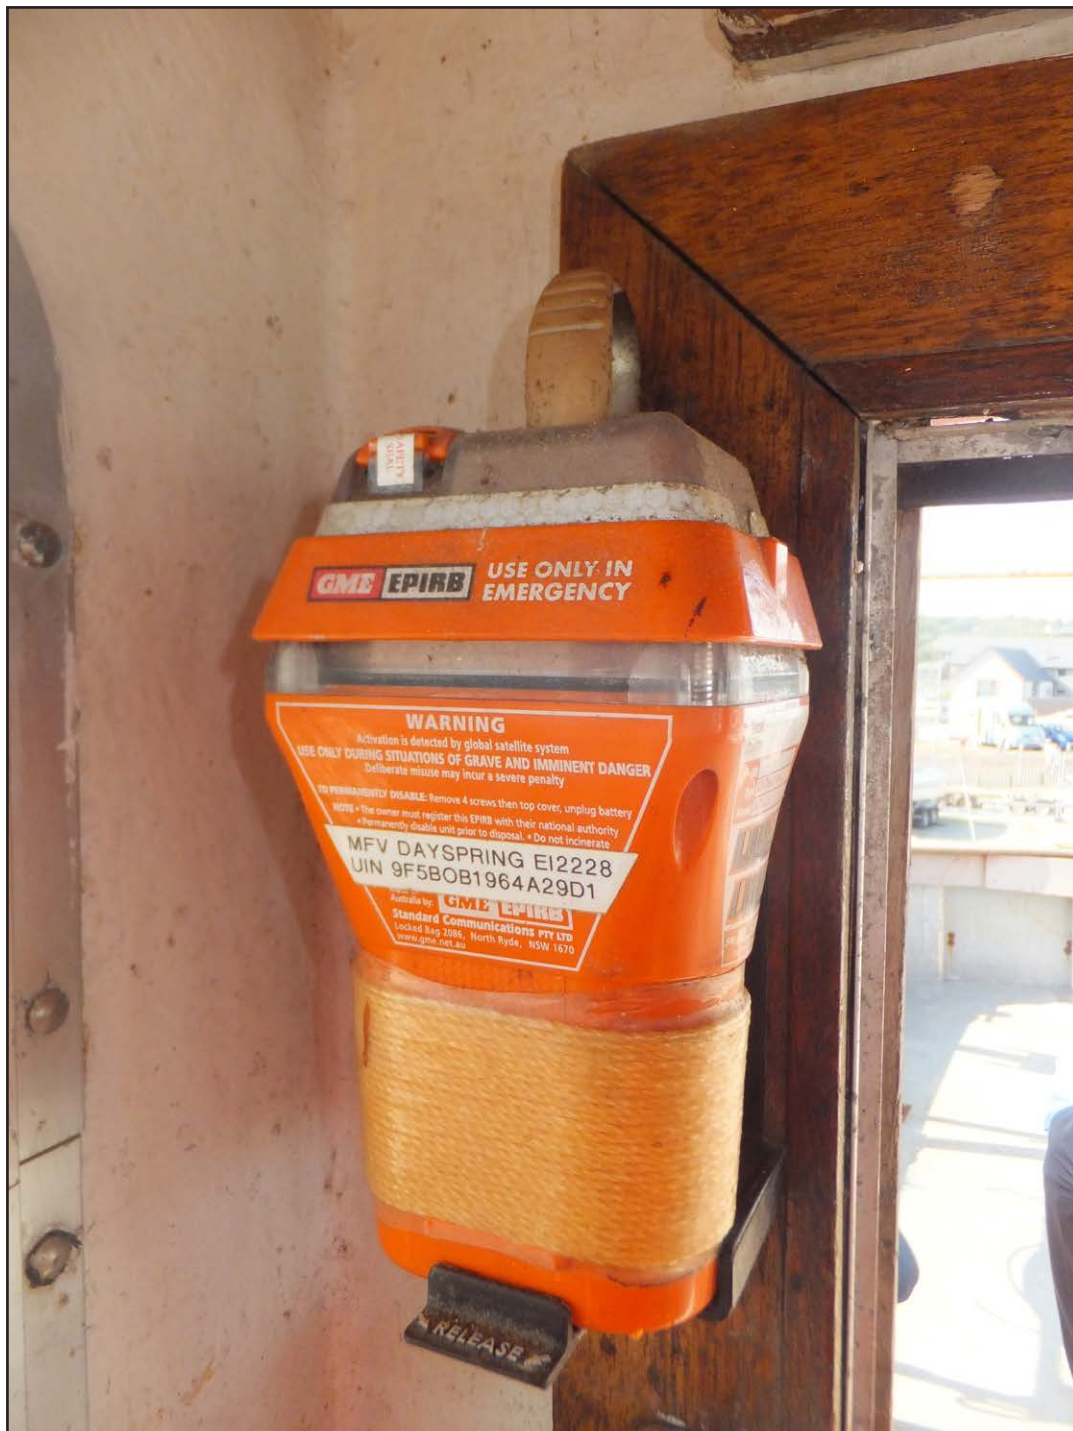
- All fire extinguishers on board were overdue their service period.
- The engine room did not have a bilge water high level alarm and the cabin was not equipped with bilge pumping capability.
- No pyrotechnics, signal lamp or fog horn were found on board.
- The vessel name on the emergency position indicating radio beacon (EPIRB)<sup>12</sup> was incorrect (**Figure 17**).

**Figure 17:** Manually activated EPIRB stowed in *Ronan Orla*'s wheelhouse

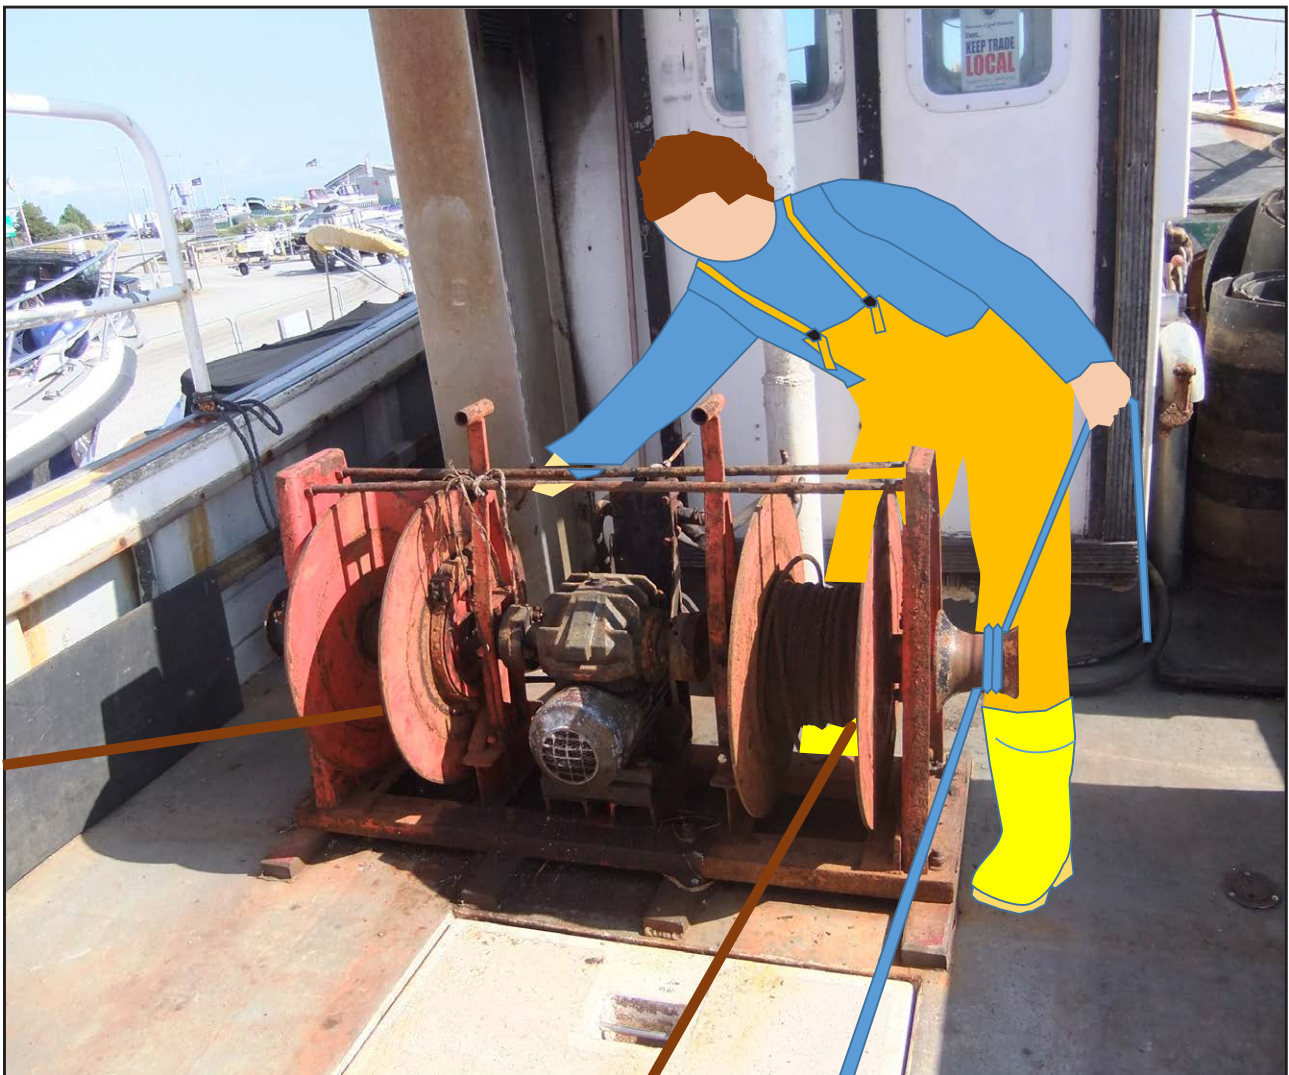
It was evident that the accident occurred as the skipper was attempting to recover and tip the dredge gear following the third tow of the day. The method used by the skipper to recover the dredges was complex, requiring him to operate the band brake on the port hauling drum while simultaneously backing up the pull-down rope on the starboard warping drum (**Figure 19**). To do this required him to work in dangerous proximity to the rotating winch. The process was made more difficult, and significantly more hazardous, by the poor material condition of the winch, specifically

**Figure 19:** Simultaneous tensioning of pull-down rope and release of hoisting drum band brake

the worn state of the port hauling drum's dog clutch and brake. Once caught on the warping drum, the skipper could not reach the winch control and the vessel was not equipped with emergency stop buttons.

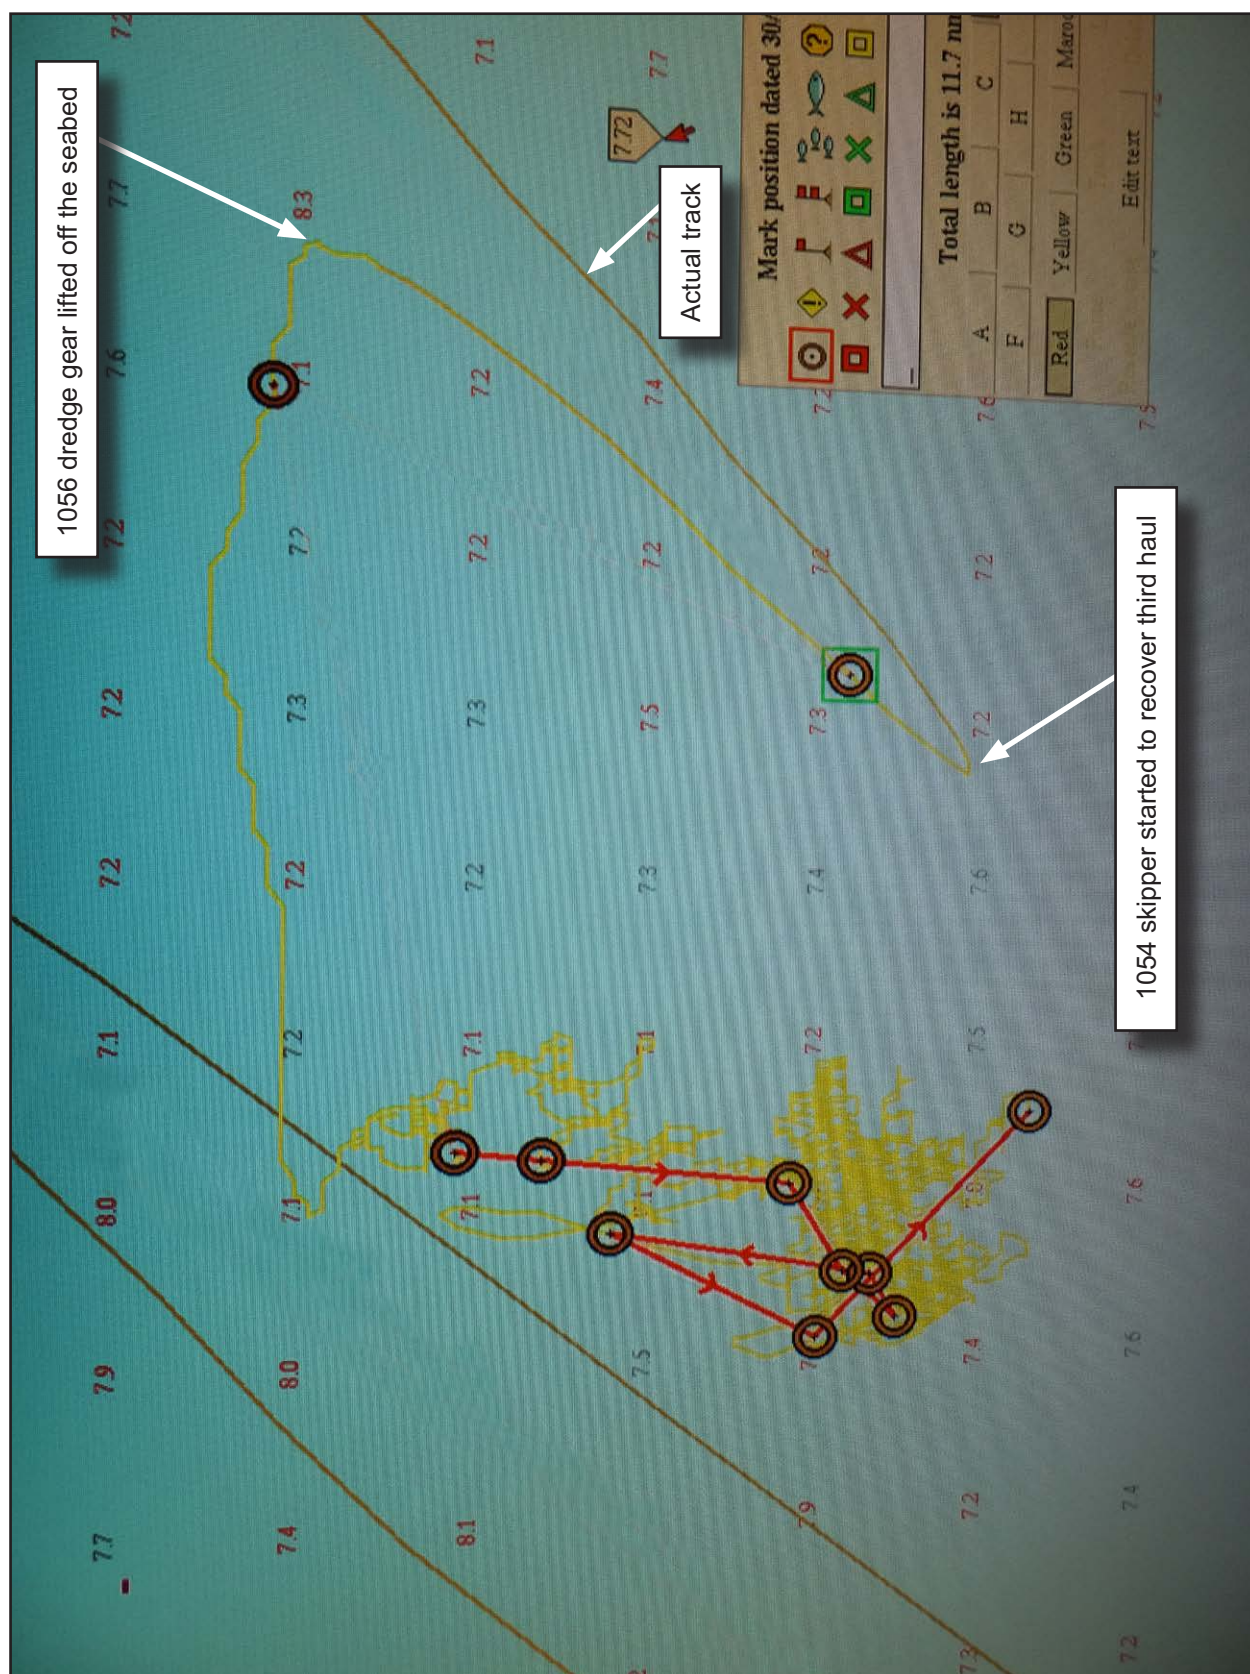
The electronic evidence indicated that the accident occurred between 1055 and 1100. The vessel's recorded track indicated that the dredge gear continued to pay out over time to the point where the vessel became anchored in the position where it was later found.

**Figure 20:** Ronan Orla's track recorded on its Olex chart plotter during the third haul of the day
