Rail Accident Investigation Branch

Rail Accident Report

Accident to a track worker near Redhill 24 June 2014

Report 06/2015
June 2015

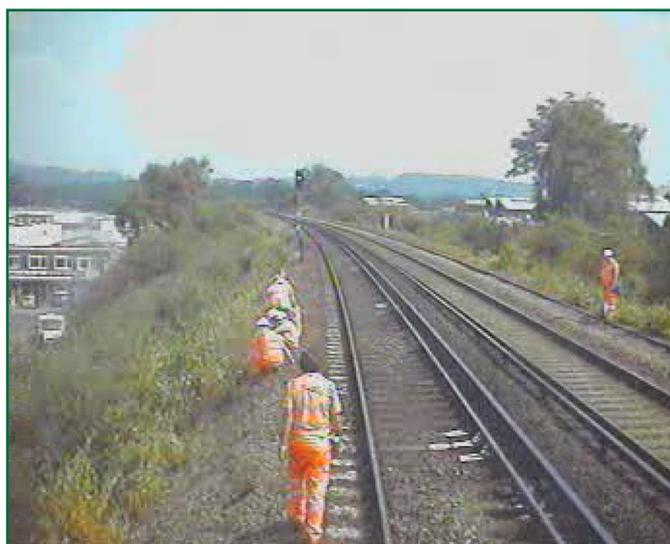
- 35 The COSS watched the approach of train 1U53. The section supervisor continued to walk north alongside the track, with his back to the approaching train (figure 2).

Figure 2: image from the train's forward facing CCTV, immediately before the accident, showing the section supervisor walking along the side of the line, the members of the gang sitting down on the embankment, and the site lookout on the extreme right of the picture

- 42 The FFCCTV from train 1U53 shows the section supervisor apparently unaware of the approach of the train, walking steadily along with his back to it. He is unable to remember exactly what he was doing, but witness evidence indicates that he had taken one measurement of lengths of rail to be replaced and was on his way to mark up and measure the next section. He was carrying a spray can of white paint in his right hand when he was struck; this burst and provided an indication of the location of the point of impact.

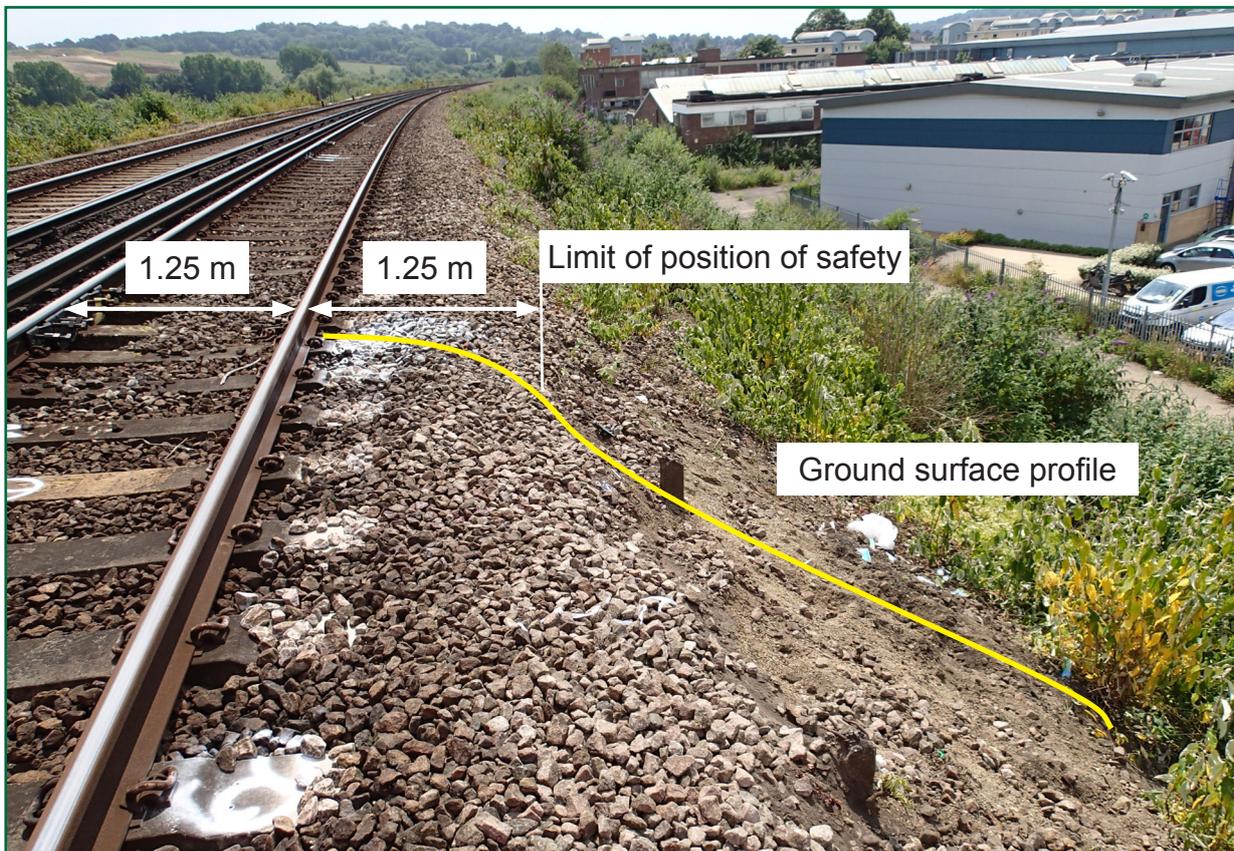
- 69 **The ccess at this location is narrow and treacherous, and not suitable as a position of safety.**
- 70 To be clear of the track and in a position of safety, a person must be⁹ at least 1.25 metres from the nearest rail (on lines where trains run at up to 100 mph). At the location of the accident, the ground drops steeply away from the track, less than one metre from the sleeper ends, as shown in figure 3.

- 71 At this location, to reach a position of safety requires scrambling down the slope of the embankment. The surface consists of loose earth and ballast, making it treacherous and difficult to stand on. To walk alongside the track, it is necessary to be on or just beyond the ends of the sleepers. Walking along the slope is almost impossible (after the accident, the emergency services passed the casualty, on a stretcher, under the train that was standing at the site. This was because it was not possible to carry it safely along the ccess to go round the front of the train (see figure 6)).

Figure 3: Location of accident, showing ground profile

- c. the cess at this location is narrow and treacherous, and not suitable as a position of safety (**paragraph 69, see paragraph 118 and Recommendation 1**);

- Review each section of line where work while trains are running is authorised, and assess the availability and suitability of the locations that are required to be used as a position of safety. Where these are found to be inadequate, Network Rail should prohibit work while trains are running.
- Ensure that staff responsible for establishing a safe system of work on site are explicitly prompted to consider potential hazards that might call into question the suitability of the position(s) of safety throughout the site (such as the number of people required to use it/them, and whether the ground is reasonably level, in good condition underfoot and free of obstructions) before permitting work to commence (paragraphs 115b, 115c).

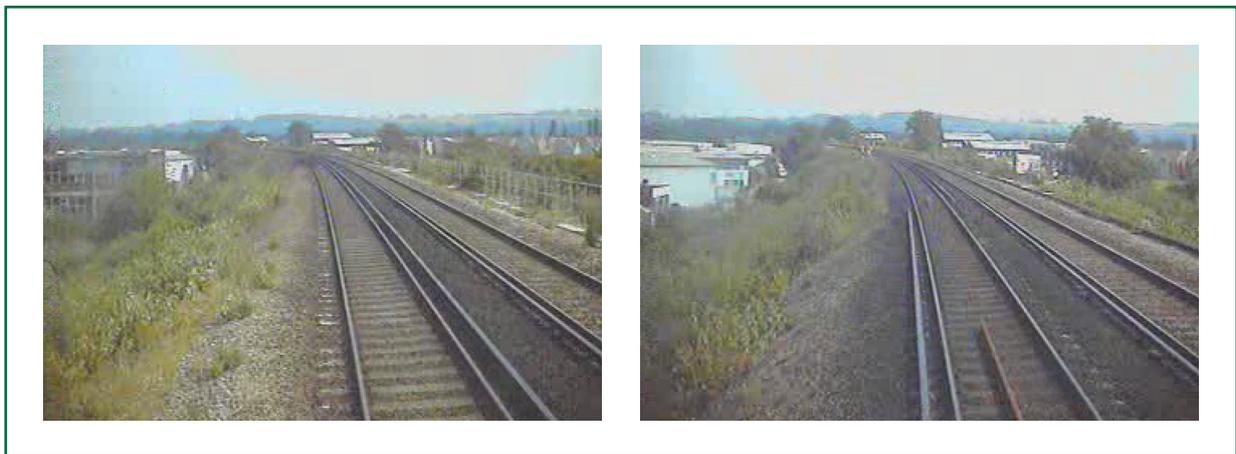
81 The train approached the work group round a left-hand curve. The group became visible to the train crew about seven seconds before the accident occurred (figure 4, left). The site lookout acknowledged the train's approach by raising his flag. From the FFCCTV evidence, it appears that only when the train was about four seconds' running time from the group did the position of the section supervisor, separate from the others, become visible to the trainee driver and the driver-instructor. The driver-instructor then realised that the person he could see to the right of the other figures was possibly too close to the track (figure 4, right).

Figure 4: FFCCTV images, seven seconds before the accident (left) and four seconds before the accident (right)

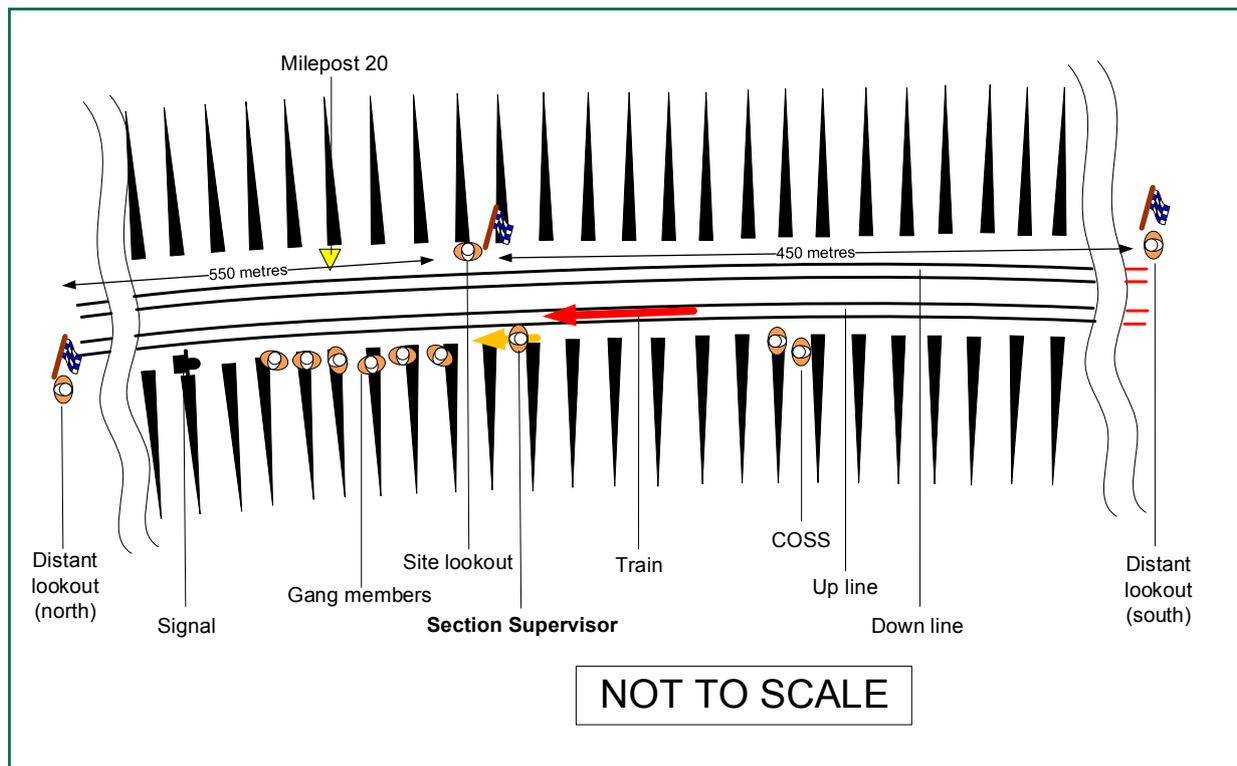
Figure 5: The accident site, showing the relative positions of the people involved

- 90 In this case, the site lookout gave the initial warning of the up train and saw that everyone was still in the position of safety after the passing of the previous down train. He says that he then turned towards the north to maintain visual contact with the distant lookout in that direction, in case another down train was approaching. He turned back towards the up train and raised his flag to acknowledge it as it came close. He states that he was not aware that the section supervisor was walking along the other side of the line. Even if he had noticed him, it would have been difficult for the lookout to tell how far the section supervisor was from the track because of the angle of vision, but he states that he would have given a further warning had he realised that the supervisor was in an unsafe position.

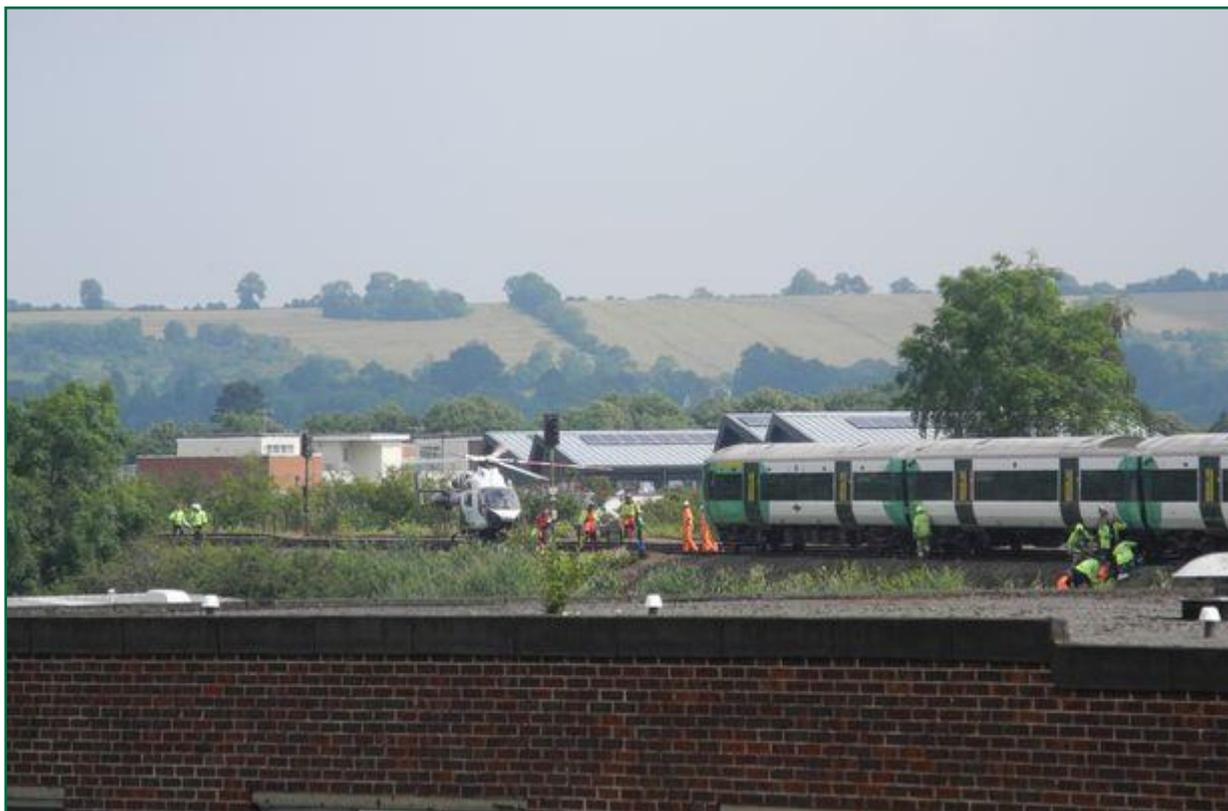
Figure 6: HEMS helicopter landing on the railway near the scene of the accident. Paramedics treating the casualty can be seen on the extreme right. The train in the picture was following the train that was involved in the accident, and had come to a stand at the signal visible in the photograph (reproduced with kind permission of the Surrey Advertiser ©Trinity Mirror group).

- 95 The helicopter landed on the track without permission from Network Rail. A railway line is a potentially hazardous place on which to land a helicopter. If trains have not been stopped, or if the electrical power to the conductor rails has not been cut off, there is the possibility of a serious accident. In this case, the power had been switched off soon after the accident. Even if these hazards have been taken into account, the tracks and ballast make up an uneven and treacherous surface, where there may be fragile troughing runs and drain covers which may not be able to support the weight of an aircraft. For these reasons, Network Rail strongly discourages helicopter ambulances from landing on or near railway lines.
