**Mooring line failure resulting in serious injury to a  
deck officer on board  
*Zarga*  
alongside South Hook LNG terminal,  
Milford Haven  
on 2 March 2015**

## MAIB SAFETY BULLETIN 1/2015

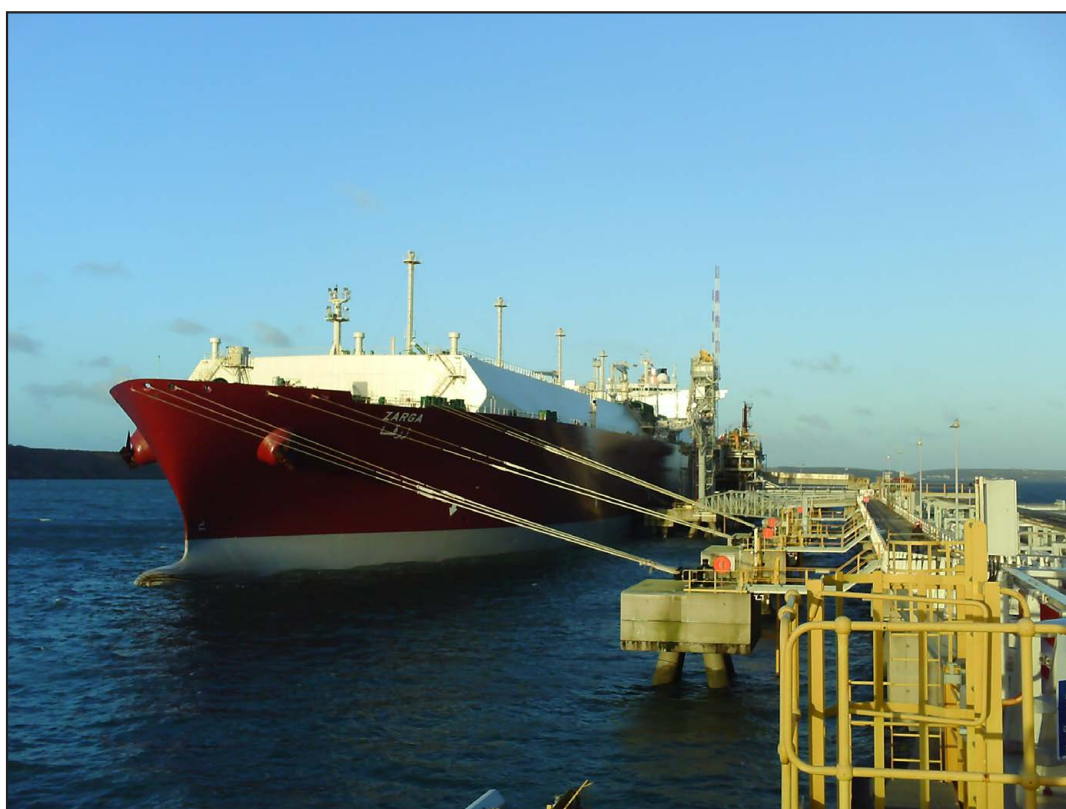
**Figure 1: Zarga alongside South Hook LNG terminal**

On 2 March 2015, a deck officer on board the LNG tanker, *Zarga* (**Figure 1**), suffered severe head injuries when he was struck by a mooring line that parted during a berthing operation at the South Hook LNG terminal, Milford Haven. The officer, who was in charge of the vessel's forward mooring party, was airlifted to a specialist head injuries trauma unit for emergency surgery.

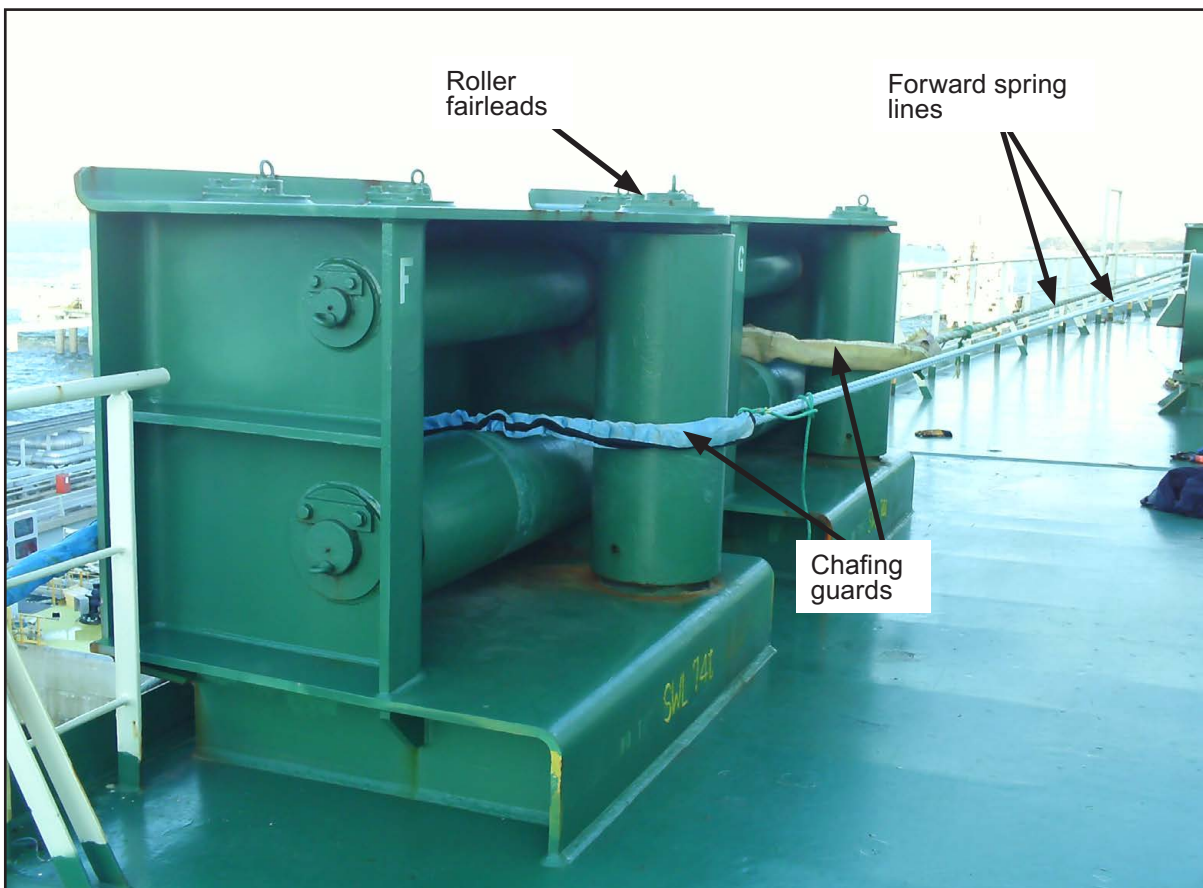
**Figure 2:** Port-shoulder roller fairlead

*Zarga* was declared *all fast* alongside about 40 minutes prior to the accident and the attending tugs were let go. The vessel subsequently moved out of position in the gusty wind conditions during which time the mooring teams were fitting chafing guards to the lines (**Figure 2**). As the tugs had already been released, the master instructed the officer in charge (OIC) of the forward mooring party to tension the forward spring lines to warp *Zarga* back into the correct position.

The OIC positioned himself aft of the forward springs' port-shoulder roller fairlead (**Figures 2 and 3**), and positioned a second crewman forward of him in order to relay his orders to the winch operator. As the winch operator attempted to heave in on the springs, the winch repeatedly stalled and rendered<sup>1</sup>. After about 10 minutes, one of the spring lines began to rattle and creak, and then suddenly parted (**Figure 4**). The section of the line between the break and the port-shoulder roller fairlead struck the OIC on his head as it whipped back before going overboard through the fairlead.

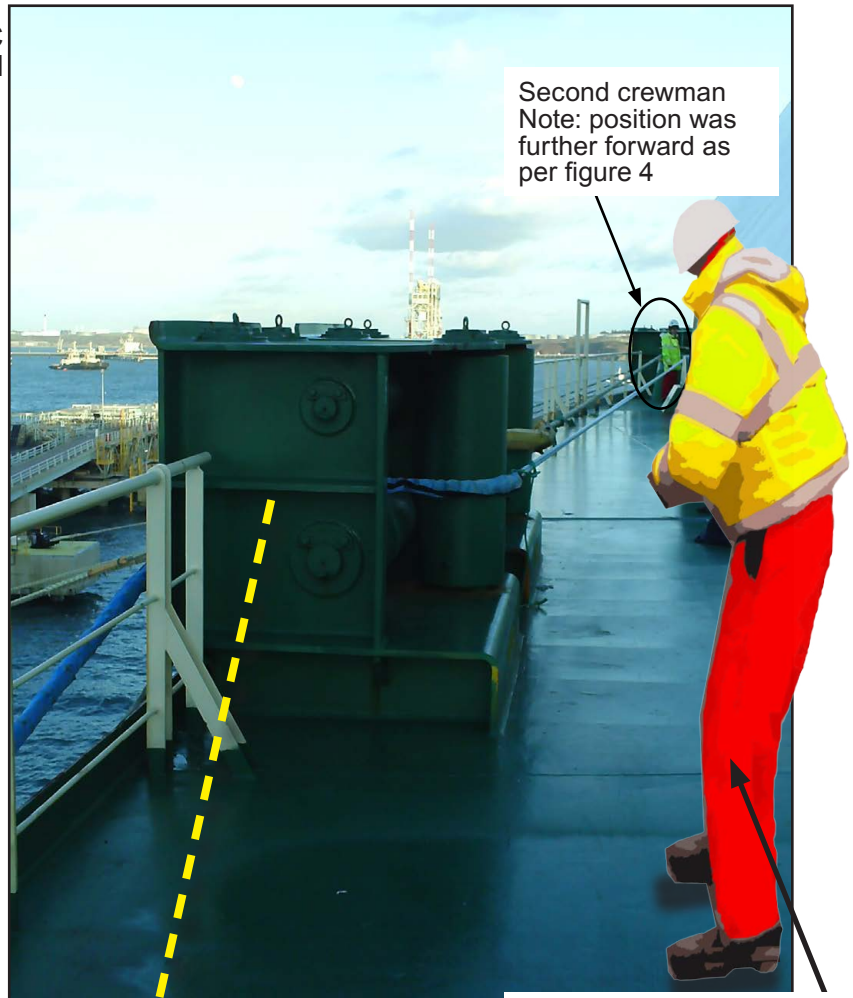
**Figure 3:** Forward mooring party OIC at port-shoulder roller fairlead

OIC forward mooring party
