ACCIDENT

Aircraft Type and Registration:	Beech BE99, VQ-THL
No & Type of Engines:	2 Pratt And Whitney PT6-27 turboprop engines
Year of Manufacture:	1974
Date & Time (UTC):	7 December 2014 at 1910 hrs
Location:	Providenciales Airport, Turks & Caicos
Type of Flight:	Commercial Air Transport (Passenger)
Persons on Board:	Crew - 2 Passengers - 2
Injuries:	Crew - None Passengers - None
Nature of Damage:	Damage to lower nose cone, both propellers
Commander's Licence:	Airline Transport Pilot's Licence
Commander's Age:	34 years
Commander's Flying Experience:	5,905 hours (of which 1,871 were on type) Last 90 days - 227 hours Last 28 days - 80 hours
Information Source:	Aircraft Accident Report Form submitted by the pilot and additional AAIB inquiries

Synopsis

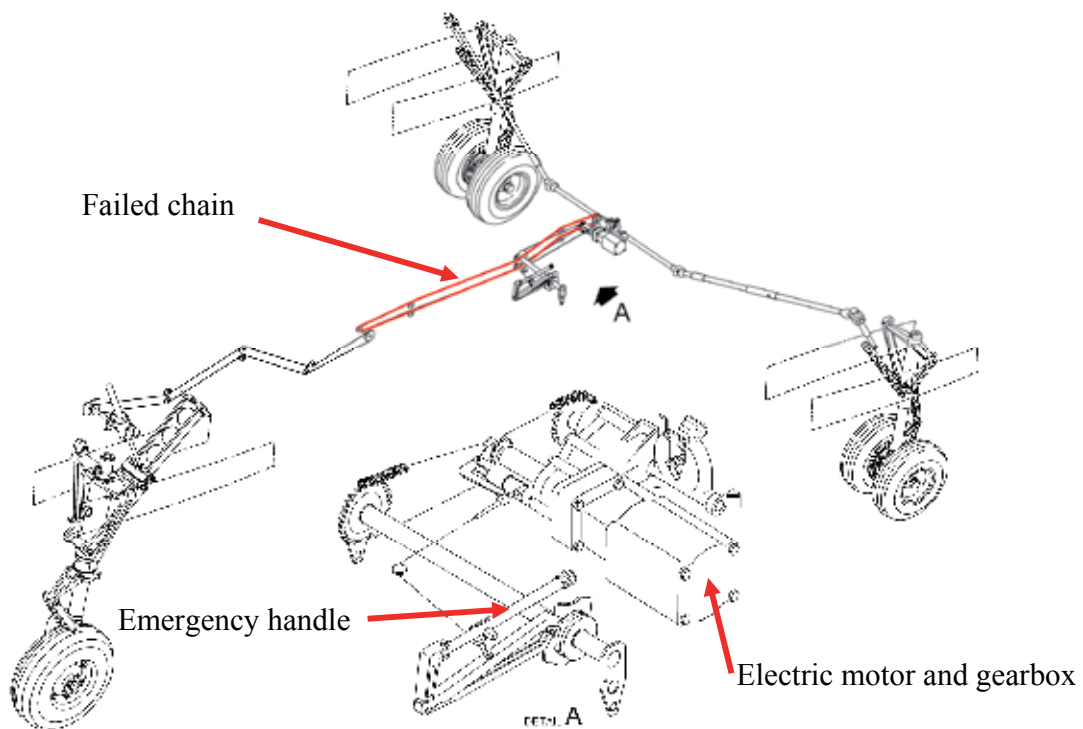
Figure 1

A diagram of the landing gear system is shown at Figure 1. It can be seen that the gear is raised and lowered by an electric motor driving the linkage via a gearbox; the two other Beech 99 aircraft in the operator's fleet are equipped with a hydraulic system.

Investigation by the operator's maintenance organisation revealed that the forward segment of the chain (the portion within the area bounded by the red line in Figure 1) was found broken at the master link following a failure of the master link itself. This effectively isolated

the nose gear from the rest of the system, such that operation of the emergency handle (intended to be used in the event of a failure of the motor or gearbox) would only operate the main gear. Figure 2 shows a photograph, taken by the maintenance company, of the master link components.

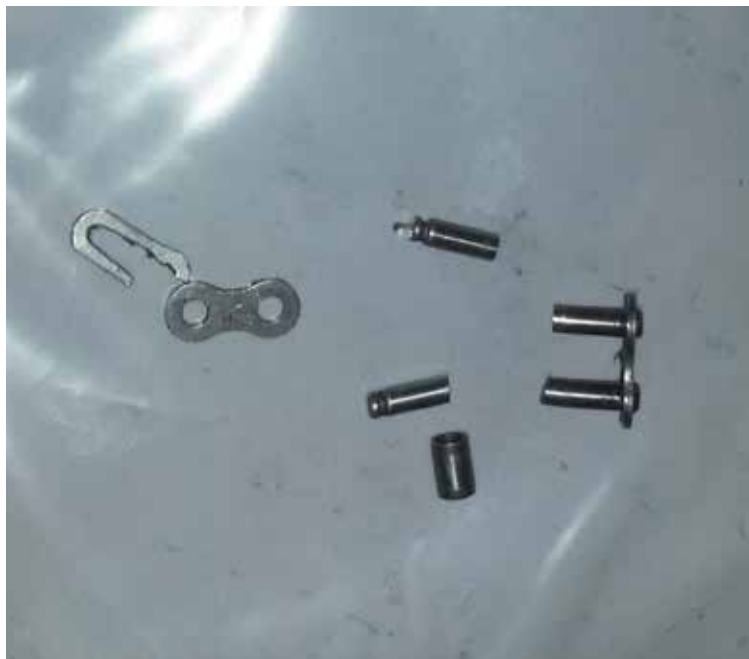
Figure 2

Master link components

The reason for the failure of the master link was not established with clarity; all the observed fracture surfaces were the result of overload. After the operator's preliminary investigation the aircraft and chain components were examined by an independent engineer. Whilst it was theoretically possible to install the master link incorrectly, the engineers who had installed the chain and the independent engineer were confident that the work had been carried out correctly.

Following the accident, the maintenance organisation has revised their maintenance programme such that, following any maintenance task requiring removal of the subject chain, an inspection will be carried out after 50 cycles. After this initial inspection the schedule would revert to the 100 hrs interval.
