AIRCRAFT ACCIDENT REPORT 1/2015

Air Accidents Investigation Branch

**Report on the accident to
Airbus A319-131, G-EUOE
London Heathrow Airport
on 24 May 2013**

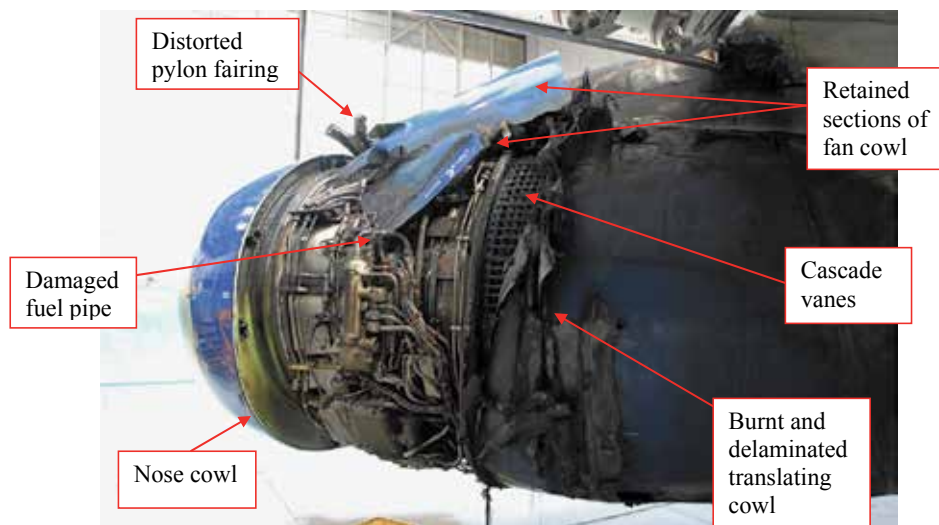
Figure 5

View of inboard side of the right (No 2) engine

Two large sections of the inboard fan cowl door remained attached to the right engine (Figure 5). The large section was attached to the hinge line along the top of the engine; the smaller section, incorporating the aerodynamic strake, was trapped behind a large diameter fuel pipe mounted on the fan case. Both attached sections showed extensive burning along their leading and lower edges. The fuel cooled oil cooler (FCOC) supply and return fuel pipes, behind

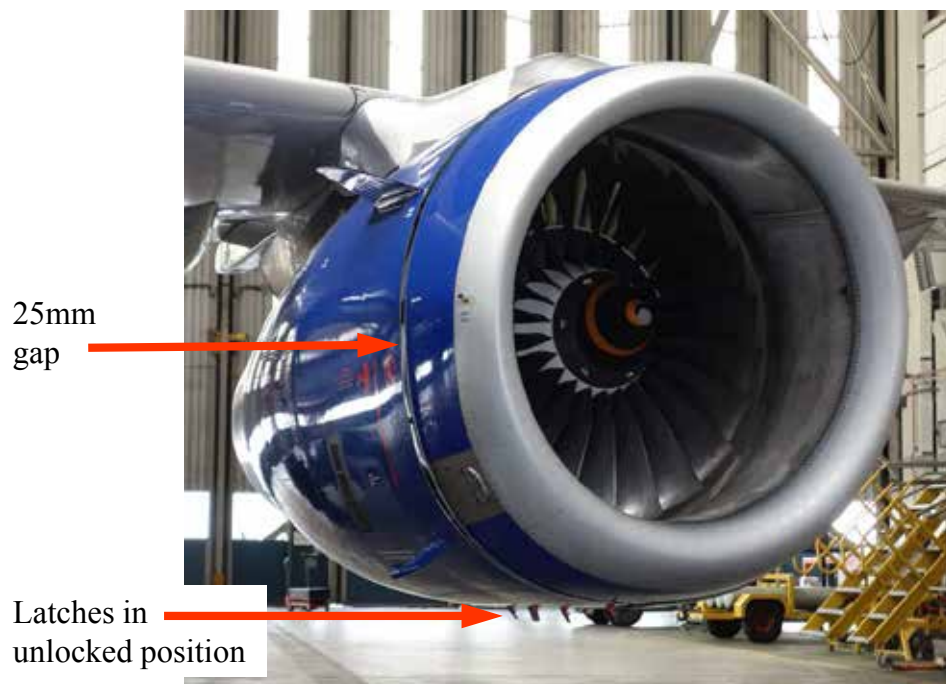
Figure 8

To make it more obvious that fan cowl doors are unlatched, the nacelle is equipped with a hold-open device that is bolted to the fixed nose cowl. The device consists of a spring-loaded blocker bar assembly which, when depressed upwards against a spring by maintenance personnel using a screwdriver, allows the fan cowls to be raised from their closed position. Once the fan cowls are raised, the screwdriver is withdrawn from the device and the blocker bar lowers into the 'hold open' position by spring force. In this condition the device prevents the fan cowls from closing flush with the nacelle, due to gravity, and the fan cowl doors stand about 25 mm proud of the nacelle to provide a visual cue that the doors are not latched (Figure 8).

Fan cowl doors on the hold-open device; latches in unlocked position as shown in Figure 7(e)

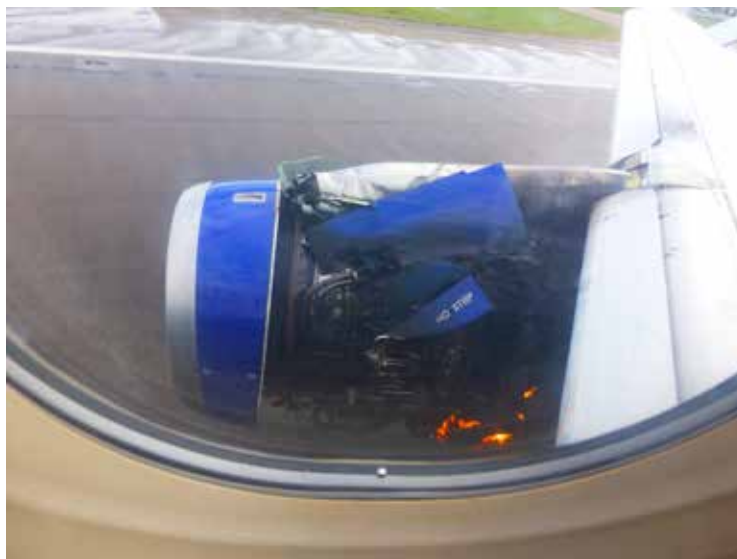
Figure 19

A photograph, taken by a passenger during the landing roll (Figure 19), shows that a fire continued to burn in the lower section of the engine until the end of the flight. Video evidence and witness statements from the attending airfield operations staff and firefighters who attended the aircraft, describe the fire intensifying again once the aircraft came to a stop on the runway. However, it was quickly extinguished by the AFRS and London Fire Brigade (LFB) assets, who had attended as part of the pre-determined response to the ATC declaration of 'Aircraft Accident Imminent'.

Engine fire during landing roll
