Report on the investigation of  
the grounding and flooding  
of the ro-ro ferry

***Commodore Clipper***

in the approaches to St Peter Port, Guernsey

on 14 July 2014

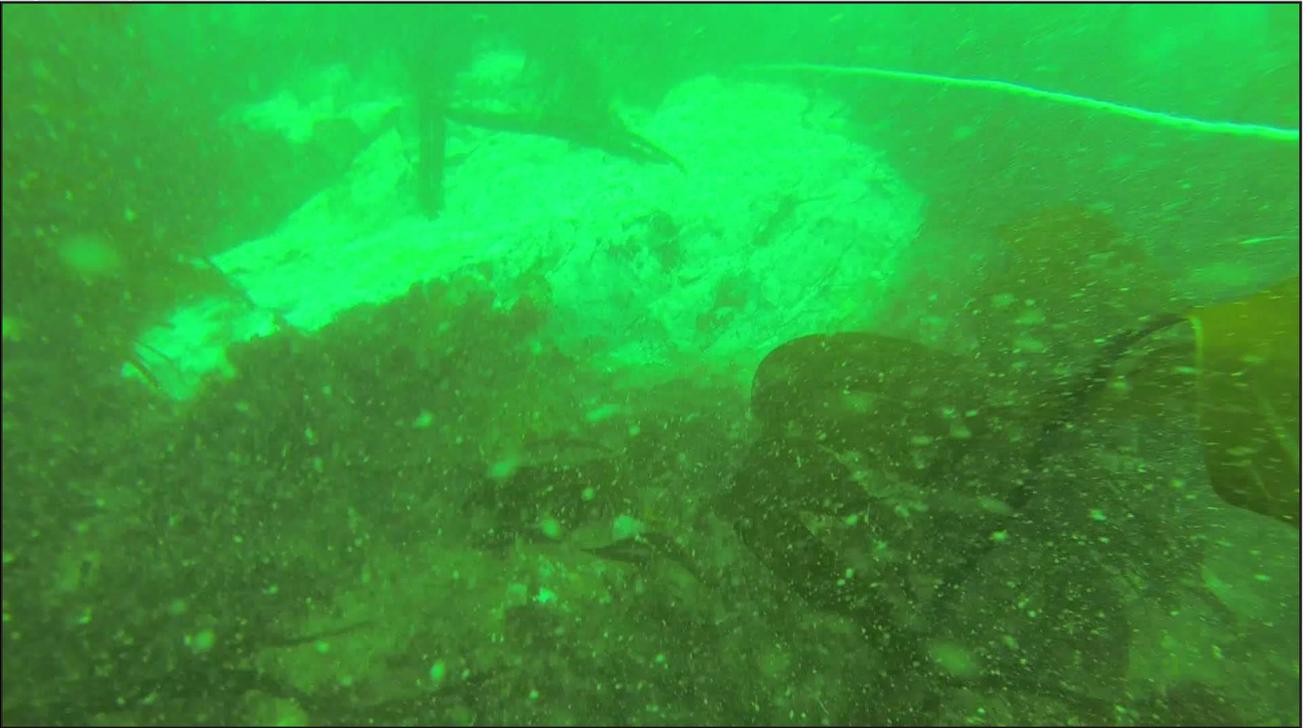
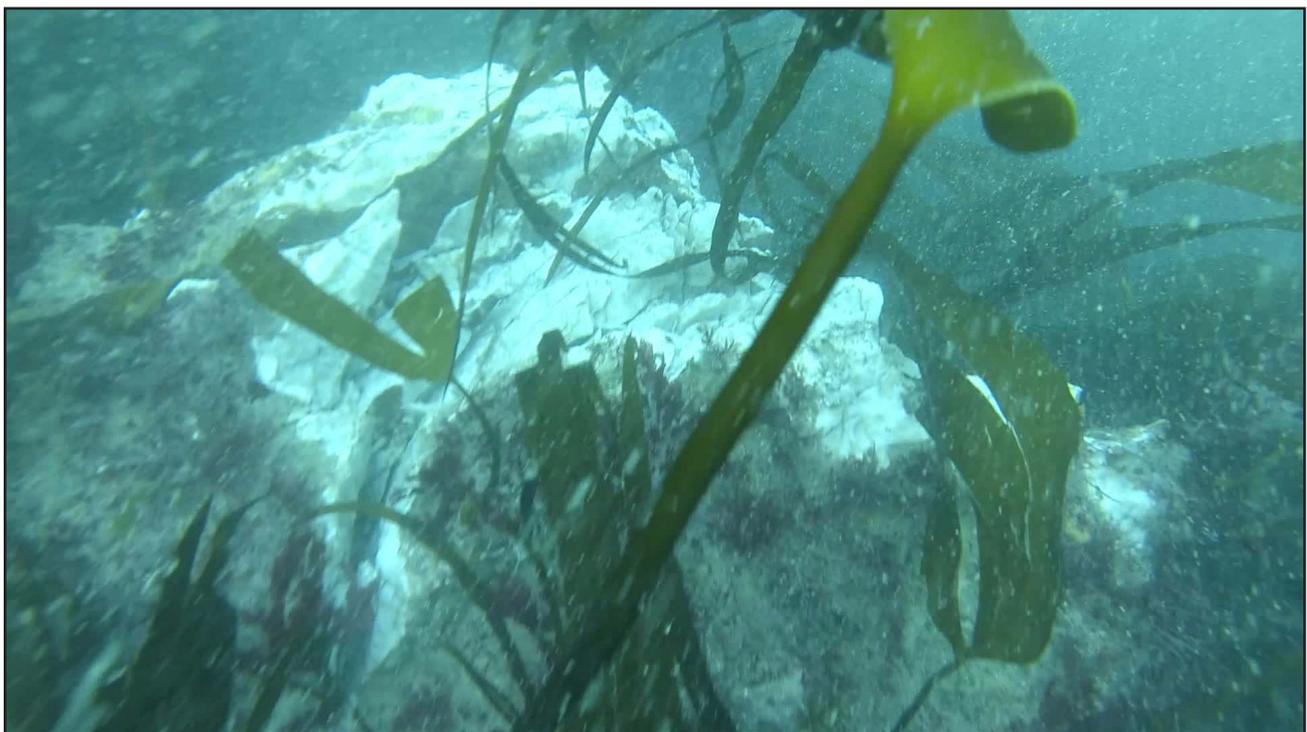
**Figure 5:** Granite pinnacles struck by *Commodore Clipper*

A post-accident dive survey of the seabed in the location of the grounding identified that *Commodore Clipper* had struck two granite pinnacles on a rocky shoal that was charted at a depth of 5.2m. During the grounding the tops of the two pinnacles broke away (**Figure 5**).

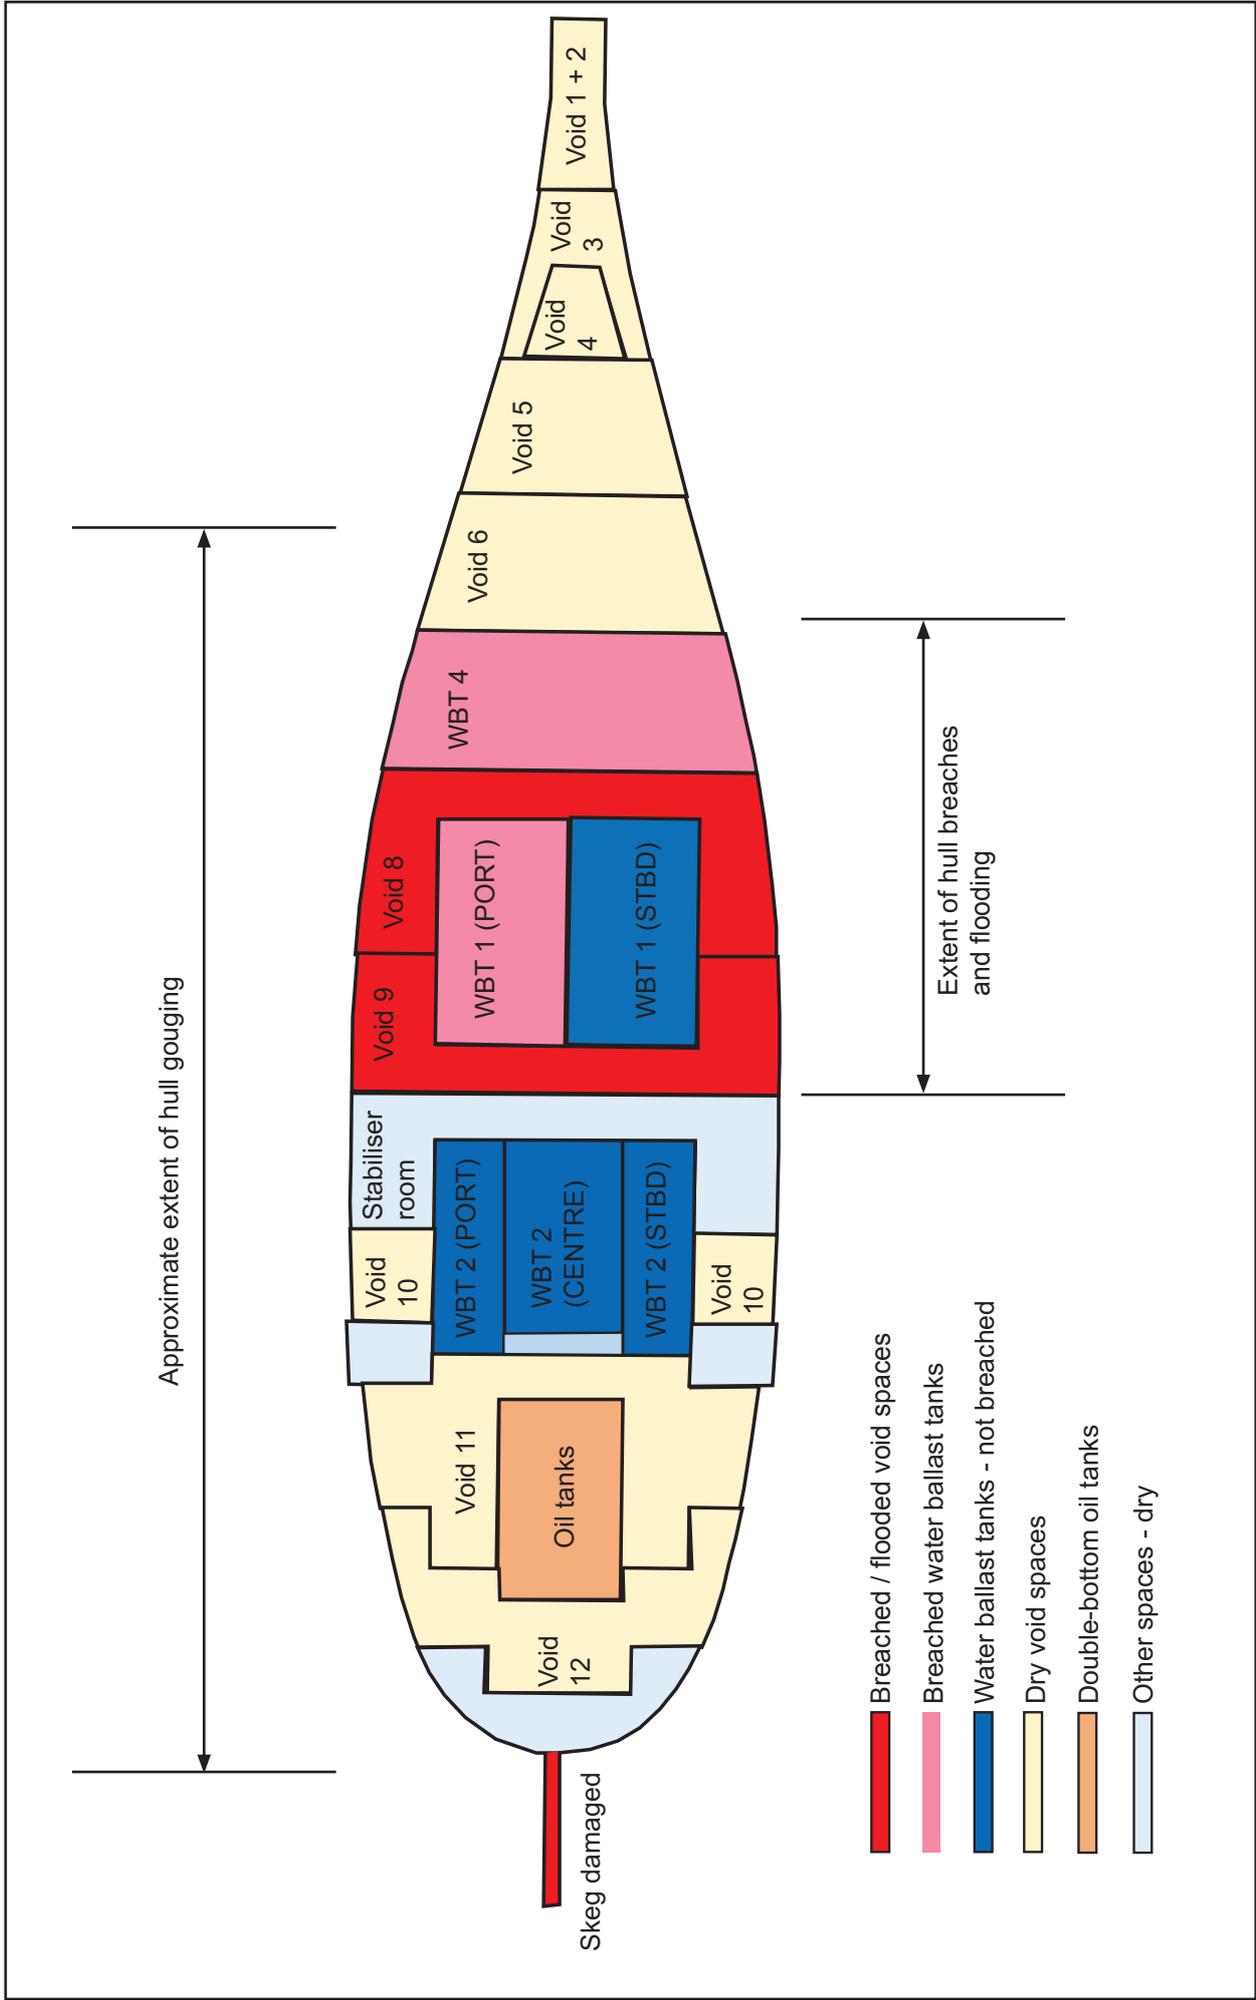
**Figure 6:** Commodore Clipper's double-bottom general arrangement showing extent of damage (not to scale)

The grounding caused significant damage (**Figure 6**) including:

- The shell plating of the hull on the port side was subject to a deep gouging distortion along approximately two thirds of its length (**Figure 7**).
- Water ballast tank 4 was holed in two places (**Figures 8 and 9**).
- Void space 8, void space 9 and water ballast tank 1 (port) were all breached by small holes and fracture damage to the hull (**Figure 10**).
- Although the propellers and rudders were not struck, the skeg was damaged along its entire underside length (**Figure 11**).

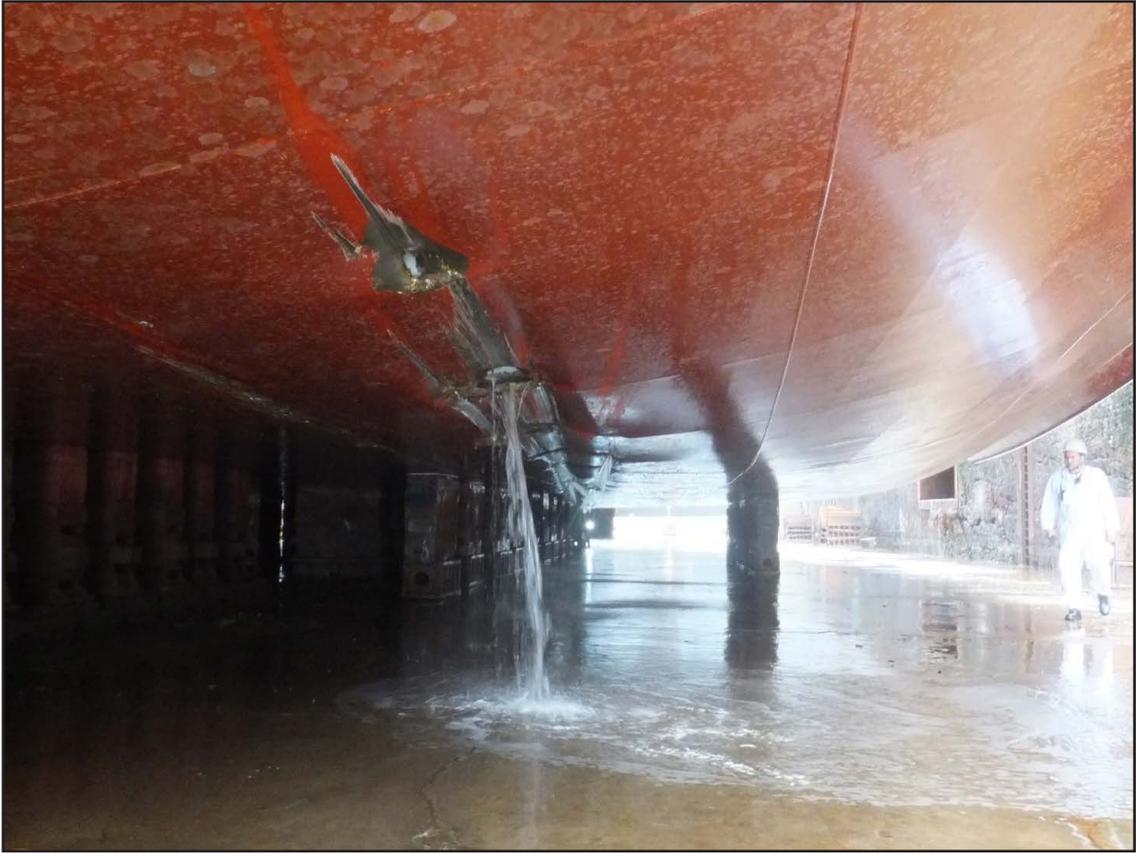
**Figure 7:** Hull gouging looking aft

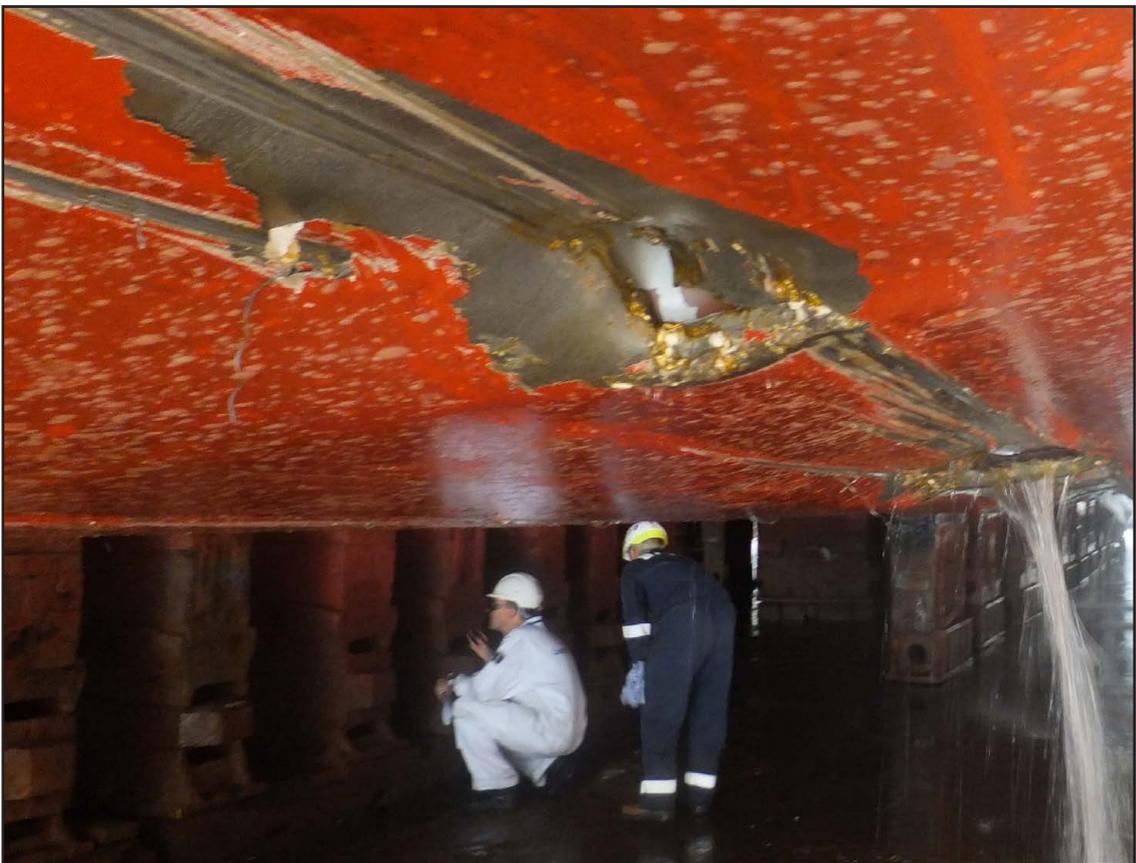
**Figure 8:** First hole in water ballast tank 4

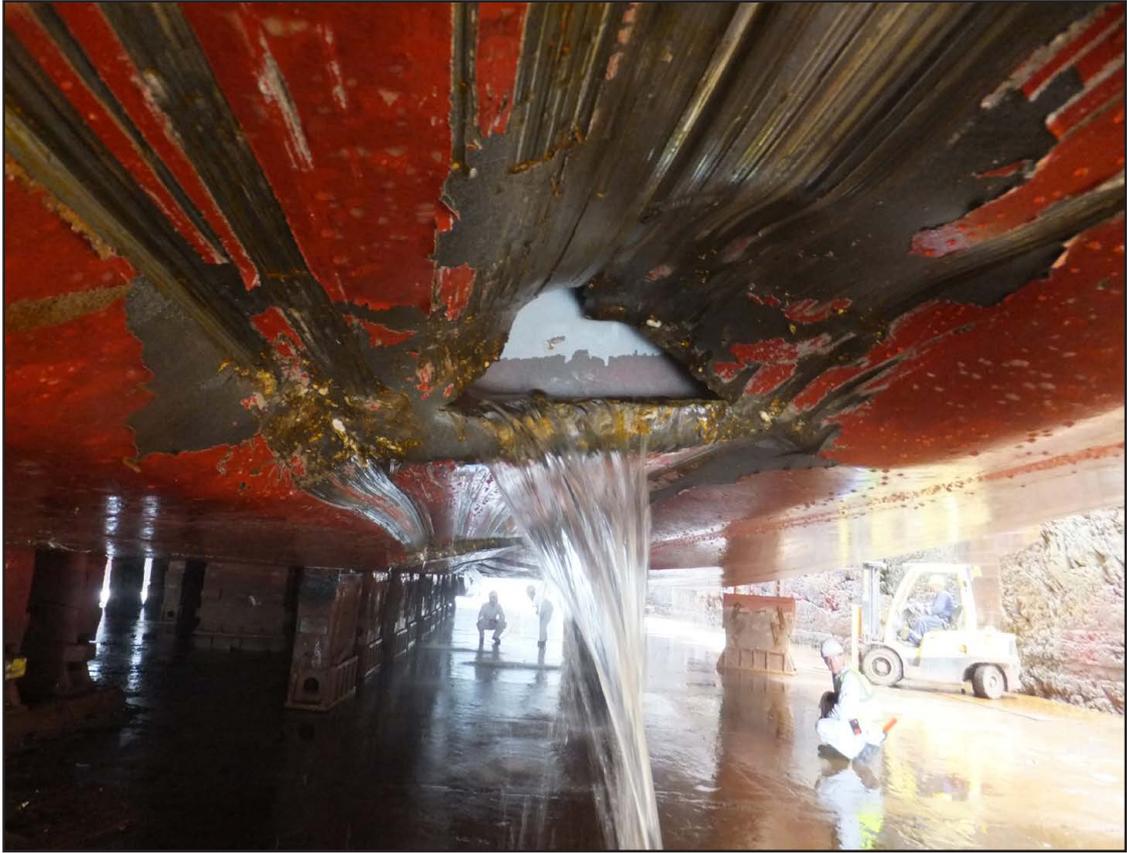
**Figure 9:** Second hole in water ballast tank 4

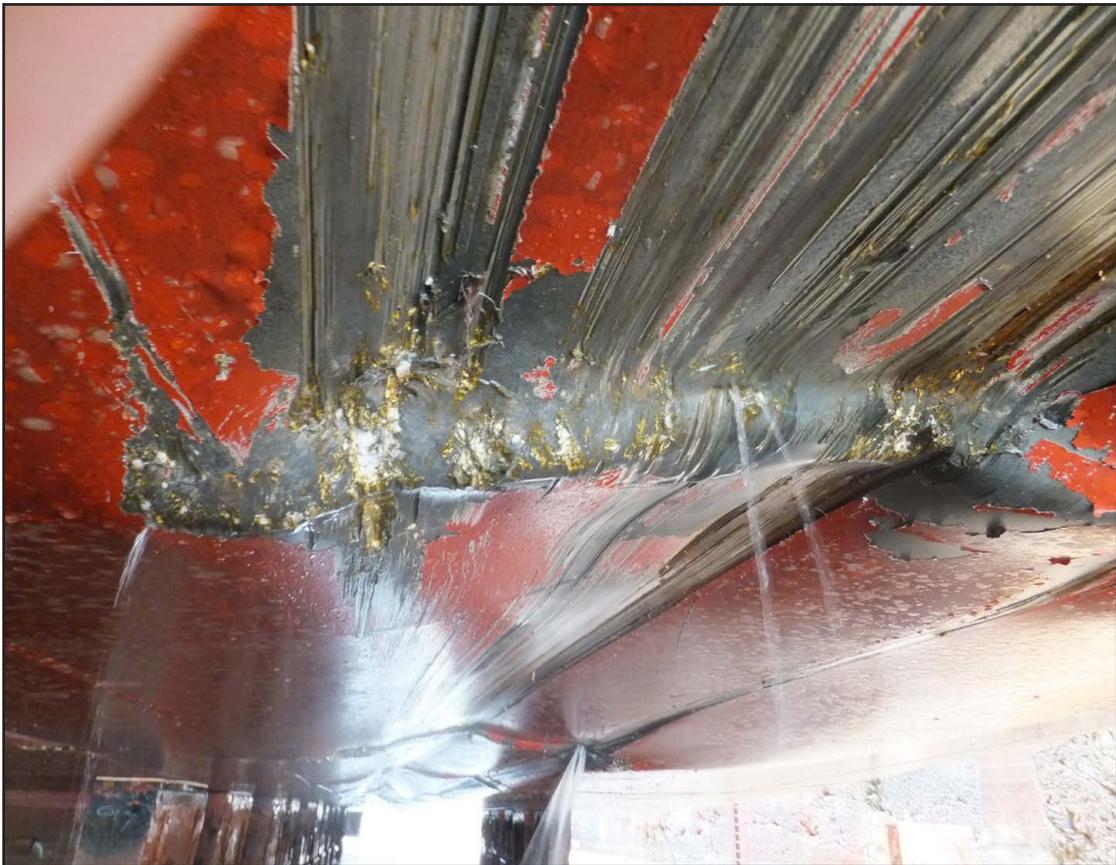
**Figure 10:** Detail of hull fracture damage

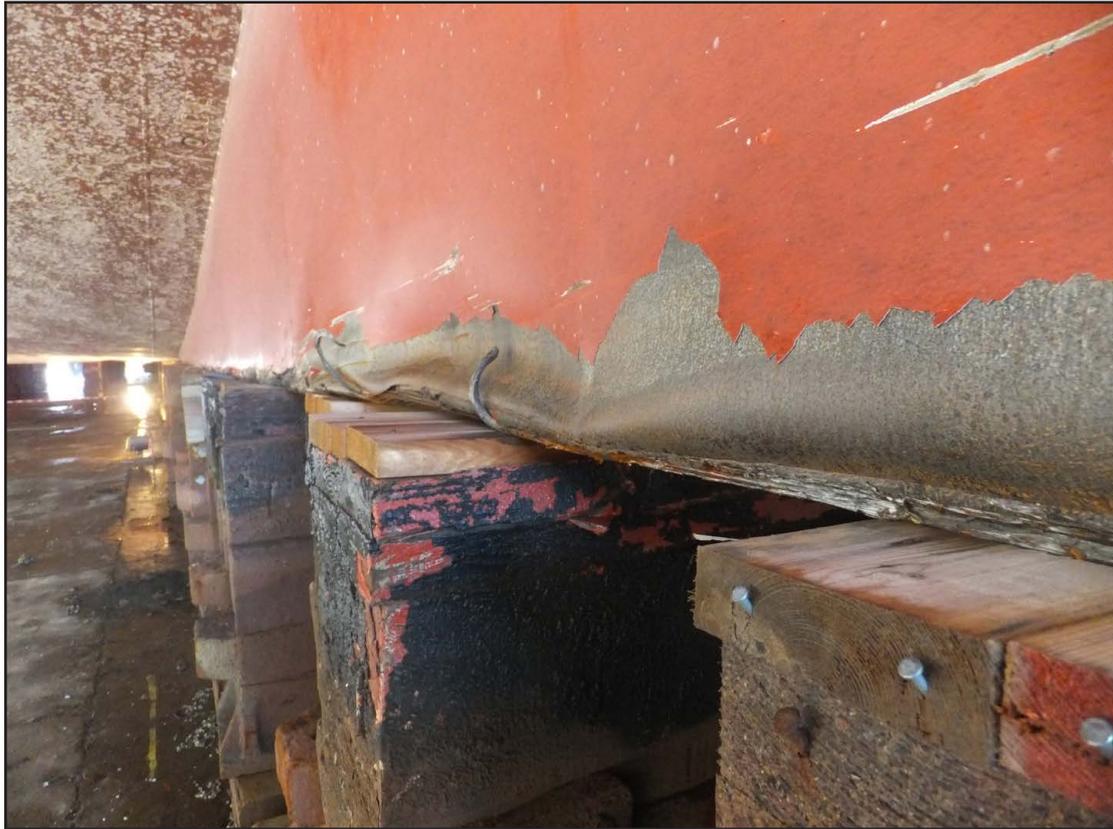
**Figure 11:** Detail of damage to keel skeg

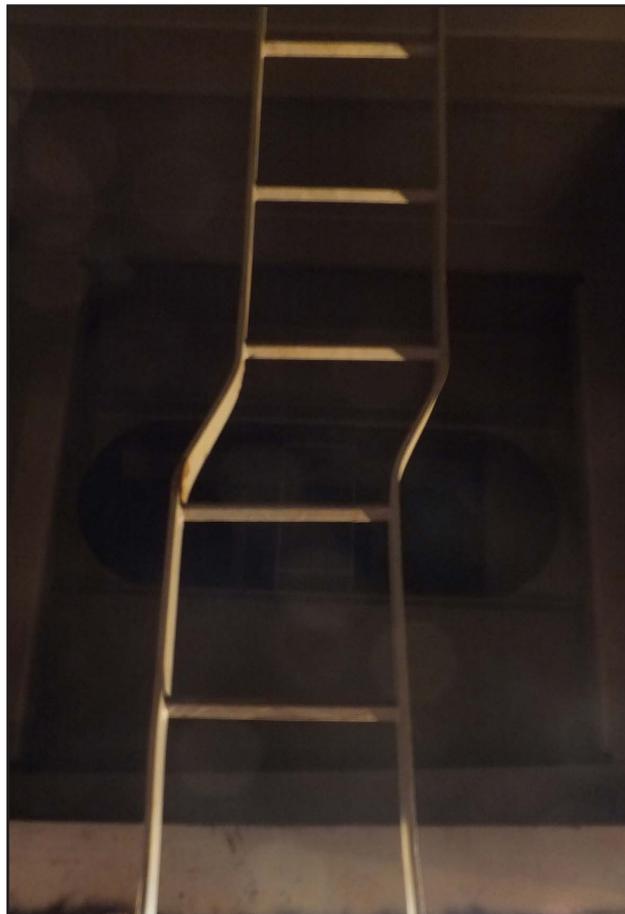
- Internal fixtures in affected areas were damaged resulting from the upward force of the grounding; an example was the distortion to a fixed ladder within a void space (**Figure 12**).

**Figure 12:** Example of internal ladder damage in a void space

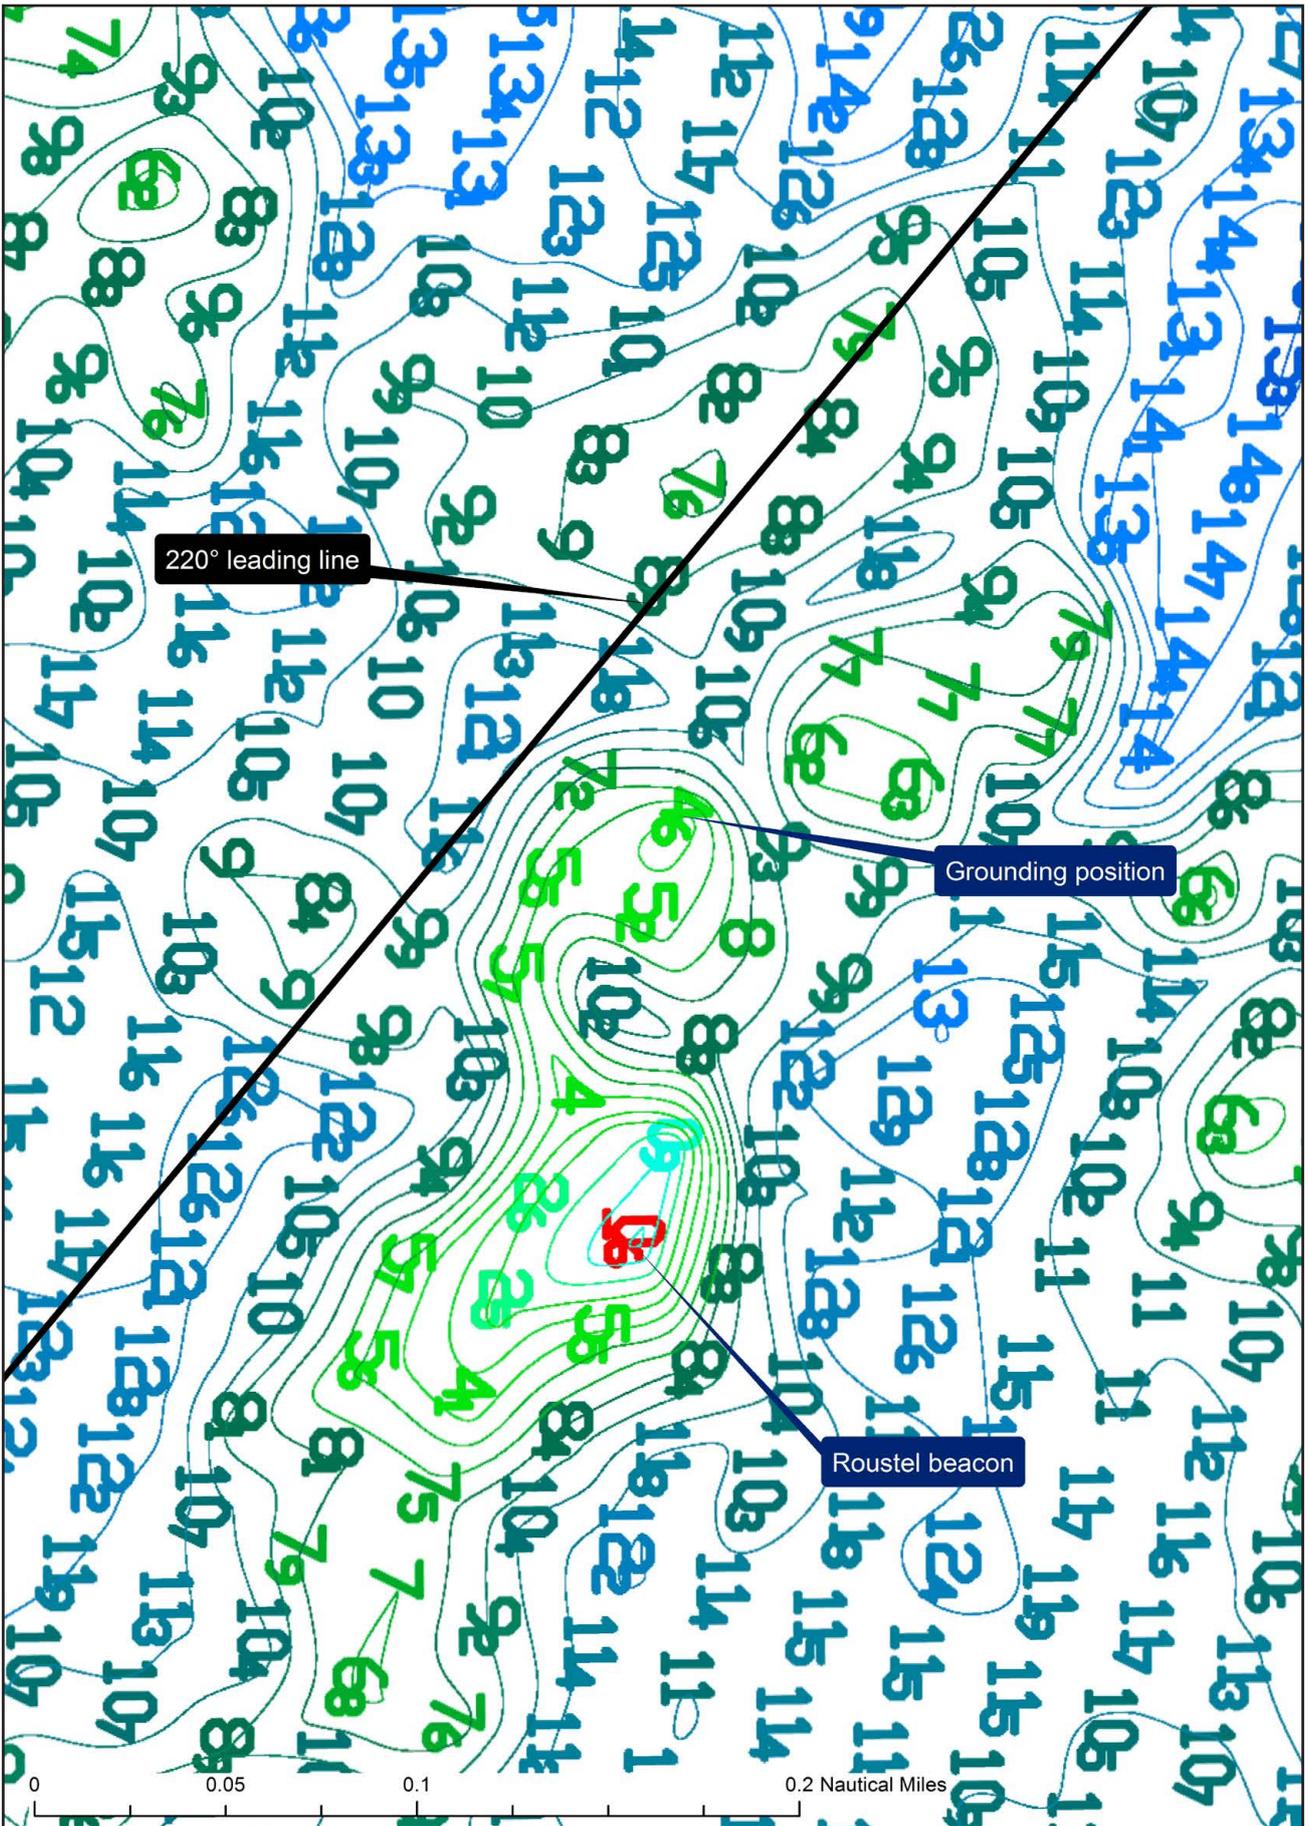
Figure 19: Extract of data from multi-beam survey conducted in March 2014 showing 4.6m sounding in grounding position (orientated north up)

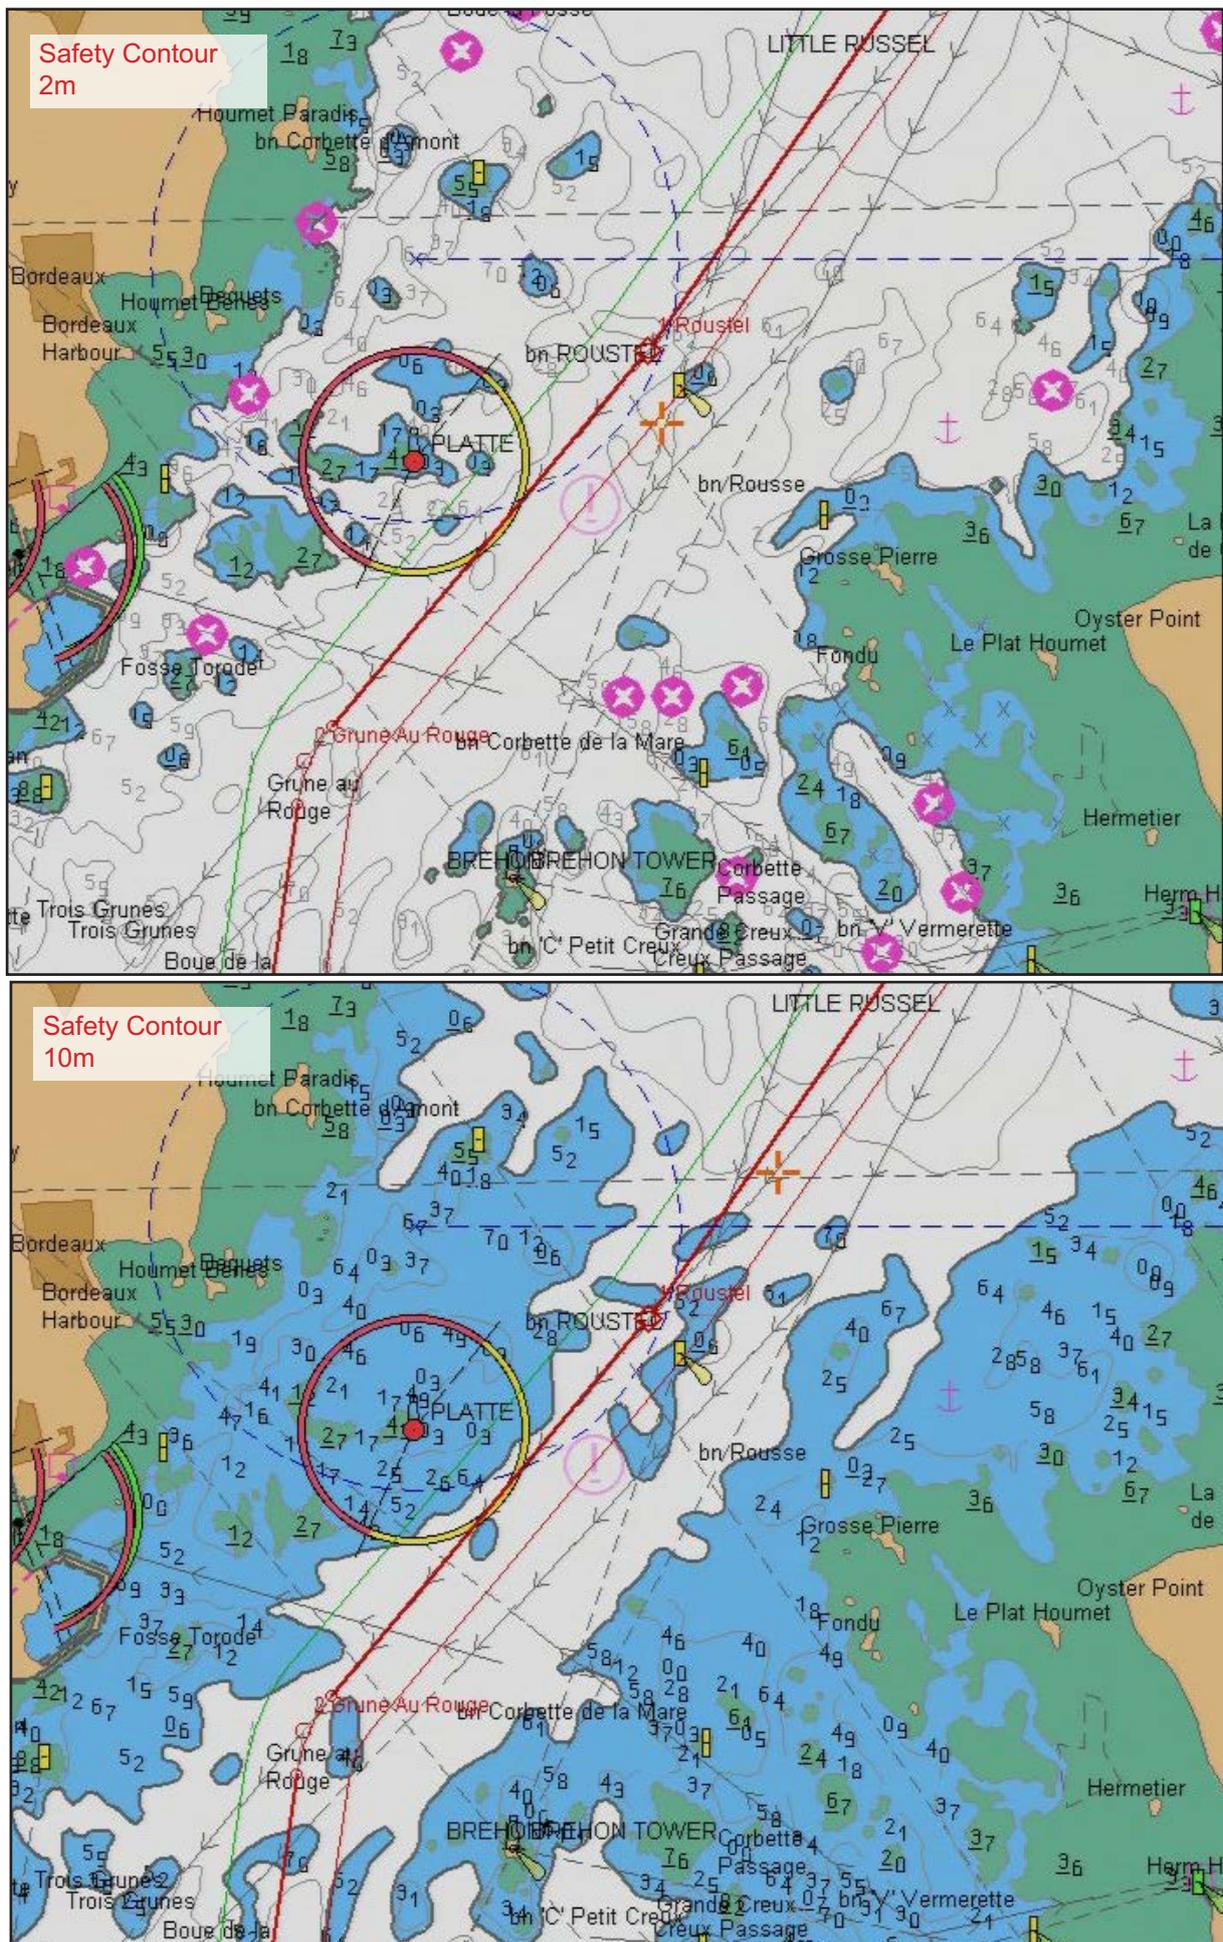
Figure 21: Comparison of ECDIS 2m and 10m safety contour lines in the Little Russel

**Figure 21** is a comparison of the ECDIS display showing safety contours set at 2m and 10m; a difference of 8m, which is effectively the mean spring range. These two images offer a visual comparison of the difference and significance that 8m height of tide makes to the width of navigable water in the Little Russel channel. For *Commodore Clipper*, the importance of this planning consideration is reinforced by the fact that several of the shoals in the Little Russel are hazardous at low water but perfectly safe to pass over at high water. Any of the OOW, chief officer or the master could have made an assessment of the effect on navigational safety resulting from such a low tide.

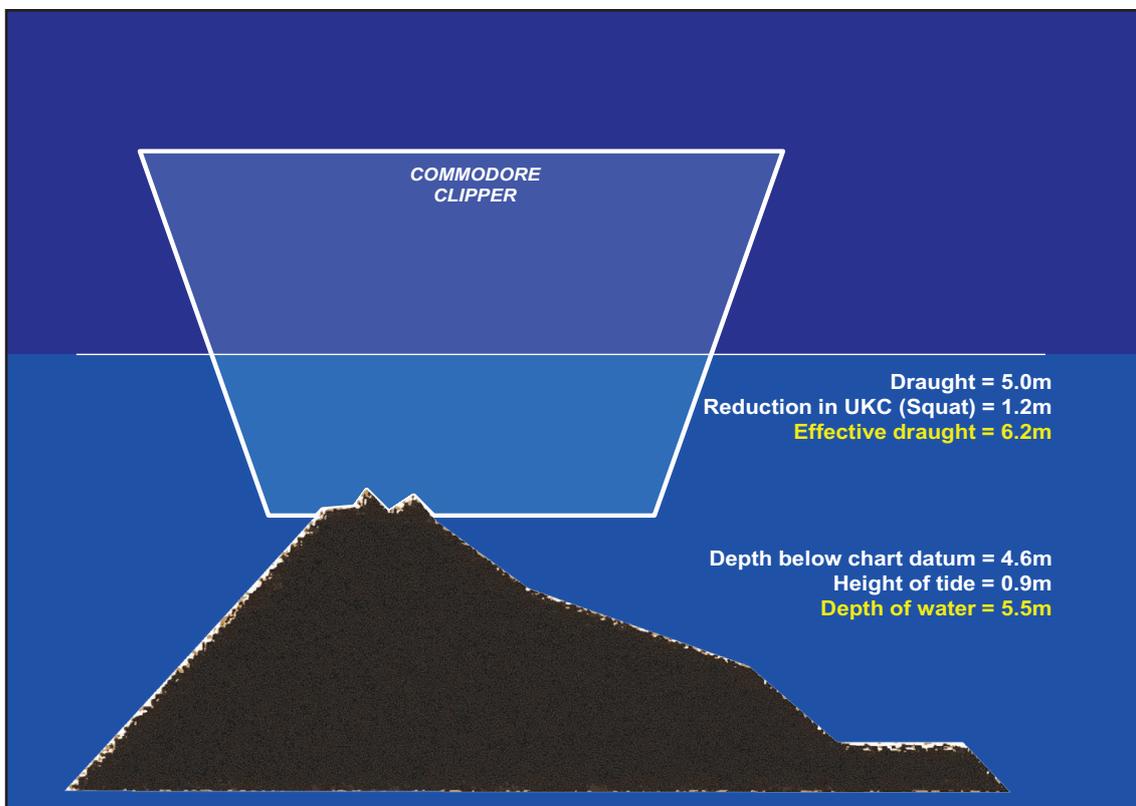
**Figure 22:** Assessment of actual values of draught and depth during grounding

Thus, the vessel should not have passed over any charted depth of 6.3m or less. Furthermore, if the +/- 1.2m source data accuracy of the chart is added to this equation then, for assurance of maintaining the minimum UKC, the vessel should not have passed over any charted depth of less than 7.5m in the Little Russel.

**Figure 22** is an illustration of the assessed values for the moment of grounding.

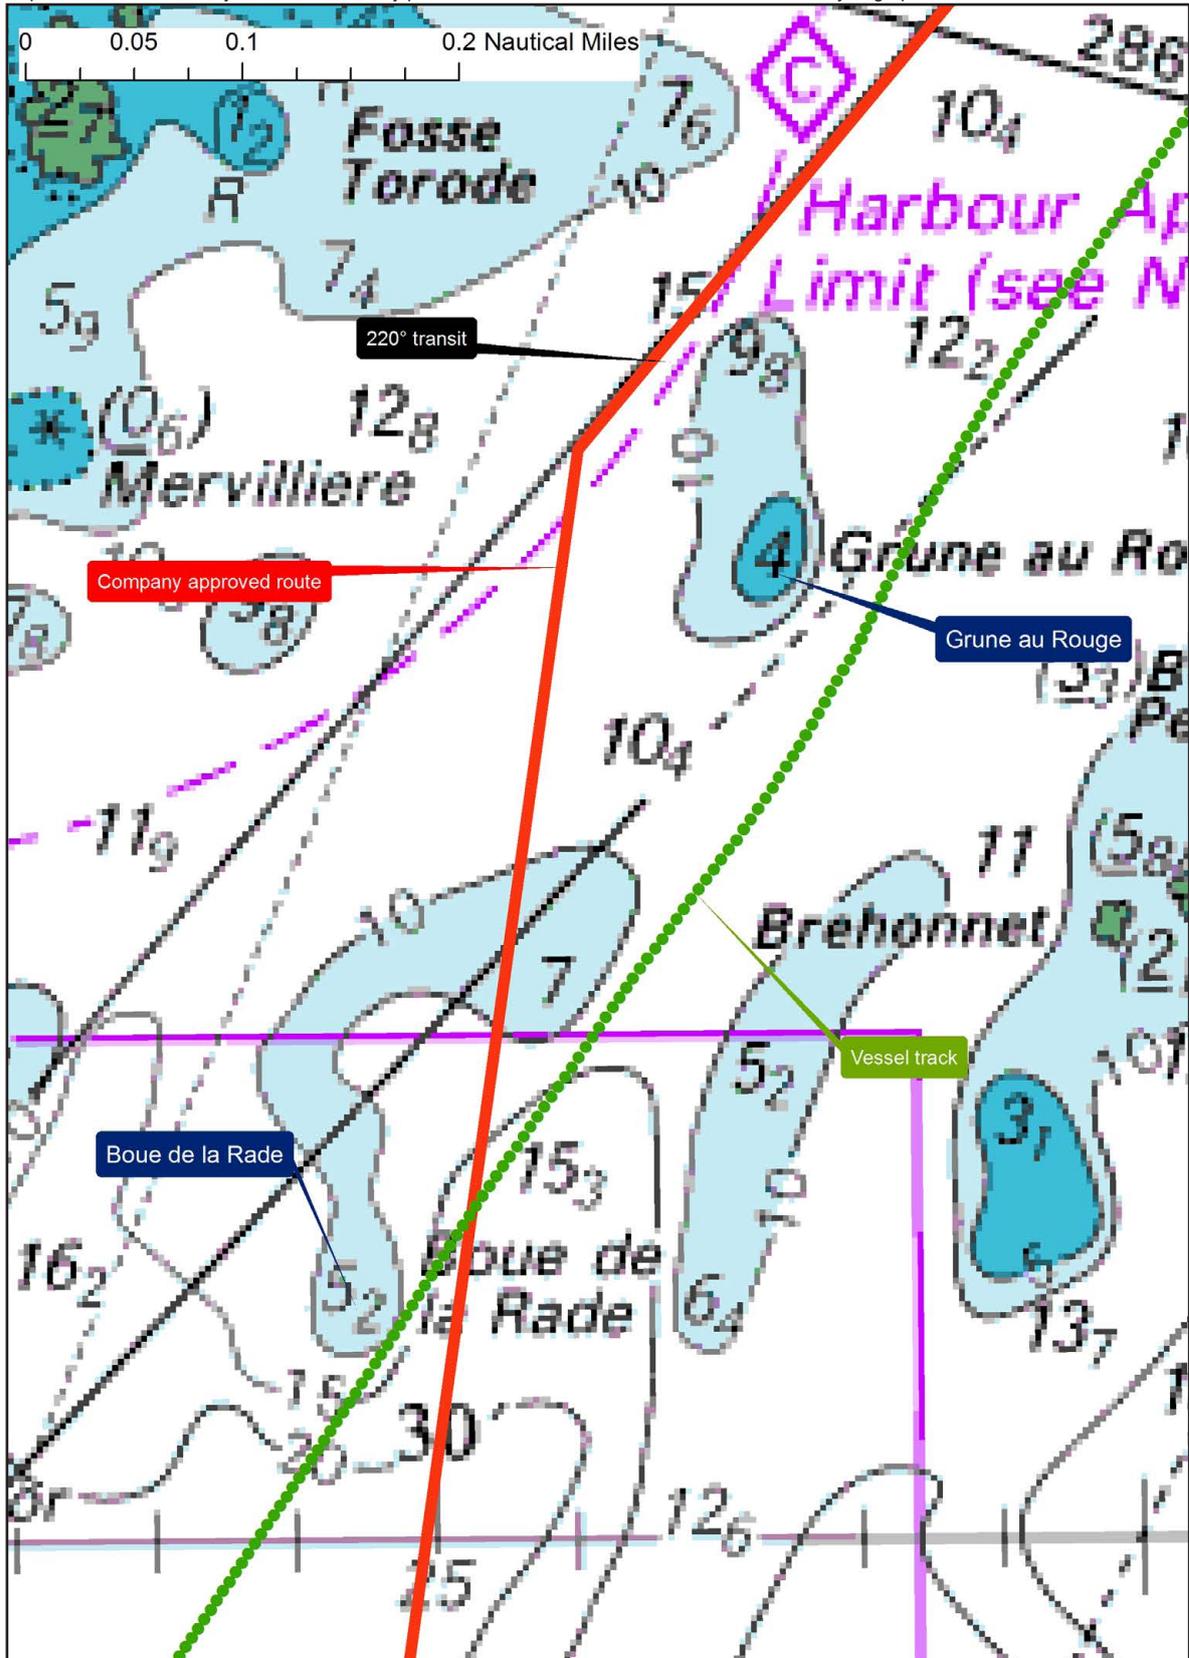
Figure 24: Detail of passage past Grune au Rouge and Boue de la Rade

The absence of leading transit marks when passing Grune au Rouge and Boue de la Rade meant that it would not be possible visually to assess the vessel's position (or the drift) to the accuracy required given the very close proximity of danger. Therefore, the Guernsey pilots' recommended route passing west of Grune au Rouge and Boue de la Rade utilising the 220° transit would be safer.

In addition, given that the Boue de la Rade is charted at the same depth as the grounding position (5.2m), and subject to the same survey accuracy of +/- 1.2m, then passing over this shoal created a similar navigational hazard to the grounding. This event reinforces the analysis that the crew were unaware of the limits of safe water in the Little Russel.

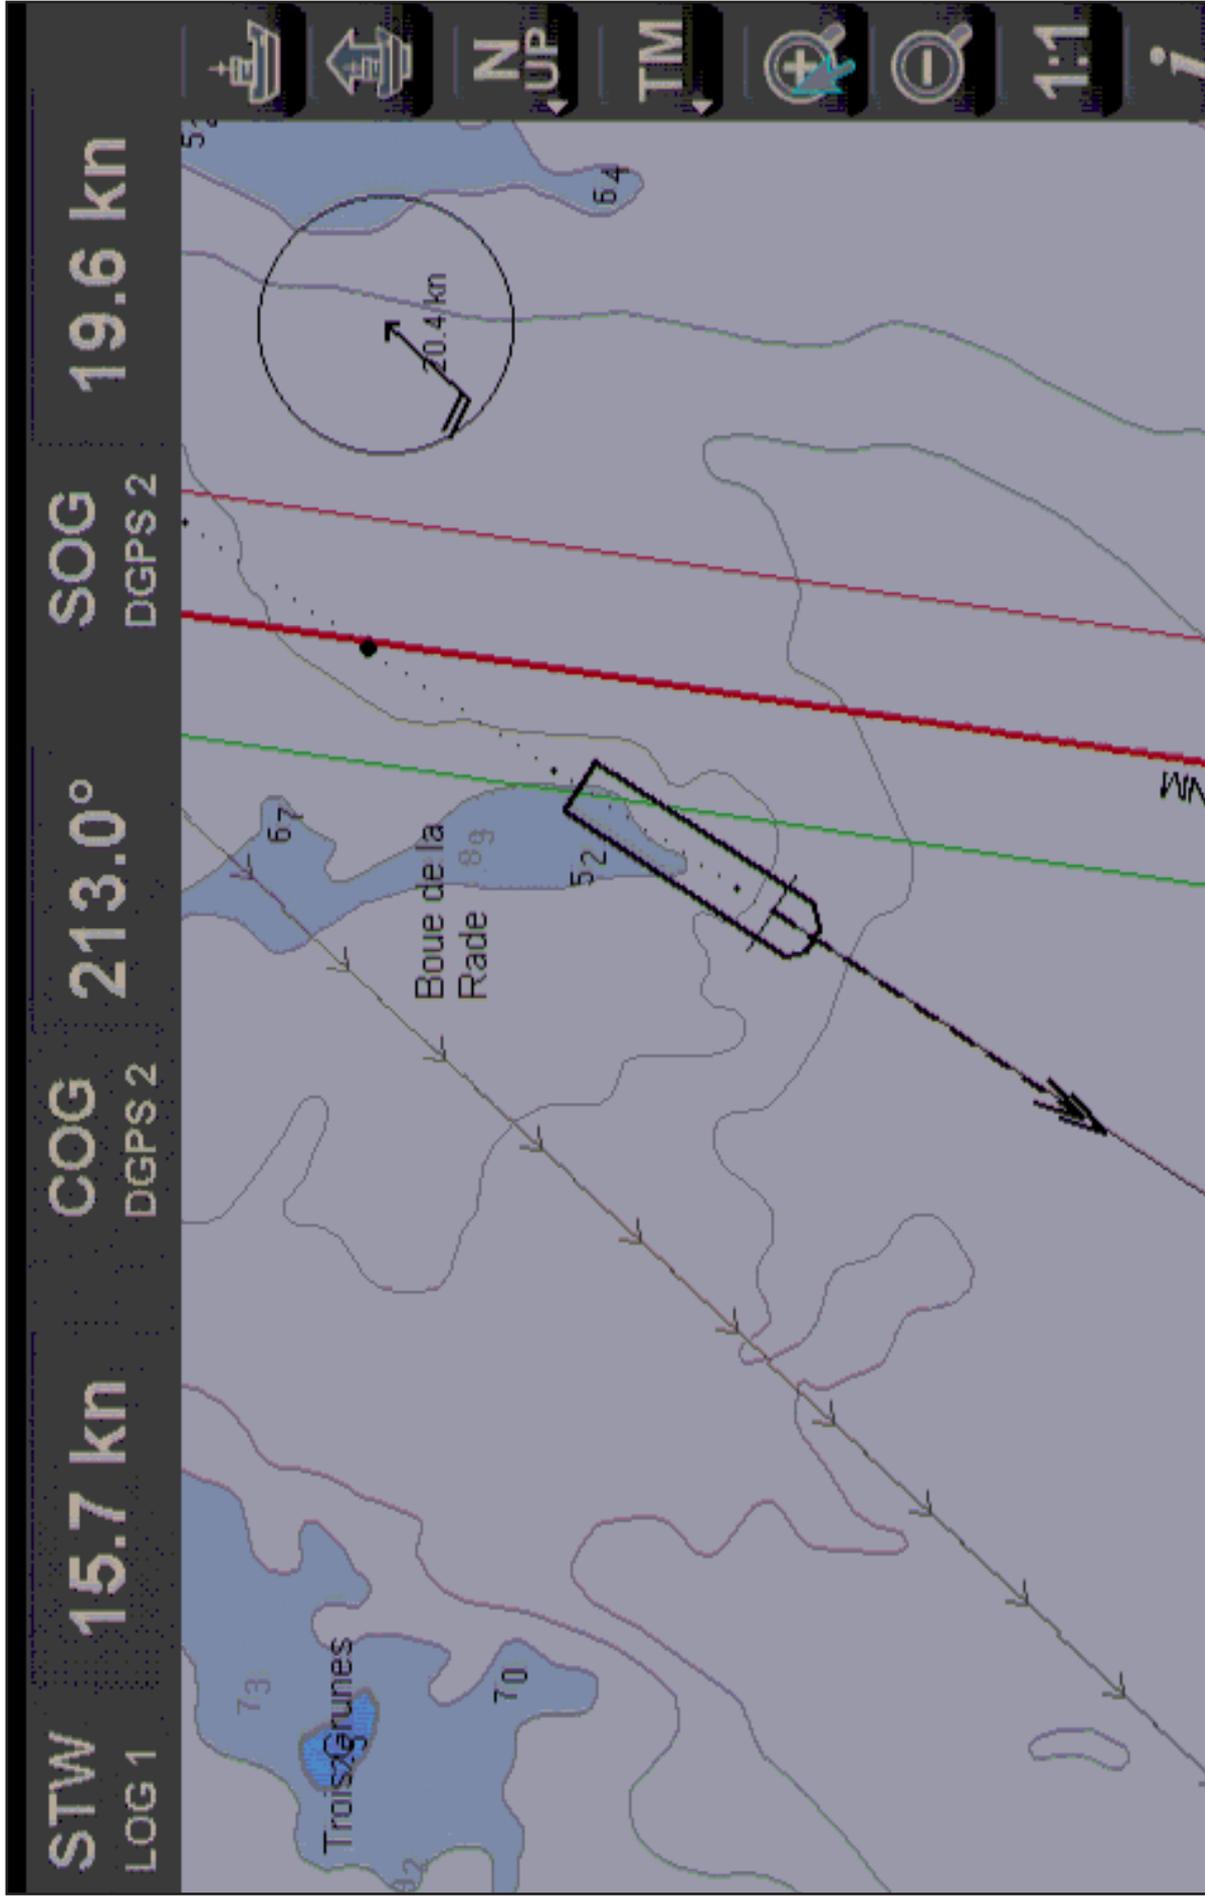
Figure 25: Details of ECDIS display as vessel crossed Boue de la Rade shoal

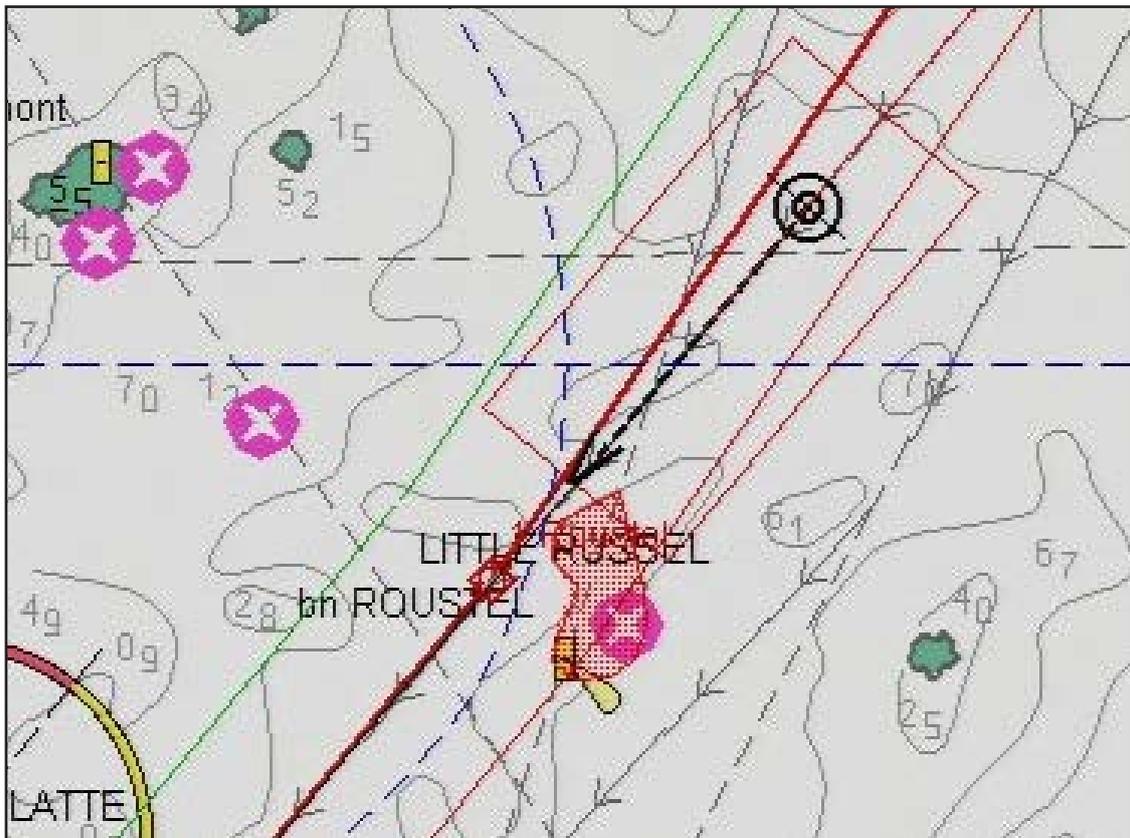
The ECDIS safety frame is a feature that offers forewarning of danger, primarily intended to prevent grounding, but this feature was switched off. However, the minimum width setting for the safety frame was 0.1nm (200 yards); this meant that the safety frame feature would have raised an alarm when the vessel was on track and in safe water as well as when it was unsafe (off-track). **Figure 30** shows a reconstructed ECDIS display with the vessel on the 220° transit approaching Roustel and the safety frame active - a 6.3m LDL is also drawn around the grounding position. It can be seen from this image that the safety frame would have activated an alarm with the vessel on the 220° transit. Thus, the safety frame feature would have been unable to discriminate between safety and danger when passing Roustel.

Figure 30: Reconstructed ECDIS display showing safety frame crossing 6.3m LDL
