AAIB Bulletin S2/2015

SPECIAL

ACCIDENT

Aircraft Type and Registration:	Embraer EMB-505 Phenom 300, HZ-IBN	
No & Type of Engines:	2 x Pratt & Whitney Canada PW535E turbofans	
Year of Manufacture:	2010 (Serial no: 50500040)	
Location	Blackbushe Airport, Hampshire	
Date & Time (UTC):	31 July 2015 at 1408 hrs	
Type of Flight:	Private	
Persons on Board:	Crew - 1	Passengers - 3
Injuries:	Crew - 1 (Fatal)	Passengers - 3 (Fatal)
Nature of Damage:	Aircraft destroyed	
Commander's Licence:	Airline Transport Pilot's Licence	
Commander's Age:	57 years	
Flying experience:	11,000 hours (of which 1,180 were on type) Last 90 days - 23 hours Last 28 days - 5 hours	
Information Source:	AAIB Field Investigation

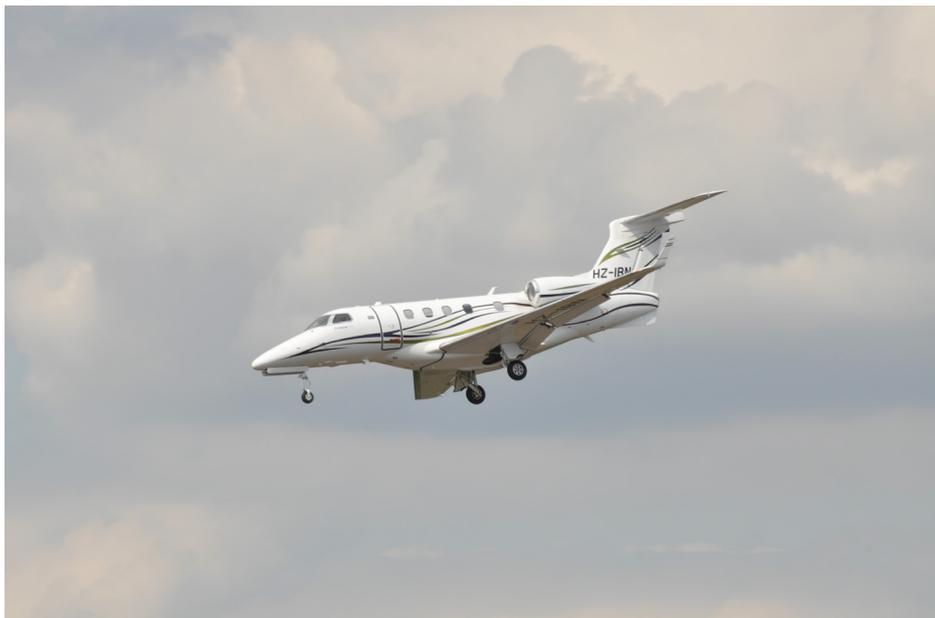
Figure 1

HZ-IBN on approach to Runway 25 shortly before the accident
(photograph taken by Geoff Pierce)

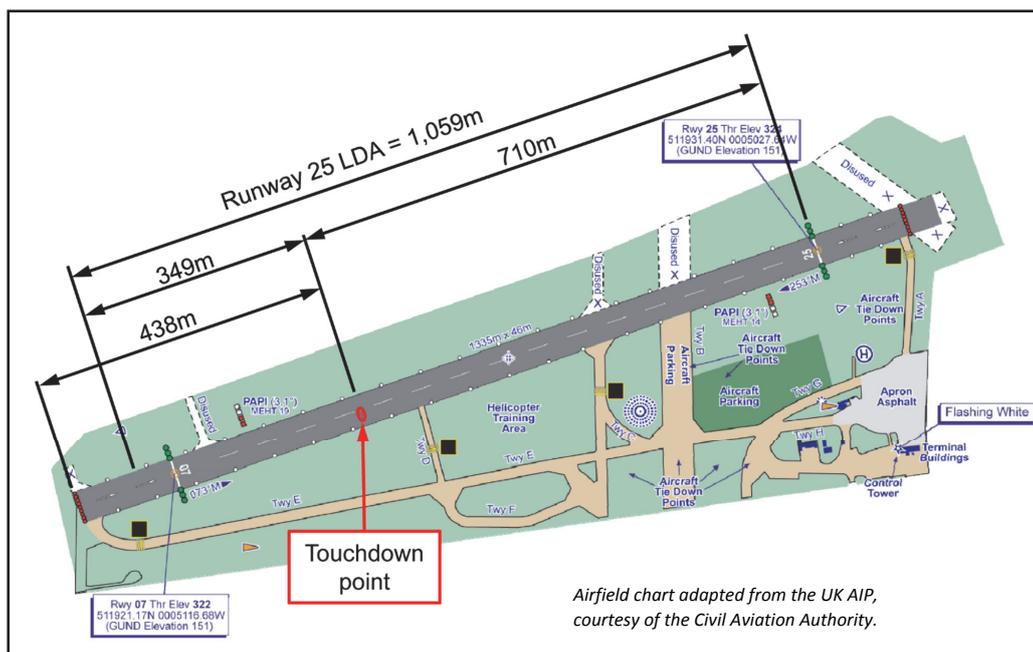
Figure 2

Tyre marks made by the aircraft at touchdown indicated that it landed approximately 710 m beyond the Runway 25 threshold. Runway 25 has a declared Landing Distance Available (LDA) of 1,059 m; therefore the aircraft touched down approximately 349 m before the end of the declared LDA, 438 m before the end of the paved runway surface.

Blackbushe aerodrome chart, showing LDA and approximate touchdown point
