**SERIOUS INCIDENT**

<b>Aircraft Type and Registration:</b>	Boeing 737-36Q, G-GDFT	
<b>No &amp; Type of Engines:</b>	2 CFM56-3C1 turbofan engines	
<b>Year of Manufacture:</b>	1998	
<b>Date &amp; Time (UTC):</b>	3 September 2014 at 1958 hrs	
<b>Location:</b>	East Midlands Airport	
<b>Type of Flight:</b>	Commercial Air Transport (Passenger)	
<b>Persons on Board:</b>	Crew - 5	Passengers - 152
<b>Injuries:</b>	Crew - None	Passengers - 1 (Minor)
<b>Nature of Damage:</b>	R1 relay damage	
<b>Commander's Licence:</b>	Airline Transport Pilot's Licence	
<b>Commander's Age:</b>	59 years	
<b>Commander's Flying Experience:</b>	10,600 hours (of which 4,100 were on type) Last 90 days - 294 hours Last 28 days - 54 hours	
<b>Information Source:</b>	AAIB Field Investigation

**Synopsis**

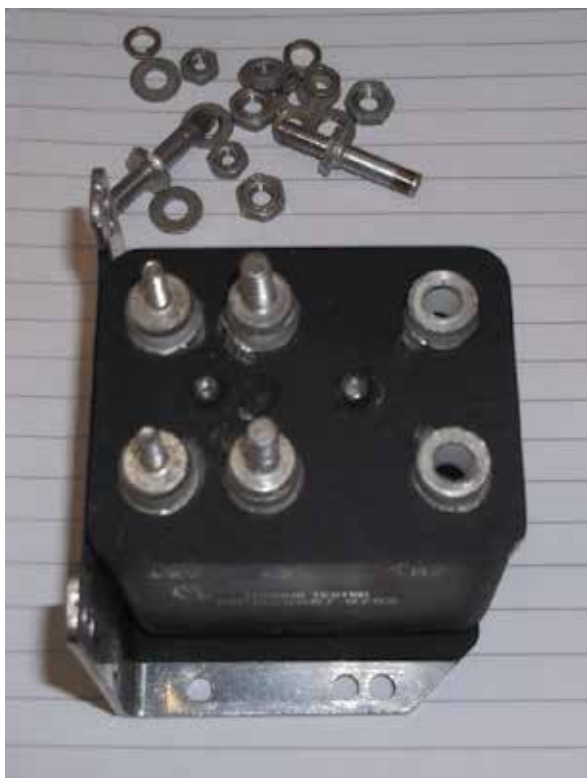
**Figure 1**

An examination of the circuit diagrams and the list of system losses indicated that the fault lay with the R1 or R326 relay. Power-off continuity checks were carried out across the two pairs of terminals on the R1 relay, but these were inconsistent and therefore inconclusive. The R1 relay was removed to aid further examination, but its removal was somewhat difficult as the terminals were loose and tending to rotate rather than remain stationary when an undoing torque was applied to the nuts. The outer collars had to be gripped with pliers in order to remove the nuts. It was difficult to carry out this task in the confined area at the bottom of the P6 bay in which the relay is located. It was also observed that the relatively large and stiff 'A' gauge cables and terminations were rigid, tightly tied within their wiring harness and did not naturally align with the terminals when the nuts were removed. When examined, the relay appeared to contain a loose object which rattled within the casing. Closer inspection of the relay terminals B1 and B2 found them to be loose and no longer fixed to their insulated mounting in the relay, to the extent that they fell out when the relay was inverted. The A1 and A2 terminals were also loose within their insulated collar, but remained in place. Figure 1 shows the R1 relay after removal.

R1 relay with detached B1 and B2 terminals

Each terminal had failed at the point where a flange on the terminal was soldered to the metal collar bonded to a ceramic insulator on the relay casing. Although the A and B pairs of terminals were loose, the solenoid terminals, labelled -X1 and +X2 were intact. The solenoid was heard (and seen under X-ray) to operate when 28 VDC was applied across the X terminals. Examination of the fracture surfaces by binocular microscopy identified what appeared to be solder porosity and areas of mechanical damage in the form of 'smearing', indicating rotation of the terminals. It was also found that the surface morphology was consistent with brittle overload. A high magnification picture of the surface is shown in Figure 2. An independent laboratory initially examined the loose terminals and observed

The reproduction of the electrical power distribution system symptoms after the incident and the rectification by replacement of the R1 relay, confirmed the failure of the R1 relay as being causal. In order to lose power to the battery bus there needs to be a loss of continuity between the A or B terminals; for this to happen one or both of the terminal post must be permanently misaligned or become 'out of reach' of the contactor plate. The continuity checks in situ, with power off, (ie the relay in a de-energised condition) were inconclusive, probably due to the terminals being loose.

Despite the exact material failure mode, the loss of the battery bus was due to the loss of electrical continuity across the B1 and B2 terminals, as this is the normal position of the Battery Bus Auto (R1) contacts for the Battery Bus to receive 28V DC from TR-3 before the relay failure. In order for this to happen a misalignment or small movement away from the contactor blade must have taken place. The length of the terminal within the relay would effectively amplify any movement at the cable connection end of the terminal, thus increasing the risk of the loss of contact. The cause of the movement cannot be determined beyond doubt. However, an over-torque on a terminal and the presence of a constant side load or tension from the stiff wiring harness is the most likely scenario to have taken place on one or more of the terminals. It is possible that excessive torque was applied to the terminals at installation or during subsequent maintenance, resulting in a weakening of the terminal insulator soldered joint.

The electrical difficulties experienced in this aircraft were as a direct result of the loss of continuity between the R1 relay terminals. This was due to one of its terminals loosening in its insulated mounting over an indeterminate period of time and moving away from the contactor, thus breaking continuity. It is possible that this was caused by an overtightened terminal nut weakening the terminal and insulator soldered joint whilst at the same time being under a degree of tension or side load from the heavy gauge electrical cables.

A replacement relay was fitted and further aircraft power supply tests were carried out, during which all aircraft systems functioned normally. In order to verify the diagnosis, the aircraft ground power was left on the aircraft for approximately one hour, with no emergent faults. The R326 relay was found not to be involved and operated correctly.

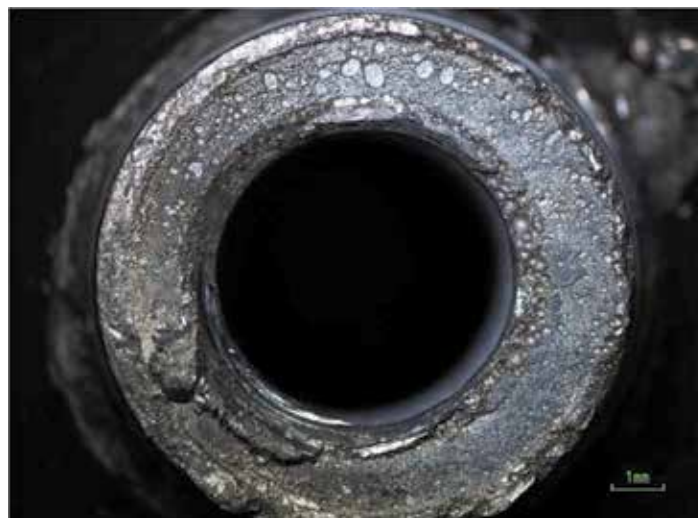
**Figure 2**

Terminal insulator soldered joint fracture face

the characteristics of porosity on the joint faces. However, the component manufacturer considered the brittle overload surface morphology to be the predominant characteristic. A particular example was the B2 stud and terminal insulator interface that showed signs of rotational motion.

Forensic examinations by an independent laboratory and by the OEM offered differing conclusions as to why the terminals became loose. There appeared to be evidence of porosity of the soldered joint and brittle overload between its surfaces. However, the difficulty experienced in the disassembly of the terminals and cables means that evidence of these two characteristics could not be relied upon to show the exact failure mode. Furthermore, all the terminals appeared to turn when an undoing torque was applied to the nuts, but exactly how loose each terminal was at the time could not be determined accurately. When the R1 relay was examined in situ, the terminals all appeared to be correctly in place when viewed from the top. However, the position of the relay in the bay made it very difficult to see whether any of the terminals had lifted away from their mountings; in addition the stiffness of the cable harness made everything look and feel tightly assembled.

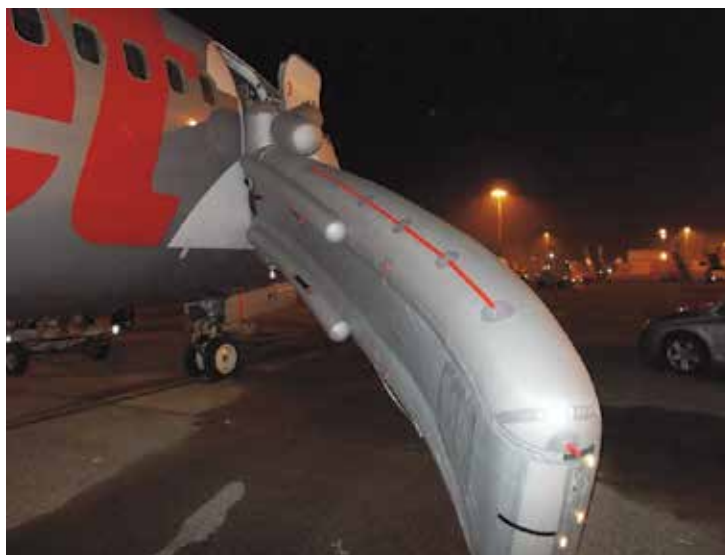
**Figure 3**

The cabin crew initiated a full emergency evacuation, opening the forward cabin doors, which automatically deployed the escape slides. However the Number 1 Right (1R) slide inflated but twisted upside down, becoming jammed against the fuselage and not in contact with the ground. This rendered the slide unusable. The slide was fully inflated and under considerable tension at the top and so for safety reasons the slide was deflated and removed before the AAIB's arrival. Prior to deflation, with the 1R door fully open, it was found that it took very little effort applied at its lower end to right the slide and once righted, it settled in its correctly deployed position. The engineers removing the slide manually took careful note of the girt bar<sup>3</sup> and reported that it was correctly engaged in its fittings. Examination of the slide in its deflated condition off the aircraft found it to be undamaged, despite the twist and tension to its girt bar apron. All the ancillary devices attached to the slide were undamaged. The slide did not appear to have any pre-existent faults or damage. Figure 3 shows that slide in its twisted state prior to removal.

1R slide fully inflated and twisted

Examination of the 1R door escape slide and girt bar after the incident revealed that it was correctly attached to the aircraft and therefore was in its automatic position. The slide material and its inflation equipment were undamaged and there was no evidence of a pre-existent fault. There did not appear to be a technical reason why the slide became twisted during deployment, but anecdotal evidence suggests that there have been previous occasional mis-deployments of the slides. Of those, the majority seem to have taken place with the right front cabin door; ie the 1R slide, as in this case. It is not clear exactly how these mis-deployments occur. In some cases the doors have been observed not to be completely clear of the slide as it deploys and so can deflect the slide while partially inflated. A twist then sets in at the top, then, as the moment (ie length and leverage of the inflating slide) increases with extension, the twist tightens and remains in place. When this happens, the resulting twist causes the slide to adopt a highly unusual angle and places the bustle apron under extreme tension, as was found in this case. A possible reason why the 1R door may not be clear in time is that the cabin crew two-handed muscular auto-motor skills are more used to opening the Number 1 Left (1L) door in one smooth, well-practiced movement. Research and discussion at a UK-based Boeing 737 cabin crew simulator suggested this was a distinct possibility.

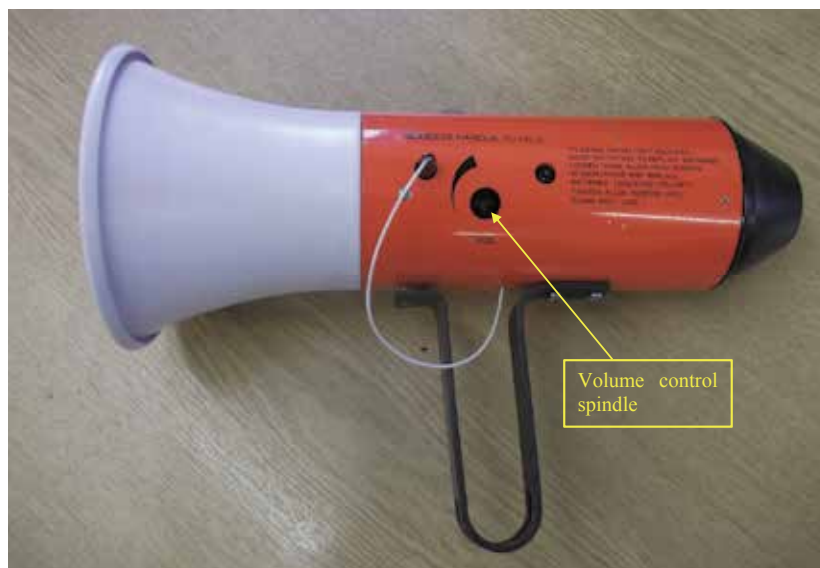
**Figure 4**

There were two battery powered emergency loud hailer fitted in the overhead lockers; one at the front and one at the rear of the aircraft. The crew reported that they had difficulty using the loud hailer at the front of the aircraft. Examination of the loud hailer (Figure 4) found that, although the unit was fully charged and the press-to-speak handle worked correctly, the volume was set to minimum and the volume control knob was missing. The knob spindle was present and undamaged. The loud hailer fitted at the rear of the aircraft was fully serviceable.

Emergency loud hailer missing volume control knob

The cabin crew reported difficulties with the handheld emergency load hailer at the front of the aircraft. The volume was turned down and the knob was missing, leaving the end of the spindle to which it was attached below the level of the casing. It was unclear how, or when, the knob came to be missing and a search of the overhead locker in which the hailer was stowed failed to locate the missing item.
