SERIOUS INCIDENT

Aircraft Type and Registration:	Boeing 757-3CQ, G-JMAB	
No & Type of Engines:	2 Rolls-Royce RB211-535E4-B-37 turbofan engines	
Year of Manufacture:	2001 (Serial no: 32242)	
Date & Time (UTC):	31 October 2014 at 1130 hrs	
Location:	During takeoff from London Gatwick	
Type of Flight:	Commercial Air Transport (Passenger)	
Persons on Board:	Crew - 10	Passengers - 239
Injuries:	Crew - None	Passengers - None
Nature of Damage:	Slide carrier, pivot forging and actuator deformed, slide loss and fuselage scuff marks	
Commander's Licence:	Airline transport pilot's licence	
Commander's Age:	50 years	
Commander's Flying Experience:	15,300 hours (of which 8,765 were on type) Last 90 days - 196 hours Last 28 days - 57 hours	
Information Source:	AAIB Field Investigation

Synopsis

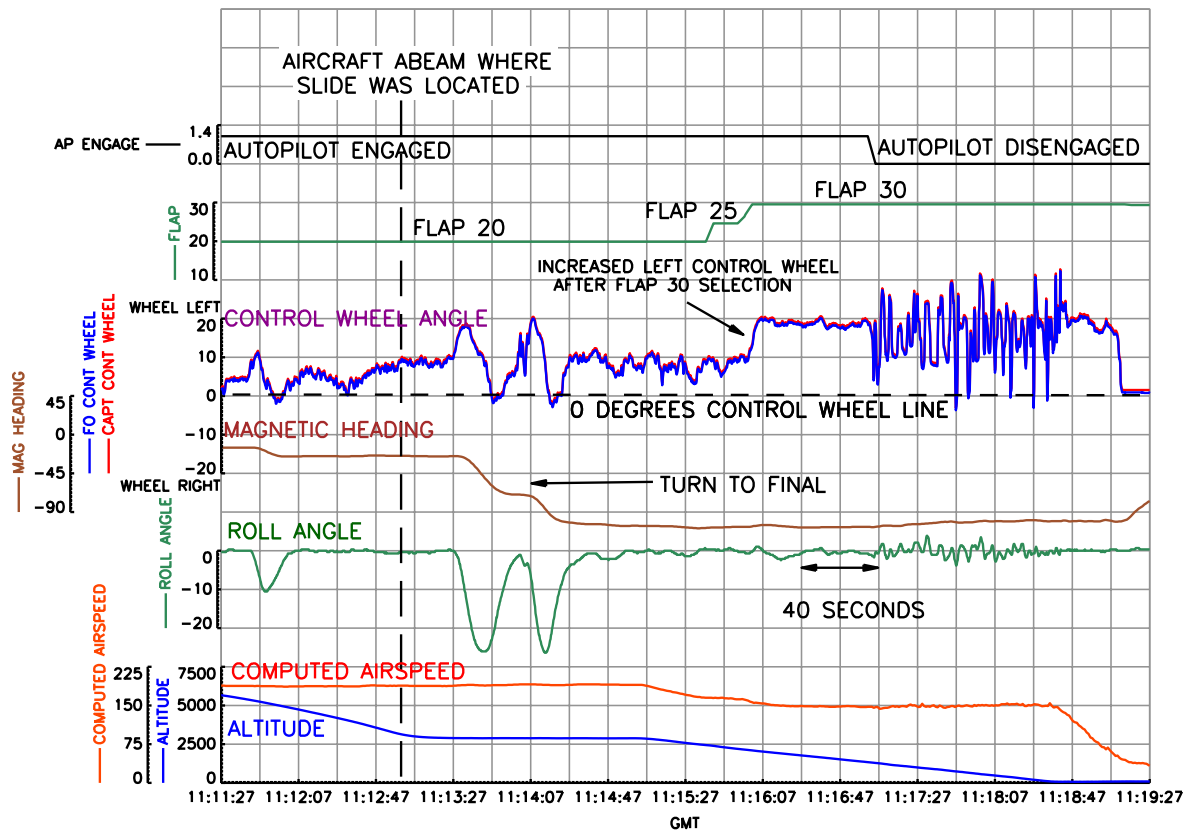
Figure 3

Flaps 30 was selected after the turn onto the final approach after which the control wheel input increased to an average of 20° to the left (see Figure 3). The autopilot was disconnected as the aircraft descended through 1,400 ft on the final approach.

G-JMAB FDR data during approach to Gatwick Airport

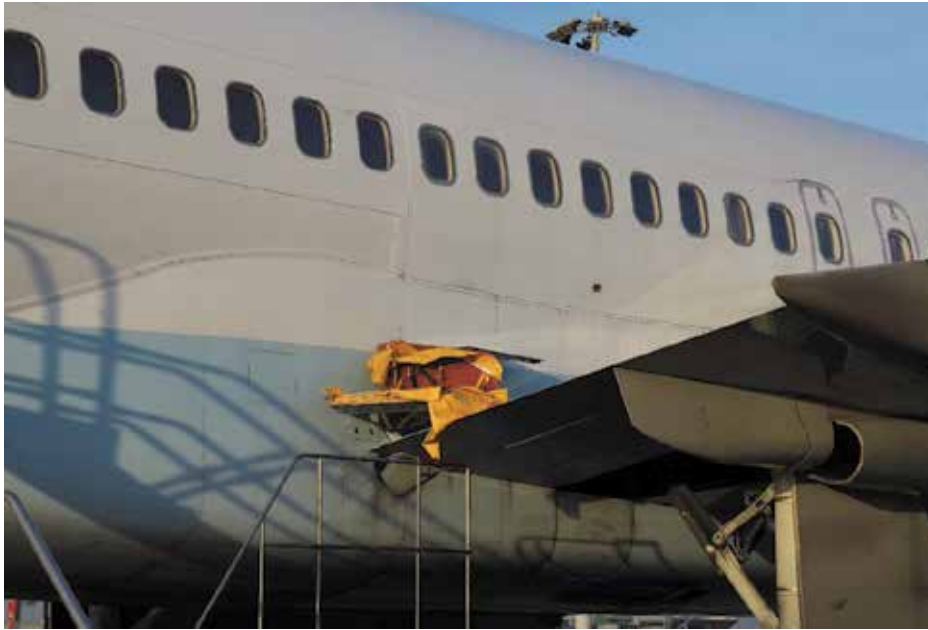
On examination it was evident that the right over-wing slide carrier had deployed and had rotated outwards. The carrier bay panel was open, attached by its hinges, and resting on the carrier. The slide pack cover was open and the slide was missing. The outer rigid sideboard of the pack had detached and was on the hardstanding beneath the aircraft. The carrier outward travel stop hook had broken from its mounting tube and detached. The carrier had over-rotated causing damage to the fuselage wing root upper fairing, forcing the actuator rod to extend and bend and cause damage to the carrier pivot forging. The slide pack lacing pin had withdrawn from the slide cover and was hanging loose attached to the aircraft by its pip-pin and lanyard. Figure 4 and Figure 5 show the slide carrier as found.

The slide carrier as it was found after landing

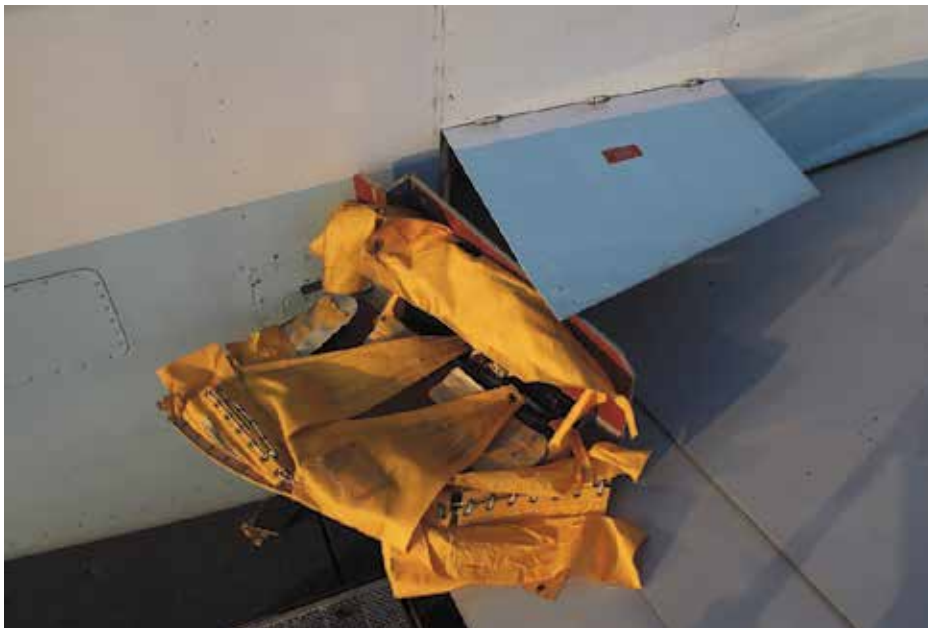
Figure 5

A close-up of the slide carrier after landing

The carrier locking device was retracted into its release position and was undamaged as were the panel latch rod tappets and slots. The forward and aft slots and tappets were covered in a protective layer of grease. The aft slot and tappet grease layer exhibited marks indicating where the tappet had been located. One of the marks was within the forward end

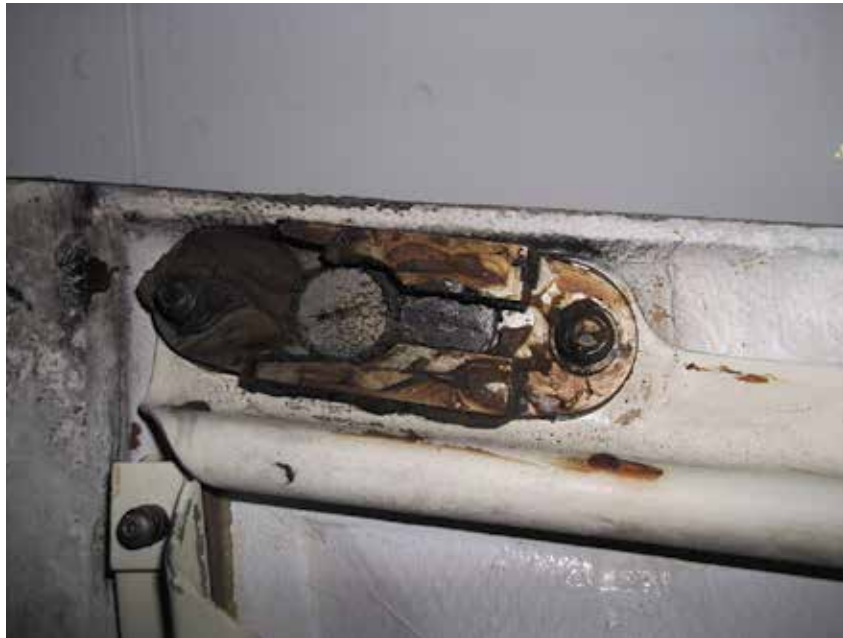
of the slot, the locked position, and the other more pronounced mark was at the opening to the slot indicating movement of the panel during tappet and slide disengagement. The forward tappet and slot had the only marks in the grease on top of the slot edges and indicated that the tappet had not been engaged within the slot in any position as shown in Figure 6 and Figure 7.

The slide panel aft latch tappet imprints within the slot

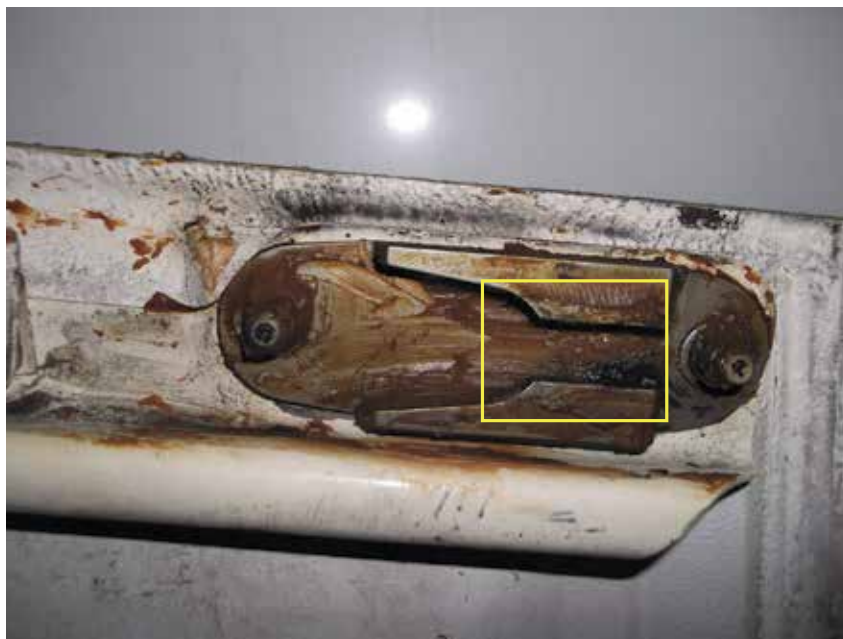
Figure 7

Slide panel forward latch slot with the tappet imprint in the grease on the slot outer face

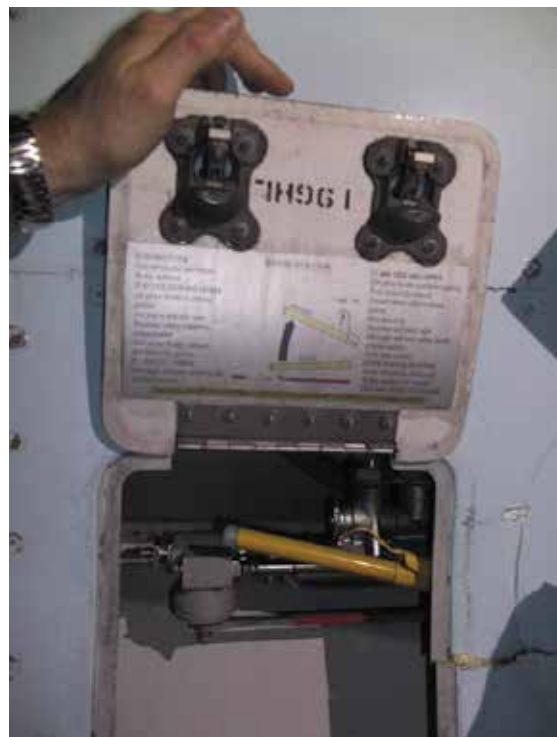
Figure 8

The slide gas bottle was fully charged and none of the initiation devices had activated. The actuator access panel was found closed. The vent lever was found positioned in the 'operate' position. However, the yellow crank lever was in the slide panel OPEN AND CARRIER RELEASE position. The lever and its trigger assembly were undamaged.

Right slide release cranked handle in the up position as found after the incident

The absence of mechanical damage to the panel latches and the carrier locking device show that these items had become fully disengaged at the time of the incident. For this to happen the cranked handle, which as part of its movement withdraws the latches, must have moved upwards to the release position as it was found.

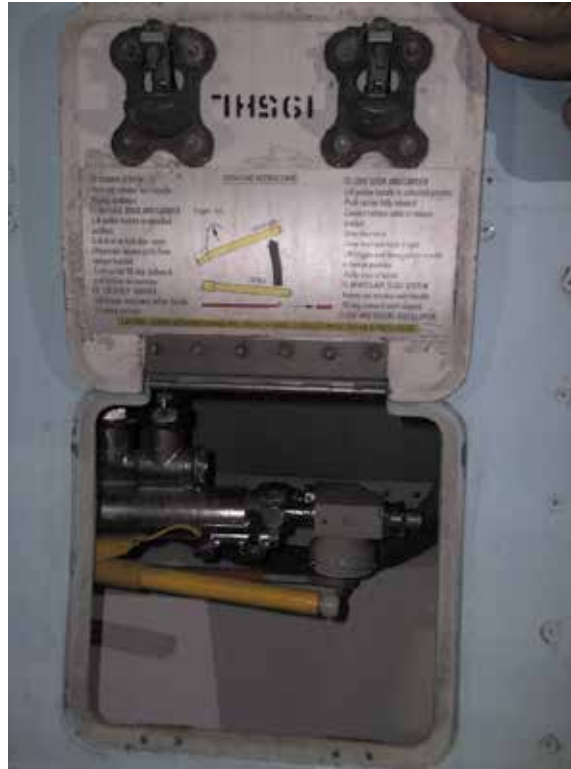
The left crank handle was examined as a comparison and found to be in the closed position as was the associated vent lever. Further checks were carried out after the aircraft had been removed from service. This included a visual examination and pull-off checks on the crank handles. The pull-off checks found that the left lever required 50 N (11.25 lb) and the right lever required 25.4 N (5.71 lb). Both these figures are within the manufacturer's maximum of 25 lb. The levers had a smooth action with no detectable backlash in their mechanisms. It was observed that the access panels and crank handle assembly differed from the line diagrams shown in the Aircraft Maintenance Manual (AMM). There should have been yellow painted markers on the land of the panel to indicate the correct closed and locked position of the crank handle. The paint marks were not present on this aircraft. However, on the inside of the panel there was a placard giving instructions on how to operate the crank handle and includes a lever position picture, but it did not include or draw attention to safety alignment marks. Figure 8 and Figure 9 show the right and left slide release cranked handles with the maintenance access panel open.

Left slide release cranked handle in the correct down position.
(Note the absence of alignment marks in Figures 8 and 9)

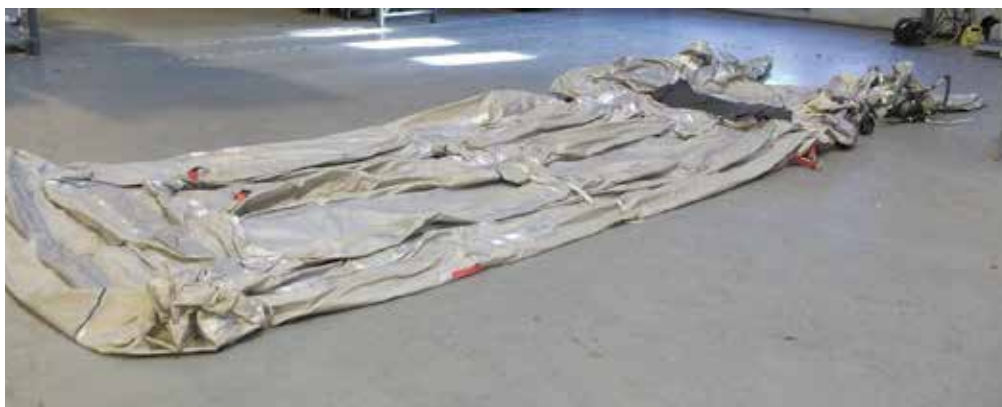
The slide unravelled in the slipstream and struck the aircraft fuselage, causing no damage except for some light scoring on one of the cabin windows. Eventually the doubler material where it attaches to the carrier and the gas inflation pipe collar failed leaving the uninflated slide to detach and fall to the ground and land in a tree. Apart from the attachment material and pipe collar damage the slide was intact. Figure 10 shows the slide (face down) after recovery.

The recovered slide

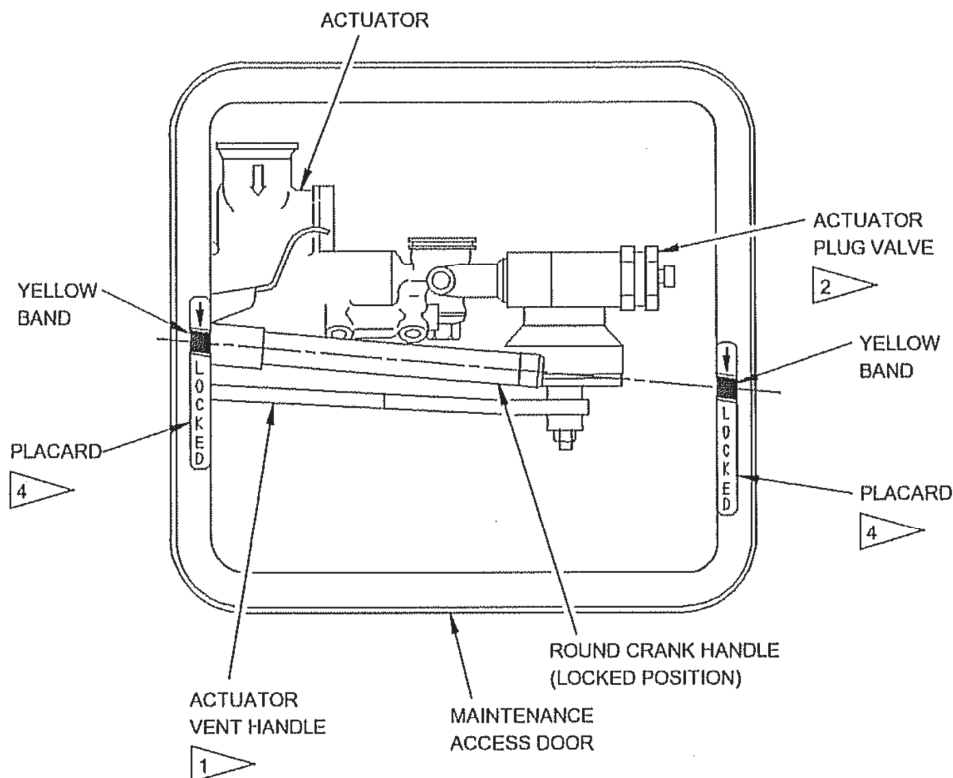
Figure 11

Revised safety markings (Boeing Proprietary. Copyright © Boeing
Reprinted with permission of The Boeing Company)

Several operators had previously reported in-flight over-wing uninflated escape slide losses. The cause was identified as the slide compartment panel not being fully locked and secured, even though appearing to be so, after access for maintenance. Accordingly the manufacturer issued Service Bulletin (SB) 757-25-0298 which was subsequently mandated by a FAA Airworthiness Directive (AD) 2012-01-09. The SB instructed operators to fit modified parts to the panel latching mechanism to provide more positive locking. It also introduced placards for better visual indication of the correct position of the crank handle (Figure 11). The AD required the actions of the SB to be completed by end of February 2017. SB 757-25-0298 was not embodied on G-JMAB at the time of the incident.
