Rail Accident Investigation Branch

# Rail Accident Report

**Runaway of 'ironmen' trolleys and subsequent  
near miss at Raven level crossing, Garnant,  
Carmarthenshire  
1 November 2014**

Report 13/2015  
August 2015

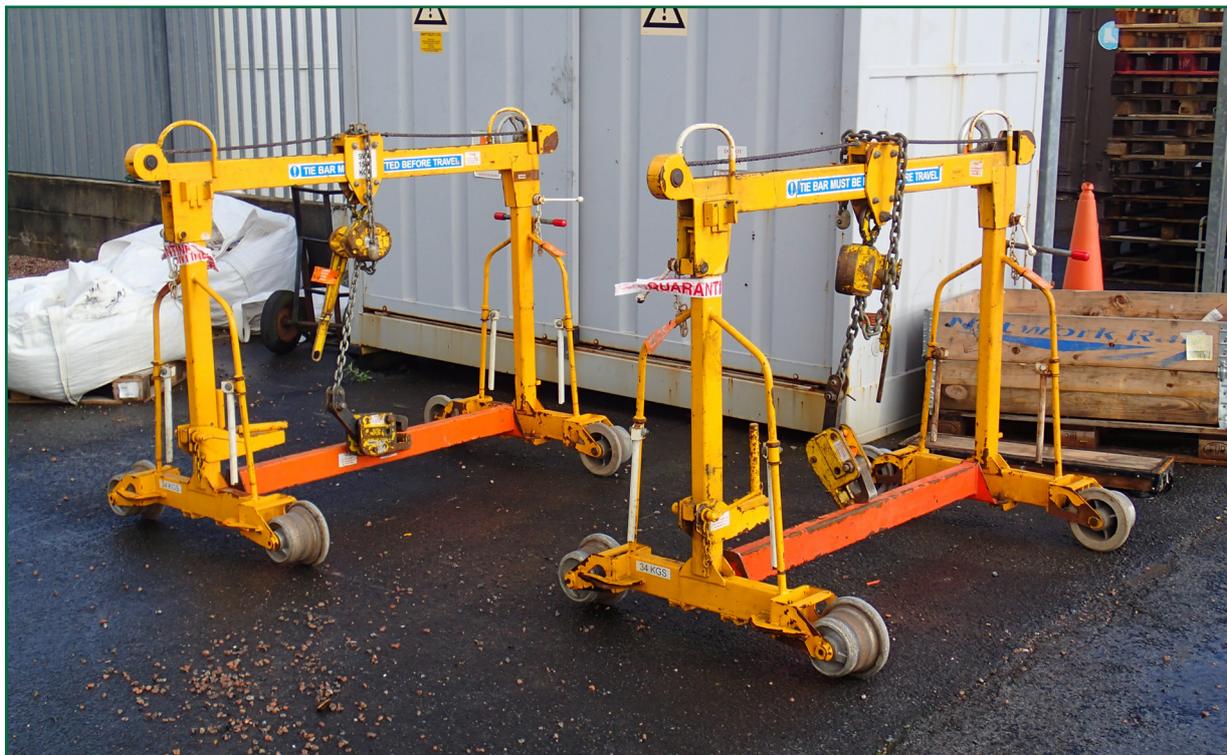
Figure 7: The runaway ironmen after the incident

- 13 The two ironmen that ran away (figure 7 and table 1) were allocated to Network Rail's Haverfordwest track maintenance depot and had been loaned to the Llanelli depot for the work planned to be carried out on the night of 1 November 2014.

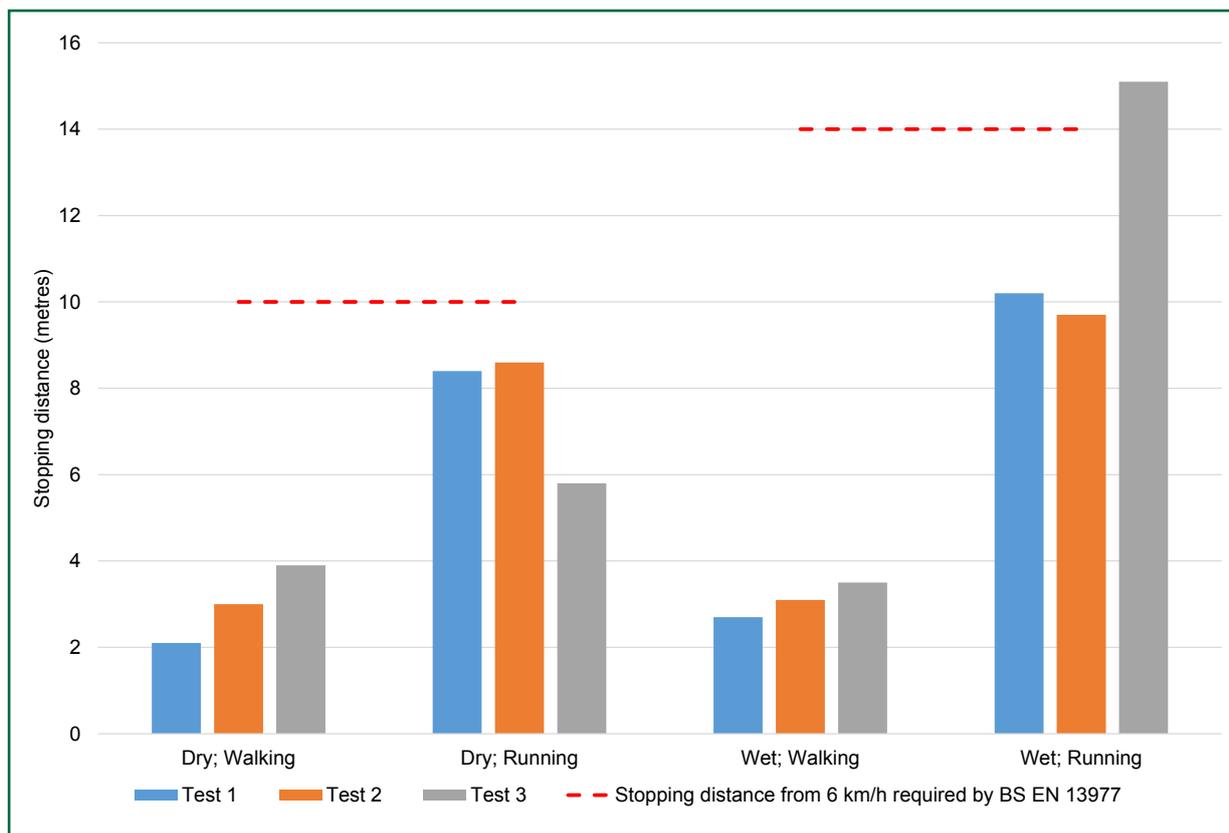
Figure 8: Ironmen stopping distance tests 18 April 2006

- 37 Neither Network Rail nor Permaquip has been able to provide the RAIB with a copy of the brake test results that supported the product acceptance certificate issued on 7 April 2006. However, records of testing carried out on 18 April 2006 do exist; these show that the ironman complied with the stopping distances mandated by BS EN 13977:2005 for wet and dry conditions, both 'walking' and 'running' (figure 8)<sup>4</sup>. The results also record that the average brake torque for the ironman being tested exceeded the minimum brake torque that was specified at the time (30 Nm, refer to paragraph 69) by 21%.

76 The results of the brake testing carried out on 18 April 2006 were not representative of the performance of brakes which would have just met the minimum torque figure, as the static torque exceeded the minimum by 21% (paragraph 37). It is not known by how much the static torque exceeded the revised minimum when further brake tests were carried out to support the product acceptance certificate that was issued on 8 February 2010 (paragraph 39). The RAIB has seen no evidence that the relationship between stopping distance and brake torque was taken into account as part of the product acceptance process; this relationship is non-linear (paragraph G2, appendix G). This means that the brake testing that was carried out in support of product acceptance may not have been adequate to ensure compliance with the required stopping distances.

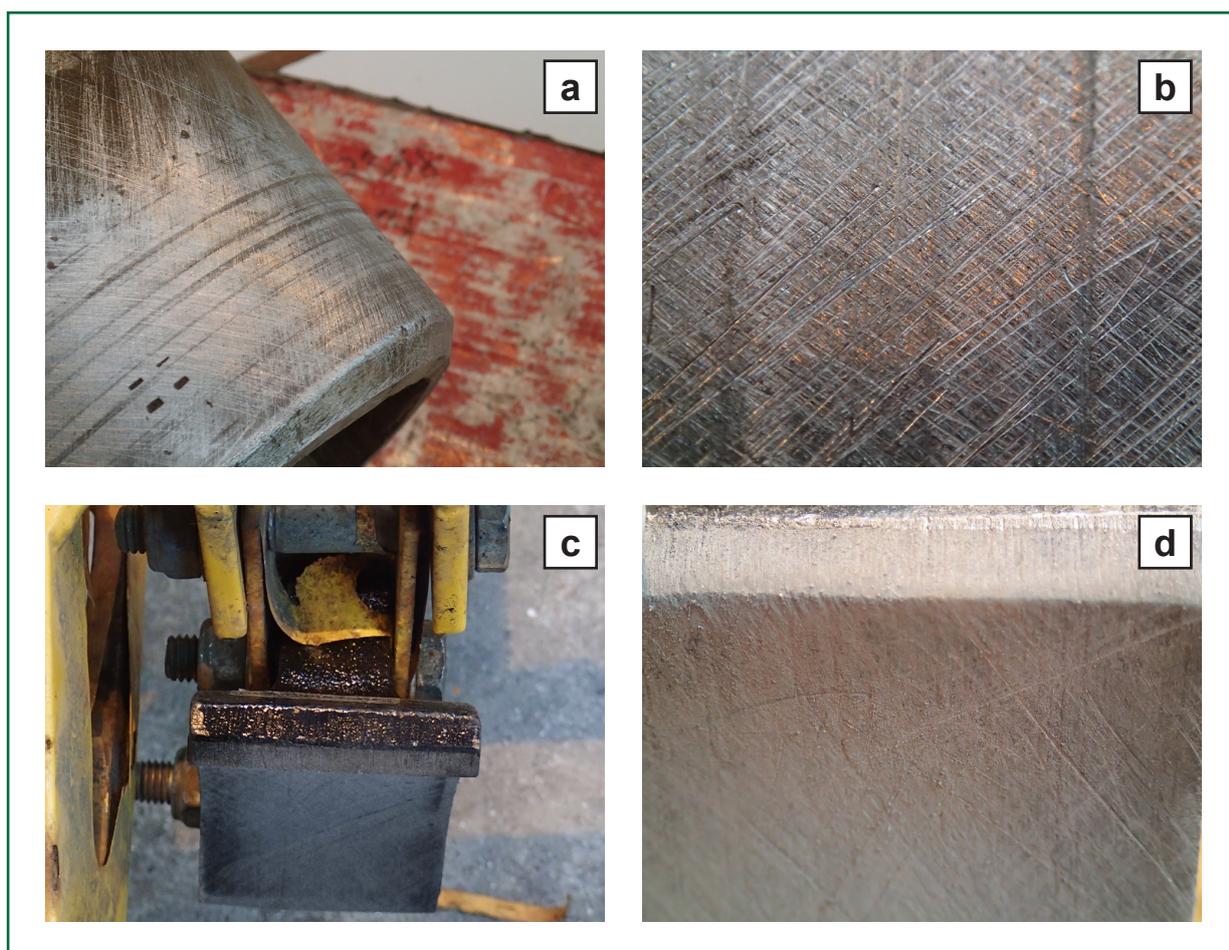
Figure 9: General view (a) and close-up (b) of wheel surface, and general view (c) and close-up (d) of brake pad surface, showing roughening with emery paper

- 74 Ironman No. E0005087 was tested on behalf of the RAIB with slack brake cables (so that the cables did not reduce the brake force, see appendix G, paragraph G5), new brake pads and the original brake springs, without shims. This found that it was practically impossible to achieve the required minimum average torque of 40 Nm. An average torque of 39.6 Nm was achieved only after both wheels and pads had been roughened with emery paper (figure 9). Such roughening is not a normal maintenance practice and would probably not be effective in maintaining the brake torque once the aluminium wheels have rolled a short distance along rails and once the pads have been used to stop an ironman a few times.

- 87 The mobile fitter also stated that he routinely roughened the surfaces of the wheels and brake pads as part of his servicing routine, if necessary using sandpaper or wire wool. MAN/M/O/105 states that any dirt or oil should be removed from the working surfaces before testing the brakes (appendix D), while MS088 requires brake pads to be checked for contamination and wear and cleaned or replaced as necessary. The RAIB did not observe any contamination of the wheels prior to its testing of the ironmen (paragraph 78), so it was not necessary to clean them. However, this is a possible difference between the condition of the ironmen in this series of tests and their condition when they were last maintained (paragraph 74).

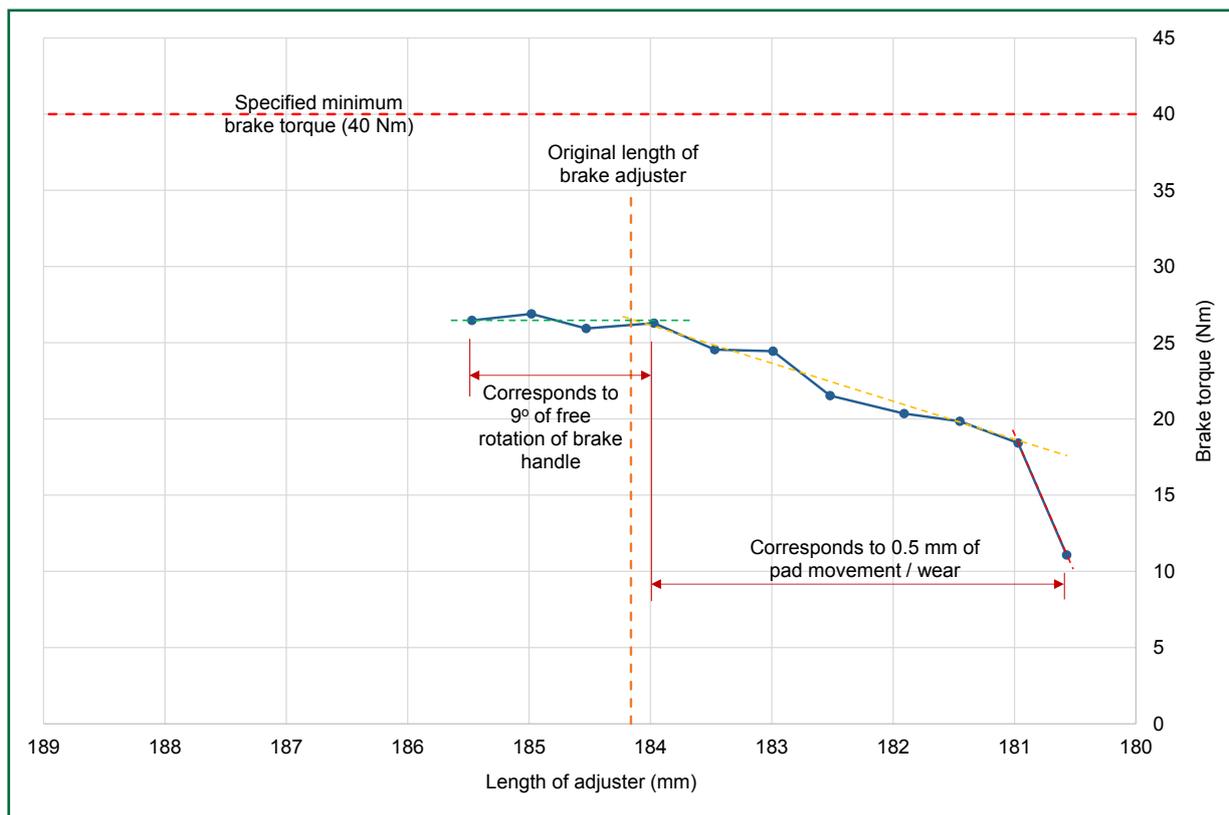
Figure 10: Brake torque measurements; ironman No. E0005087

- 79 The results for testing of the leading ironman (No. E0005087) are shown at figure 10. These show that there is a region of constant brake torque while there is still slack in the cables; this was 26 Nm without roughening of the wheels and pads (paragraph 74). This region is followed by a linear reduction in torque as the length of the adjuster is reduced further, culminating in an abrupt reduction when the pad is no longer held in contact with the wheel. The length of the adjuster, as found after the runaway, indicates that the brakes had previously been adjusted so that there was minimal slack present with new brake pads. This is consistent with witness evidence that Torrent Trackside's mobile fitter would normally turn the adjuster by hand to take the slack out of the brake cable before tightening the locknuts. A total loss of brake force occurred after a reduction in adjuster length that was equivalent to 0.5 mm of brake pad wear.

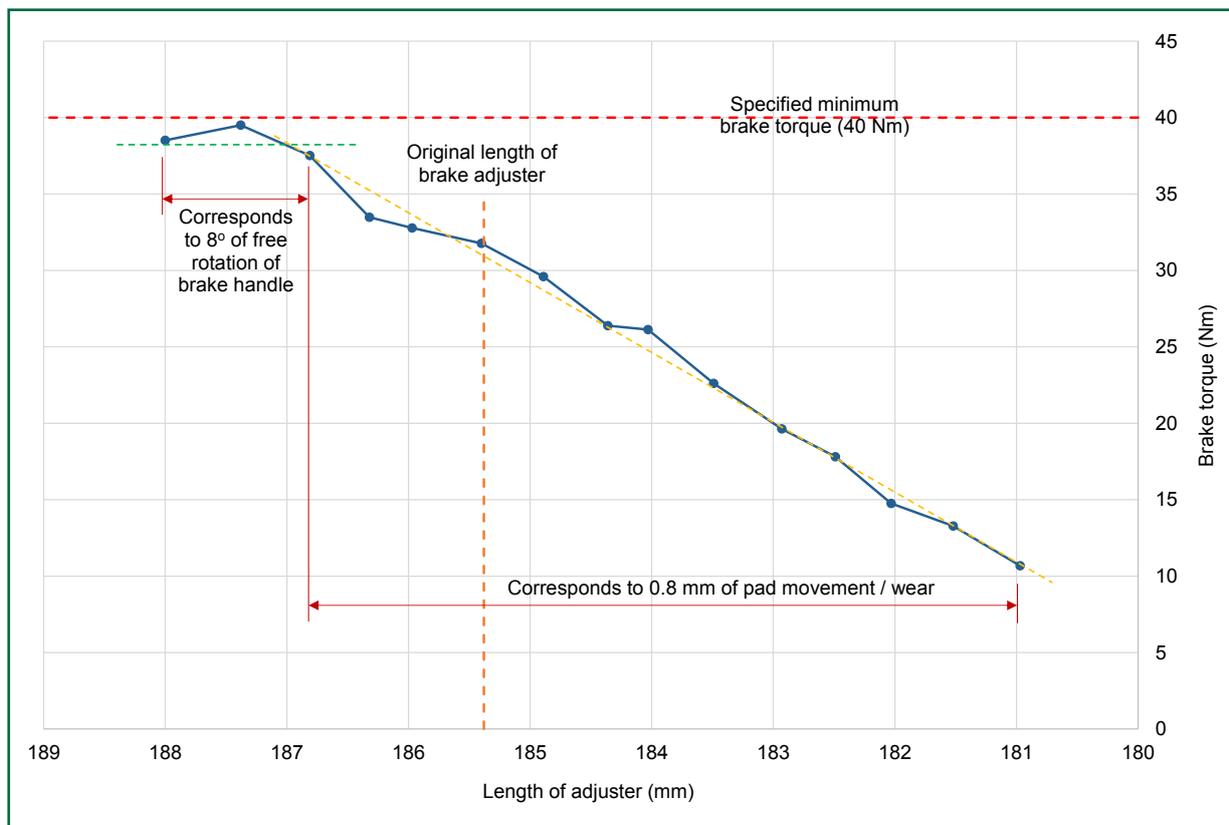
Figure 11: Brake torque measurements; ironman No. 202003429

80 The results for testing of the trailing ironman (No. 202003429) are shown at figure 11; this ironman was fitted with the later type of springs that had a spring rate 37% higher than those fitted to the leading ironman (paragraph 70). The results show a region of constant torque while the cables are slack; this is slightly lower than the specified minimum of 40 Nm. There is a linear reduction in torque as the adjuster is progressively tightened, up to the point that the measurements became unreliably small. No sudden loss of brake force was observed; this may have been because the bottom pulley of the vertical brake cable was progressively collapsing with increasing cable tension during the testing (figure 12). The average brake torque with new brake pads, and with the brake adjuster at the length at which it was found after the runaway, was approximately 32 Nm.

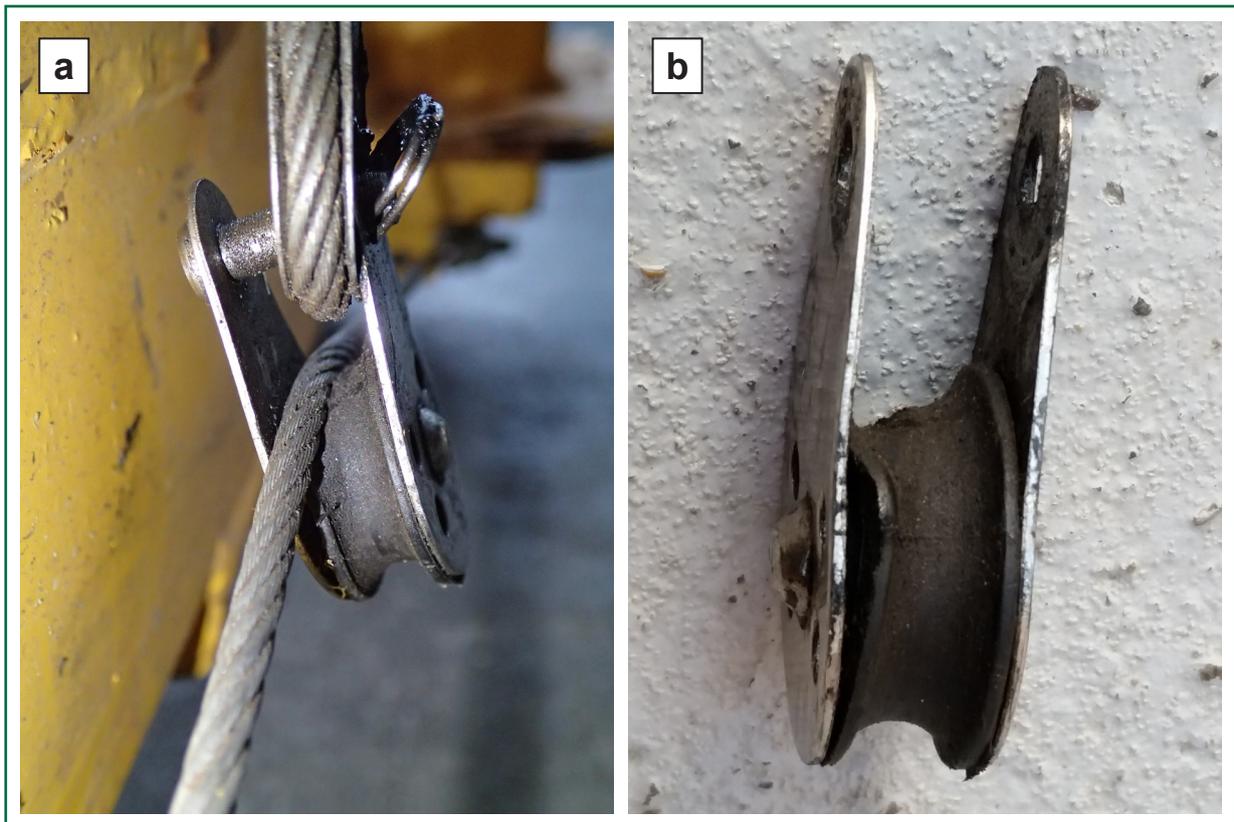
Figure 12: Bottom pulley from ironman 202003429 (a) after the runaway, (b) after testing

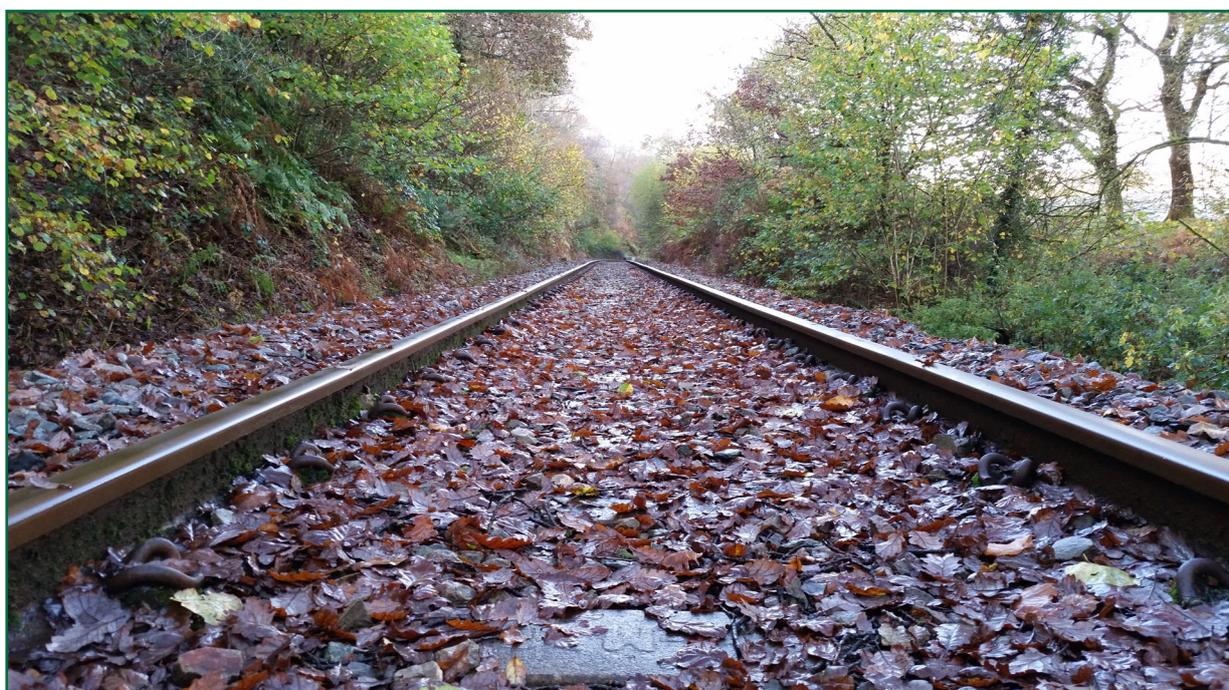
Figure 13: Garnant Branch line below GCG on 3 November 2014

92 As well as the reported heavy rain, the runaway occurred at a time of leaf fall (figure 13). Subsequent examination of the ironmen revealed the presence of leaf contamination on the brake pads (figure 14); it is possible that this may have reduced the friction between the pads and wheel treads. There was no evidence that leaf contamination had caused the wheels of the ironmen to lock up and slide along the rails, and witness evidence indicated this did not happen.

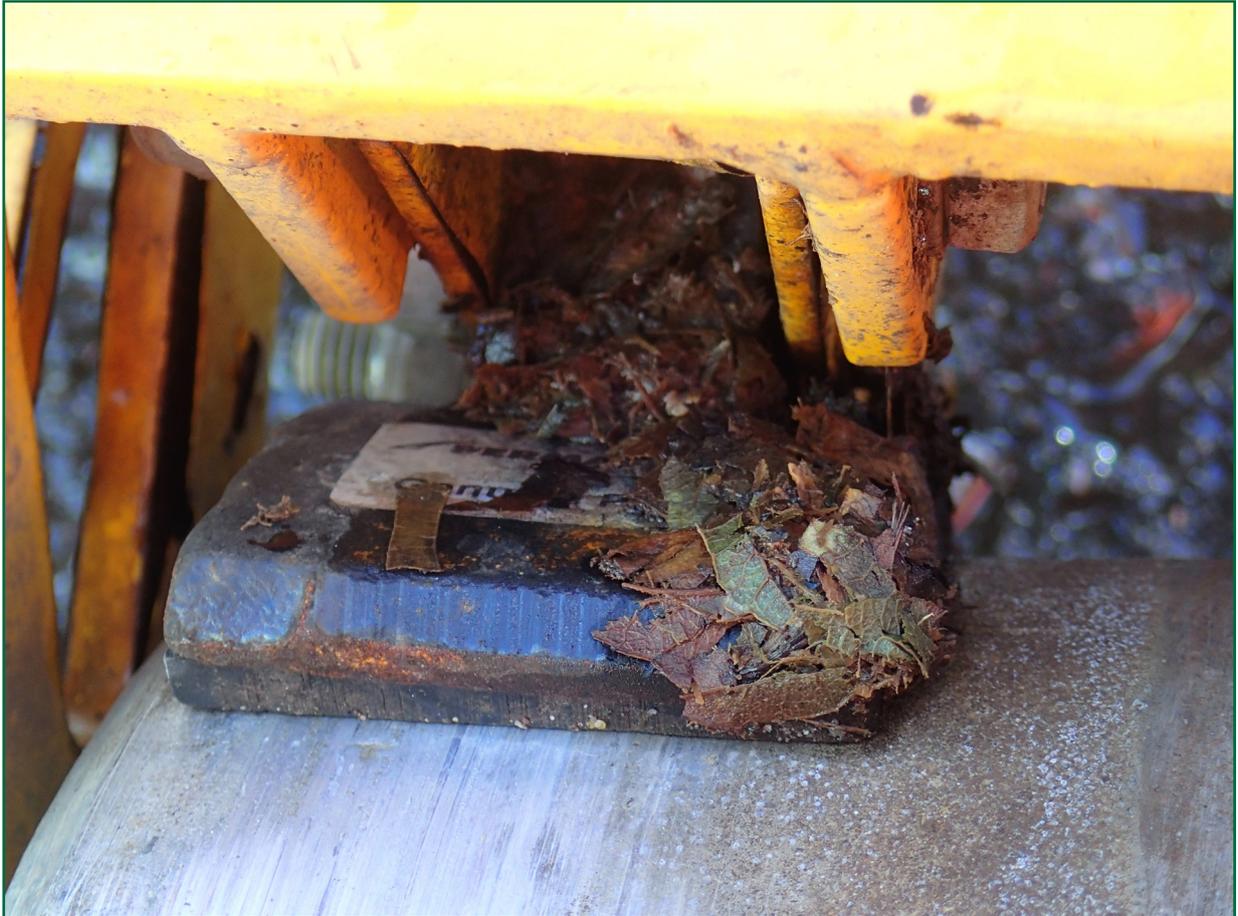
Figure 14: Leaf contamination of brake pad (ironman No. E0005087) on 3 November 2014

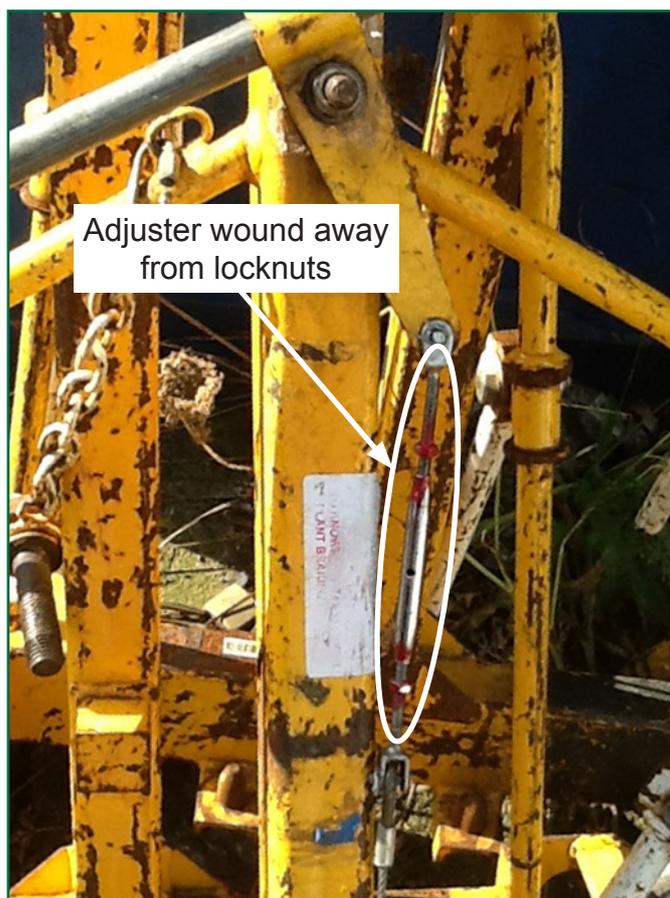
Figure 15: Evidence of interference with ironman brake adjustment (courtesy Torrent Trackside)

- 96 Torrent Trackage has reported a number of instances in which the adjustment of the brakes of Network Rail's manually propelled plant has been interfered with. These include slackening ironmen brake cables, to make it easier to depress the handle and release the brake (figure 15), and tying off brake handles with rope or cable ties.

- 97 The RAIB has seen no evidence of track maintenance staff illicitly tightening (as opposed to slackening) the brake cables on ironmen, and considers that tying off the brake handles would be a quicker, easier and more effective means of releasing the brakes. The original lengths of the brake adjusters (figures 10 and 11) also indicate that they had not been tightened to reduce the brake force. The tension that was observed in the brake cables of the ironmen after the incident was probably the consequence of wear of the brake pads during the descent of the Garnant Branch line.

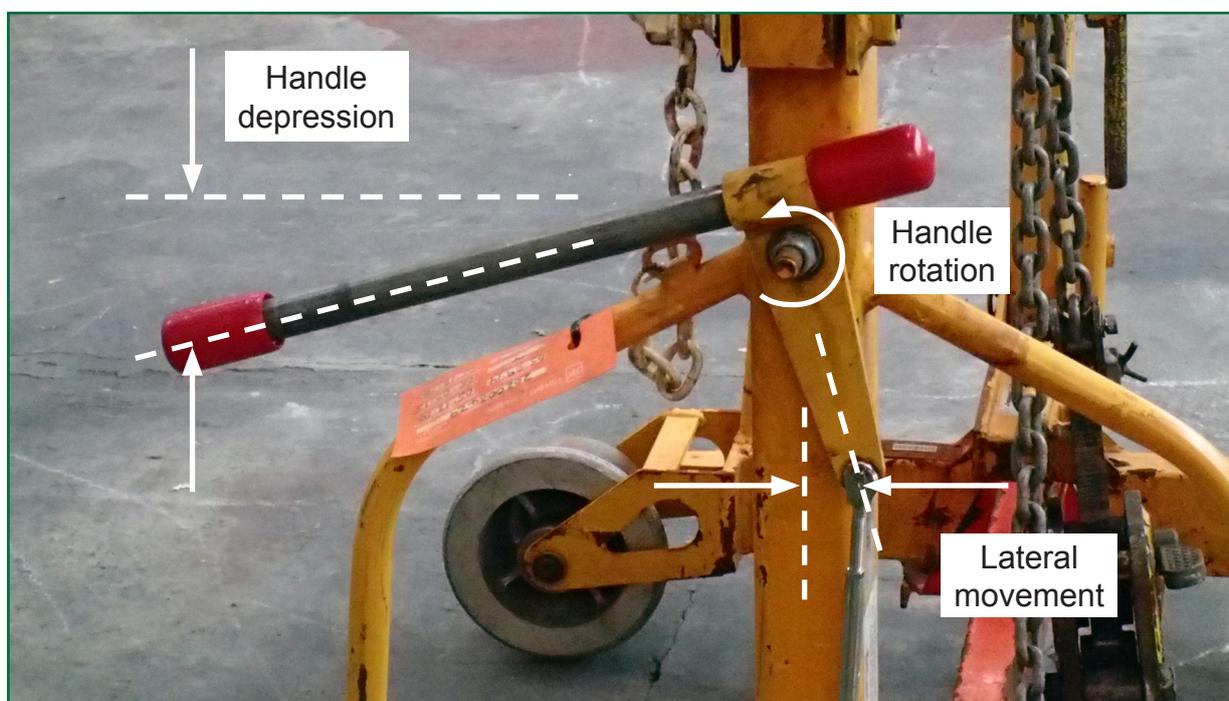
Figure G5: Measurement of slack in the brake cable

- G6 The maintenance section of Permaquip’s user guide MAN/M/O/105 (appendix D) states that the brake cables should be slack when the brake handle is released and the brakes are engaged, although the extent of slack that is required is not defined. Permaquip advised the RAIB that it typically adjusts the cable slack to make one end of the brake handle approximately 40 to 50 mm lower than the other end when the handle is released and the brakes are applied; this is equivalent to a rotation of approximately 7 to 9° (figure G5 shows a rotation of 14°).
