AIRCRAFT ACCIDENT REPORT 2/2015

Report on the serious incident to Boeing B787-8, ET-AOP London Heathrow Airport on 12 July 2013

Air Accidents Investigation Branch

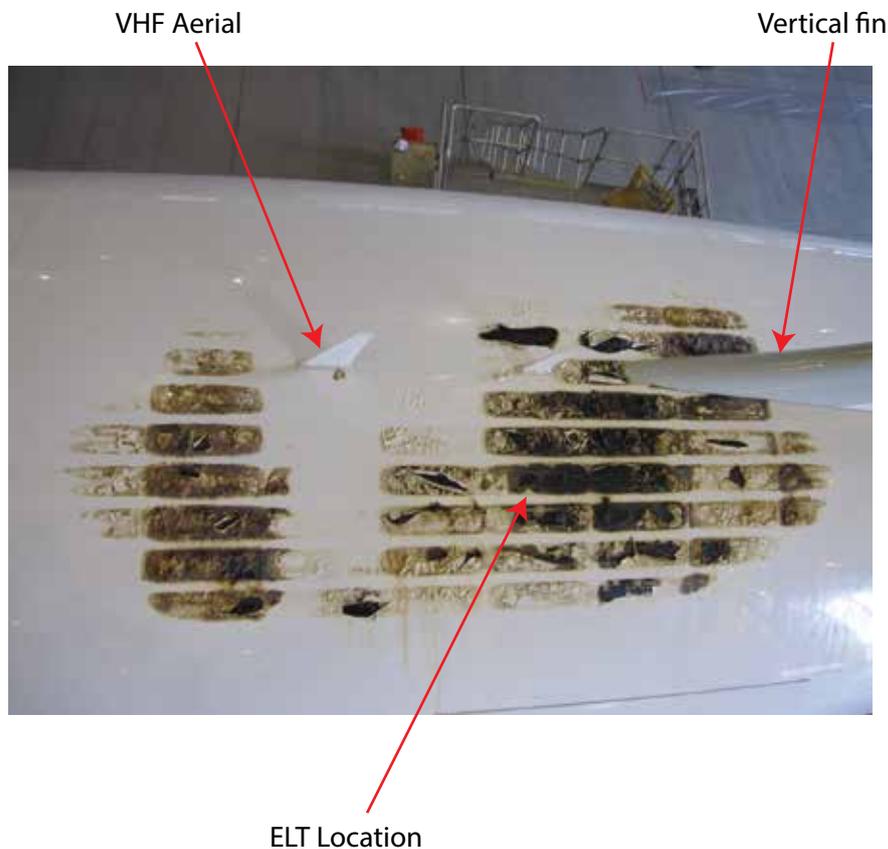
Figure 1

The aircraft structure sustained fire damage to a section of the rear fuselage crown skin and fuselage frames. The damage extended over an area of approximately 9.5 square metres, bounded by frame nos. 1644 to 1794 and stringers 7L to 3R (Figure 1). In this area the fuselage insulation blankets had been destroyed or severely damaged. The structural damage was most severe

in the area adjacent to the location of the ELT, with significant resin loss and ply disbonding in the fuselage skin and frames. The cabin interior tie-rods in this area had sustained damage to their upper portions and the Environmental Control System (ECS) ducts in the region of the fire had been damaged.

External view of fuselage damage

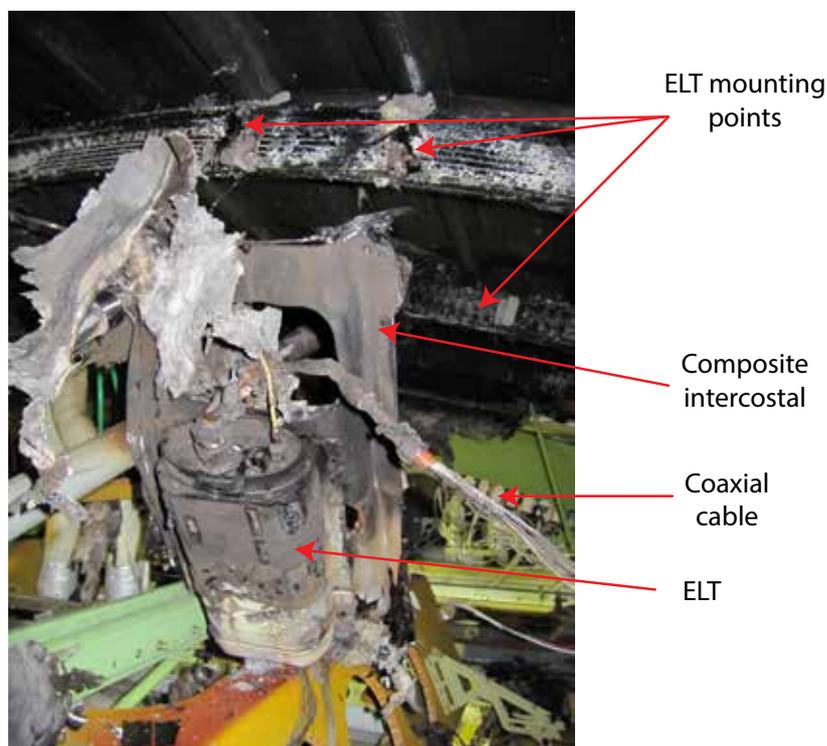
Figure 9

The ELT, its mounting plate and sections of the frames to which it was attached, had suffered severe thermal damage. The ELT forward frame attachment point had failed and the ELT was supported only by its rear attachment point and the coaxial cable (Figure 9).

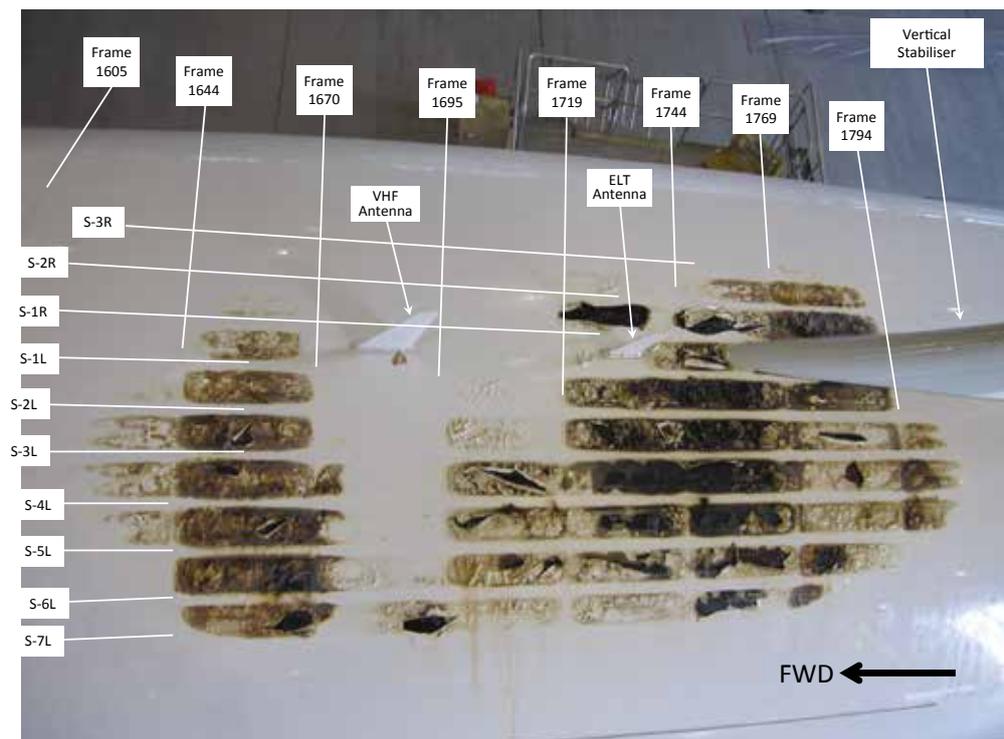
Figure 10

Fire damage was found on the interior of the fuselage skin between stringers 4R and 7L, which extended forward to frame 1618 and rearwards to frame 1815. This damage appeared more severe in the region of the ELT mounting structure. The external fuselage skin showed clear evidence of heat damage in the location of the ELT and its surrounding area (Figure 10). Despite the degree of damage observed, the fuselage skin had not been breached by the fire.

Photograph of external skin damage with frame and stringer numbers super-imposed

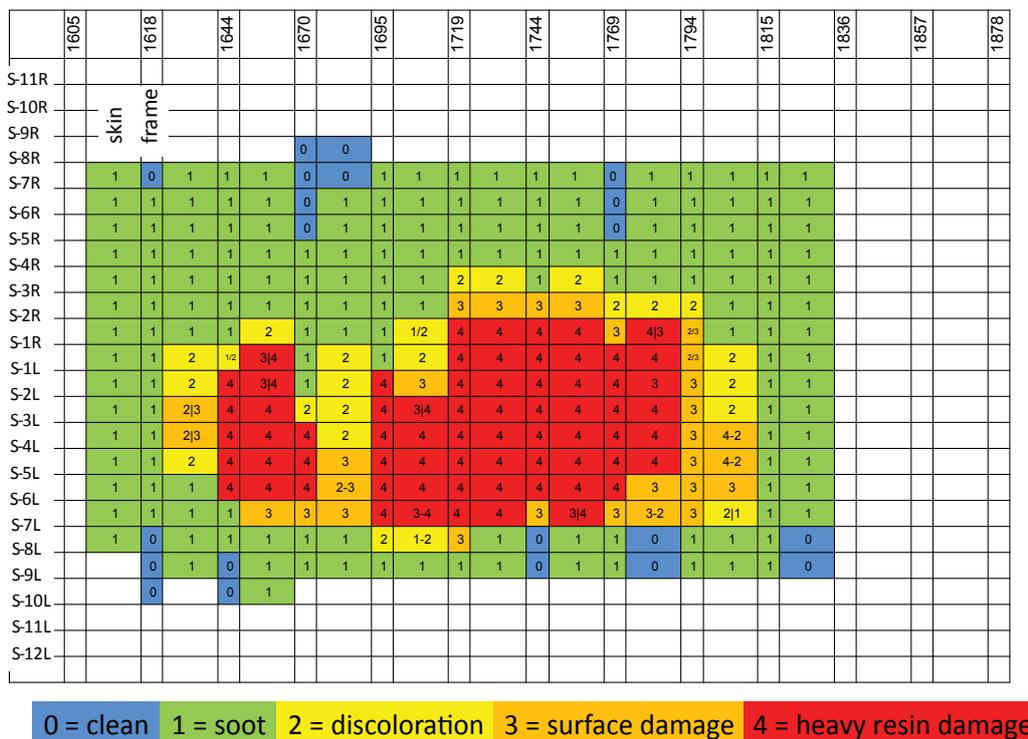
During the course of the aircraft repair, a large section of the rear crown skin was replaced, together with all the damaged frame sections. This included all the areas identified as being damaged or discoloured in Figure 12. To facilitate removal the damaged section was cut into six pieces which, together with the damaged frame sections and the remains of the insulation blankets, were transported to the AAIB headquarters for further investigation.

Figure 12
Plot of interior skin damage (viewed from above)

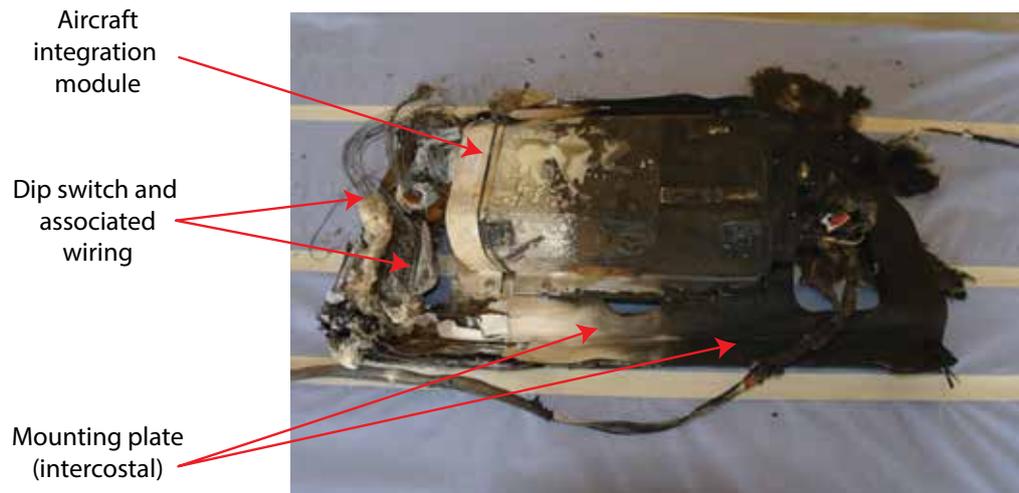
Figure 14

Initial examination of the ELT, after removal from the aircraft, showed that the ELT case was badly heat damaged and all of the orange paint had burnt off. Heavy sooting and carbon deposits were evident on the forward two-thirds of the ELT TU. There was no sooting on the rear third of the TU or the AIM, indicating that temperatures on this portion of the ELT had been sufficiently high to burn off the soot deposits (Figure 14). A small gap was evident between the AIM and TU.

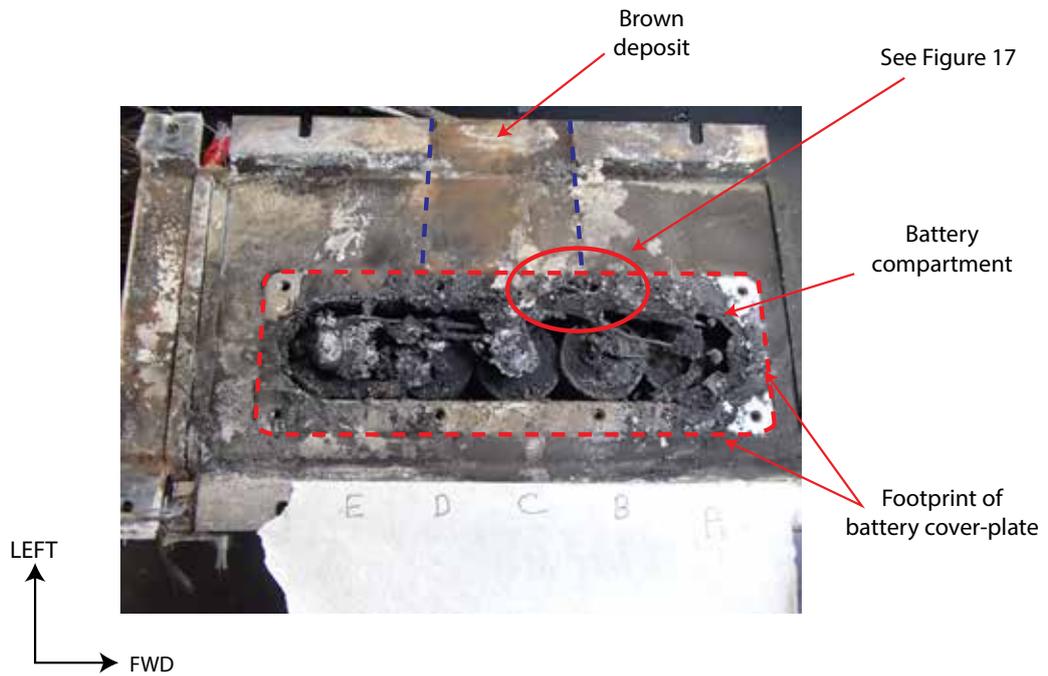
Figure 16

Upper surface of ELT with battery cover-plate removed;
tops of battery cells visible

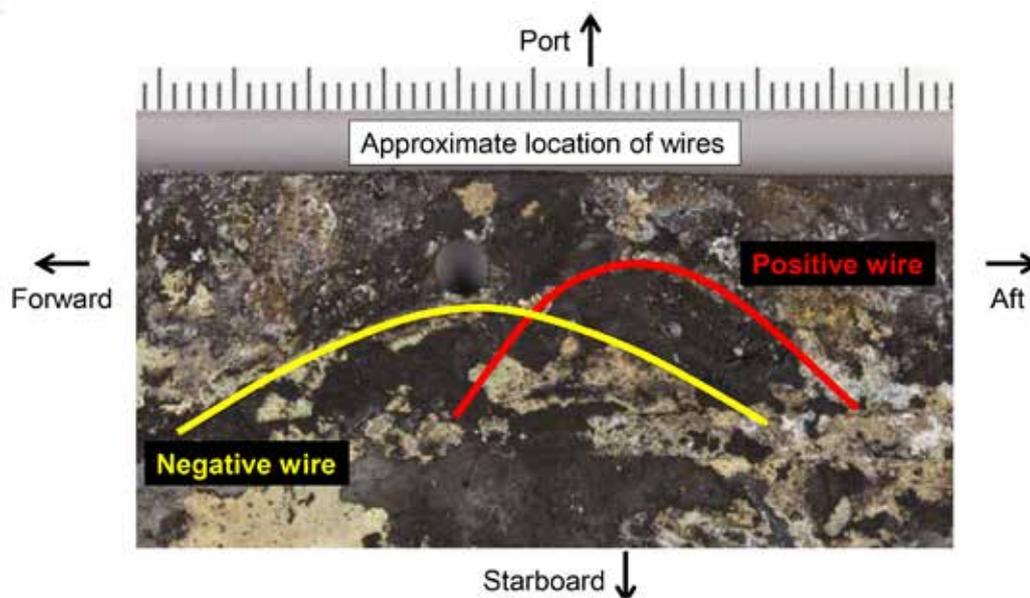
Figure 19

Two adjacent contact locations were identified along the path of the trapped wires (Figure 19). These were consistent with having been made by two separate wire strands from the positive (upper) conductor. A very thin layer of material rich in copper and silver, consistent with the battery wire material, had been transferred to the cover-plate at these locations. There was no evidence of arcing, melting or fretting.

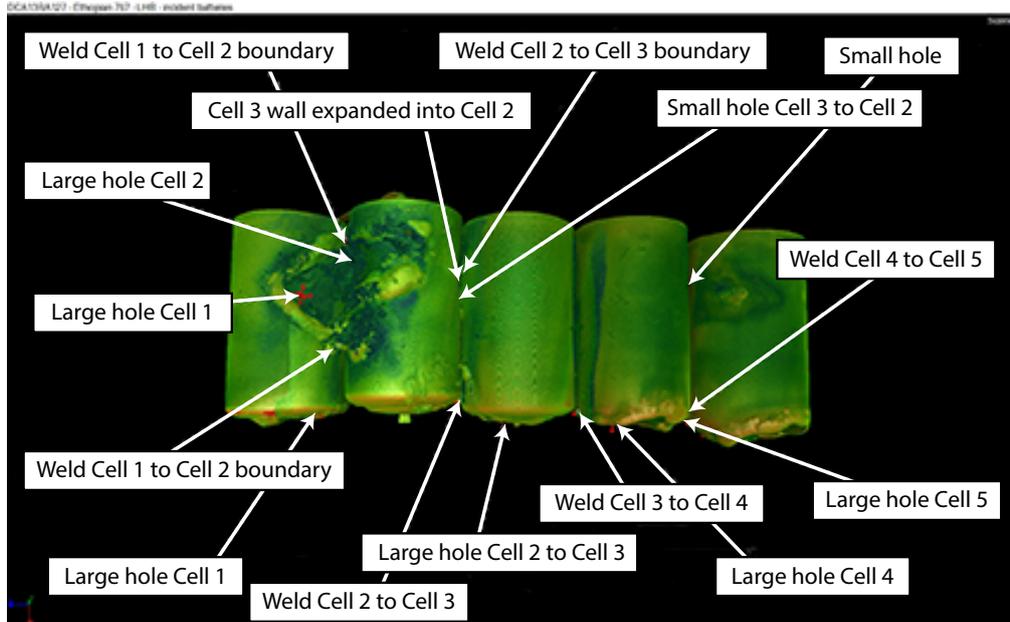
Figure 20

Rendered image from CT scan of battery, showing Cell 1 to Cell 5 (left to right)

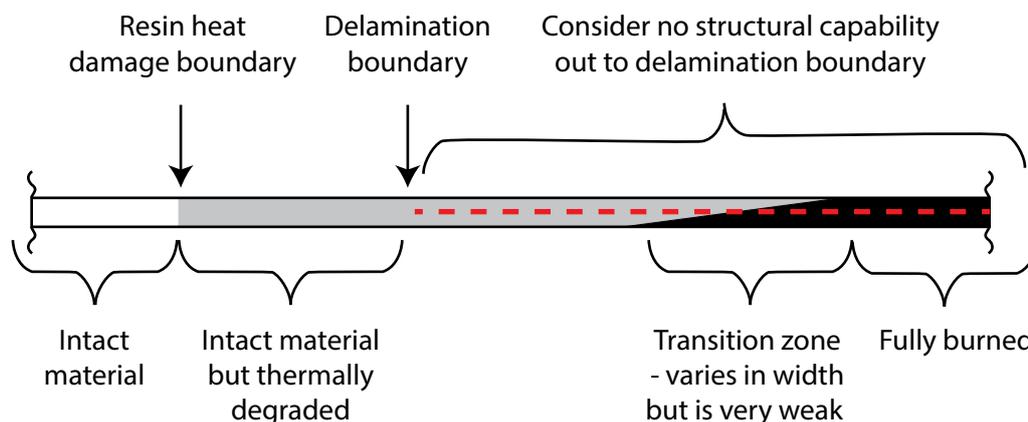
vaporisation of the B787 CFRP typically occurs at approximately 300°C and ignition could occur when the temperature reaches 330°C to 360°C. Figure 23 illustrates a typical cross-section of a CFRP skin panel after exposure to fire. Typically in 'open air' conditions, after ignition has occurred and the heat source is removed, CFRP will self-extinguish. Sustaining combustion within CFRP requires a combination of sustained elevated temperatures and sufficient thermal input to cause adjacent CFRP to reach ignition temperature.

Typical cross section of burned CFRP (Boeing)

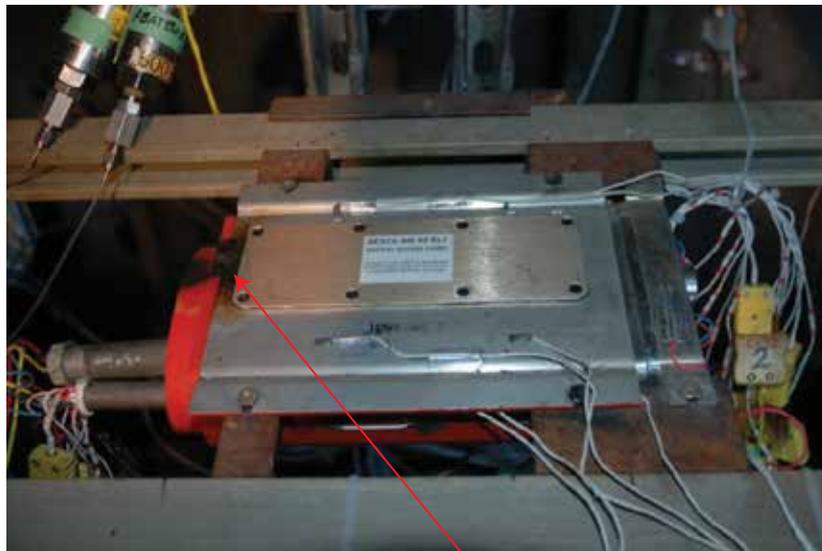
The cells were found burnt and blackened but most of the decomposition products were retained within the ELT (Figure 31).

Evidence of minor escape of development products

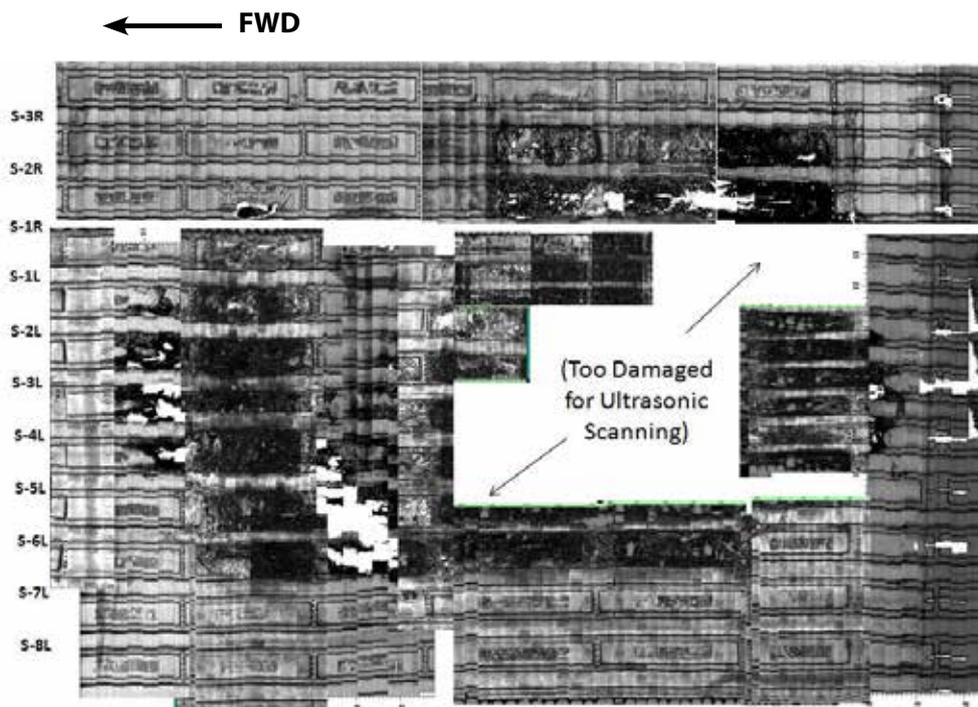
Figure 38

Ultrasonic pulse-echo mosaic of crown skin damage

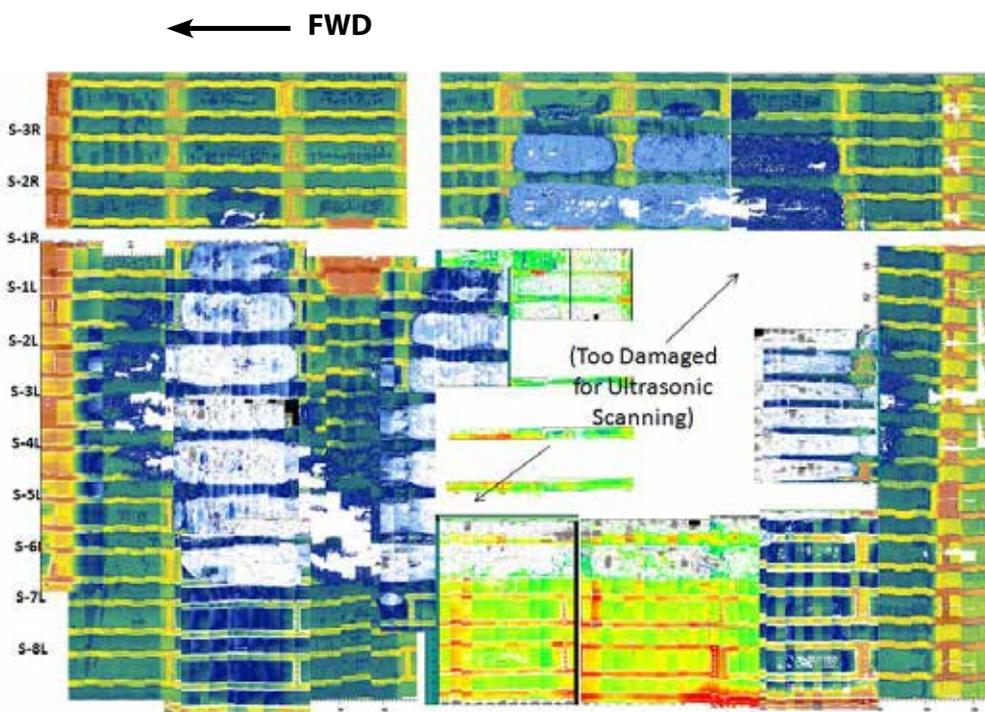
Figure 39 provides an indication of the depth of undamaged material, measured from the outer face of the skin section. The darker blue areas indicate areas where damage extends through the majority of the skin thickness. The white areas represent areas which have full-thickness delamination. This illustrates that in the region of the ELT, where the fuselage skin has its smallest cross section, all the resin within the CFRP had been consumed. In areas of greater cross section, despite significant visual damage, some resin was still present.

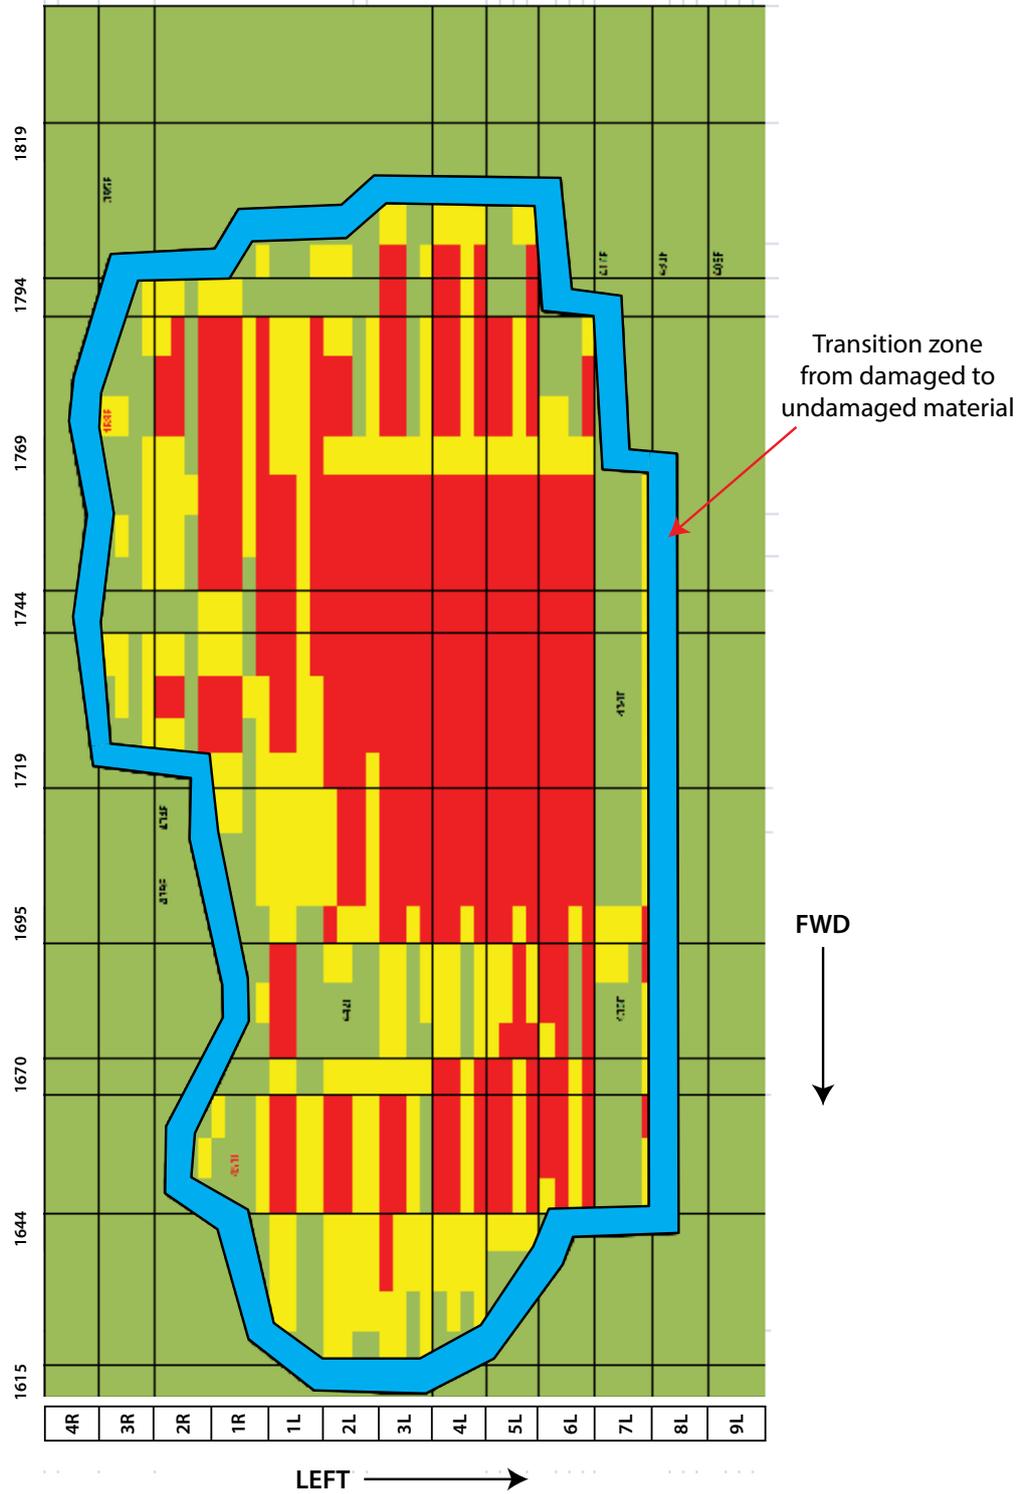
The FTIR technique was used to assess the condition of thermally degraded resin beyond the boundary of delamination. The results indicated that within the crown skin, the typical transition zone extended approximately six inches beyond the boundary of any delamination. The FTIR results were superimposed on the composite skin-stringer damage mosaic (Figure 42) to provide an overall image of the damage to the skin panels and the stringer webs (Figure 43).

Figure 42
Boundary of damaged skin panel resin
