Report on the investigation of  
a fire on board the RoPax ferry

***Dieppe Seaways***

on the approach to, and subsequently alongside,  
the port of Dover, UK  
on 1 May 2014

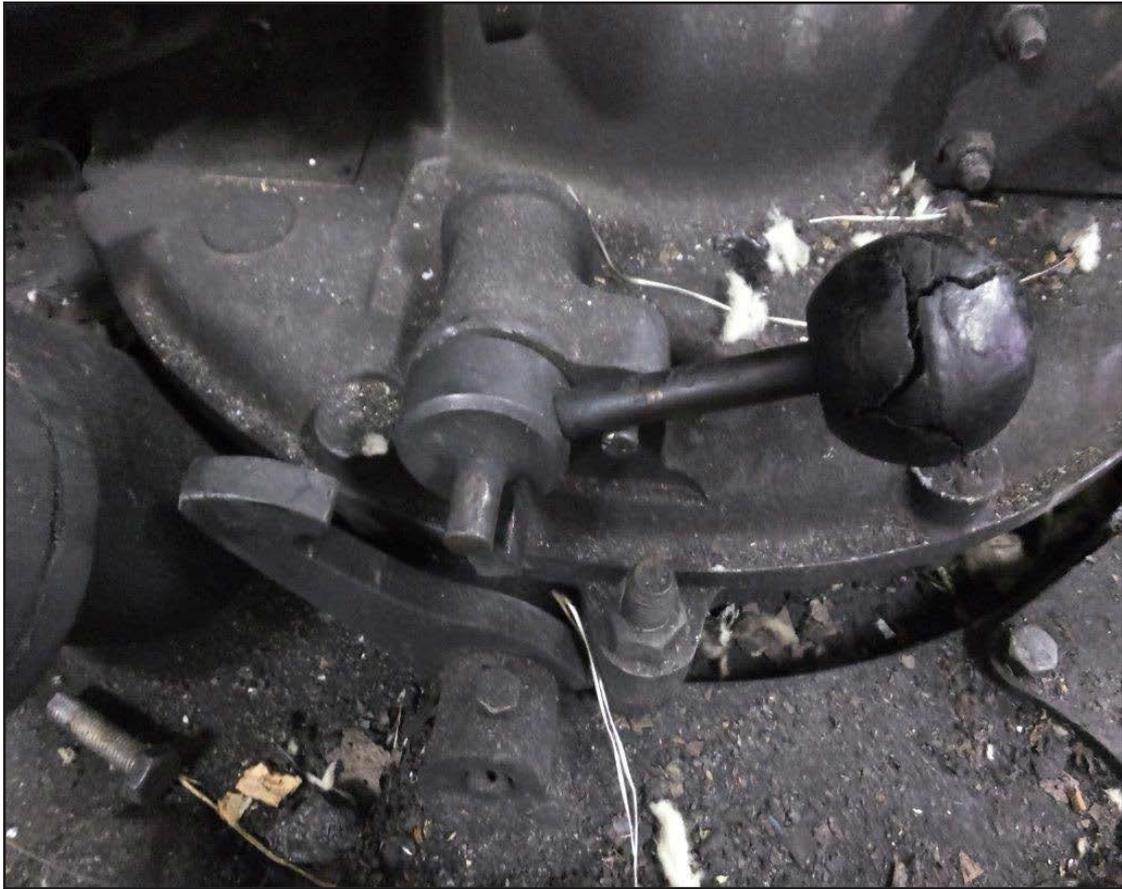
**Figure 3a:** Photograph showing burner unit latching mechanism (open)

The burner unit comprised a rotary cup nozzle assembly with a linking orifice to a forced draught fan. There was an integral electric motor driving the rotary cup. The unit was located on top of the heater and was hinged to allow access to the nozzle assembly for maintenance. The burner unit securing device consisted of a moving pawl and locking lever (**Figures 3a and 3b**).

The securing device was found to have significant wear, with excess play in the bushes and on the nose of the clip.

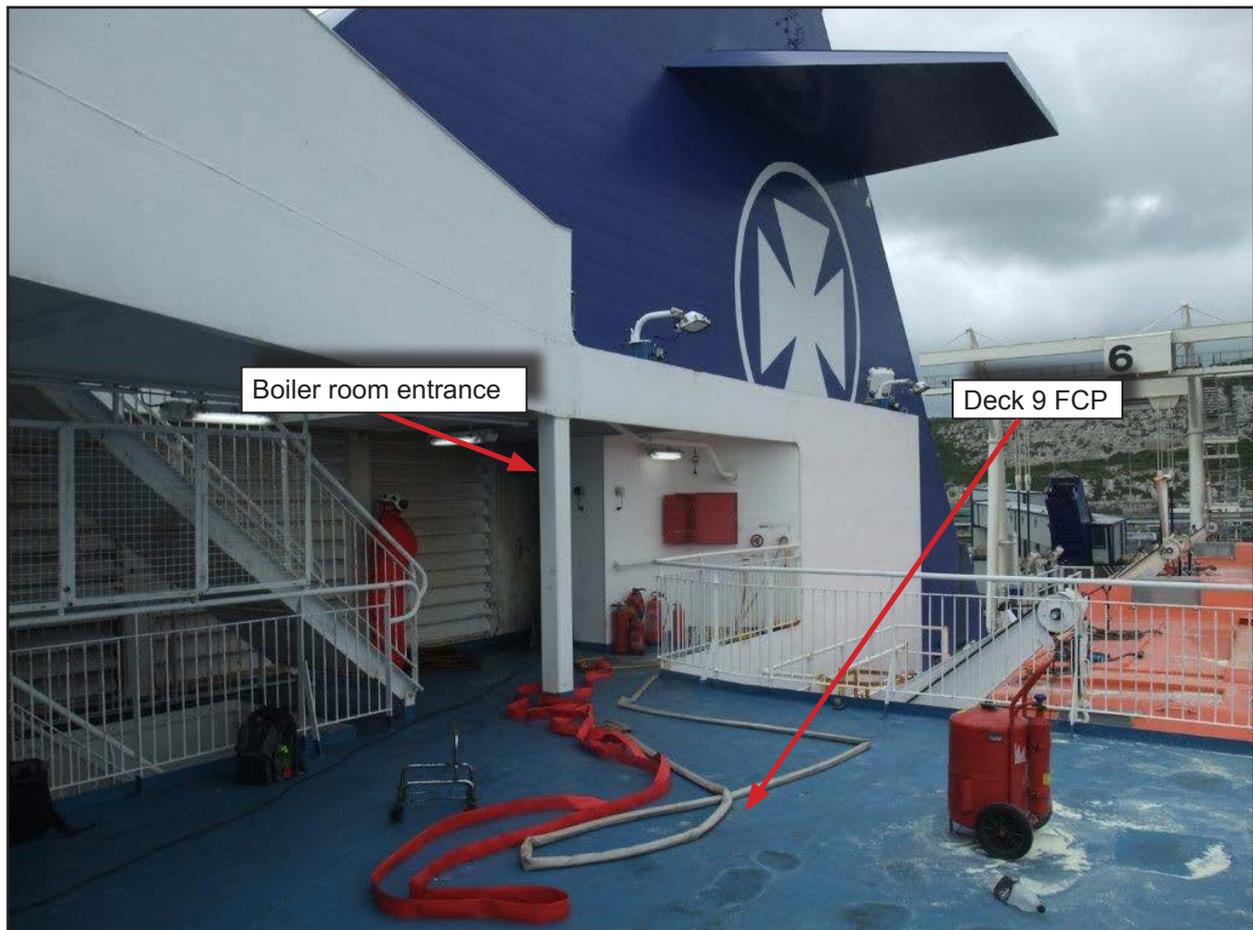
**Figure 4:** Photograph of forward control point location on deck 9

As a consequence of the fire, six ship's crew and four KFRS firefighters suffered burn injuries, three of which were serious. All of the injuries resulted from the backdraught. The injured personnel had all been located in the vicinity of the FCP on deck 9.

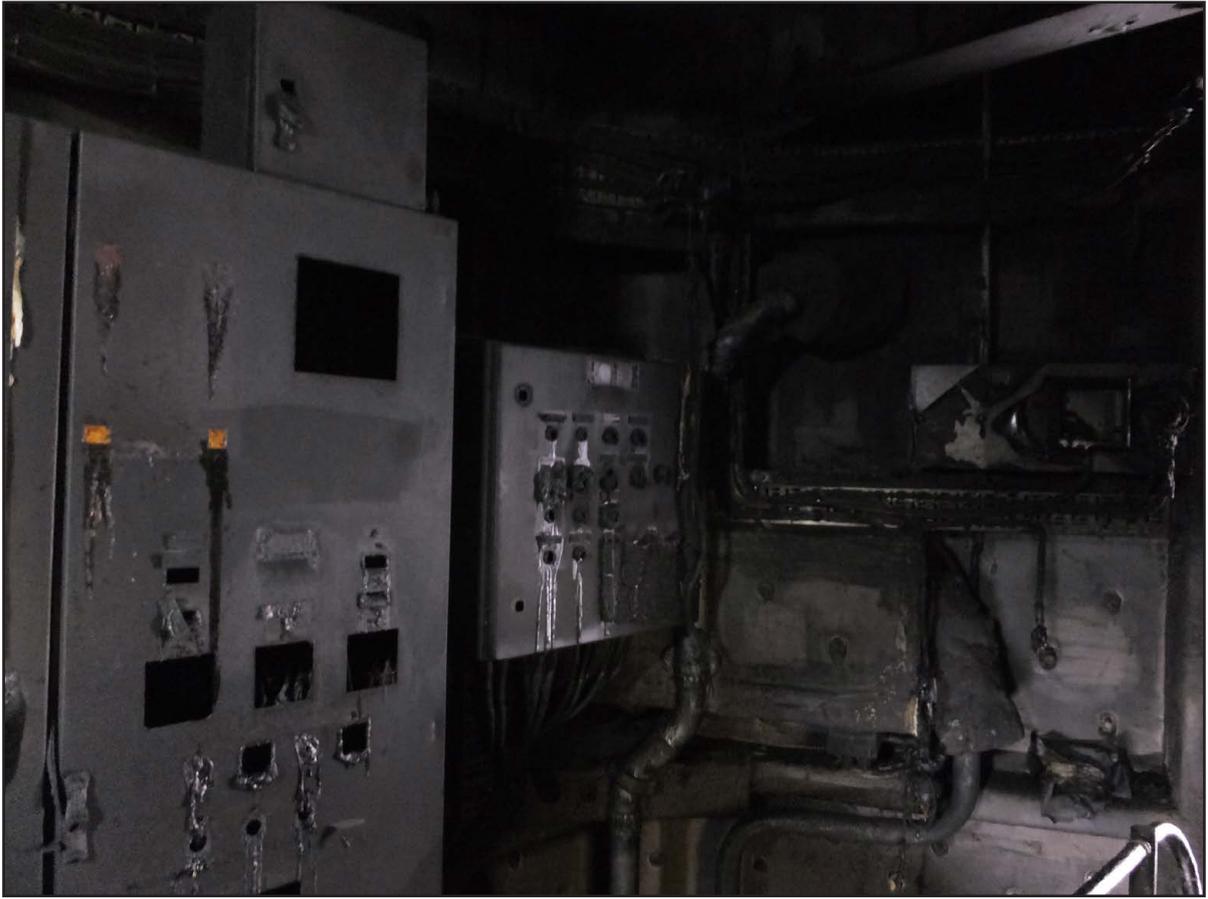
**Figure 5a:** Fire damage to thermal heater control panel

There was mechanical damage throughout the port boiler room. This included fire-damaged electrical cables on lighting and monitoring circuits, significant damage to the heater control panel and the burner unit (**Figures 5a** and **5b**), and numerous melted light fittings. There was significant smoke damage within the space that resulted in the need to replace much of the A-60 insulation in the upper areas of the compartment.

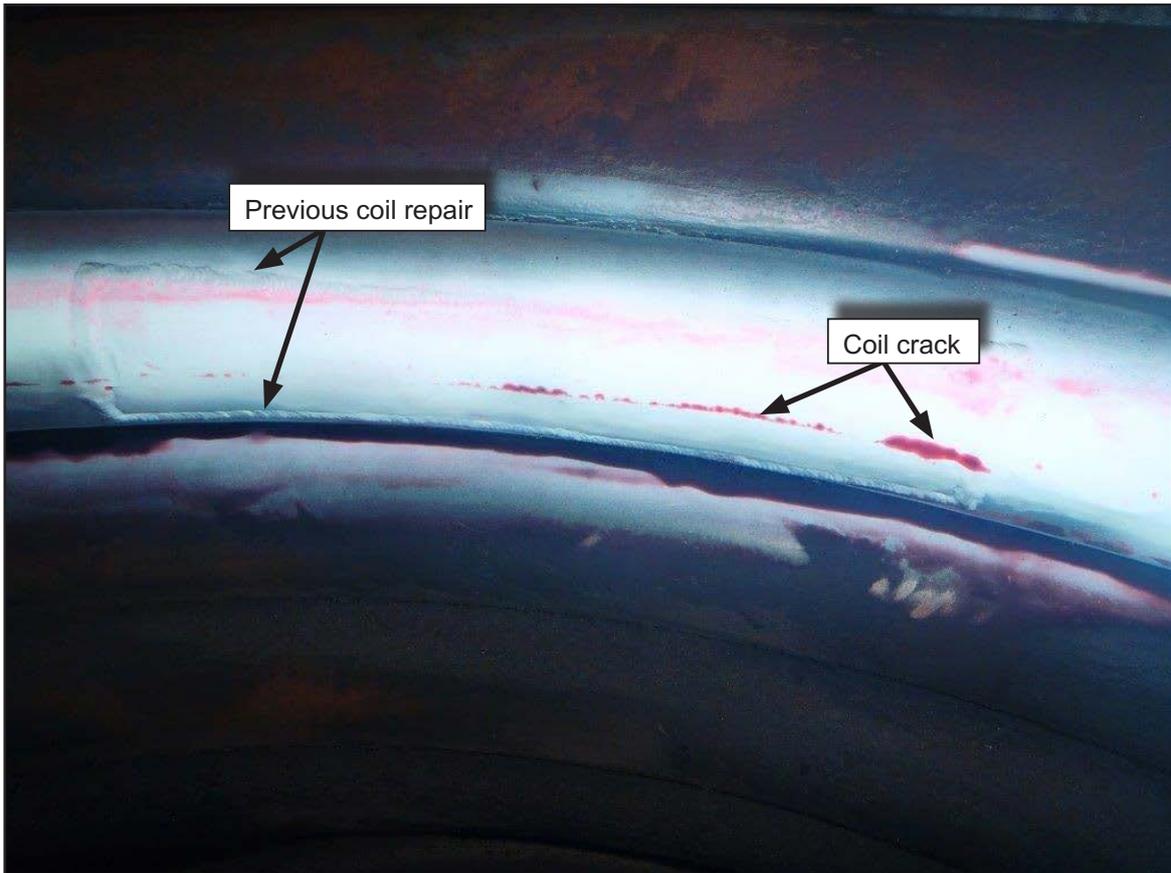
**Figure 10:** Photograph of port thermal oil heater coil fracture

The port thermal heater coil was found to have failed at the top of the furnace, resulting in fire damage to the refractory insulation and its supporting structure within the furnace.

The analysis of the coil sections carried out by CETIM on behalf of DFDS A/S confirms that the failure of the port thermal oil heater coil was the result of a fracture along the circumferential weld securing the refractory insulation support plate at the top of the furnace (**Figure 10**). The welds were assessed as having an insufficient melt that caused a notch effect with acute stresses on the tube walls adjacent to the weld. The report also noted that an inappropriate filler material had been used for the welding.

It is concluded that the port thermal oil heater coil failed as a result of stress caused by the weld securing the refractory insulation support plate. This was as a result of stresses introduced through insufficient melting of the weld and an inappropriate filler material for the welding. This might have been exacerbated through thermally induced stress resulting from previous damage to the refractory insulation (**Figure 12**).

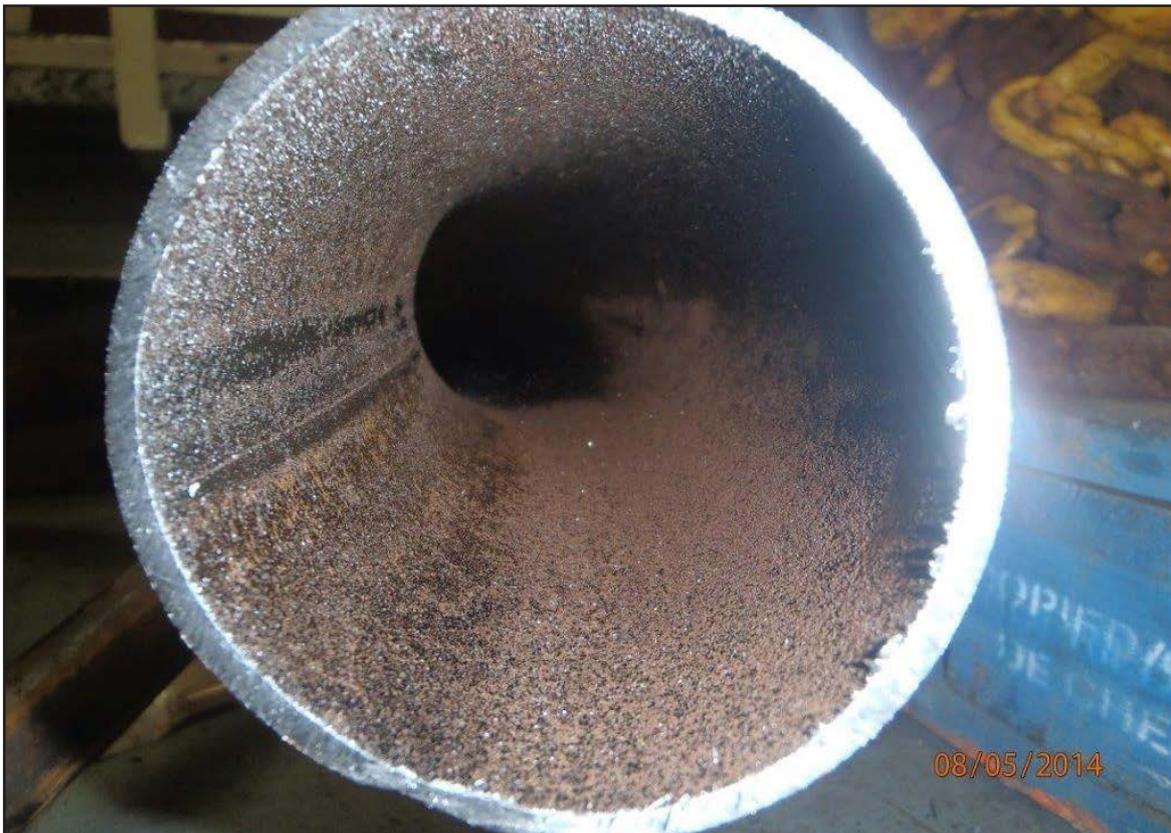
**Figure 11:** Photograph of internal surface of damaged section of port thermal oil heater coil

With the damaged section cut out of the coil, some evidence of light contamination of the internal coil walls was noted (**Figure 11**). However, the level of contamination is unlikely to have contributed to additional thermal stress.

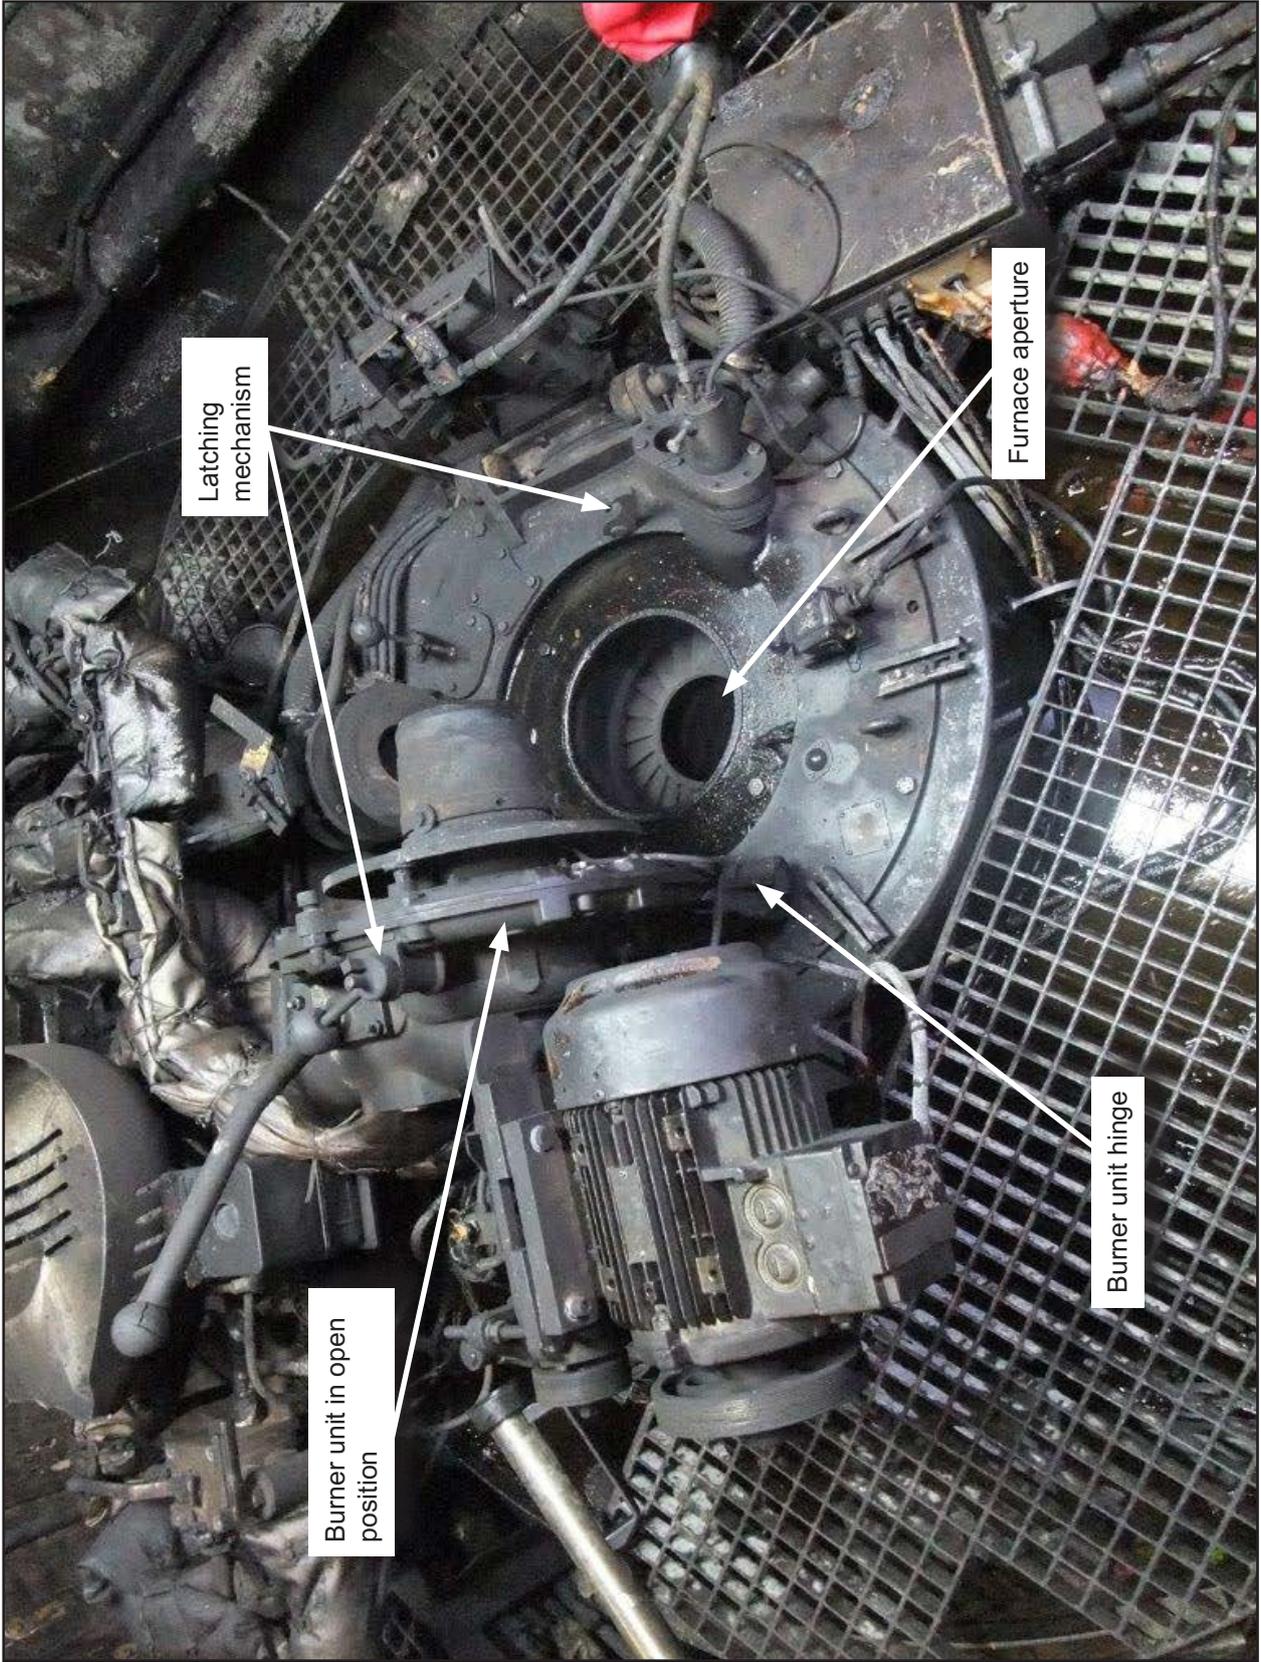
Figure 13: Photograph of port thermal oil heater burner unit in open position

Although the heater had been shut down and the burner fuel and air isolated, a fuel source remained available through the thermal oil in the system. The pressure in the thermal oil coil caused by thermal expansion is likely to have forced the thermal oil through the crack in the coil, forming an atomised and therefore more readily ignitable fuel source. The inability to operate the coil pressure relief valve might have exacerbated this situation. Therefore, with fuel and heat sufficient for ignition, the fire became dependent on oxygen. An oxygen source existed through the heater exhaust. However, the main source was probably from the opening created at the top of the furnace after the burner unit had lifted. The observed pulses of smoke emanating from the jointing surfaces at the top of the furnace were consistent with the fire diminishing due to oxygen starvation and then suddenly re-igniting when the air/fuel ratio was again sufficient to support combustion.

While the fire continued to burn within the furnace, smoke and fire gases escaped through the burner unit aperture and amassed at the top of the port boiler room. Heat from the fire then melted fittings, forming unburnt pyrolysis products and adding to the combustible mixture within the compartment. The accumulation of this mixture, combined with a fire that had become dependent on oxygen, resulted in a backdraught when the port boiler room entrance door was opened and air was allowed to enter the space.
