Fatality following capsizing of Fletcher speedboat

Tor Bay

2 May 2015

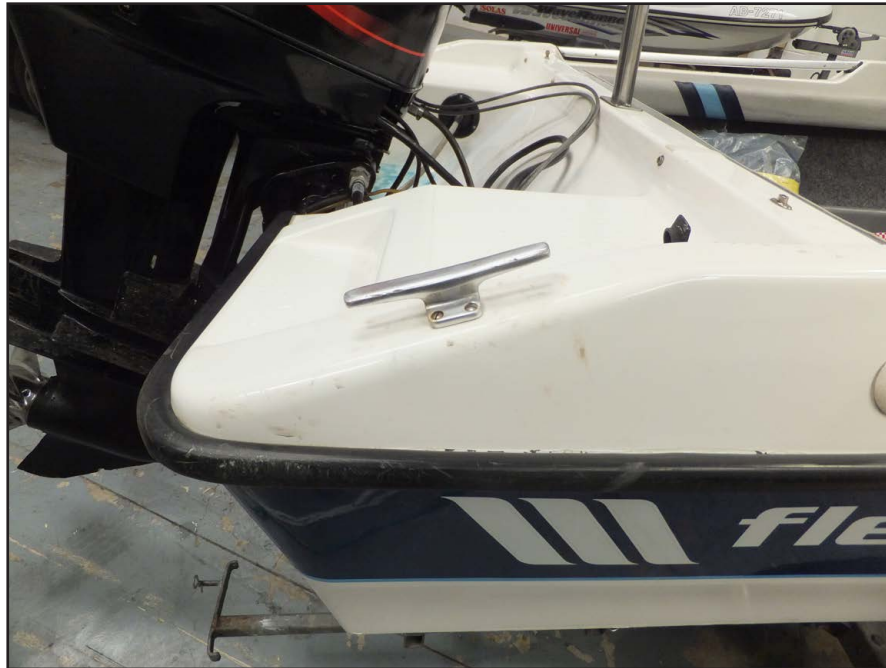
Figure 4: Aft starboard mooring cleat

Given the location of the speedboat's stern cleats and the means by which the strap of the buoyancy aid became snagged, it is concluded that Emily was conscious and was attempting to escape from under the speedboat when the strap became snagged.

In this case, the speedboat ended up floating vertically in the water with the cleat hook aligned in this direction. This meant that as Emily's buoyancy aid tried to lift her to the surface it held her on the cleat. If the boat had remained horizontal after capsize it would have made her rescue easier and the cleat would have remained horizontal, reducing the snag hazard.

- Emily drowned as a result of the strap of her buoyancy aid snagging on the aft starboard mooring cleat of the speedboat after it capsized.
- The capsizing occurred after the speedboat encountered a large wave. The speedboat's relative course and speed in the prevailing sea conditions contributed to the capsizing but other potential contributing factors were the fitting of a new propeller, the low quantity of fuel in the bow tank and the manner in which the engine speed was increased prior to the accident.

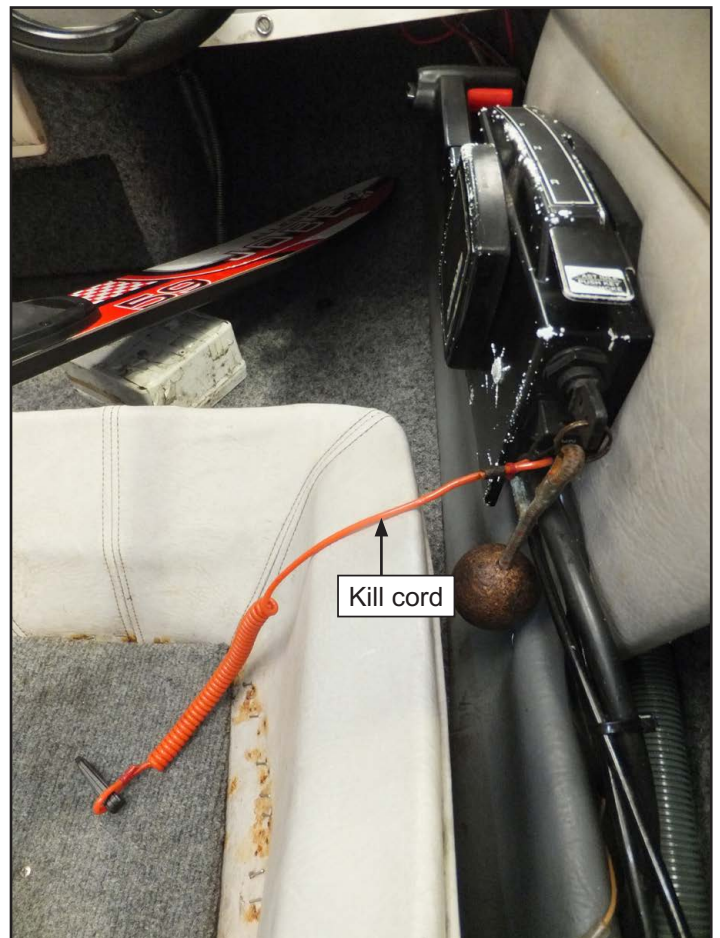
Figure 5: Throttle and kill cord

The outboard engine throttle had a kill cord (Figure 5) that, if fitted correctly, would stop the engine in the event of the driver being thrown out of the boat.

Although not contributing to the accident, since the outboard engine stopped when inverted, that the speedboat driver forgot to attach the kill cord is of concern. The kill cord is vital in ensuring a boat does not run out of control if the driver is thrown overboard. There have been numerous campaigns encouraging the wearing of kill cords, but this accident shows there remains a need to continue to reiterate this important safety message to boat users.

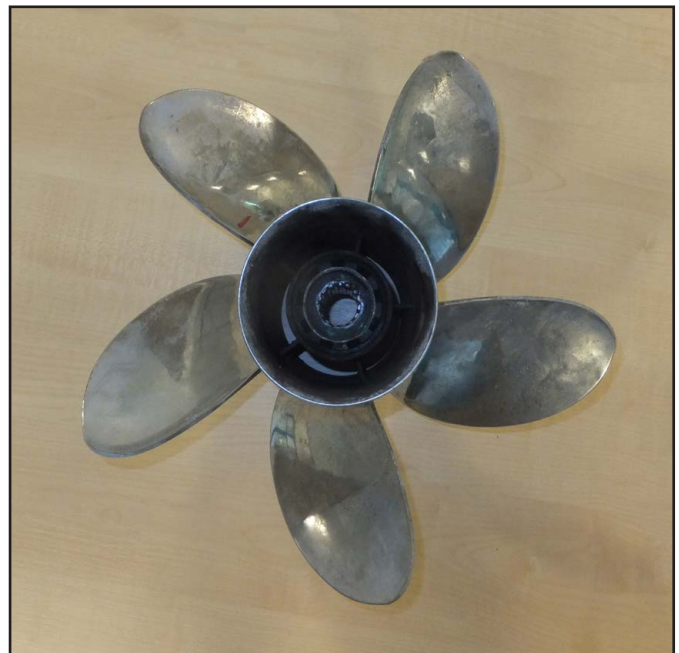
Figure 7: 'HighFive' five-bladed stainless steel propeller

In September 2014, after researching the appropriate size, the owners bought on Ebay a 'HighFive' five-bladed stainless steel propeller (**Figure 7**). This propeller was 12.75 inches in diameter with a 19-inch pitch and was double the weight of the three-bladed aluminium alloy propeller, which had weighed 2.3kg. The owners had bought the new propeller to improve the boat's acceleration so that it would make it easier to pull a heavier water skier up and out of the water, though the new propeller would also have the effect of reducing the boat's top speed.

While it is common practice to change a speedboat's propeller, the new propeller fitted to the outboard engine might have had a significant effect. The five-bladed propeller was intended to provide more thrust to improve acceleration and the boat's ability to pull a water skier up and out of the water. This greater thrust at the aft end of the speedboat would also have had a tendency to increase initial bow lift, reducing further the waterplane area during the transition to planing speed. The low quantity of fuel in the bow fuel tank would also have exacerbated this effect.

As well as providing more thrust, the new propeller would have generated more torque. The effect of this would have been for the boat to twist to port, in opposition to the propeller's direction of rotation, thereby assisting the boat's rapid capsize to port.

Given the variables involved it cannot be concluded with any certainty that the accident would not have occurred with the originally fitted three-bladed propeller. However, fitting a new propeller to an outboard engine can have a significant effect on a boat's performance and therefore should be approached with some caution.

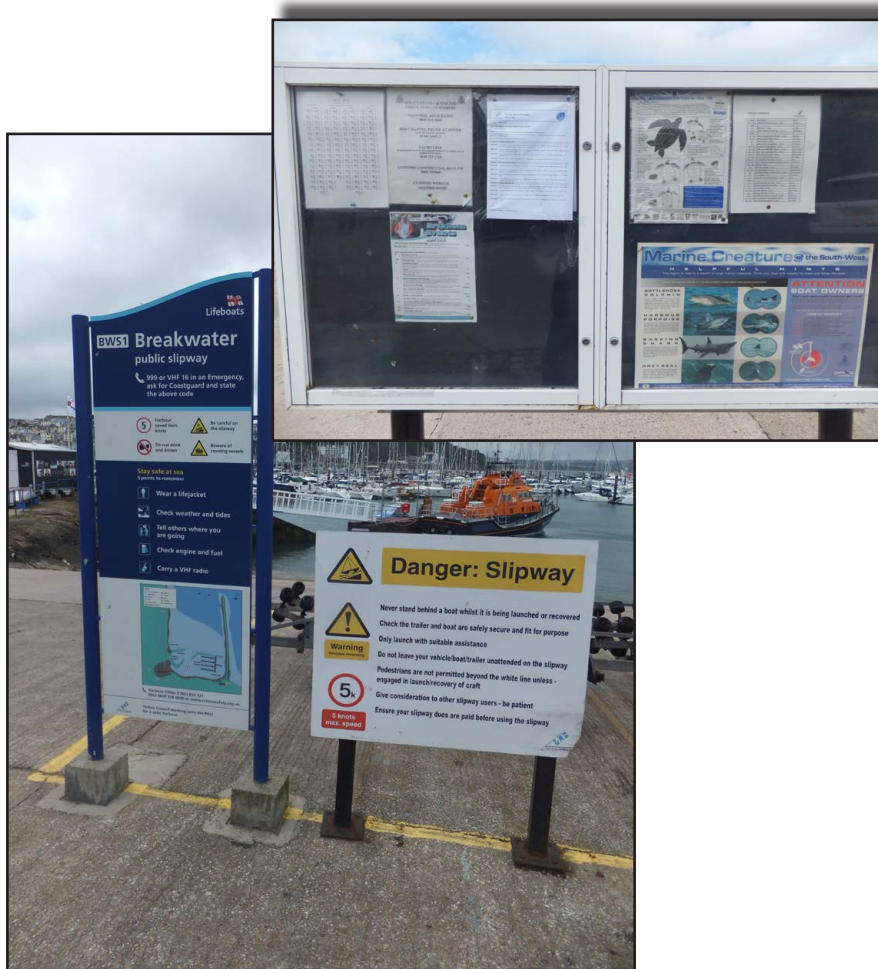
Figure 8: Brixham slipway noticeboards

Brixham Harbour is part of Tor Bay Harbour Authority and provided the slipway facility used by the speedboat and jet skis. Located at the slipway were several noticeboards. One displayed the local harbour byelaws, another tides and the local weather forecast, and a further two provided safety advice (**Figure 8**). The 72-hour marine forecast for the 'Off Tor Bay' area had been posted the previous day and covered Friday, Saturday and Sunday. For the period Saturday 2 May 0600-1200 it predicted:

Obtaining a maritime weather forecast, determining the tidal flow and assessing the likely sea conditions are all important issues to consider when preparing to go to sea. Local weather forecasts from the television and internet had been examined. However, the local maritime weather forecast, which was posted on the slipway noticeboard, was not seen by anyone in the group. 'White horses' or breaking waves are often regarded as a good indication of how rough sea conditions are, but can be misleading. Given the ESE wind and sea direction, Berry Head (**Figure 1**) provided relative shelter for the southern end of Tor Bay. This might have provided a misleading impression to those ashore of the sea conditions likely to be experienced once clear of Brixham's breakwater.

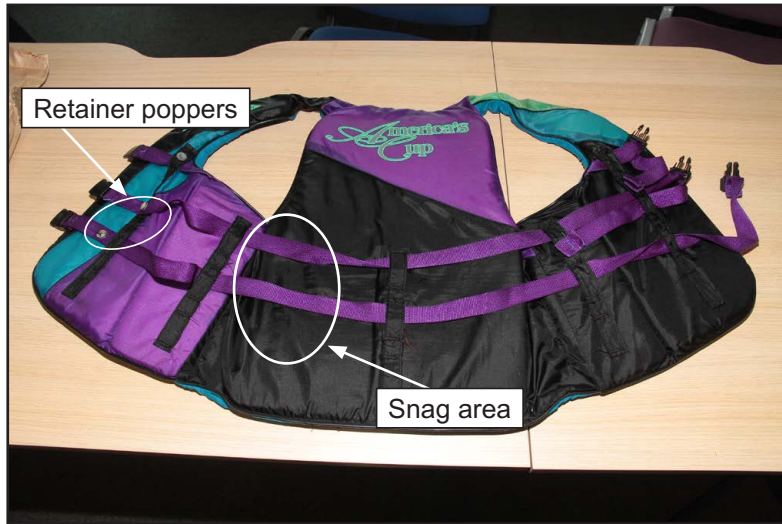
Figure 9: Snagged buoyancy aid

Emily's buoyancy aid was a water ski vest, approved by the United States Coastguard as a Type III⁷ personal flotation device. The vest labelling indicated it was an adult extra-large size, suitable for a chest of 44-50 inches. The vest was secured using three buckles on the front of the vest, two of which attached to straps that passed round the torso (Figure 9). There were loops on the vest for a third lower securing strap, but the strap was found to be missing following the accident. Two of the strap retaining-poppers were no longer attached.

Emily drowned after her buoyancy aid became caught on a stern cleat of the upturned speedboat as it sank by the stern following its capsize. Despite the valiant efforts of those on scene, Emily was not freed until the RNLI lifeboat arrived about 25 minutes later.

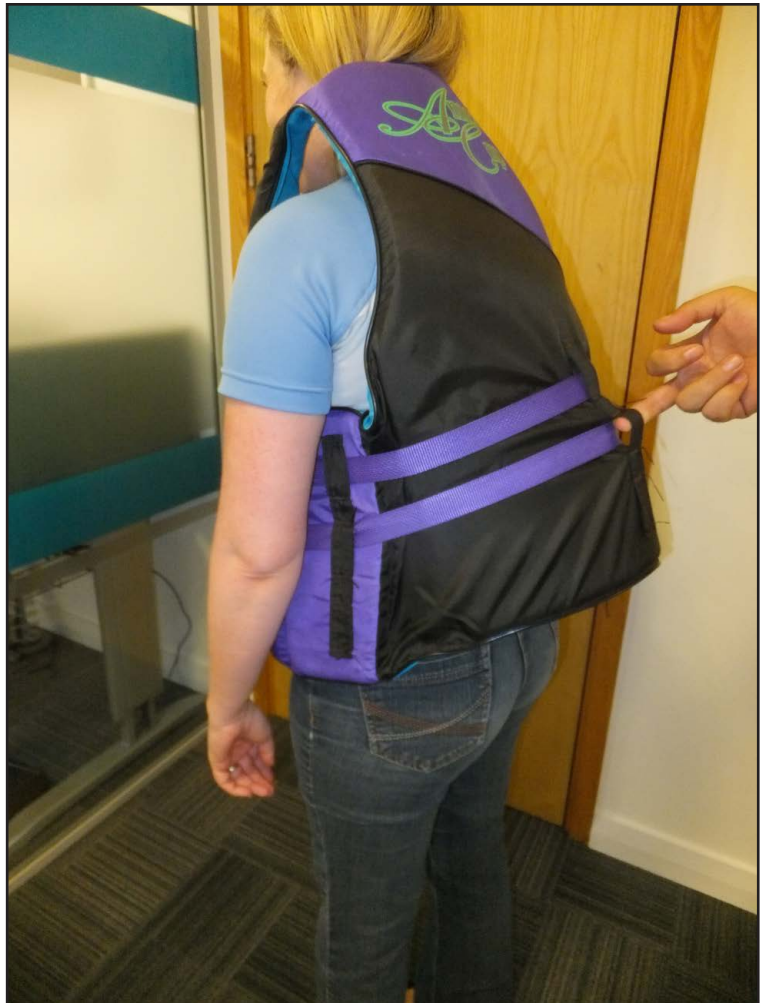
Figure 10: Oversized buoyancy aid

Although there is no legal requirement for buoyancy aids to be worn in privately owned pleasure craft, it was sensible for them to be worn. However, it is also important to ensure they are the right size and in good condition. Emily was wearing an extra-small 'shorty' wetsuit and an extra-large adult buoyancy aid. A buoyancy aid should be a close fit to prevent it rising up when floating in the water and to minimise the risk of it snagging (**Figure 10**).

- The adult extra-large buoyancy aid worn by Emily would not have been close fitting, increasing the risk of it becoming snagged.
- The speedboat driver was not wearing the kill cord and this highlights the need to continue raising awareness of the issue in the speedboat community.
