ACCIDENT

Aircraft Type and Registration:	Agusta Westland AW139, G-LBAL	
No & Type of Engines:	2 Pratt & Whitney Canada PT6C-67C turboshaft engines	
Year of Manufacture:	2012 (Serial no: 31421)	
Date & Time (UTC):	13 March 2014 at 1926 hrs	
Location:	Near Gillingham Hall, Norfolk	
Type of Flight:	Private	
Persons on Board:	Crew - 2	Passengers - 2
Injuries:	Crew - 2 (Fatal)	Passengers - 2 (Fatal)
Nature of Damage:	Aircraft destroyed	
Commander's Licence:	Commercial Pilot's Licence (Helicopters)	
Commander's Age:	36 years	
Commander's Flying Experience:	Approximately 2,320 hours (of which approximately 580 were on type) Last 90 days - approximately 105 hours Last 28 days - approximately 30 ¹ hours	
Information Source:	AAIB Field Investigation

Synopsis

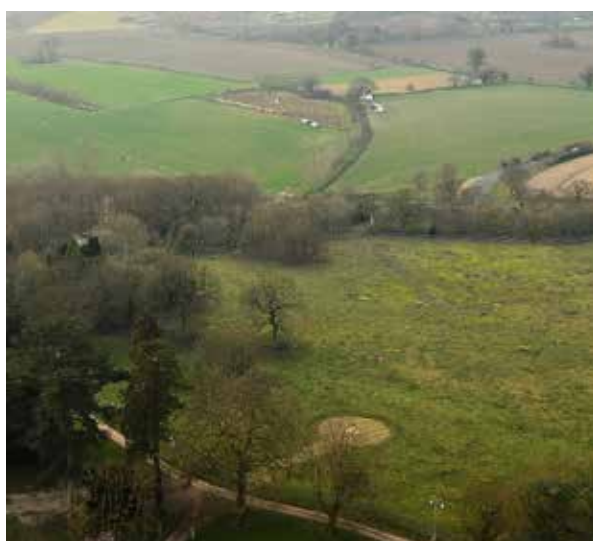
Figure 1

The paddock and helipad (foreground) and accident site (in nearest ploughed field).
Yarmouth Road runs across the middle of the picture,
Raveningham Road joins it at the T-junction

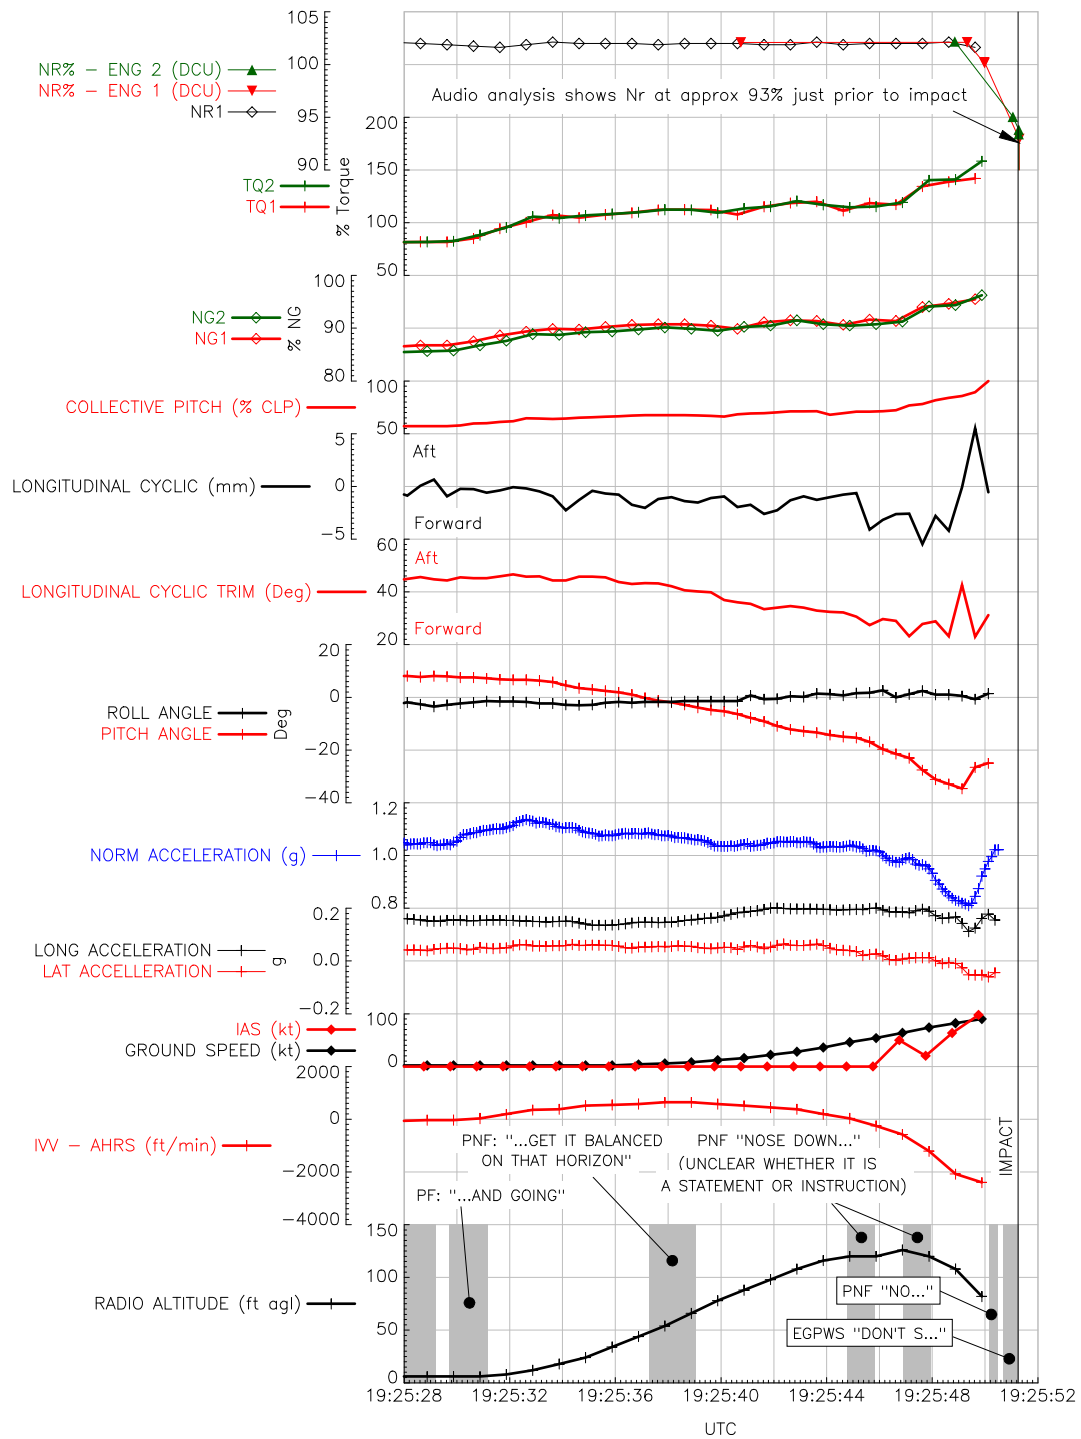
Figure 2

Pertinent engine DCU data parameters and CVFDR recorded data and transcript extracts. The commander was the Pilot Flying (PF) the co-pilot was the Pilot Not Flying (PNF)

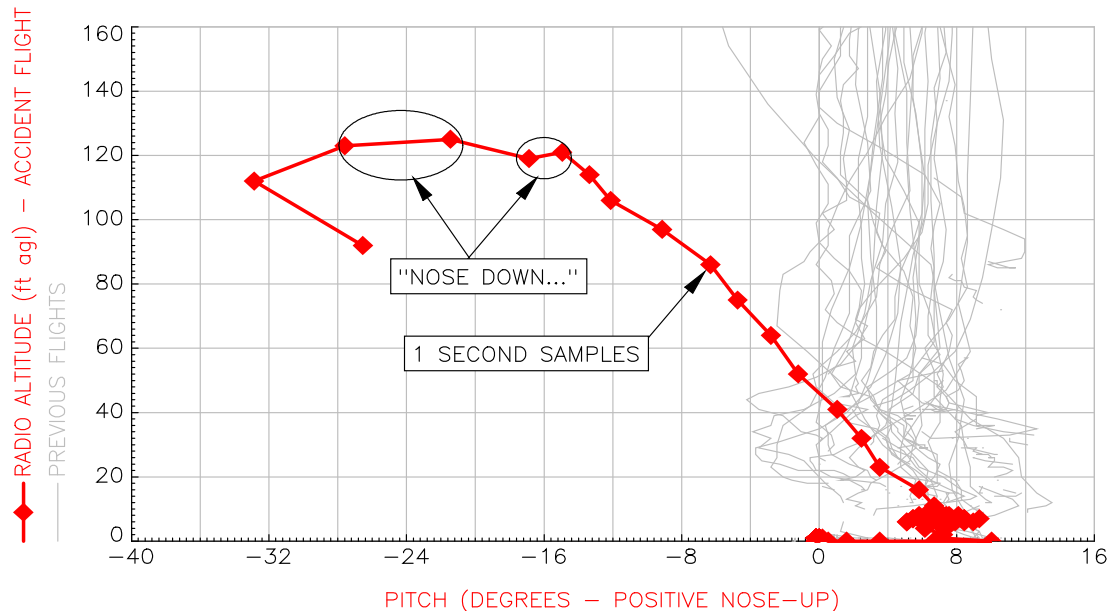
Figure 4

A comparison of the pitch attitude recorded during the accident flight with the previous flights recorded by the CVFDR is given in Figure 4. The maximum nose-down pitch attitude is not plotted as this graph uses a lower sample rate than the FDR data plot in Figure 2.

Radio altitude compared to pitch for the accident flight, compared with the previously recorded climb profiles

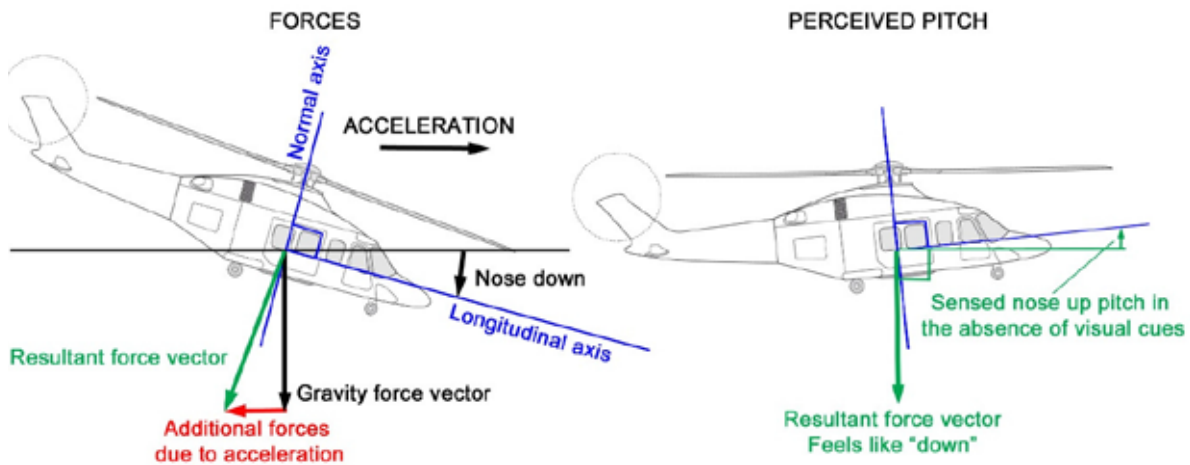
Figure 5

Effect of acceleration on perceived pitch in the absence of visual cues

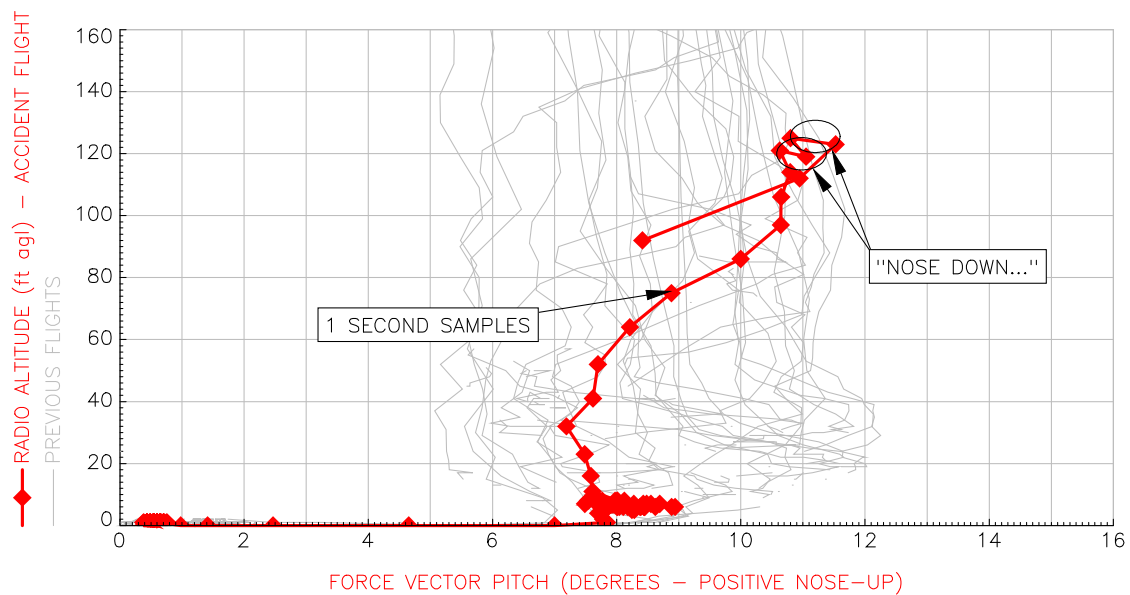
Figure 6 plots the radio altitude against the force vector pitch derived from the tri-axial accelerometer data and compares the plot with those of previous flights.

Radio altitude plotted against force vector pitch for the accident flight compared to previously recorded climb profiles
