ACCIDENT

Aircraft Type and Registration:	Saab-Scania SF340B, G-LGNL	
No & Type of Engines:	2 General Electric CT7-9B turboprop engines	
Year of Manufacture:	1991 (Serial no: 340B-246)	
Date & Time (UTC):	2 January 2015 at 0833 hrs	
Location:	Stornoway Airport, Isle of Lewis	
Type of Flight:	Commercial Air Transport (Passenger)	
Persons on Board:	Crew - 3	Passengers - 26
Injuries:	Crew - None	Passengers - 1 (Serious)
Nature of Damage:	Extensive damage to the nose landing gear, powerplants and underside of the aircraft	
Commander's Licence:	Air Transport Pilot's Licence	
Commander's Age:	46 years	
Commander's Flying Experience:	3,880 hours (of which 3,599 were on type) Last 90 days - 98 hours Last 28 days - 28 hours	
Information Source:	AAIB Field Investigation

Synopsis

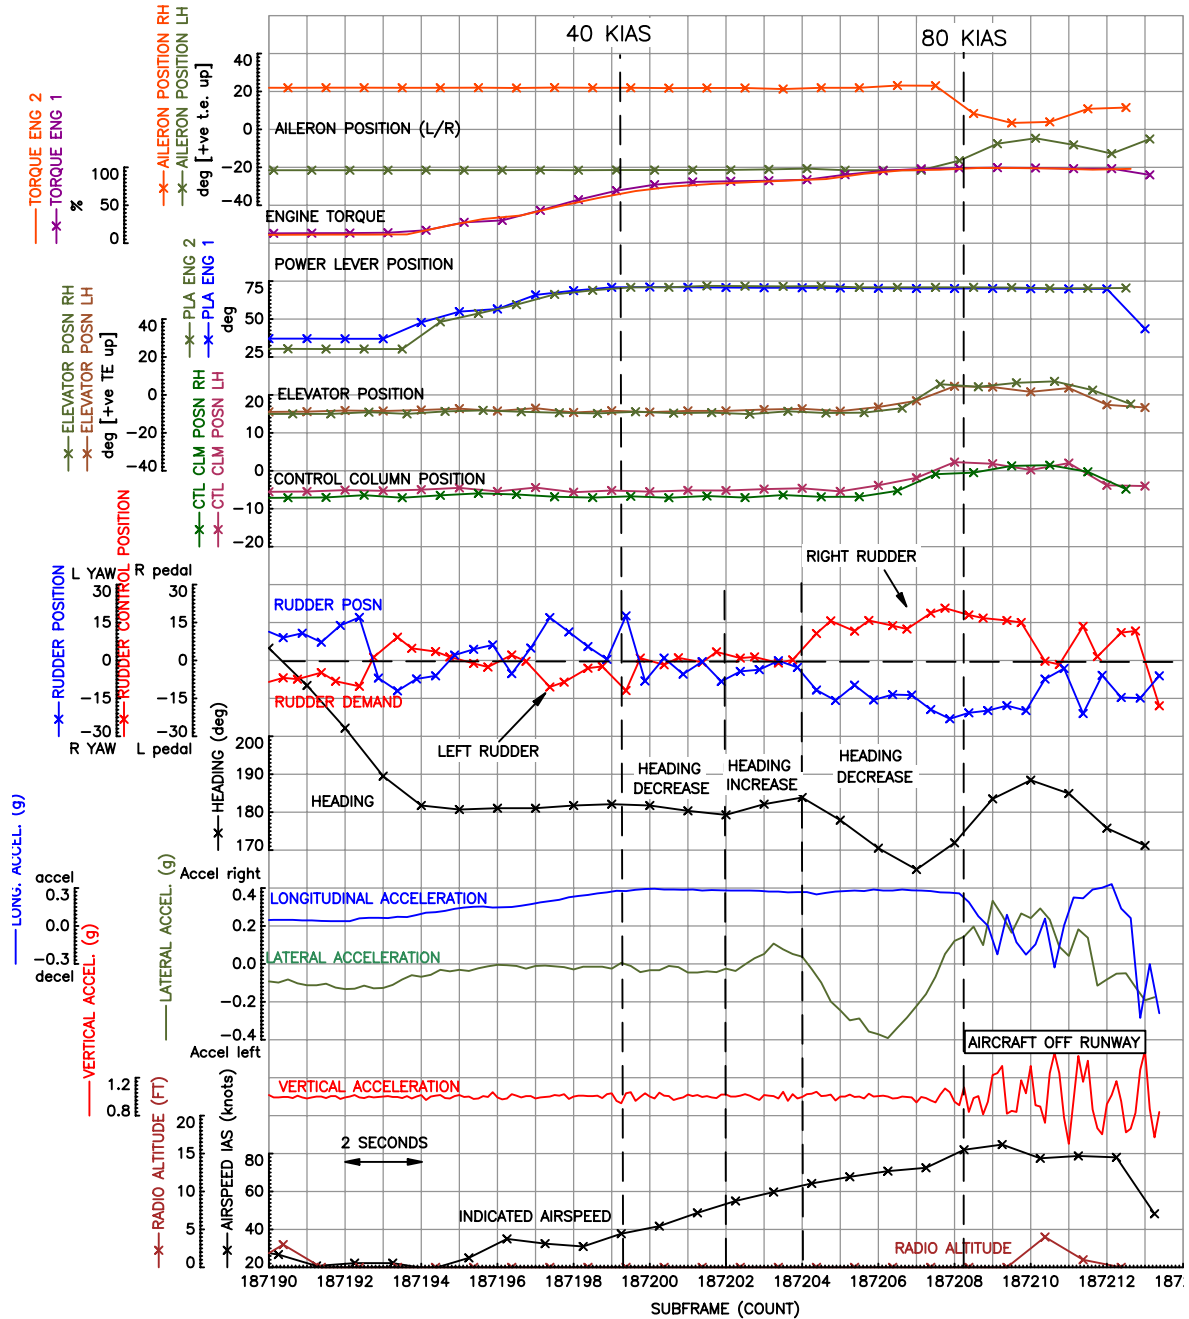
Figure 3
G-LGNL FDR data⁷

Over the next three seconds, the aircraft heading decreased to the left to 164.9° . As the aircraft began to turn, right rudder was commanded which increased the heading to 188° as the aircraft accelerated through 80 kt. During this heading change, fluctuations in the normal and longitudinal accelerations suggest that the aircraft had left the paved surface at an indicated airspeed of approximately 80 kt. Despite the heading indicating a turn to the right, the ground marks confirmed the aircraft departed the left side of the runway, yawing to the right. Right rudder was applied continuously throughout.

During the attempted takeoff, the rudder was central from 40 kt and remained so until approximately 65 kt. Between approximately 52 and 65 kt, the aircraft turned right slightly before it turned left sharply at approximately 65 kt (Figure 3). Given that the rudder was central, this change of direction might have been caused by one, or a combination of the following factors:

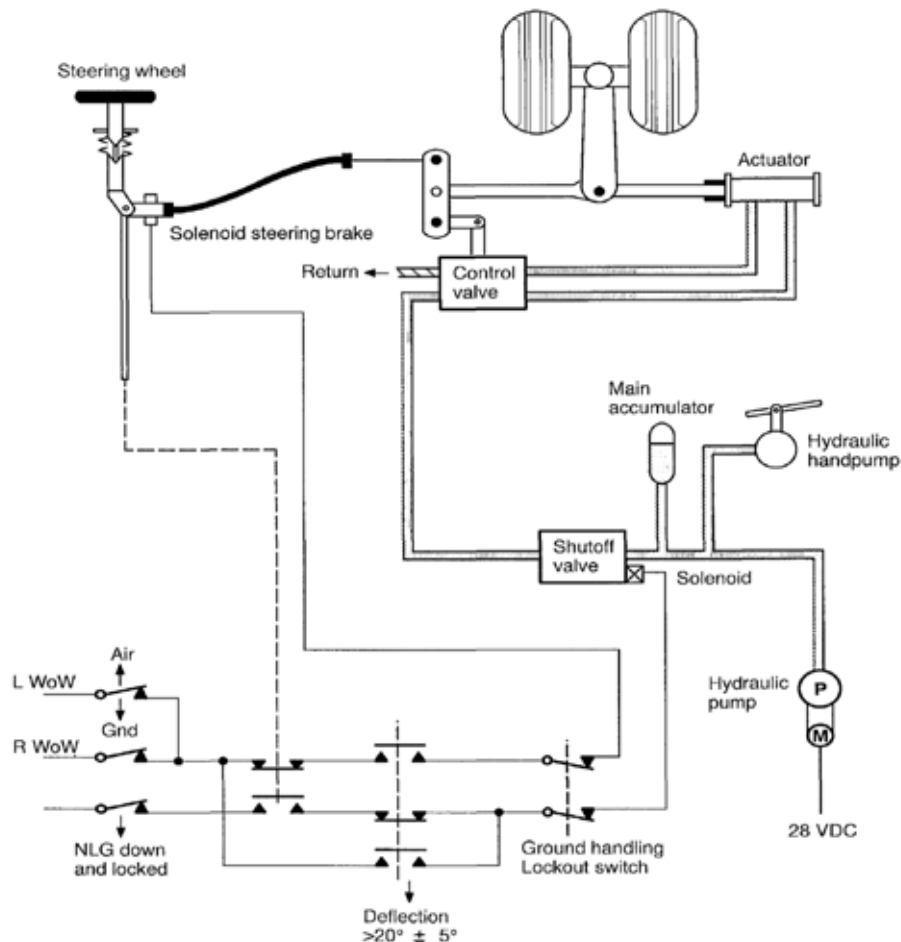
Figure 4

Schematic of NWS (from Aircraft Operating Manual)

Due to damage sustained, it was not possible to conduct a detailed check of the steering system and its rigging. However, a visual examination of the system did not reveal any pre-existing defects.
