SERIOUS INCIDENT

Aircraft Type and Registration:	Boeing 747-443, G-VROM	
No & Type of Engines:	4 General Electric CF6-80C2B1F turbofan engines	
Year of Manufacture:	2001 (Serial no: 32339)	
Date & Time (UTC):	29 December 2014 at 1334 hrs	
Location:	Near London Gatwick Airport	
Type of Flight:	Commercial Air Transport (Passenger)	
Persons on Board:	Crew - 18	Passengers - 447
Injuries:	Crew - None	Passengers - None
Nature of Damage:	Damage to right wing landing gear door and strike board	
Commander's Licence:	Airline Transport Pilot's Licence	
Commander's Age:	47 years	
Commander's Flying Experience:	12,279 hours (of which 9,771 were on type) Last 90 days - 162 hours Last 28 days - 95 hours	
Information Source:	AAIB Field Investigation

Synopsis

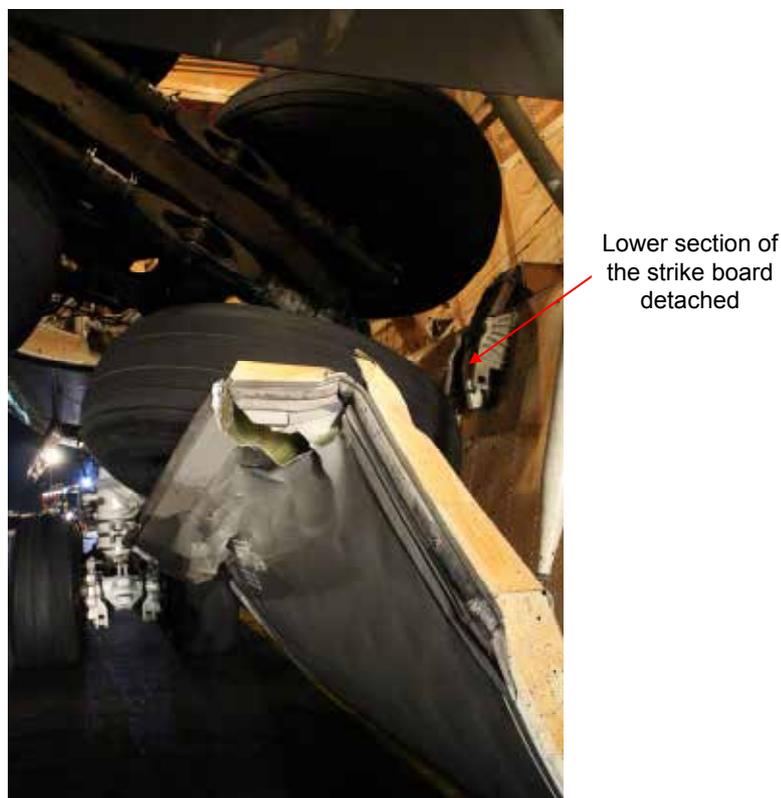
Figure 2

Once the passengers had been disembarked, an initial inspection of the landing gear was conducted. The right wing landing gear door was partially open, with the outboard rear wheel of the wing gear resting on the outboard section of the door. The outboard section of the door was significantly deformed, but the door itself was still firmly attached and the gear was securely held in a partially deployed position. (Figure 2) Evidence of leaking hydraulic fluid was found around the upper section of the gear leg, but there was no obvious damage to the wing gear in the areas visible during initial inspection. The lower section of the strike board in the right wing landing gear bay was missing.

Right wing landing gear door and gear leg as found just after landing.

gears and the left wing landing gear were undamaged, although the uneven weight distribution caused by the non-weight bearing right wing landing gear, meant the aircraft was canted over to the right, such that the outboard wheels of the left wing landing gear were no longer in contact with the ground. This also resulted in the engine nacelle of the number three engine on the right wing being significantly closer to the ground than normal. However, no evidence was found that the engine had contacted the ground during the landing.

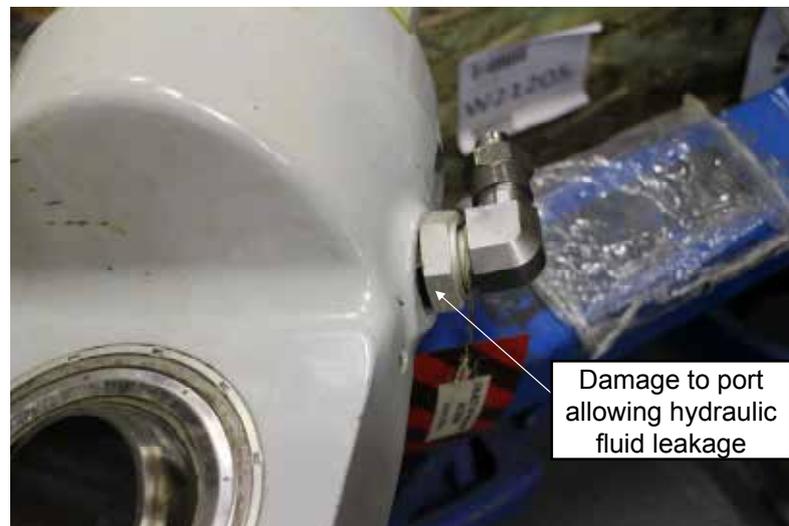
Figure 3

The aircraft was recovered from the runway and towed to the operator's hangar for further investigation. The damaged wing landing gear door was removed and the right wing landing gear leg fully extended. The right wing landing gear actuator was found installed 180° out of alignment. The hydraulic port boss fitting on the head end of the actuator was distorted and damaged (see Figure 3).

Damaged hydraulic port on landing gear actuator

Ultimately, the maintenance team working on G-VROM elected not to use any form of mechanical support, thus greatly increasing the difficulty and risk associated with installing the replacement actuator. The result of this decision was that the task became so physically demanding that the maintenance team became entirely focused on just attaching the actuator to the aircraft, in order to relieve themselves of the 85 kg weight they had manually supported for over 30 minutes. As such, they had no remaining capacity to ensure they installed the actuator in the correct orientation. It was subsequently determined that they had rotated it 180° about its long axis during installation, effectively installing it upside down.

The significance of this maintenance error was that the hydraulic fluid ports on the actuator were now transposed, with the port at the head end of actuator facing upwards. The AMM did not require the gear to be fully cycled following maintenance. Consequently, the insufficient clearance between the hydraulic port and the top of the landing gear bay, when the gear was in the retracted position, was not identified until the first time the gear was retracted fully during the incident flight the following morning. The force exerted on the hydraulic port as the gear retracted, caused it to distort and release hydraulic fluid at the full system pressure of 3,000 psi. This rapidly depleted the reserve of hydraulic fluid in system 4, generating a low quantity and then low pressure warning in the flight deck.

It is recommended that Boeing amend the 747-400 Approved Maintenance Manual task for removal and installation of the wing landing gear actuator, to provide clear instructions for the safe manoeuvring of the actuator in or out of its location in the wing landing gear bay.

It is recommended that Boeing modify the 747-400 wing landing gear actuator to reduce the likelihood of incorrect installation occurring or remaining undetected.

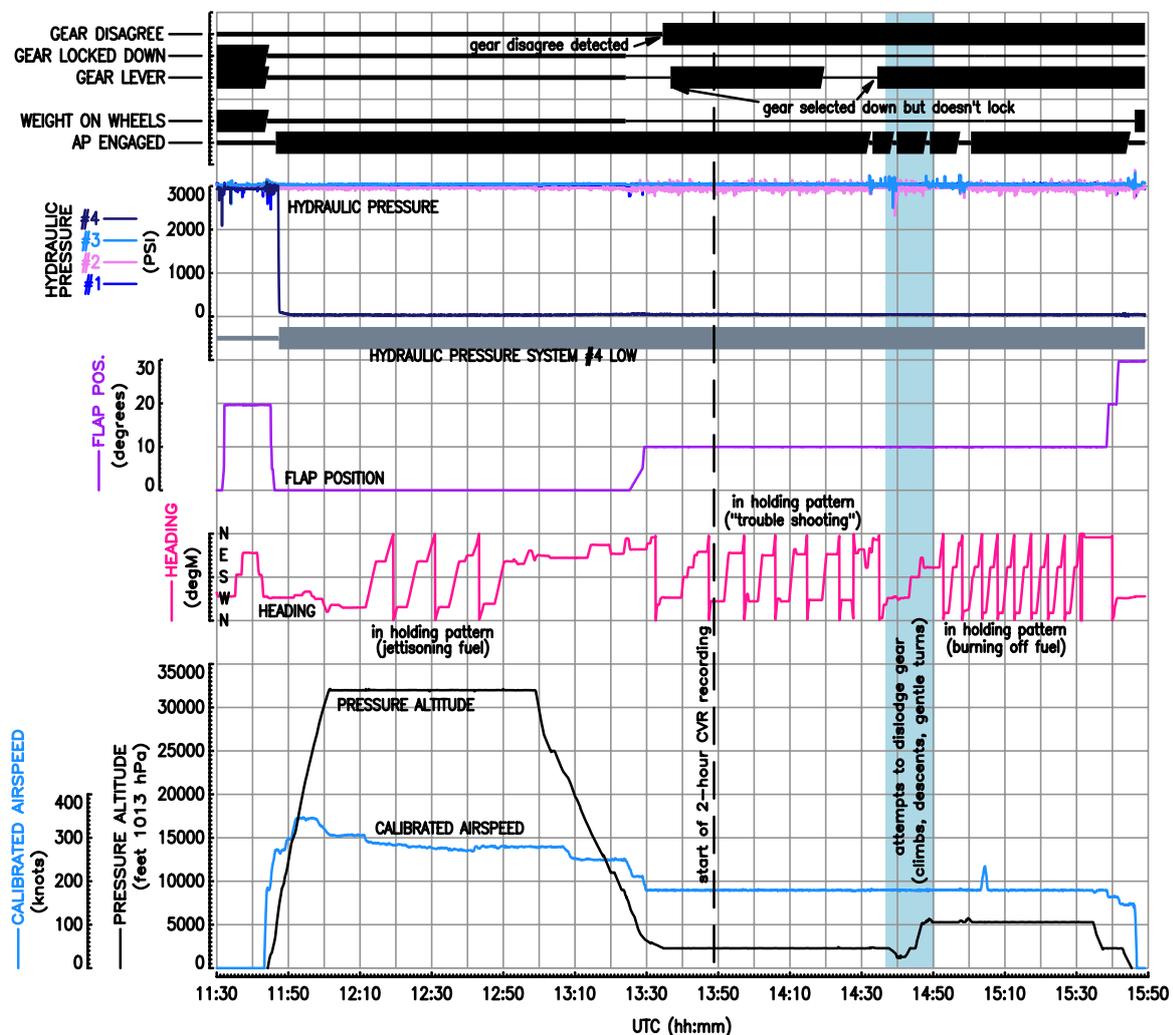
Figure 4
Salient data from FDR

Relevant data from the FDR is presented in Figure 4 for the whole flight although for the landing gear, these were restricted to gear lever position, all gear down and locked, and gear disagree discretely. Alternate gear selection or individual gear positions were not recorded. The radar track for the flight is presented in Figure 5.

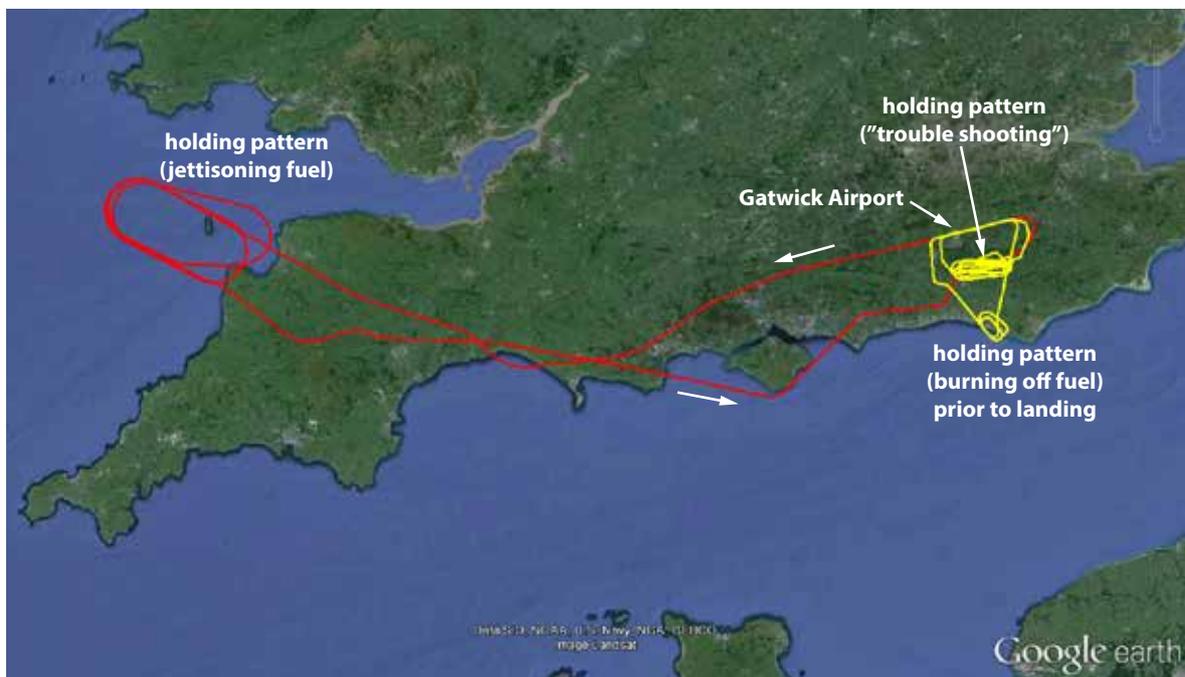
Figure 5

Radar track with portion of flight when the gear disagree was detected highlighted in yellow

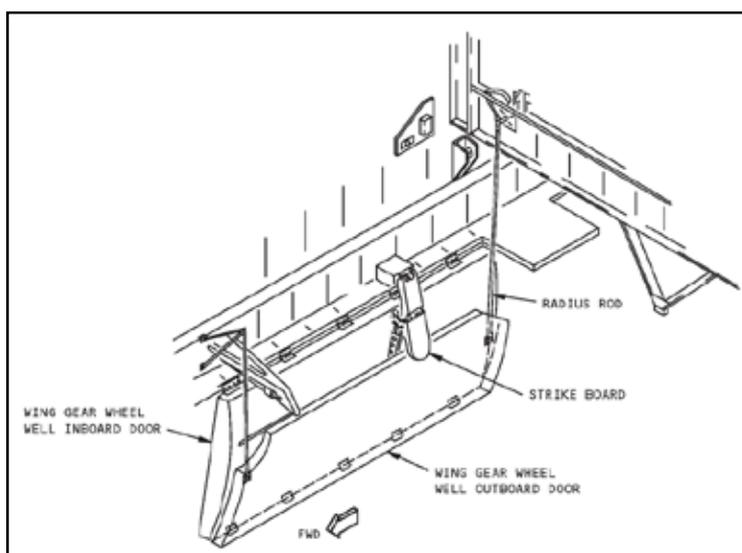
Figure 8

Wing gear door and strike board (right door design is identical in mirror image)

Due to the location of the leak on G-VROM, the right wing landing gear system was drained of hydraulic fluid. The landing gear alternate extension system is designed to work with hydraulic fluid present in the system. Most significantly for this event, the rate at which the gear leg descends, when deployed using the alternate system, is controlled by slowing the flow of hydraulic fluid around the system by means of a restrictor valve. When the hydraulic fluid is lost, the descent of the gear leg is undamped and accelerates under gravity. This has two potential implications for the wing landing gear, as demonstrated by the G-VROM event. Firstly, the gear door may not have fully opened prior to the arrival of the descending gear leg. Given the concertina design of the door, this will result in the gear leg becoming 'hung up' on the door, with no way of releasing it prior to landing. Secondly, as a result of the door being partially open, the strike board is mechanically held in the horizontal position when the tyre strikes it. The strike board attachment hinge was not designed to withstand the load imparted when the board is stuck in this orientation by an undamped gear leg. On G-VROM, this caused the hinge to fail and the board to be released from the aircraft. The aircraft was at an altitude of approximately 3,000 ft and travelling at 180 kt when this occurred. The 5 kg strike board would therefore have reached the ground with sufficient energy to cause significant damage or injury.

It is recommended that Boeing modify the design of the 747-400 wing landing gear door mechanism to prevent release of the strike board from the aircraft when the alternate gear extension system is used following a loss of hydraulic fluid.
