AIRCRAFT ACCIDENT REPORT 3/2015

**Report on the accident to
Eurocopter (Deutschland) EC135 T2+, G-SPAO
Glasgow City Centre, Scotland
on 29 November 2013**

Air Accidents Investigation Branch

Published 23 October 2015

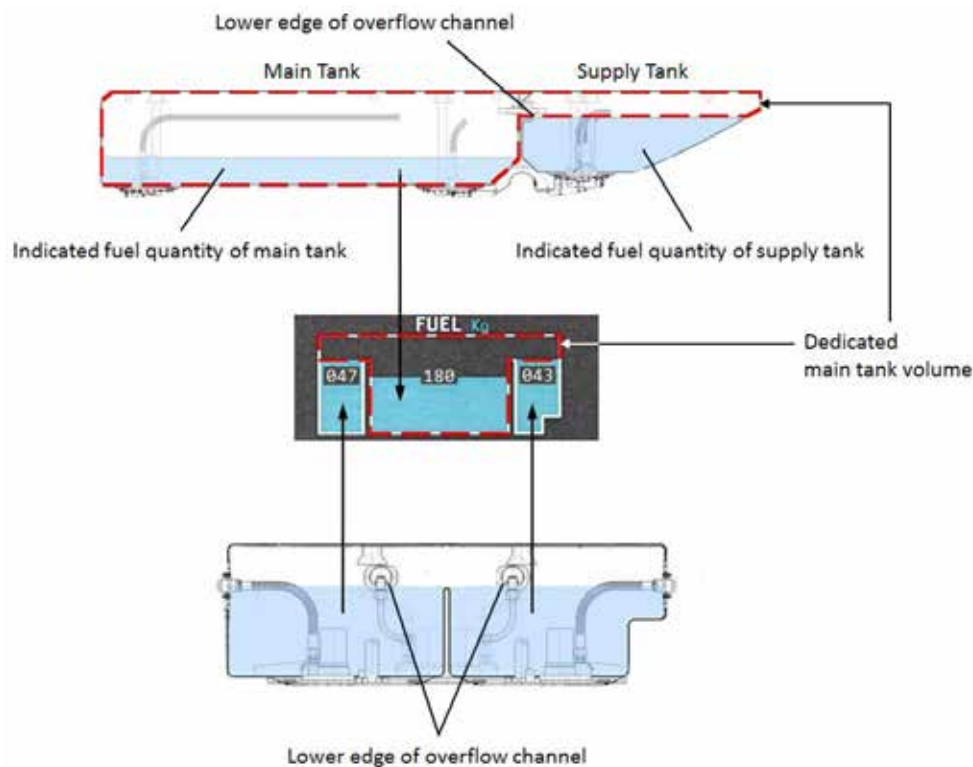
Figure 4

If a very low frequency registers, significantly below that appropriate to full fuel tanks, the software detects an impossible situation and the relevant pictorial and numerical fuel displays on the CAD are supplemented by F QTY FAIL OR F QTY DEGR captions¹¹. The F QTY FAIL caption indicates that one of the supply tank sensors has failed or both main tank sensors have failed. Under these circumstances, the respective graphic on the CPDS indicates zero. The CAD caption F QTY DEGR indicates that one of the two main tank sensors has failed and that the fuel tank indication is degraded and no longer reliable. In this case, the CPDS graphic will not change to zero but will show a fuel quantity based on a more conservative calculation within the indication algorithm, so as not to show more fuel than is available.

to the amount in the main tank, to produce a total which is displayed as main tank contents. Thus, the fuel in the supply tank above the level of the divider is treated as part of the main tank contents. See Figure 4.

Fuel tank contents indication schematic

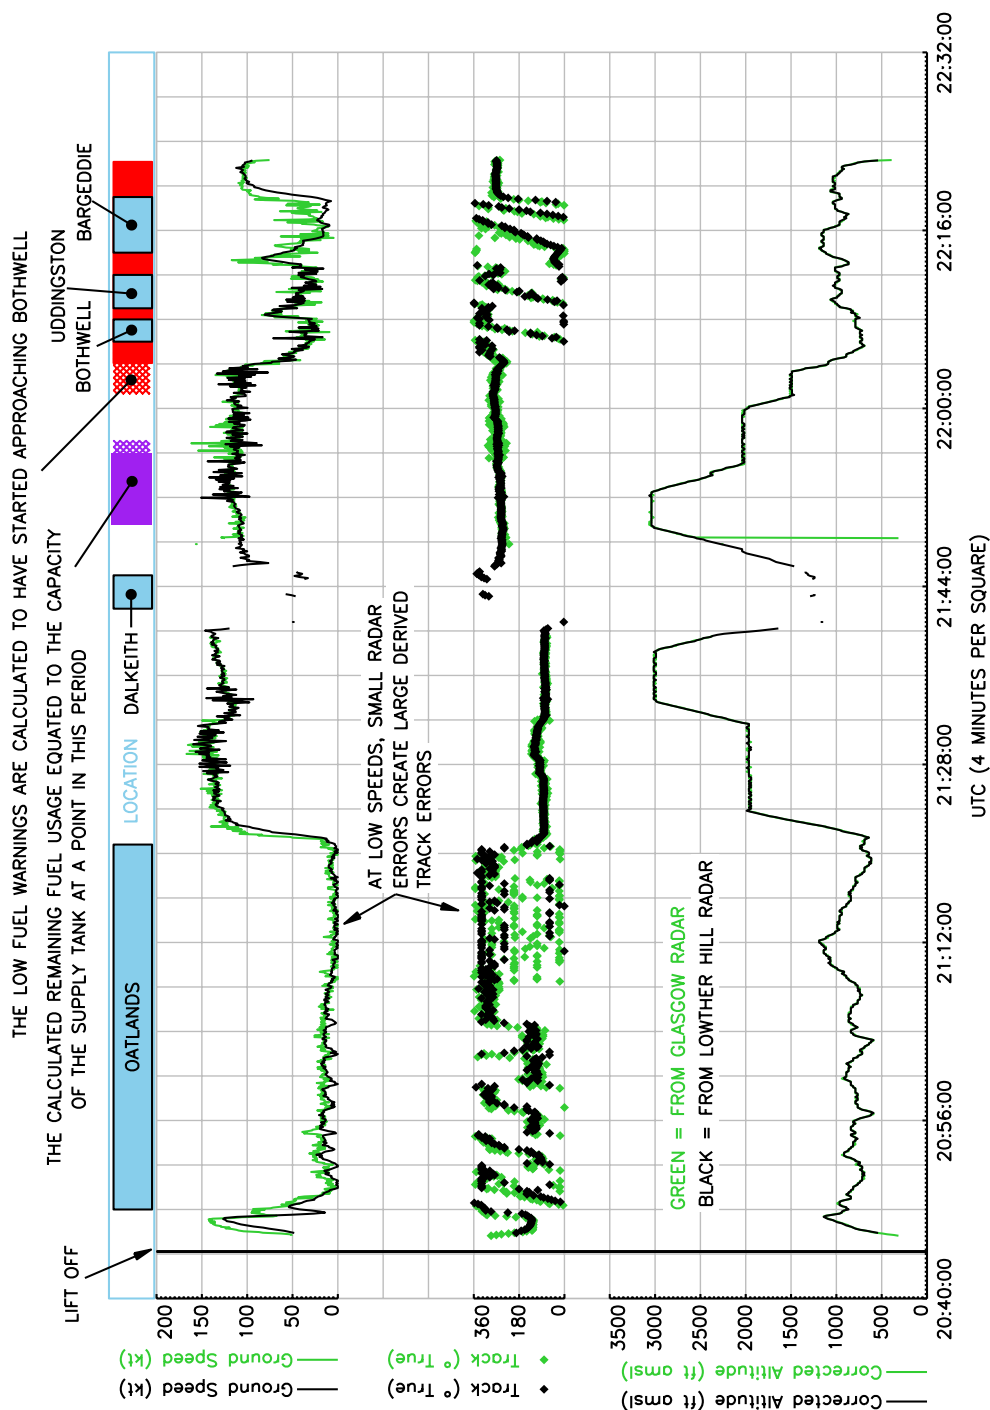
Figure 7

It was concluded that the transfer of fuel from the main tank to the supply tank stopped while the helicopter was returning to Glasgow from Dalkeith, leaving only the fuel in the supply tank available to the engines. It was estimated that this occurred during the latter stage of the cruise at 3,000 ft, during the descent to 2,000 ft or in the early stage of the cruise at 2,000 ft. The exact time this occurred could not be determined, as it was affected by the accuracy of the fuel burn modelling and the capacity of the supply tank. The supply tank capacity is affected by the pitch attitude of the helicopter because fuel can spill from the supply tank back into the main tank, via the connecting overflow channels. Also, the pitch attitude of a helicopter is dynamic, constantly varying, whereas the modelling of the pitch attitude during the flight was based on low sample rate radar data which relied on assumptions, with associated margins for error.

Derived speed and track information, with calculated fuel contents

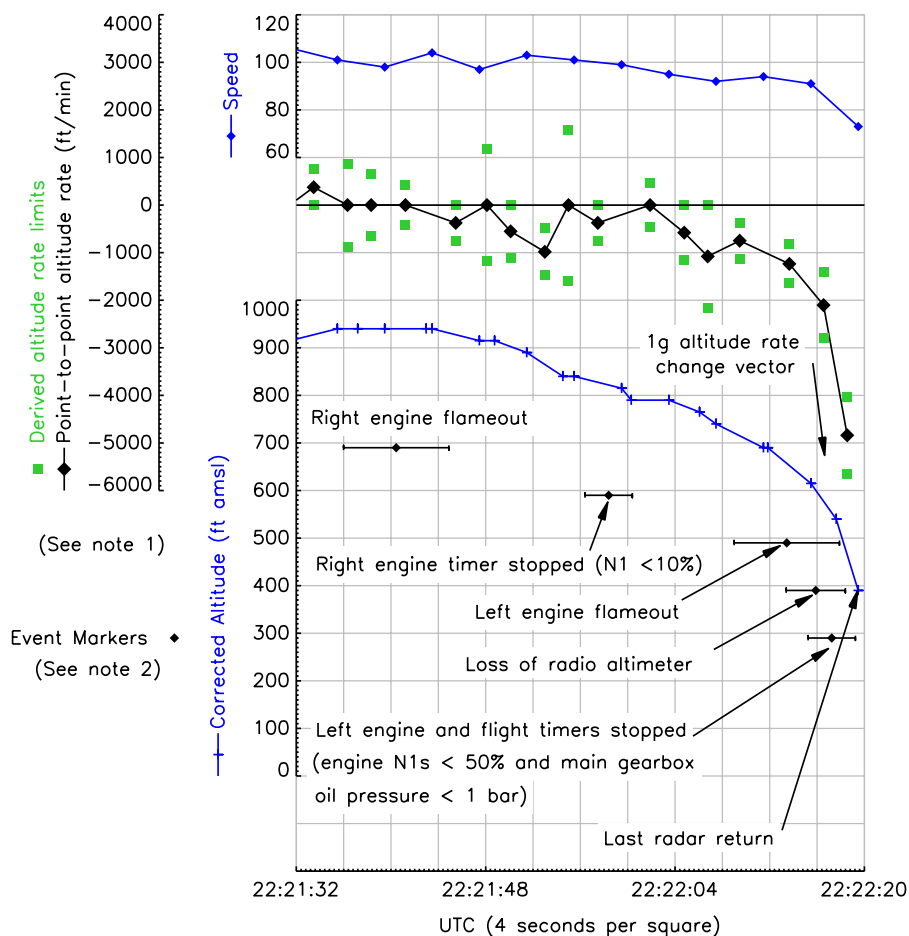
Figure 9

1. Derived altitude rate data uses combined Lowther Hill and Glasgow radar data. Calculations from radar returns less than one second apart were removed for clarity.
2. Event marker bars show the period in which the event occurred and reflects uncertainty in the precise time.

Radar data and related events at the end of the flight

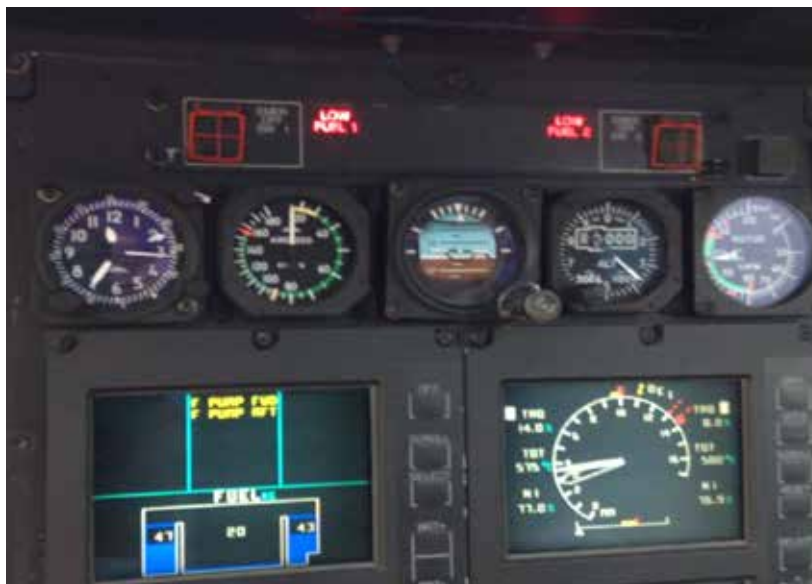
Figure 11

A ground run was carried out, starting with the fuel system indicating 47 kg and 43 kg of fuel in the left and right supply tank cells, respectively, and 41 kg in the main tank. During the ground run the main fuel tank contents were seen (by reference to the fuel gauge on the CAD) to deplete, with the forward and aft fuel transfer pumps OFF. When the main tank contents had depleted to approximately 20 kg, the LOW FUEL 1 and then the LOW FUEL 2 warnings illuminated on the Warning Unit, with an indicated 47 kg and 43 kg still in the supply tank cells. At no stage did the FUEL caution illuminate. See Figure 11.

G-NWEM fuel indications during ground run
