Report on the investigation of  
the capsize and foundering of  
the fishing vessel

***Ocean Way FR349***

100 miles north-east of Tynemouth

on 2 November 2014

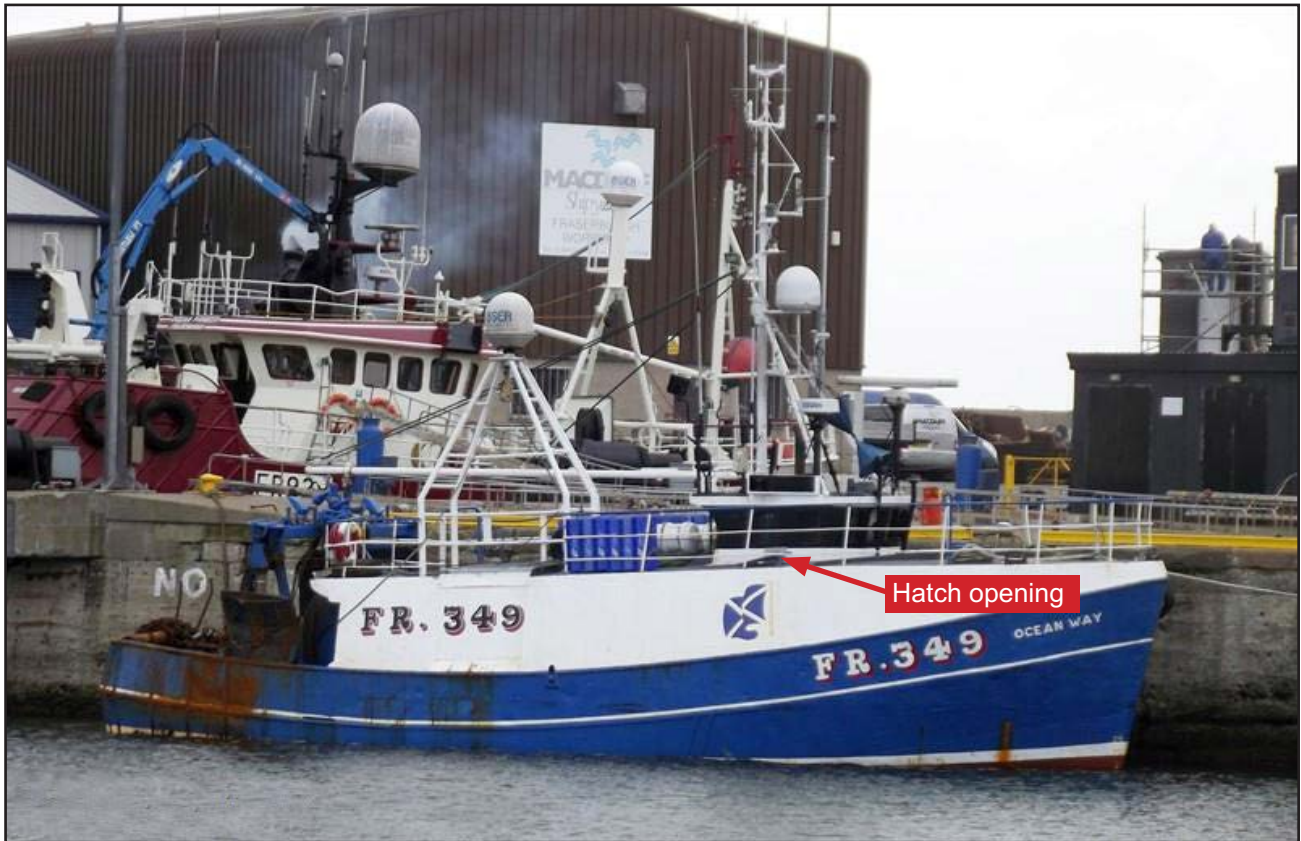
**Figure 2:** *Ocean Way* - location of hatch at the top of the vertical ladder from the main deck

Two crewmen climbed out of the cabin, through the mess room and onto the main deck before climbing onto the top of the shelter via a vertical ladder on the starboard side of the accommodation (**Figure 2**). The vessel was capsizing to port as they reached the top of the ladder and the men helped each other over the rails onto the starboard side of the hull and into the water.

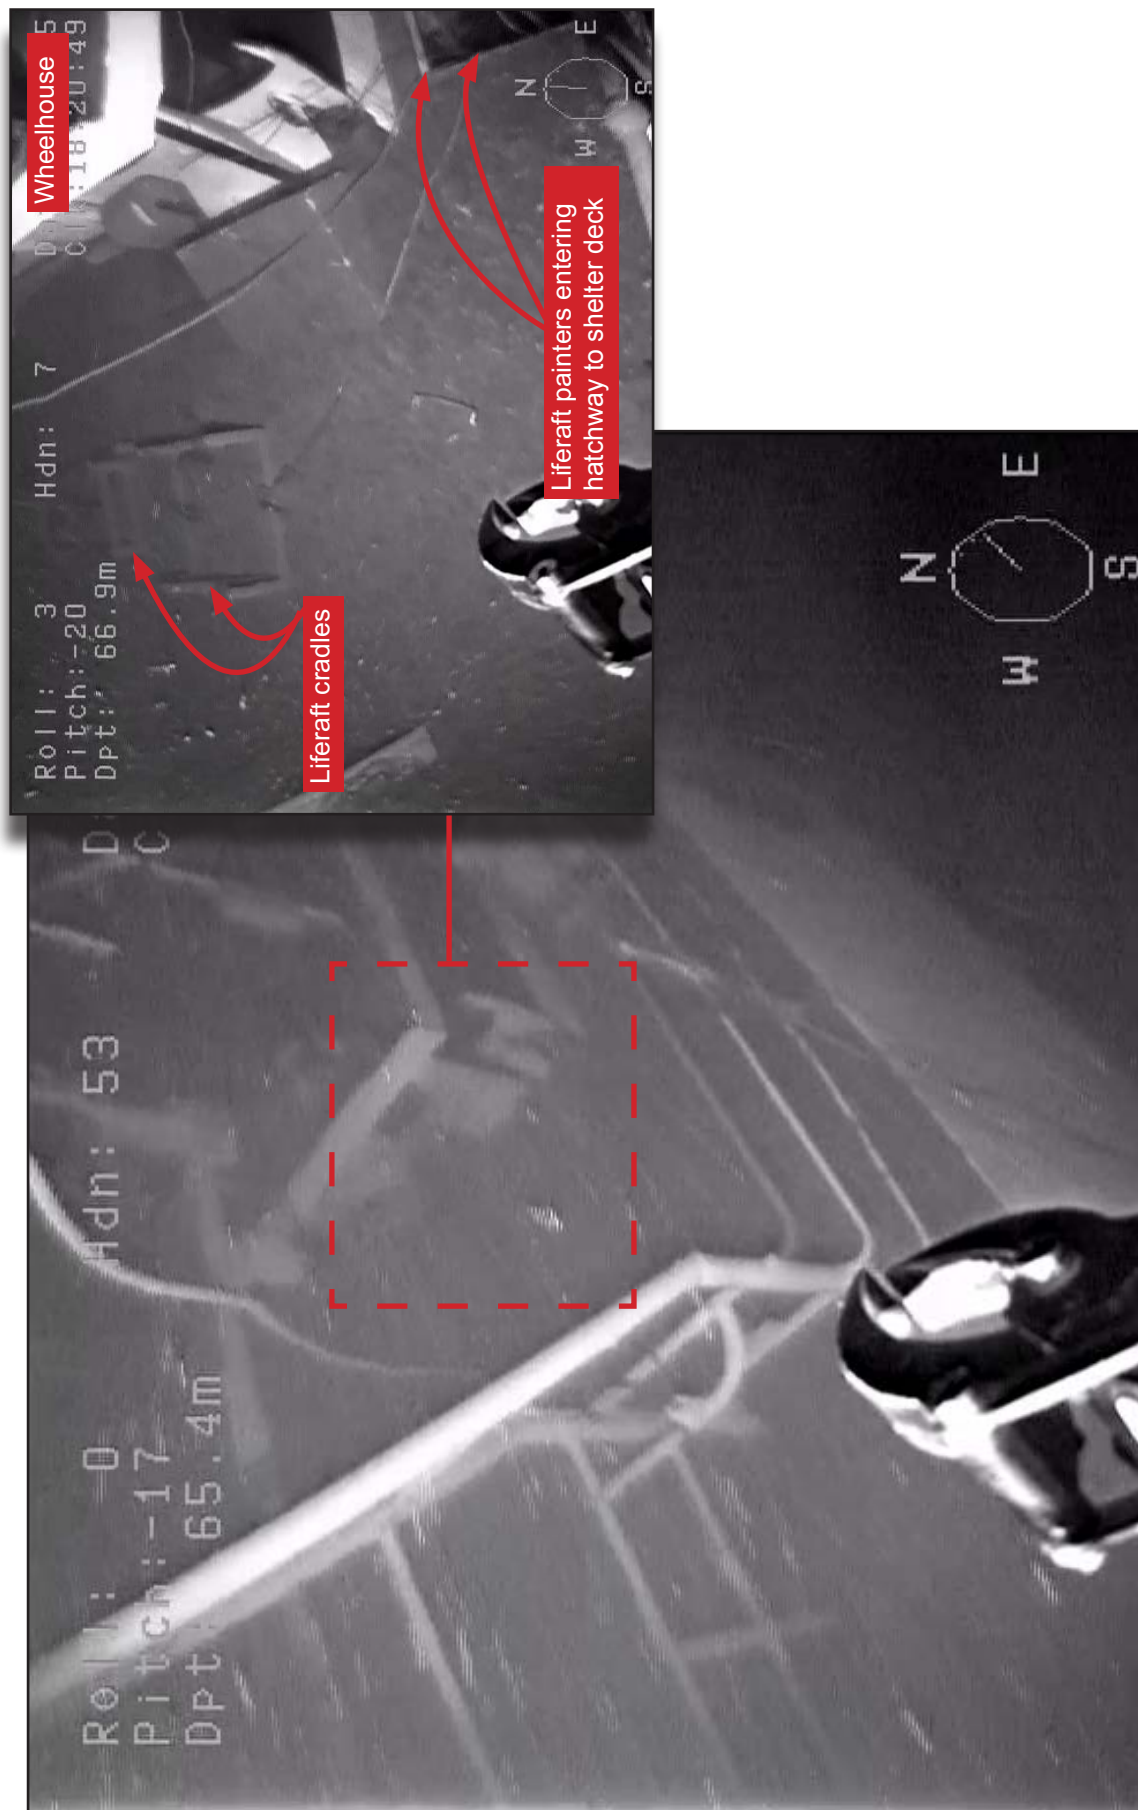
Figure 4 (and inset): ROV survey - showing the location of both liferaft painters

*Ocean Way* carried two liferafts, which had not floated to the surface after the accident. The hydrostatic releases attached to the cradles of both liferaft canisters were observed to have activated correctly. The liferaft painters were still attached to the cradles and both led across the top of the shelter and through the hatch that the survivors had opened when escaping from the main deck (**Figure 4**).

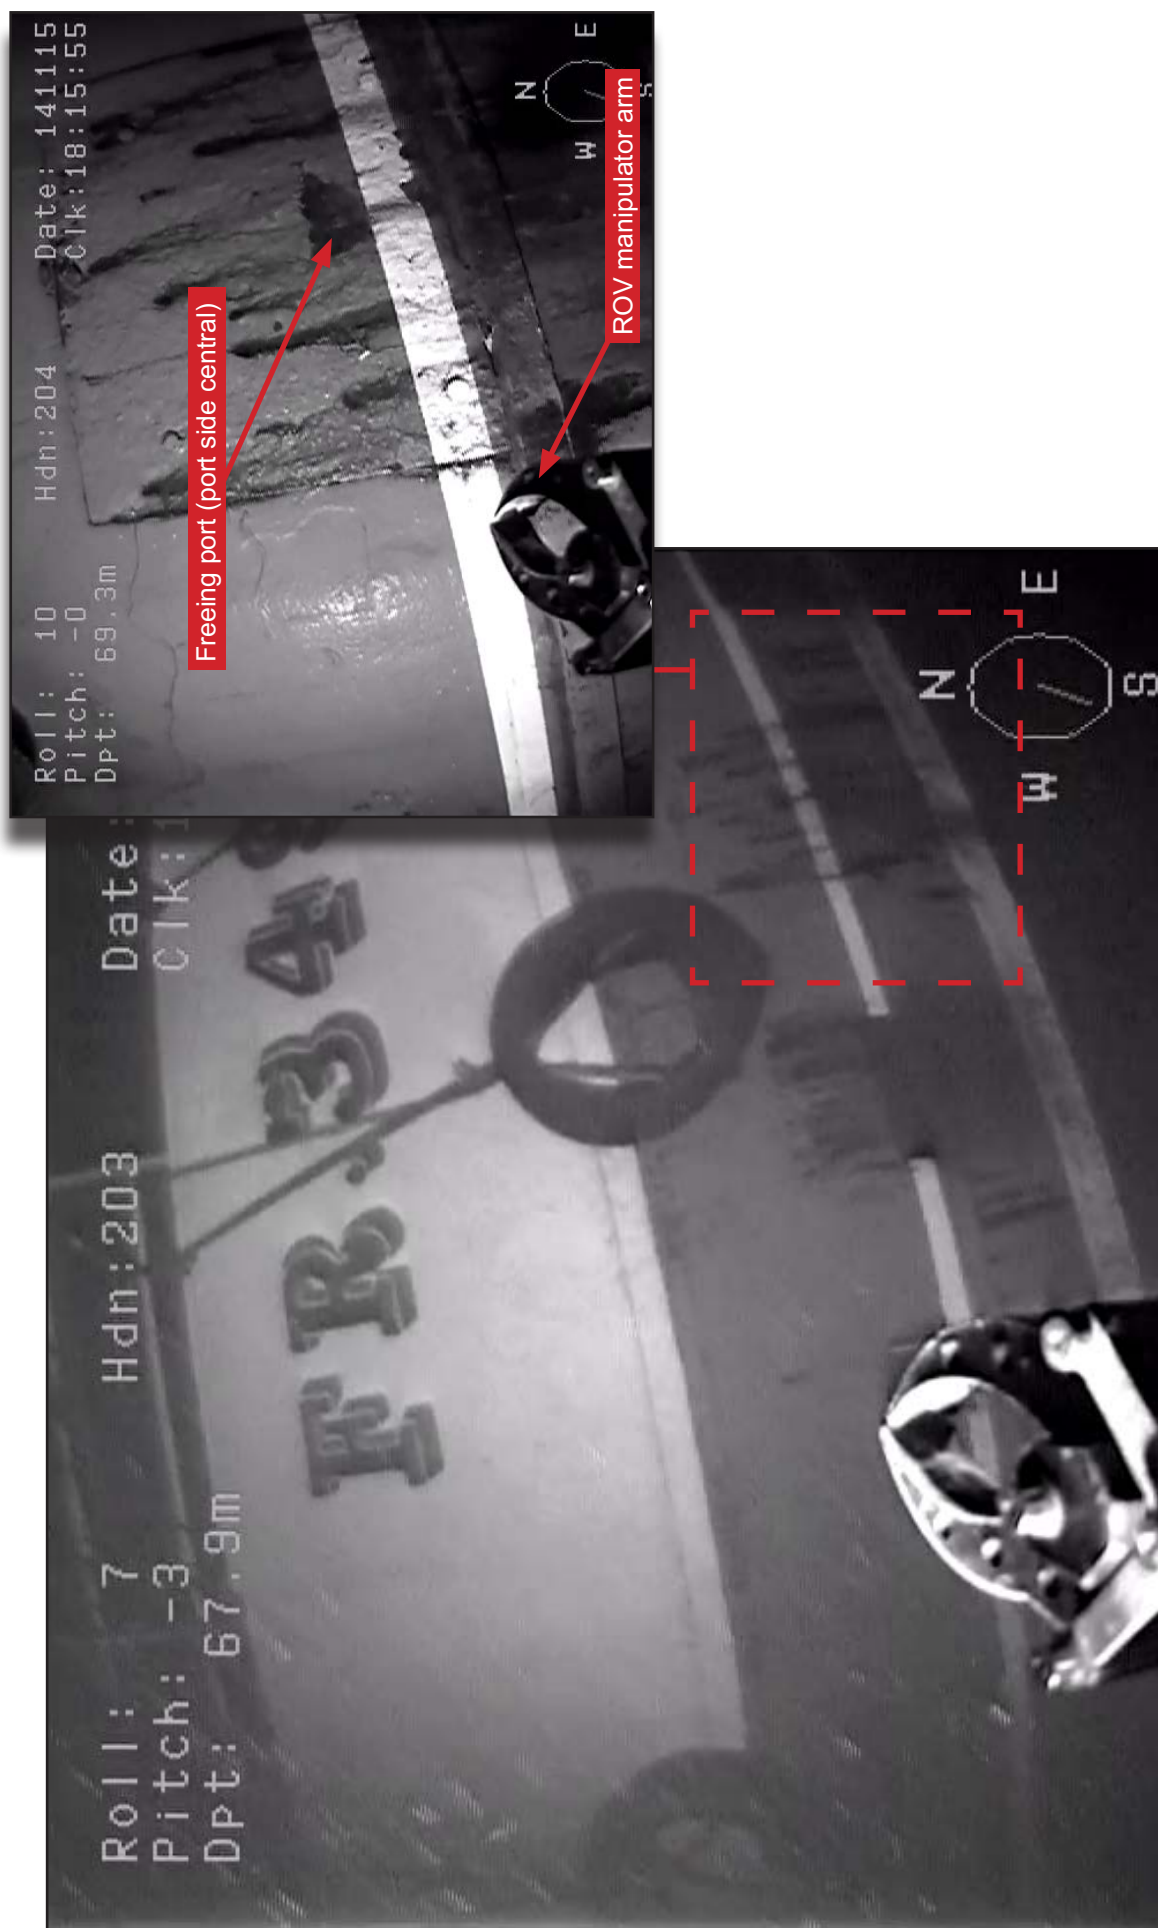
Figure 5 (and inset): ROV survey - showing checks made on freeing port operation

- Forward freeing port was a hinged plate that moved when pressed by the manipulator arm.
- Centre freeing port was observed to be partially open with strands of rope visible and was assumed to have been operational at the time of the accident.
- Aft freeing port appeared to have been welded shut with a slot cut into its lower section.

*Ocean Way's* freeing port capacity was found to be less than required by the 15-25m Code. It was calculated that with 0.29m of entrapped water on deck the vessel's stability and freeboard aft would have been significantly reduced.

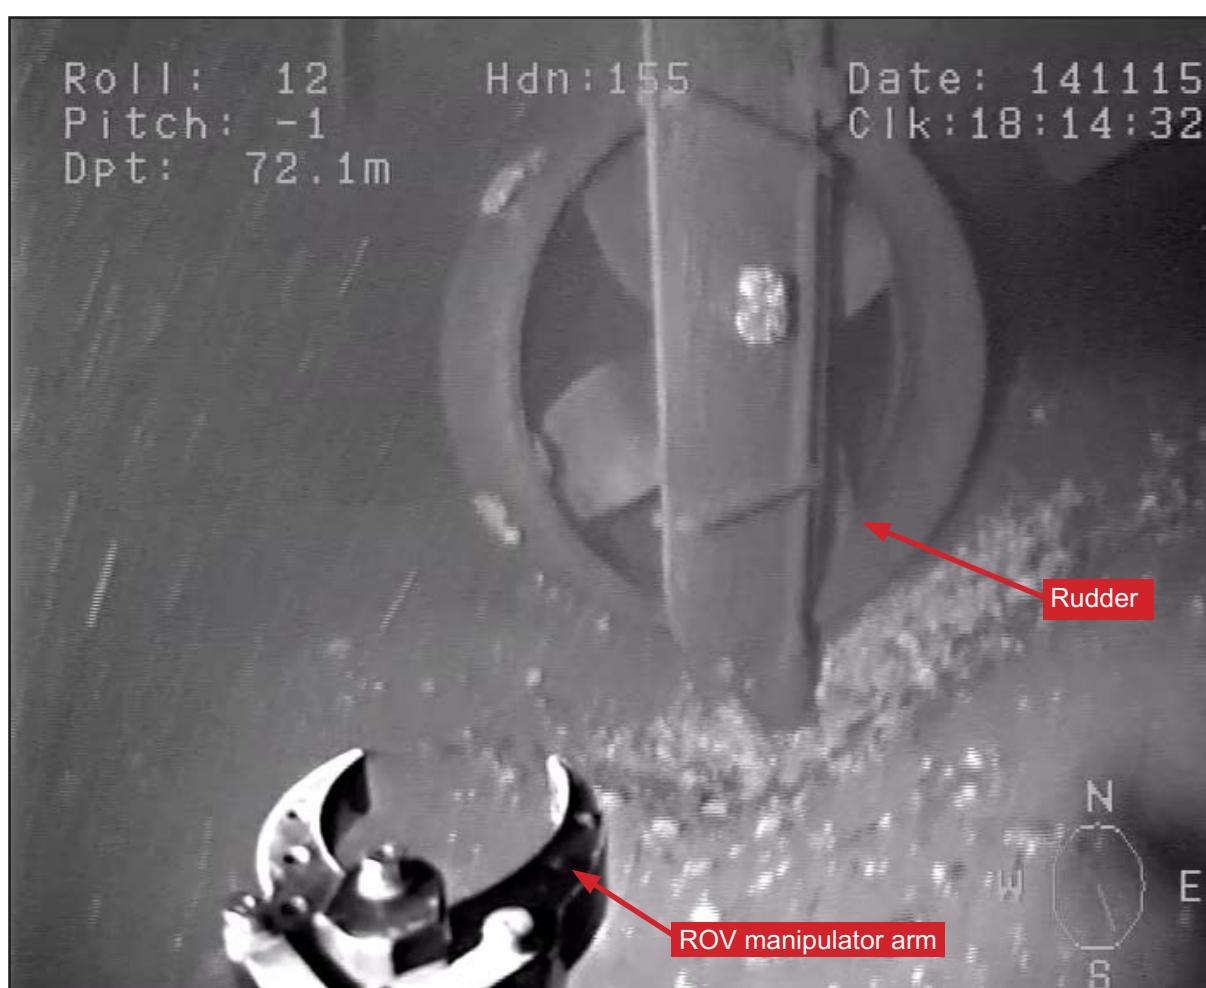
**Figure 6:** ROV survey - rudder found hard-a-port

The rudder position was observed to be hard a port (**Figure 6**).

The ROV survey of *Ocean Way* found the vessel upright on the seabed with its rudder hard to port. This suggests the autopilot had moved the helm to port to counter a significant change of heading to starboard, consistent with the vessel surf-riding and broaching to starboard immediately prior to its capsize.

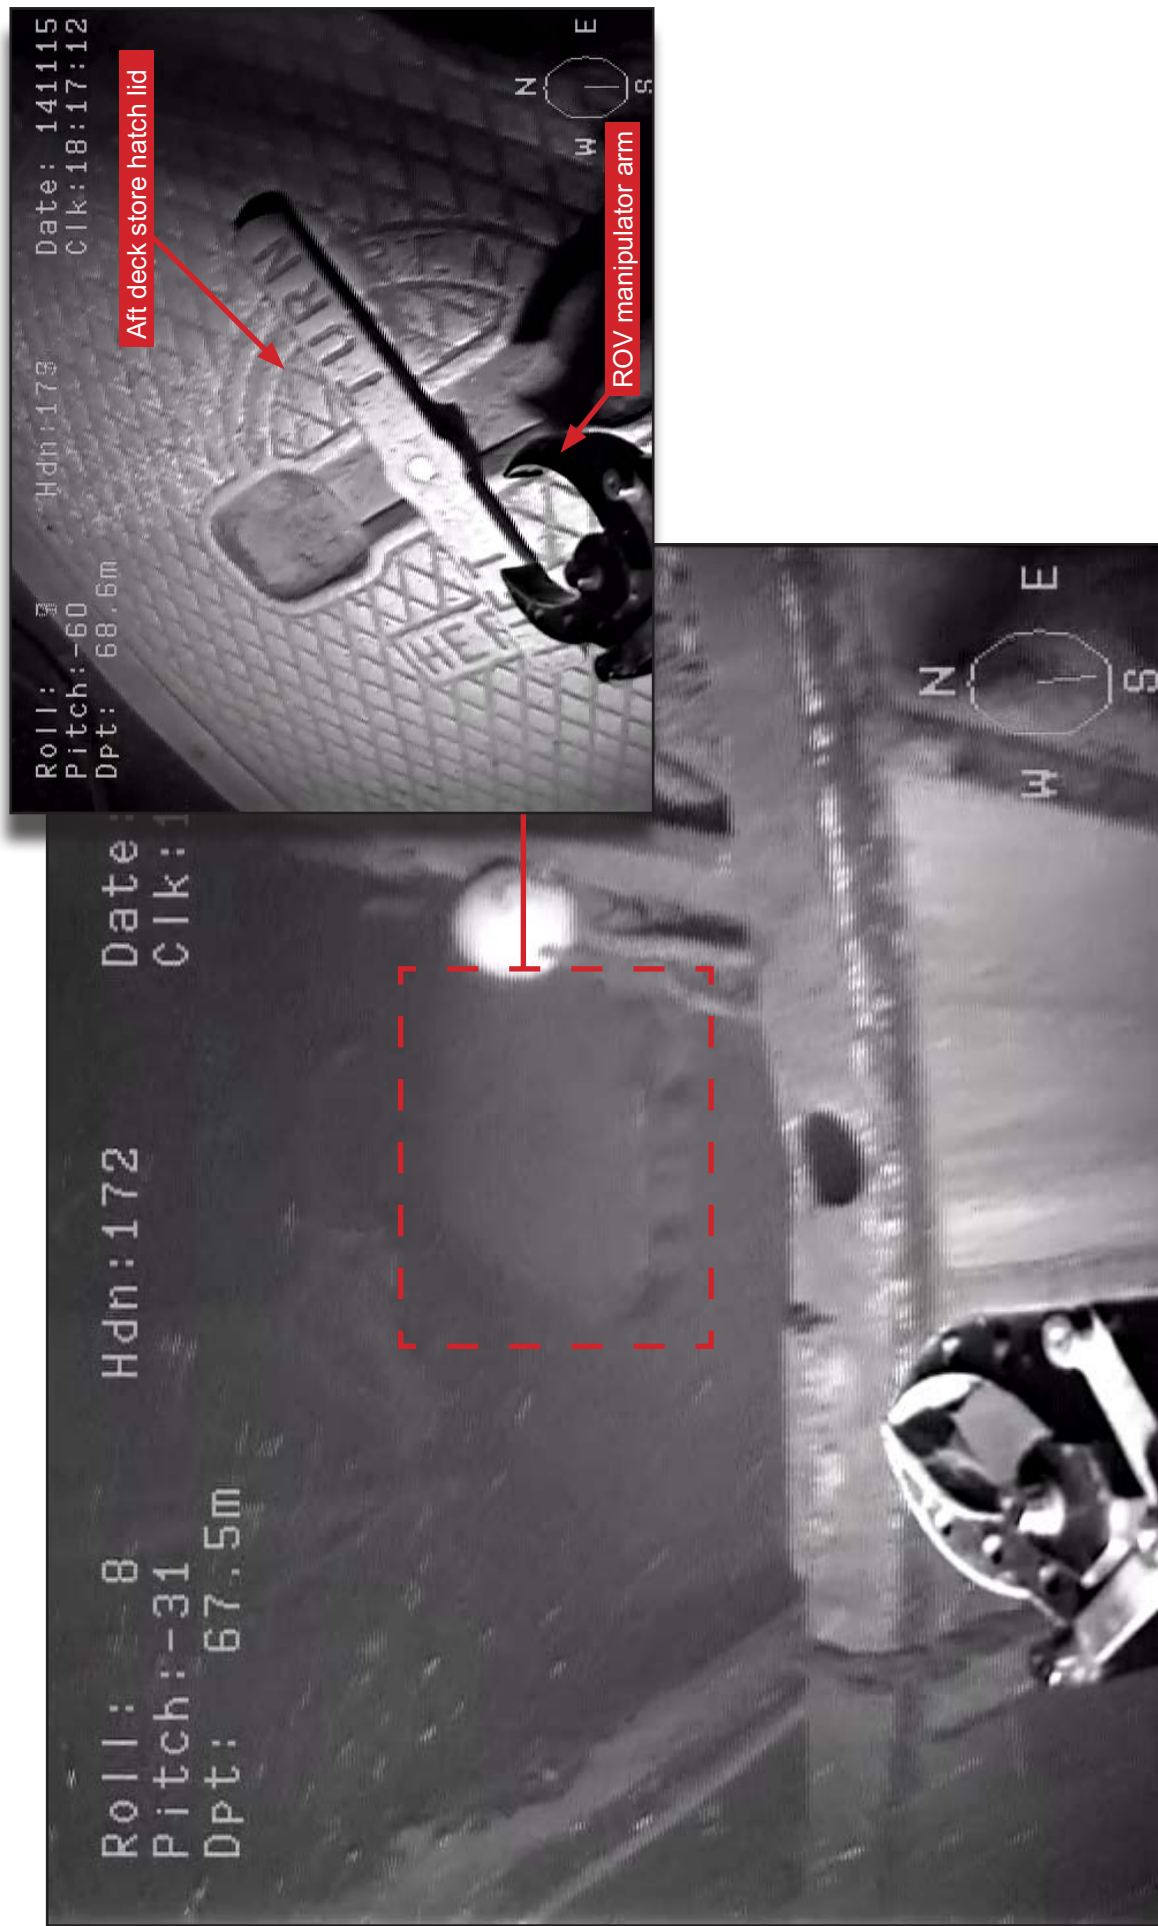
Figure 7 (and inset): ROV survey - aft deck Hercules hatch

The aft deck hatch, which provided access to the aft store, was found closed and secured by a *Hercules* watertight lid (**Figure 7**).

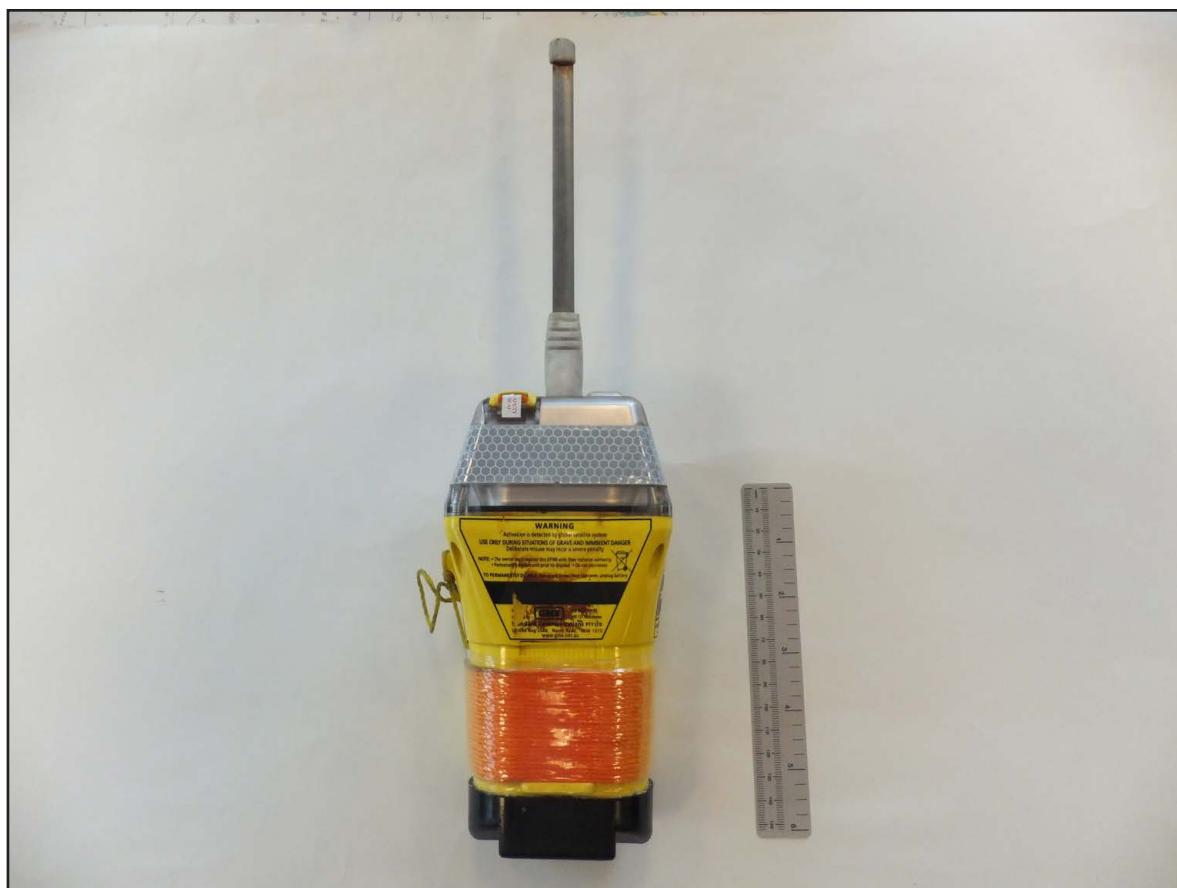
**Figure 10:** EPIRB fitted on *Ocean Way*

The EPIRB installed on *Ocean Way* was a Standard Communications GME, type MT403FF (**Figure 10**). This model was not fitted with an integral GNSS receiver.

The unit had been tested by an approved contractor in October 2014 when the operation of its hydrostatic release unit (HRU), expiry date July 2016, was also verified.

A recommendation has been made to the MCA designed to ensure that EPIRBs carried on UK registered fishing vessels are equipped with an integral Global Navigation Satellite System (GNSS) receiver to improve the time taken to identify the position of a vessel in distress.
