Dover Seaways' contact with the South Breakwater,

Dover

9 November 2014

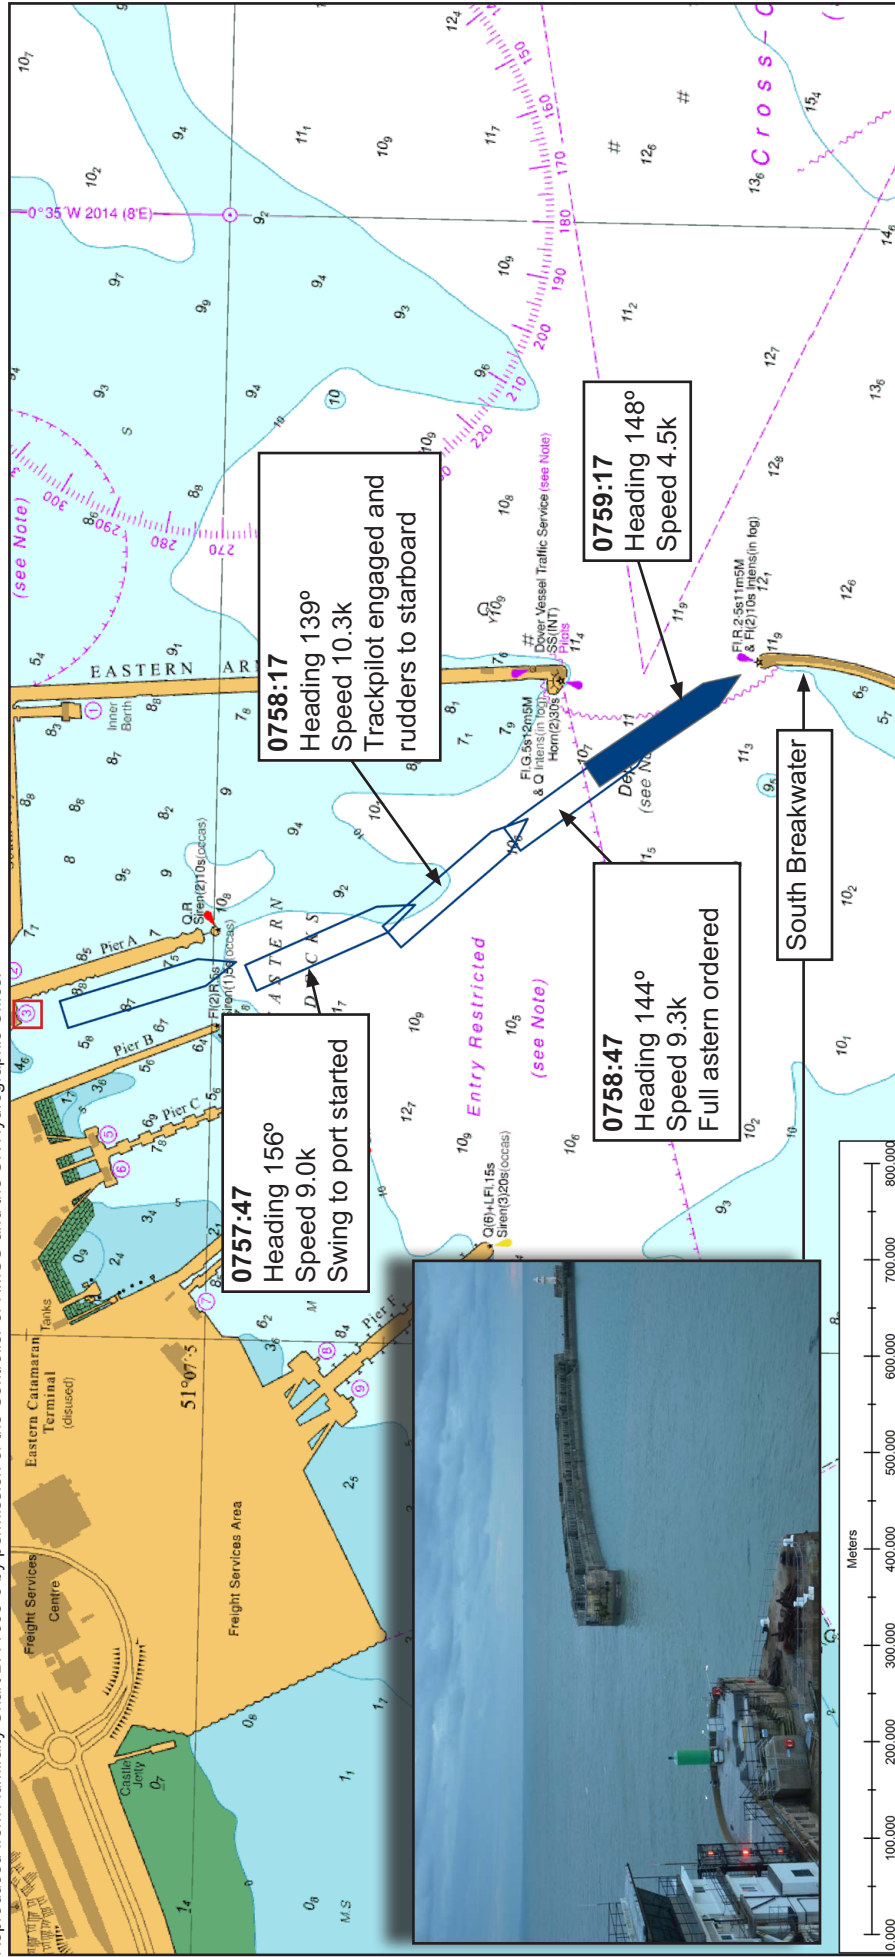
Figure 1: AIS plots of Dover Seaways with inset of Eastern Entrance. (Times taken from alarm logs, AIS data and CCTV)

Dover Seaways' speed reduced as it continued towards the end of the South Breakwater. At 0759:19, the ferry hit the end of the breakwater (**Figure 1**) at a speed of about 3.5kts. The passengers and crew were not warned of the impact and many fell to the deck or were thrown from their seats; three passengers and ten crew sustained minor injuries. Several vehicles were also damaged.

No tracks had been input to the trackpilots from the ECDIS. Therefore, the trackpilot in control of the steering would have applied the helm required to steer the gyro heading at the time control was transferred. As the ferry was turning to port, the trackpilot would have applied up to 30° (the rudder limit set) of starboard rudder in order to stop the swing and return the vessel to the initial heading (approximately 139°) (**Figure 1**).

Dover Seaways was less than 400 metres from the port of Dover's eastern entrance when steering control transferred to the trackpilot at 0758:14 (**Figure 1**). At a speed of approximately 10kts, it was imperative that the bridge team acted quickly. However, although steering control was established at the 'main wheel', the main engines set to 'full astern' and the starboard anchor let go, these actions were taken too late to be effective. Furthermore, the use of the bow thrusters would have been ineffective at speeds above 5kts.

Directional control was lost for 28 seconds. During this period, *Dover Seaways* closed to within 250 metres from the end of the South Breakwater. The master appreciated that there was insufficient time and sea room to resume the turn to port to pass through the eastern entrance. However, by then there was also insufficient sea room ahead for the ferry to stop. Had the vessel's engines been set to 'full astern' in accordance with the onboard checklist for 'steering failure' (**Figure 8**) as soon as the loss of steering control was identified, contact with the breakwater could have been avoided.

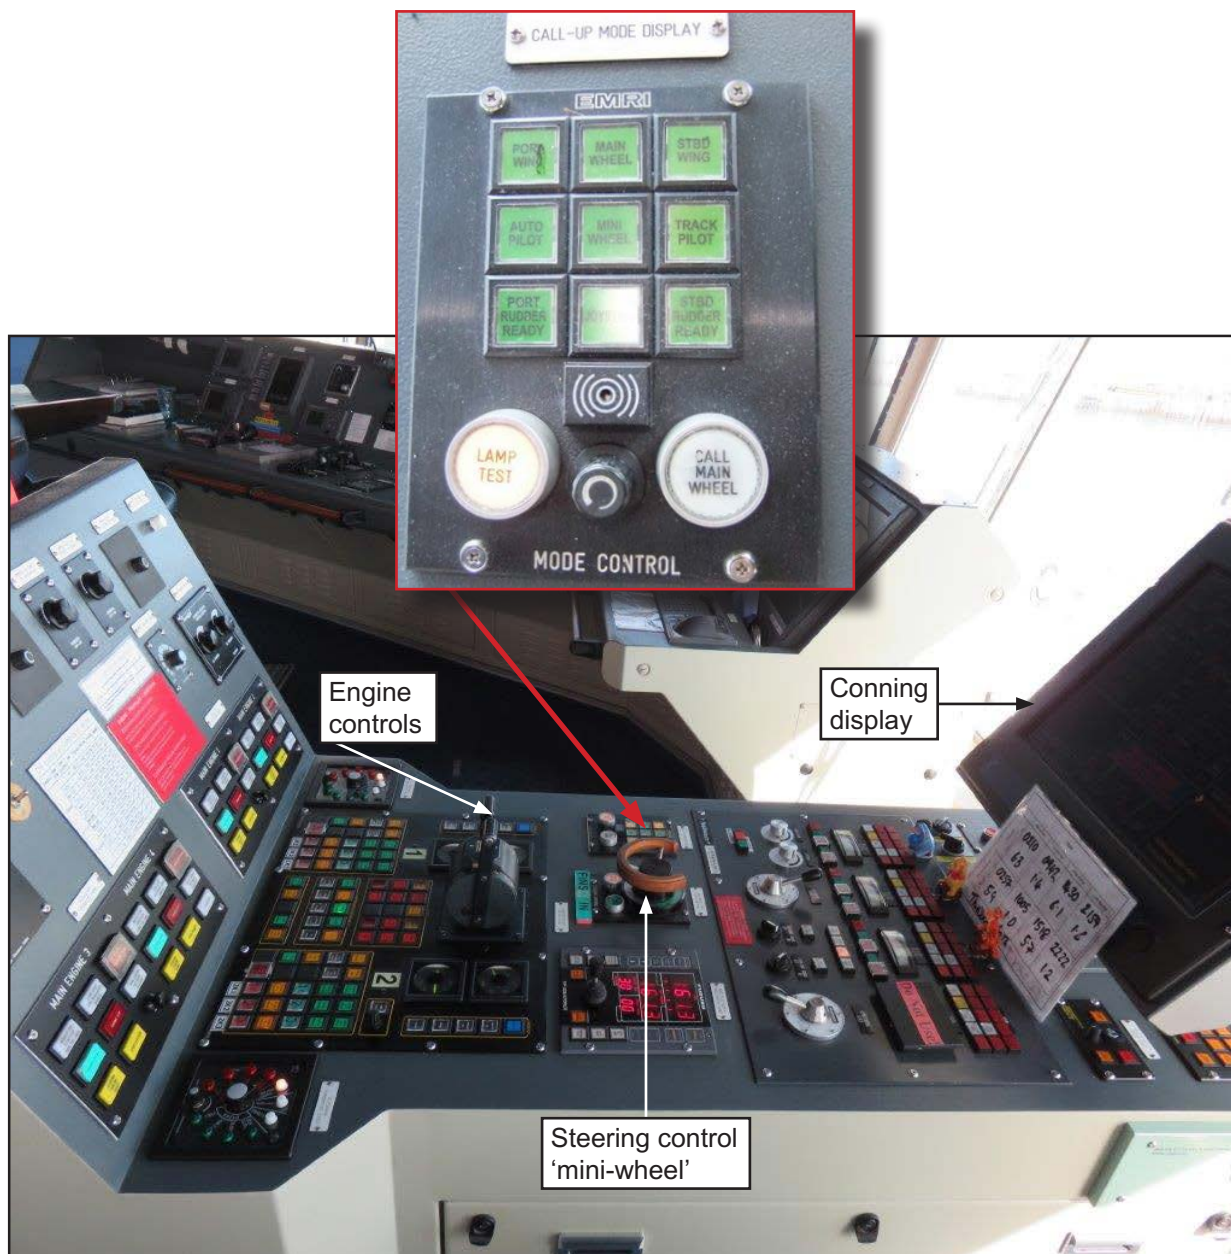
Figure 4: Centre console

- The 'call-up' indicator panel (**Figure 4**) was not checked when the audible indication of the change in steering mode was first heard. This would immediately have shown that the steering control had transferred to one of the trackpilots.
- The bridge team were not aware that in 'call-up' mode the control of the steering could be transferred to the trackpilots.
- The rudder angle indicators on the conning displays or overhead repeaters were not monitored. Otherwise, the movement of the rudders from port to starboard when control was transferred to the trackpilot would have been appreciated sooner.

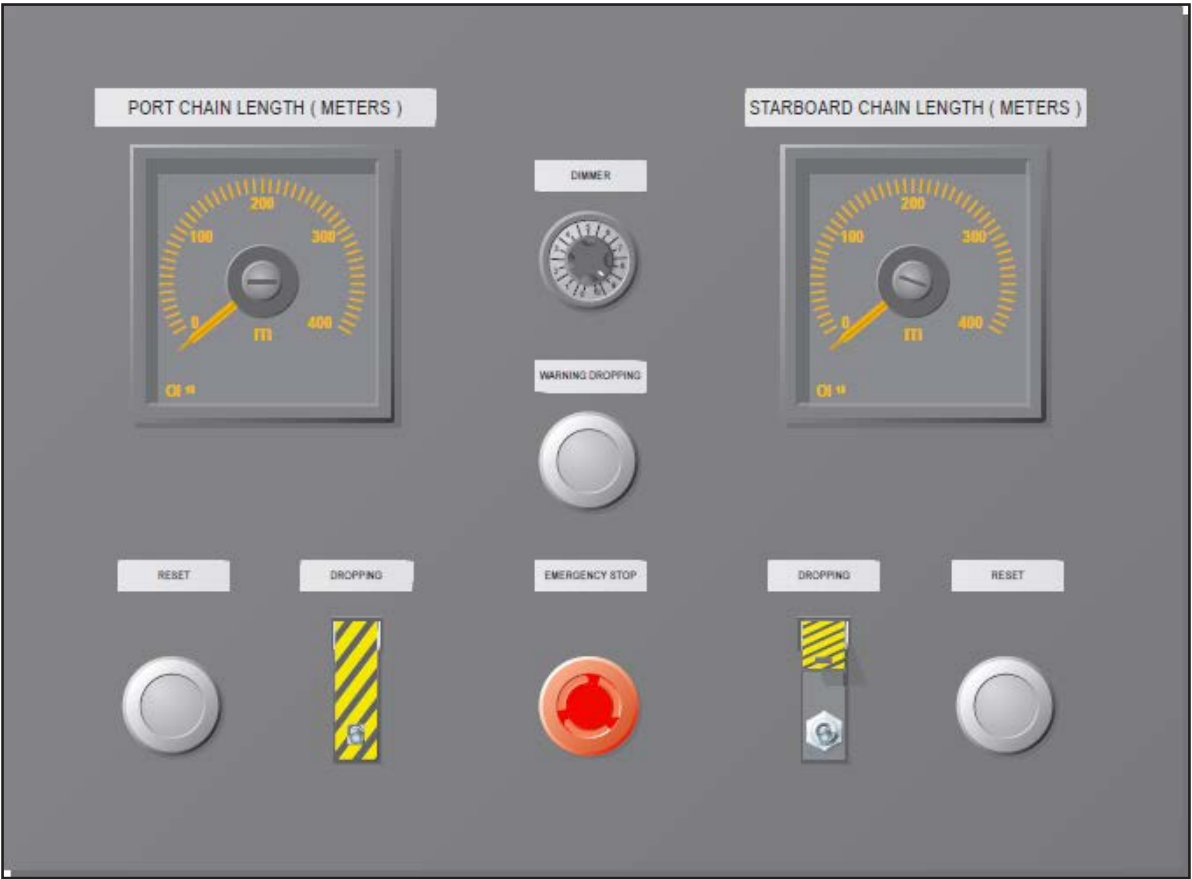
Figure 5: Bridge remote anchor release controls

Although the starboard anchor was let go, it did not reach the seabed. Therefore, the anchor did not act as a brake as intended. As the anchor release system functioned correctly following the accident, the late release of the starboard anchor and the non-release of the port anchor were probably due to the need to clear the forecastle, the inherent system delay and the interruption to the release sequence following the master's change of order (see footnote 4).

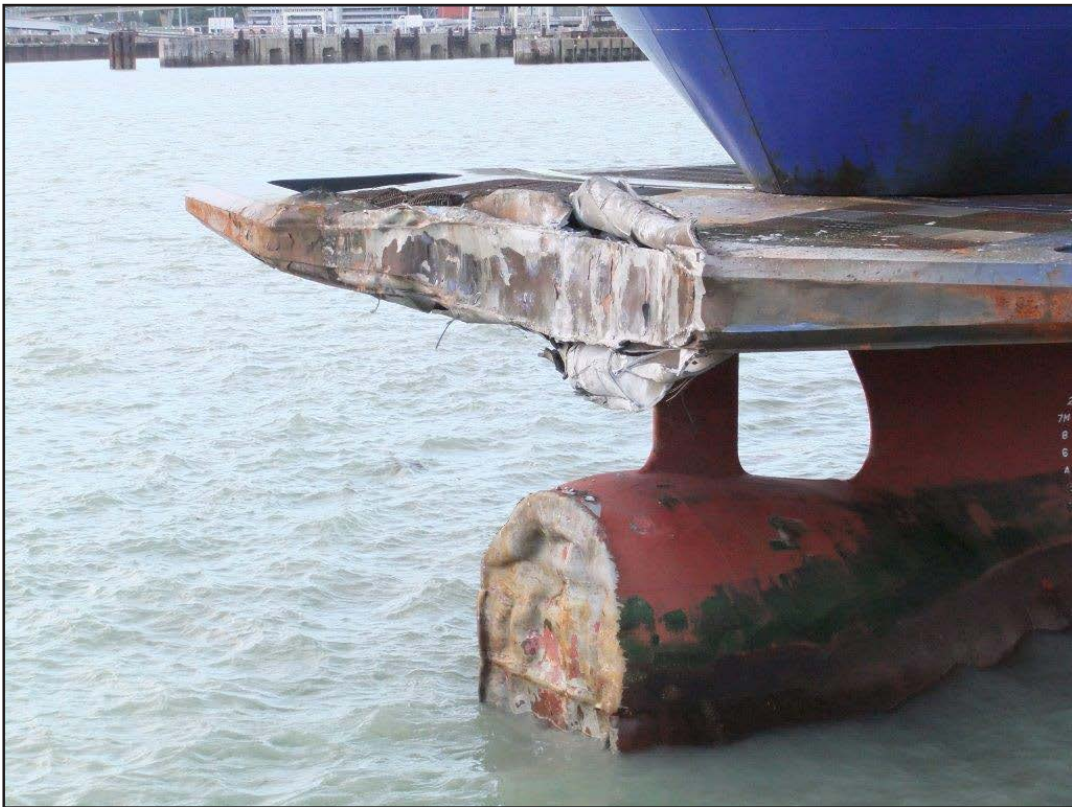
Figure 6: Damage to bulbous bow and “cow-catcher”

Dover Seaways' bulbous bow and 'cow-catcher'⁵ were damaged (**Figure 6**), which required the ferry to be dry docked in Rotterdam, The Netherlands for repair. There was no pollution, and *Dover Seaways* returned to service on 21 November 2014.

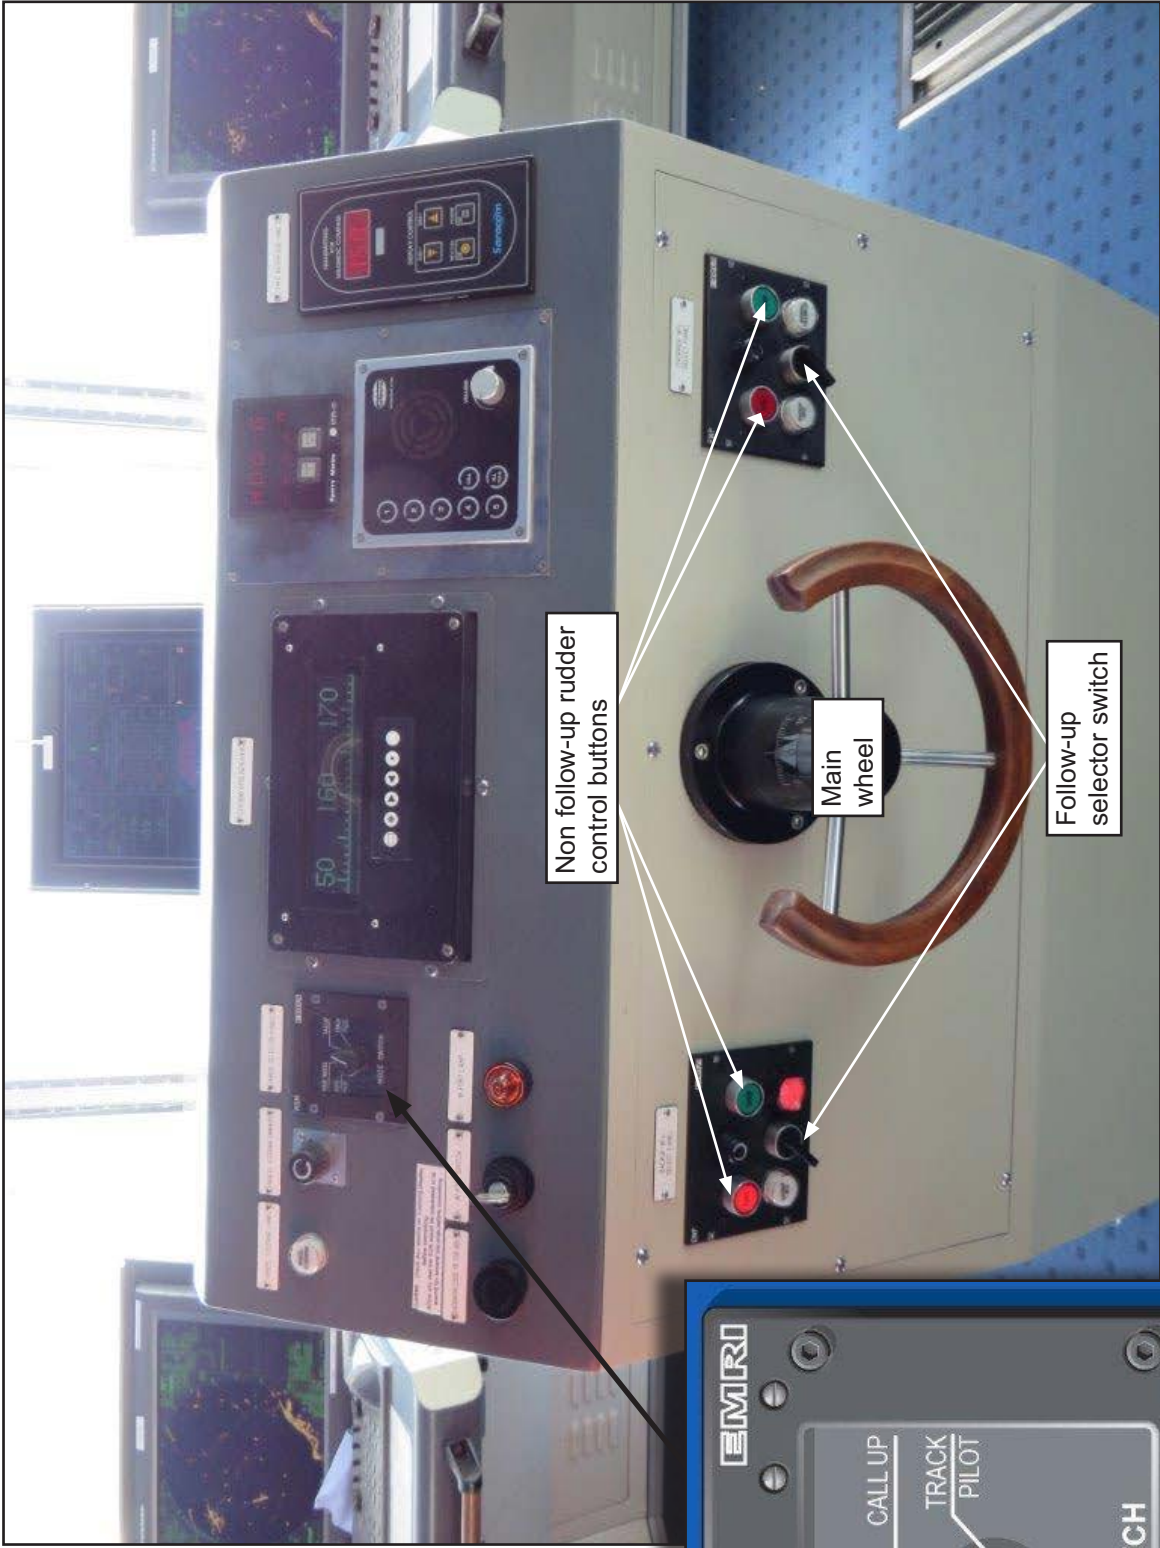
Figure 7: Main steering stand with mode control switch

The defect to the mode selector switch had been recorded in the defect log 5 days before the accident but it had not been reported to the company's technical managers. The mode selector switch was removed for examination. The switch shaft retaining nut on the underside of the casing was found to be loose; no other defects were found.
