Report on the investigation of
a person overboard from the
fishing vessel

Beryl (BF 440)

with the loss of one life
west of the Shetlands Islands

10 February 2015

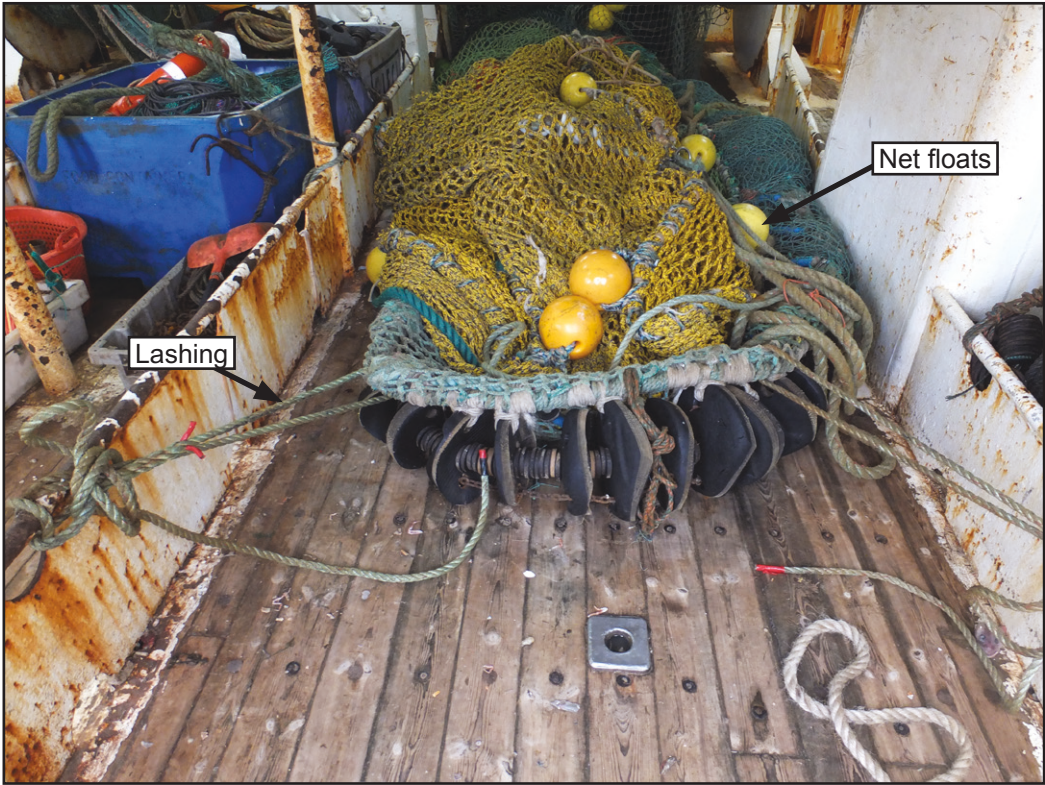
Figure 2: Starboard trawl ground gear lashed into the track

At 0900 on 10 February, *Beryl*'s crew were preparing to shoot the trawl nets on the main deck. The nets had not been used for several weeks and were lashed in tracks¹ (**Figure 2**). Approximately half of the lashings were removed in readiness for shooting. The leading deckhand, Joshua Aryeetey, intended that the remaining lashings would be removed after the cod end and the 'bag' (**Figure 3**) had been deployed through the 'shooting doors' at the stern (**Figure 4**).

The arrangement of the tracks on *Beryl's* main deck provided a physical barrier between the trawl nets and the deckhands (**Figures 2 and 5**). As a result, the risk of the deckhands being inadvertently entangled in the gear as it was shot away was reduced significantly. A risk of entanglement existed if the crew had to free jammed or snagged equipment. However, this hazard had been addressed during the assessment of the vessel's operations undertaken in July 2014, when the crew agreed that they should stand back and await instructions from the skipper.

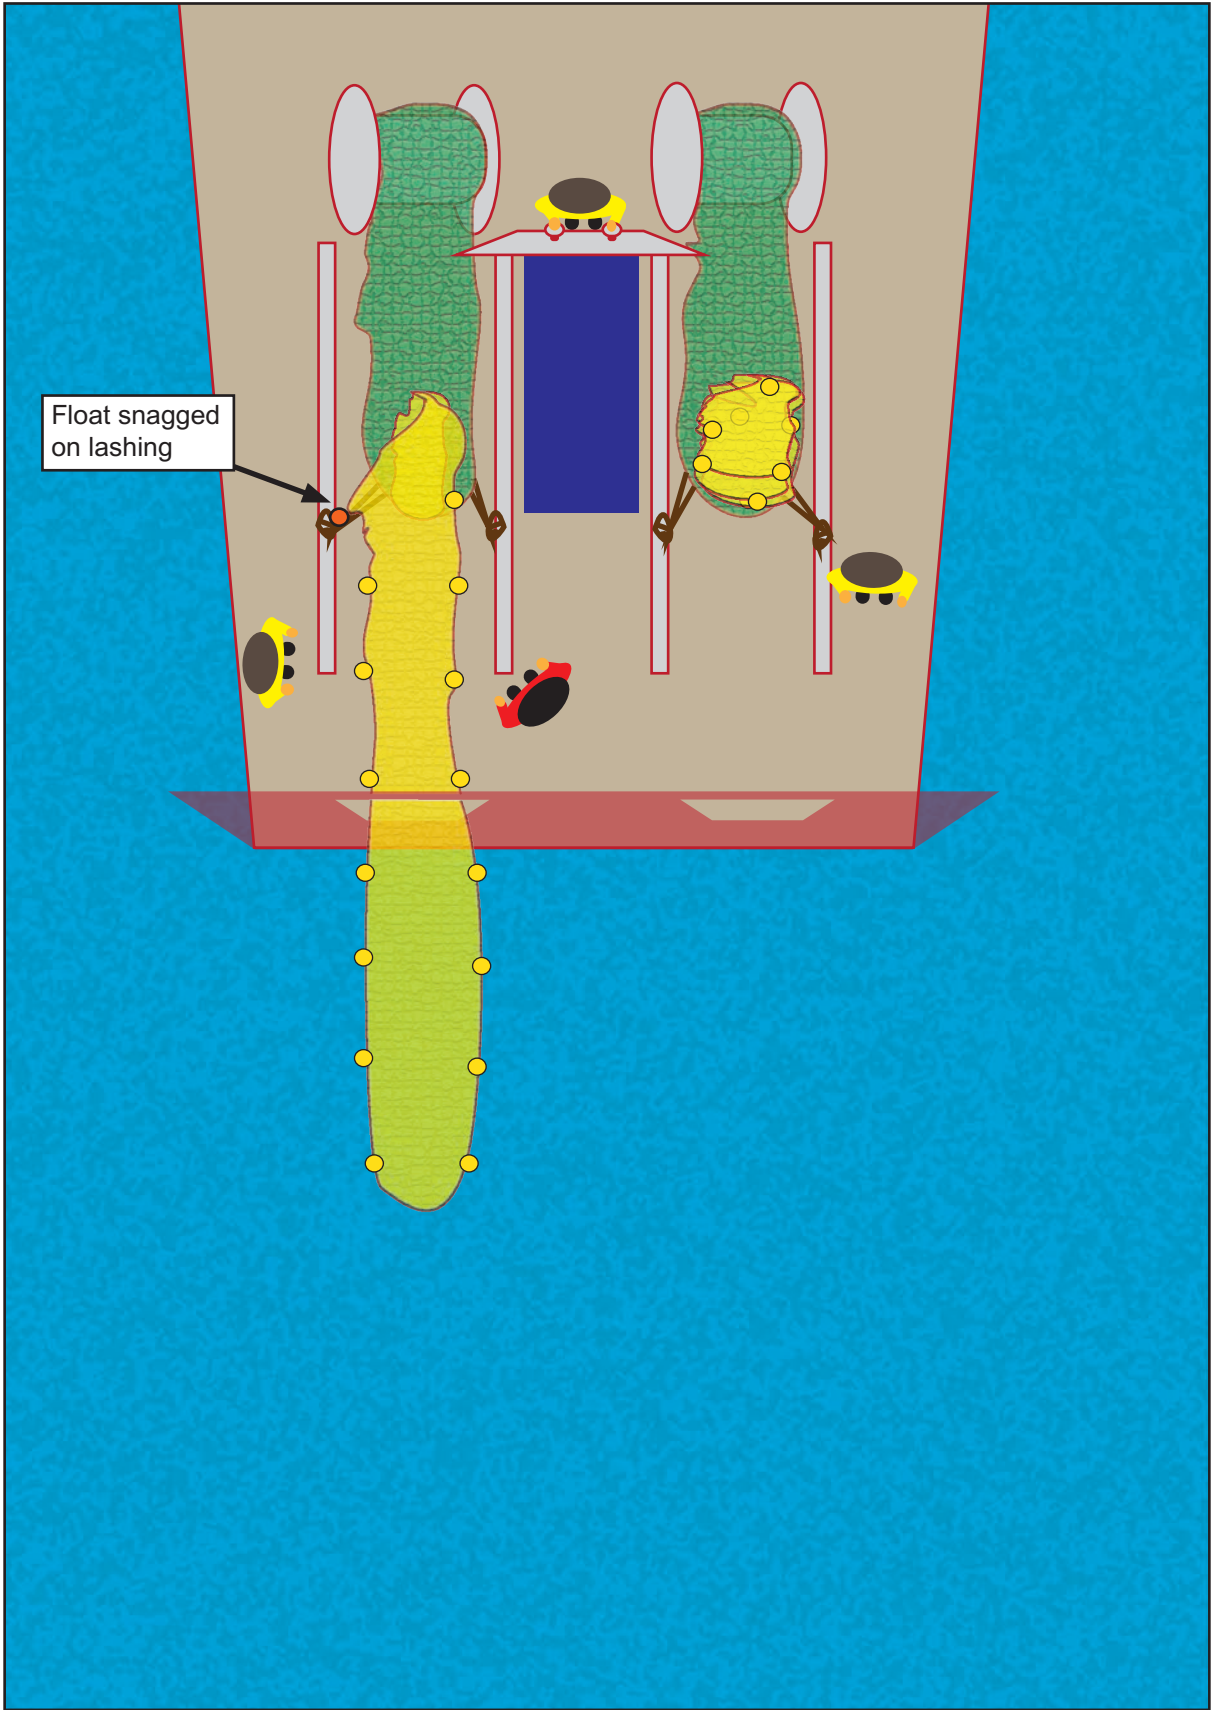
Figure 6: Illustration of the net float snagged on the lashing

To start shooting the nets, the power block pulled the port trawl net's cod end through the port shooting door. As soon as the cod end entered the water and streamed astern, the net remaining in the track started to run out. Shortly afterwards, a float attached to the net snagged on one of the lashings used to secure the nets inside the track (**Figures 2 and 6**). The net stopped running out and the crewman at the net drum controls shouted to the leading deckhand to cut the lashing.

It is not known why the leading deckhand removed only half the lashings before shooting the port trawl net or why he attempted to free the snagged float from inside the track. The lashings were an identifiable snagging hazard and standing on the net was a dangerous short-cut. If the leading deckhand had properly assessed the risks of shooting the nets secured on the main deck or informed the skipper when the net float snagged, in accordance with the vessel's risk assessment, the accident could have been avoided.

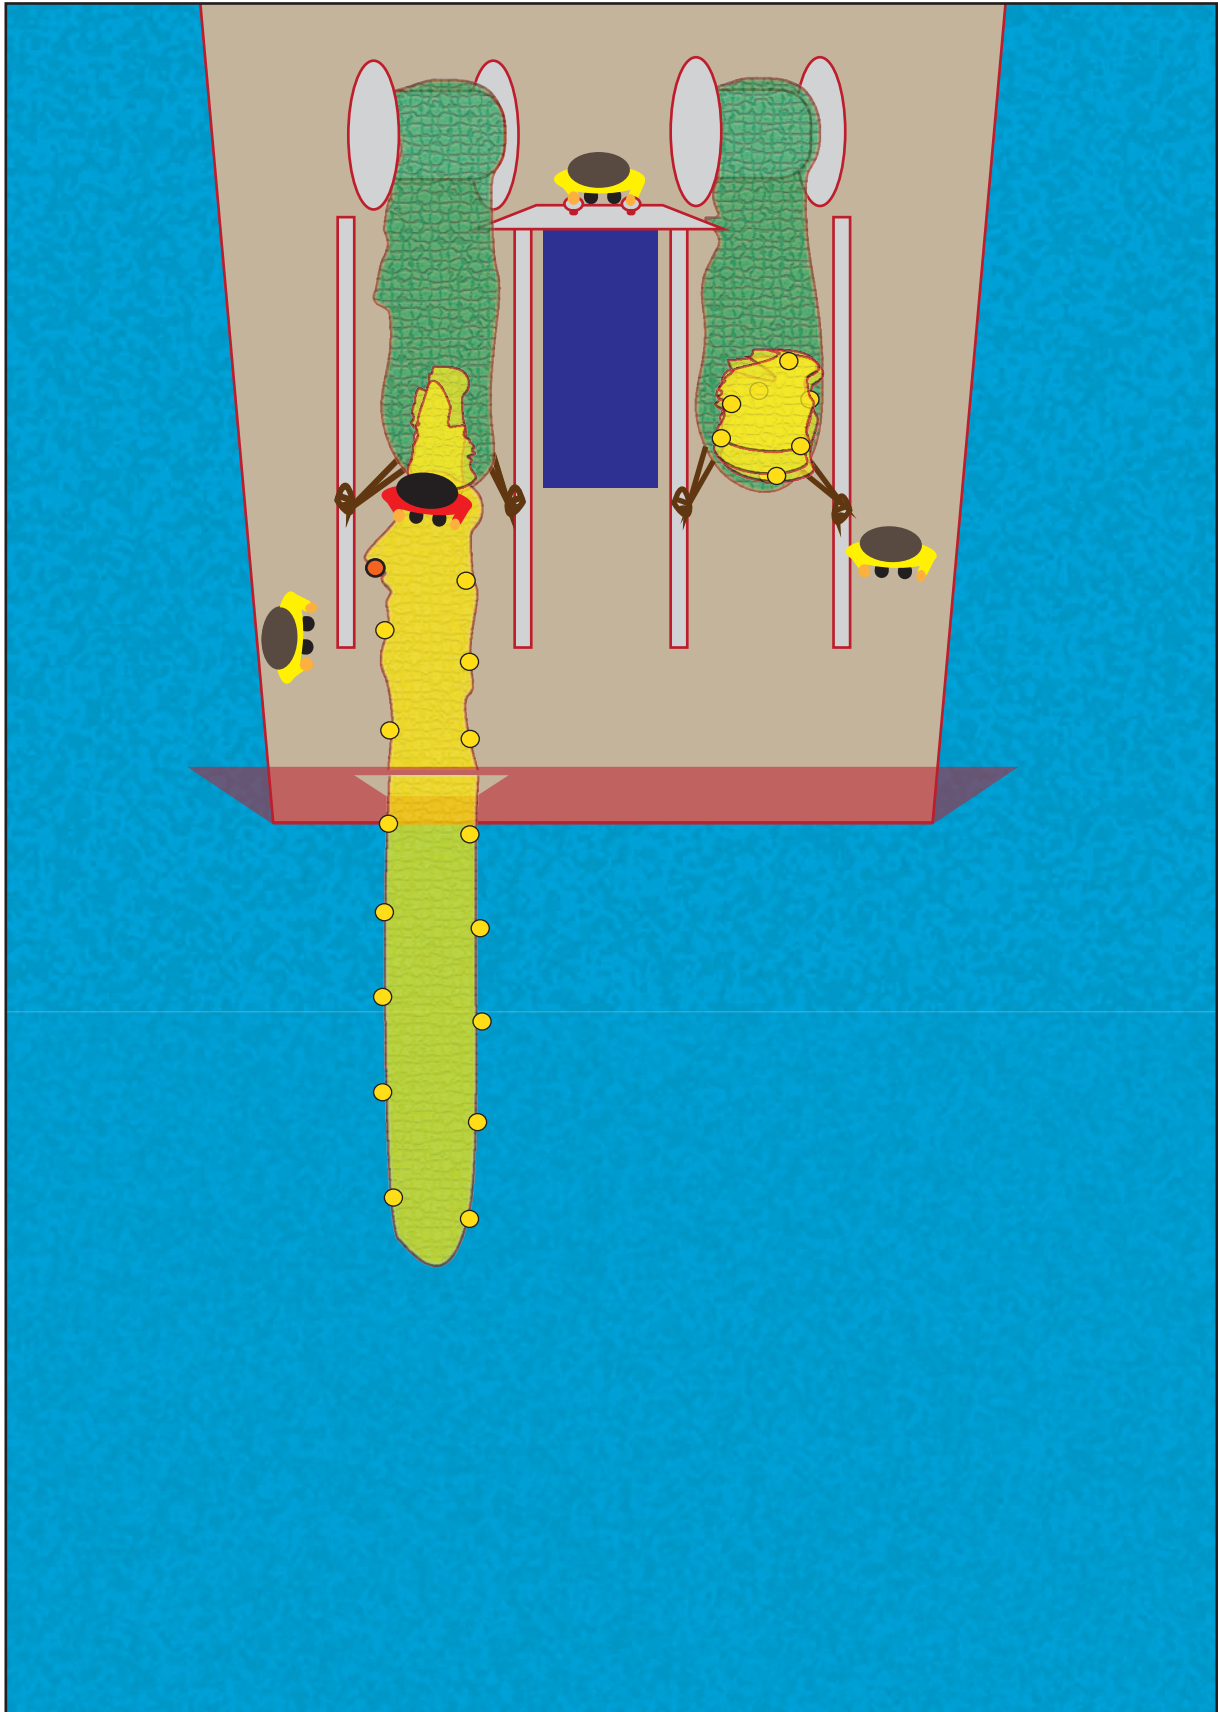
Figure 7: Illustration of the leading deckhand standing on the net

At about 0910, the leading deckhand stepped into the port track to release the snagged float. As he stood on the net facing aft (**Figure 7**), the float suddenly released and the net again ran out astern. The leading deckhand was carried by the net through the port trawl door and into the rough seas astern.

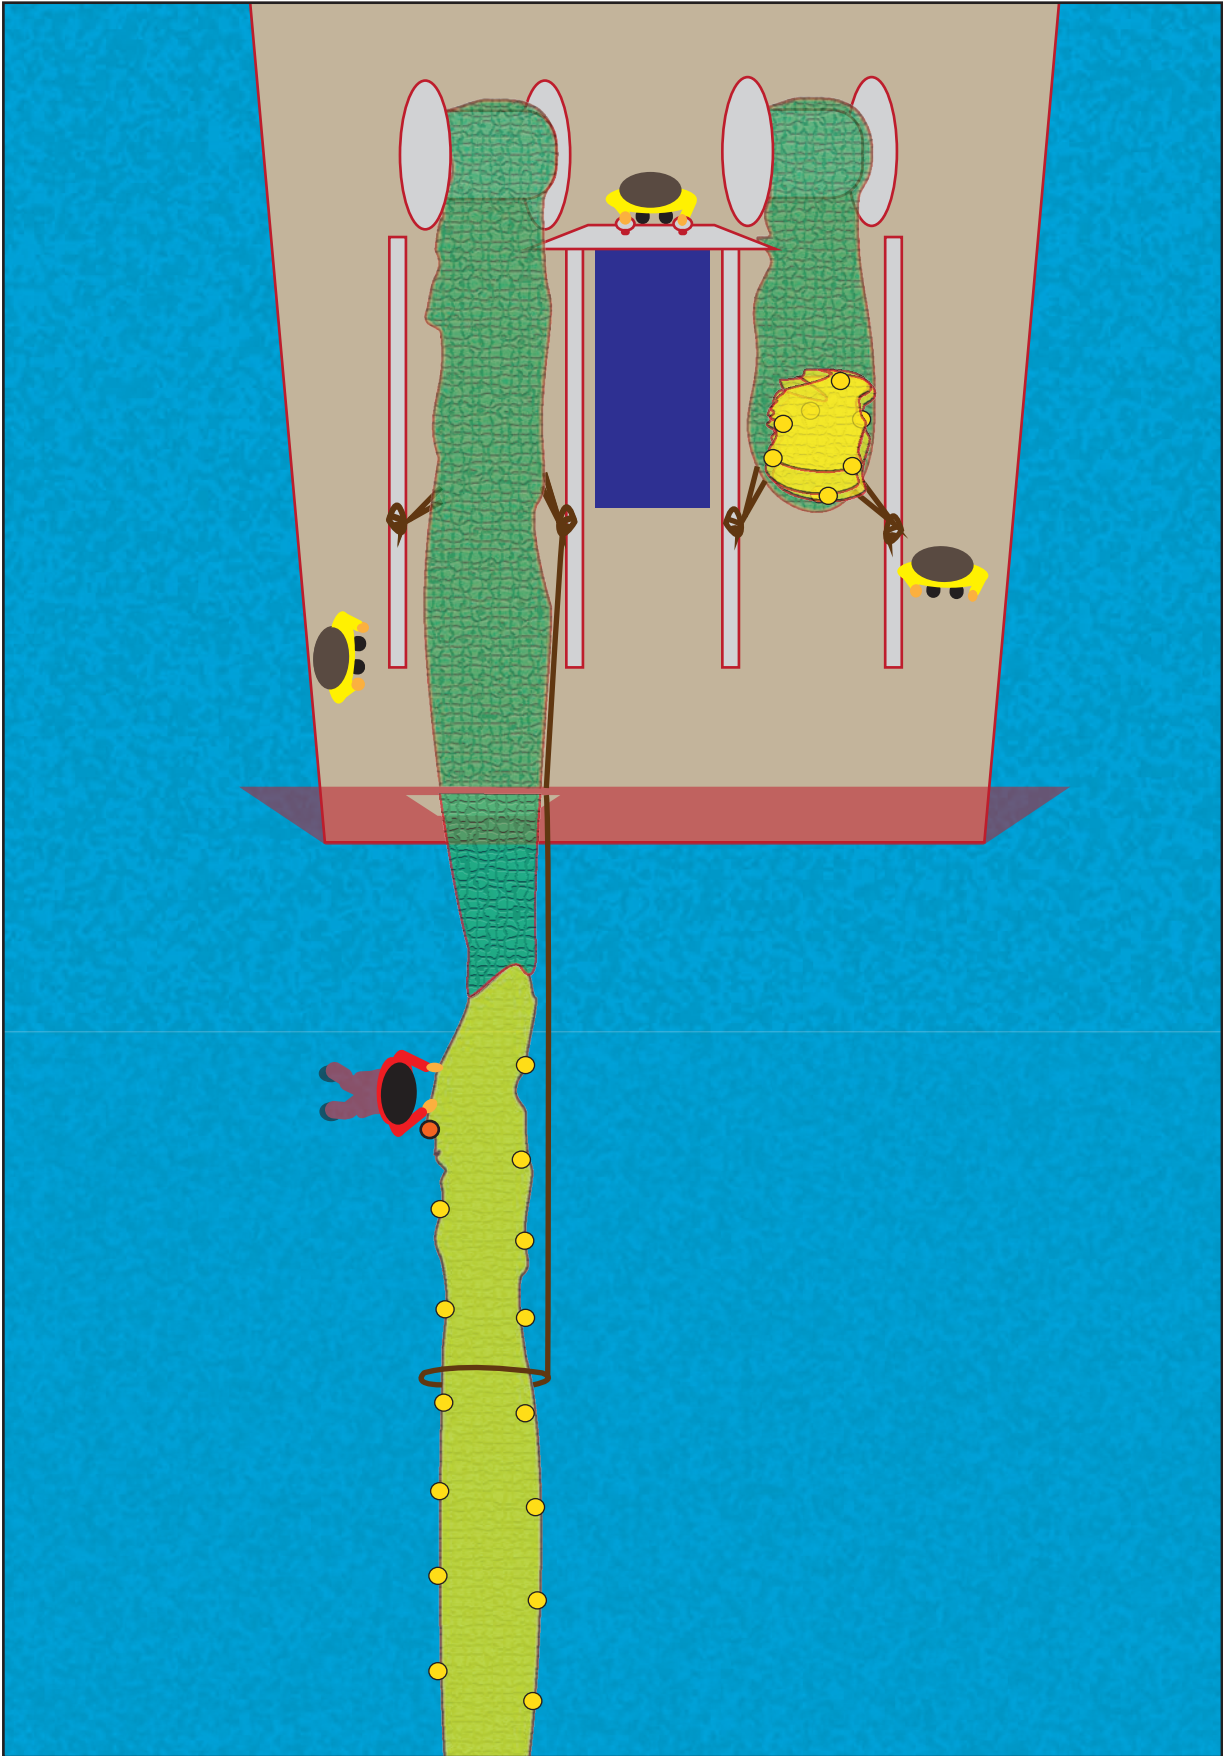
Figure 8: Illustration of the leading deckhand's position after entering the water

The leading deckhand's lifejacket automatically inflated. He was conscious and holding onto the cod end (**Figure 8**). The engineer on the top deck immediately alerted the skipper, who reduced *Beryl*'s speed. At 0916 the skipper also pressed the 'event mark' on the electronic chart plotter to record the vessel's position.

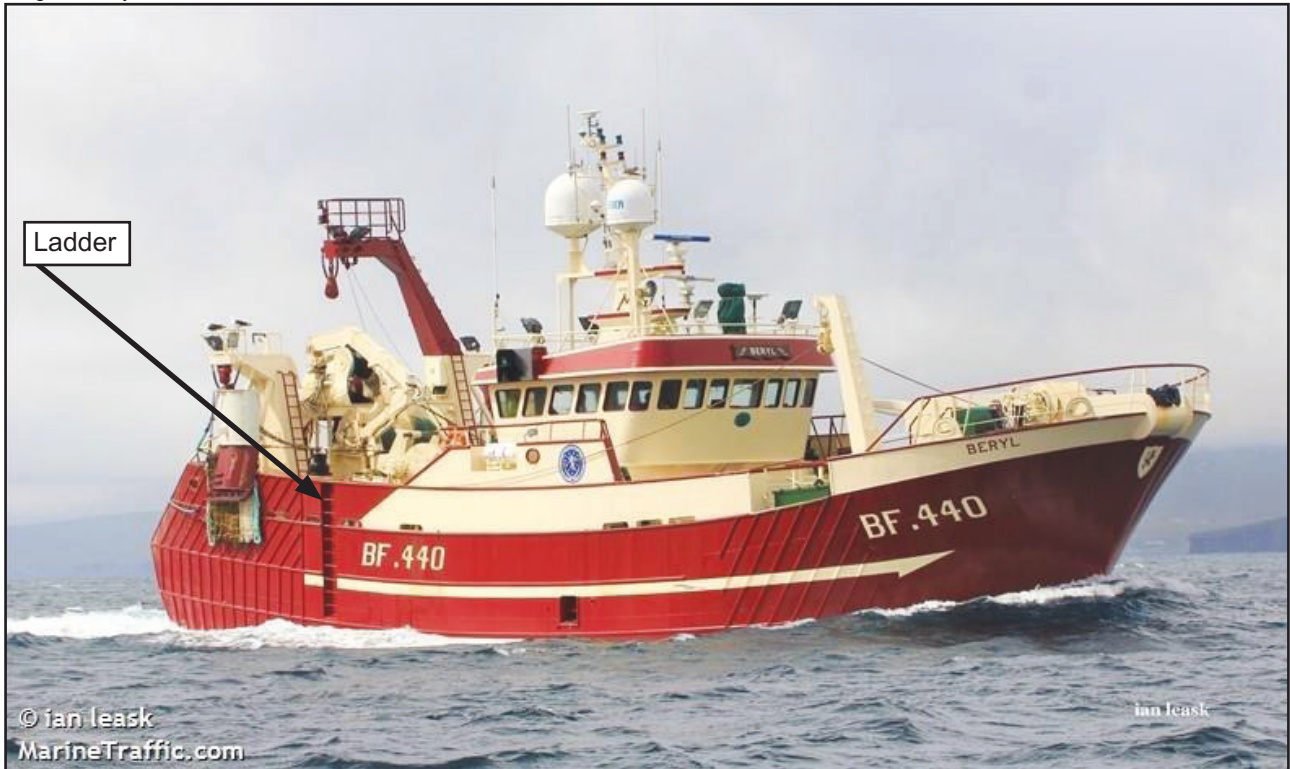
Figure 10: Vertical ladder built into *Beryl's* side plating (note - an identical ladder was sited on the vessel's port side)

Meanwhile, *Beryl* had stopped with its port beam to the sea and wind. The leading deckhand was by now floating close to the bottom of the vertical ladder on the trawler's port side (**Figure 10**). He managed to grab the ladder but was unable to hold on due to the vessel's violent rolling motion. Waves were washing over the leading deckhand's head and he started to vomit. The leading deckhand was becoming unresponsive.

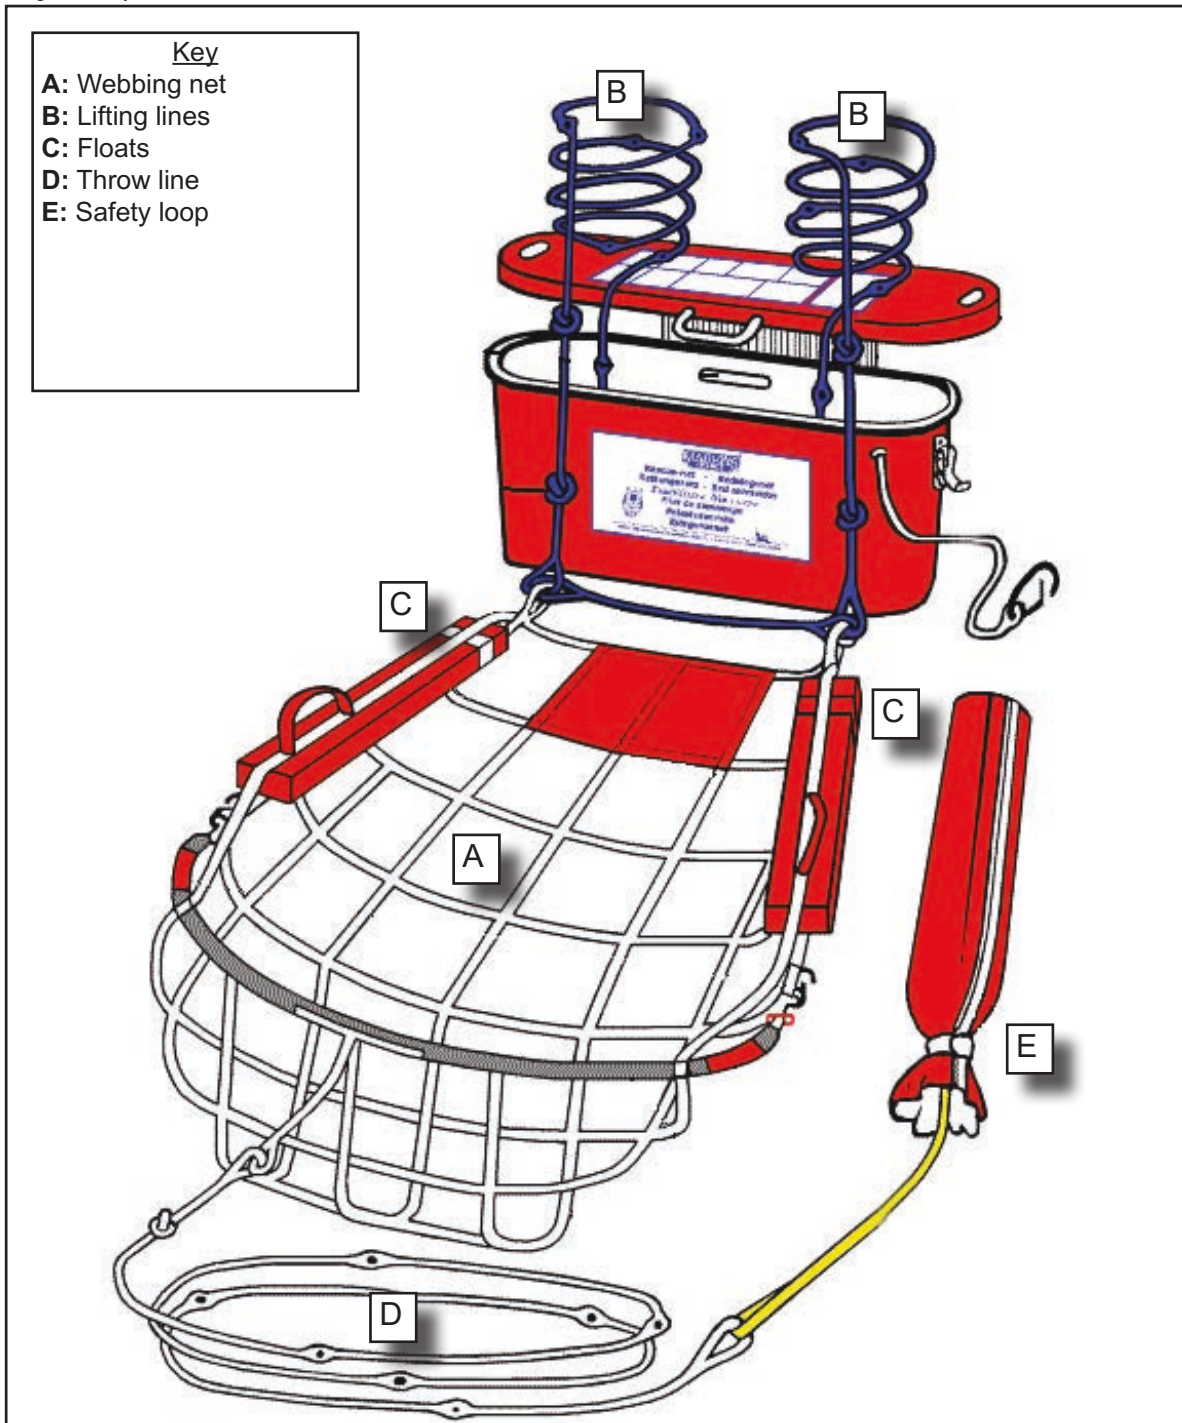
Figure 11: Markusnet manoverboard recovery system

Beryl's crew continued to try and recover the leading deckhand from the water. They deployed the Markusnet manoverboard (MOB) recovery system (**Figure 11**) but had difficulty deploying the device into the wind and were unable to catch the leading deckhand, who was unable to help himself, in its net. Grapple hooks were then lowered to try and snag the leading deckhand's clothing or lifejacket webbing. The skipper and the engineer also took turns to climb down the ladder to try and grab hold of him. Neither was wearing a lifejacket or a lifeline.

Beryl's crew had never used the Markusnet.
