ACCIDENT

Aircraft Type and Registration:	Pegasus Quik, G-CBYE	
No & Type of Engines:	1 Rotax 912ULS piston engine	
Year of Manufacture:	2003 (Serial no: 7933)	
Date & Time (UTC):	3 July 2015 at 1830 hrs	
Location:	Enstone Airfield, Oxfordshire	
Type of Flight:	Private	
Persons on Board:	Crew - 1	Passengers - 1
Injuries:	Crew - 1 (Fatal)	Passengers - 1 (Fatal)
Nature of Damage:	Extensive	
Commander's Licence:	National Private Pilot's Licence	
Commander's Age:	62	
Commander's Flying Experience:	213 hours (of which 163 were on type) Last 90 days - 2 hours Last 28 days - 2 hours	
Information Source:	AAIB Field Investigation

Synopsis

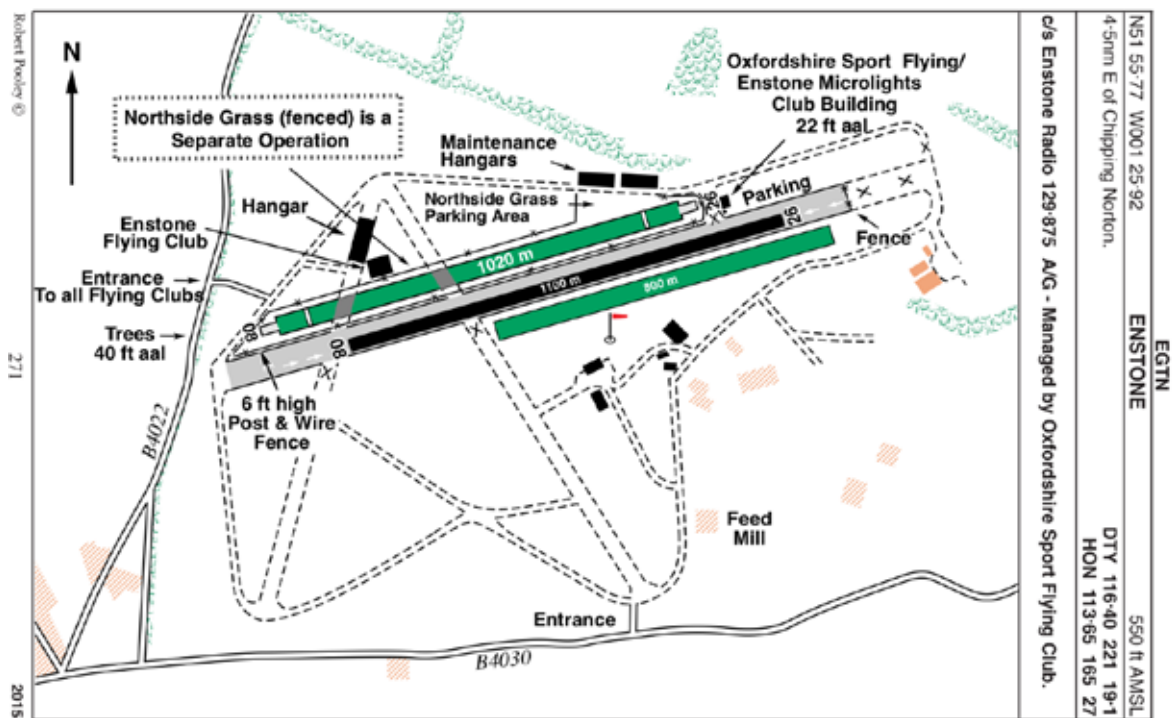
Figure 1

Diagram of Enstone Airfield as depicted in Pooleys Flight Guide. The area around the threshold of the Northside Grass Runway 26 has been altered since this diagram was published.

The Northside Grass runway is shown by Pooleys Flight Guide to be 1,020 m long, and the two cross runways are depicted as disused (Figure 1). The pilot of G-CBYE had previously flown from the asphalt runway and the Northside Grass runway. He had been observed using the section of the Northside Grass runway which is approximately 550 m long and lies east of the cross runways.

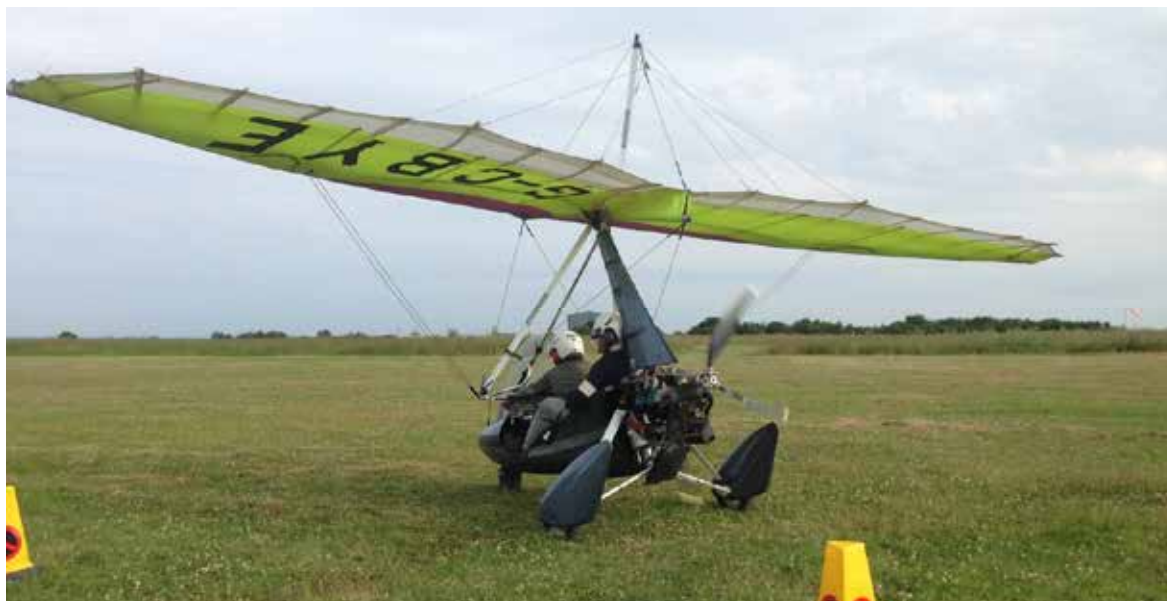
Figure 2

Photographs were taken as the aircraft taxied out from the Northside Grass parking area at 1802 hrs (Figure 2). In the photograph it was noted that the occupants were wearing helmets and that the pilot was not using the diagonal shoulder strap on his seat harness.

G-CBYE taxiing from the Northside Grass parking area towards the asphalt runway

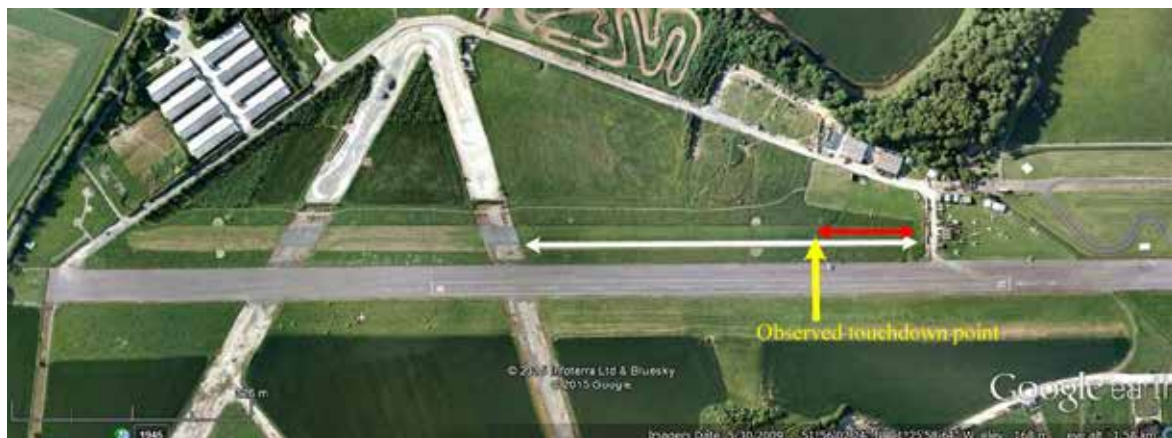
Figure 3

The three people working on the microlight outside the Northside Grass maintenance hangar had seen the aircraft take off. One of them was facing west and spotted it again during the latter stages of its approach and brought it to the others' attention. They watched it touch down in a position that was later measured to be approximately 145 m before the end of the grass runway (Figure 3).

Google Earth image of Enstone Airfield.

The Enstone Flying Club buildings were erected after this image was taken and the area around the threshold of Northside Grass Runway 26 has also changed. The white arrow shows the estimated distance from the easterly cross runway to the end of the Northside Grass Runway 08 at the time of the accident (approximately 550 m), and the red arrow indicates the landing distance available from the observed touchdown point (approximately 145 m)

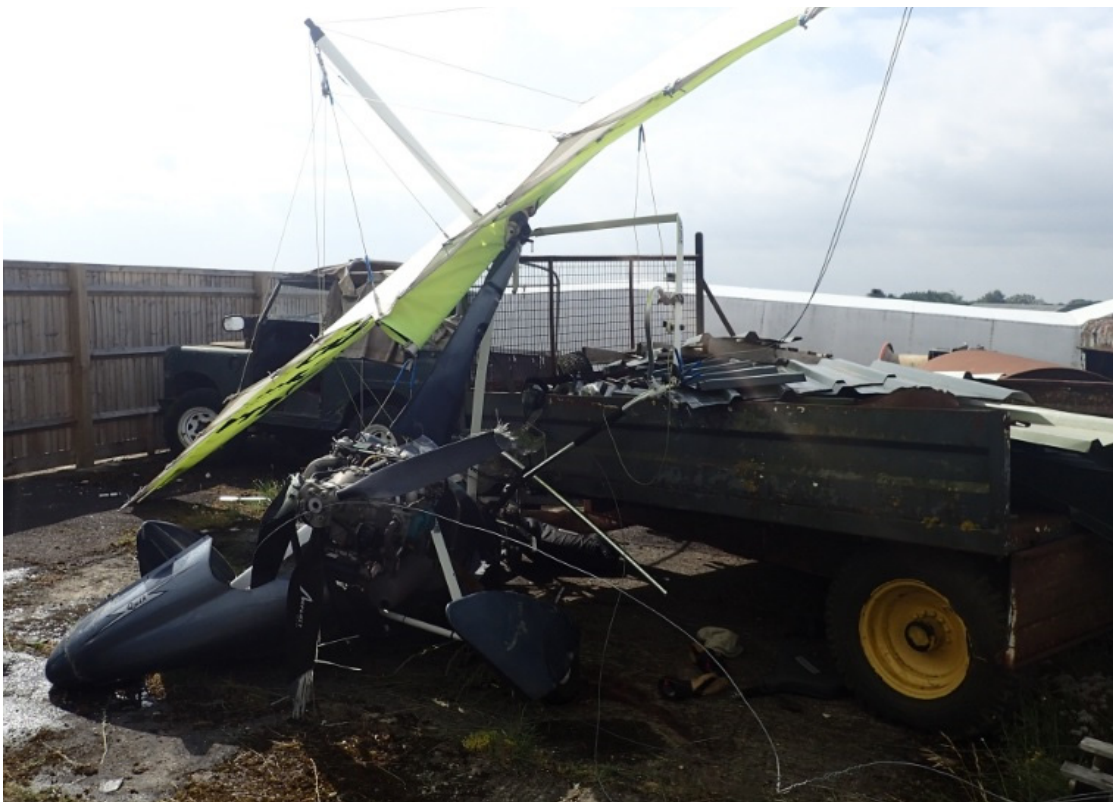
Figure 4

After touchdown the aircraft passed through a wire fence at the eastern end of the runway and collided with a vehicle trailer that was parked beside other equipment (Figure 4) before coming to rest. The aircraft remained upright with the nose embedded under the trailer but the wing showed little sign of obvious external damage. Ground marks showed that the trailer and a large grass roller adjacent to it had been displaced sideways when the aircraft struck the trailer.

General view of the accident site

There were no markings at the end of the Northside Grass Runway 08 and there were a number of vehicles and other obstructions in the overrun and immediately adjacent to it. These were not marked or mentioned in available aeronautical information. A CAA Inspector visited the site after the accident and stated that it is an unlicensed airfield with no requirement for an overrun area (runway strip end) beyond the notified landing distance available. He noted that while it may not be sensible to place obstacles in this area, there are no regulations to prevent this. It is the same at licensed airfields where obstacles can exist beyond the runway strip end, provided they do not infringe the prescribed vertical surfaces for aircraft takeoff or approach/climb requirements.
