Report on the investigation into
carbon monoxide poisoning
on board the motor cruiser

Arniston

on Windermere

1 April 2013

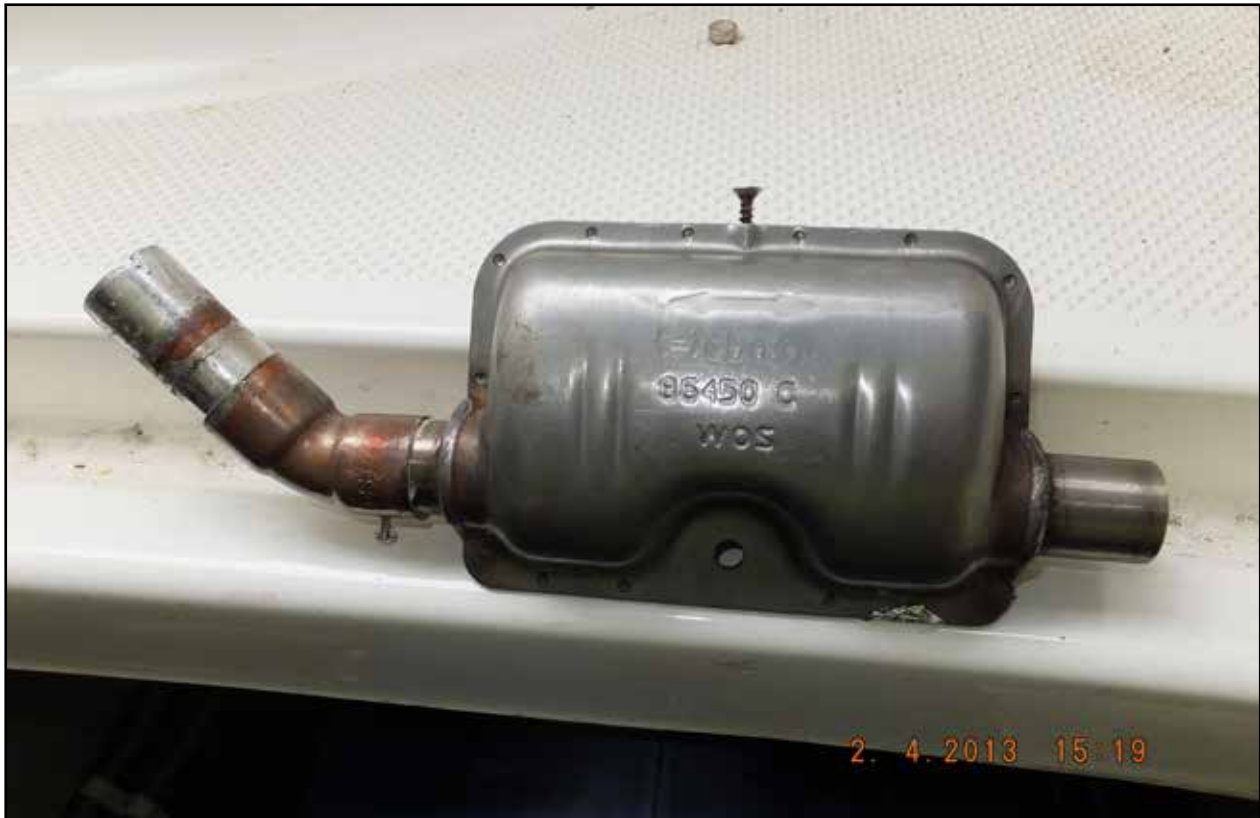
The owner purchased a *Webasto 86450C* silencer (**Figure 7**), which was specifically designed for use with *Webasto* 5kW diesel heaters and was not approved for any other application. The exhaust line incorporating the silencer was then assembled by the owner and fitted to the generator at his home prior to the trip to Windermere on 31 March. He had tested the combined generator/exhaust system by running the engine in fresh air. No electrical load was applied.

Figure 7: Webasto silencer

Although the *Webasto* silencer (**Figure 7**) weighed 0.35kg, the external exhaust system was unsupported throughout its entire length. Therefore, when the solder softened and the vibration increased after the generator was put under load, the

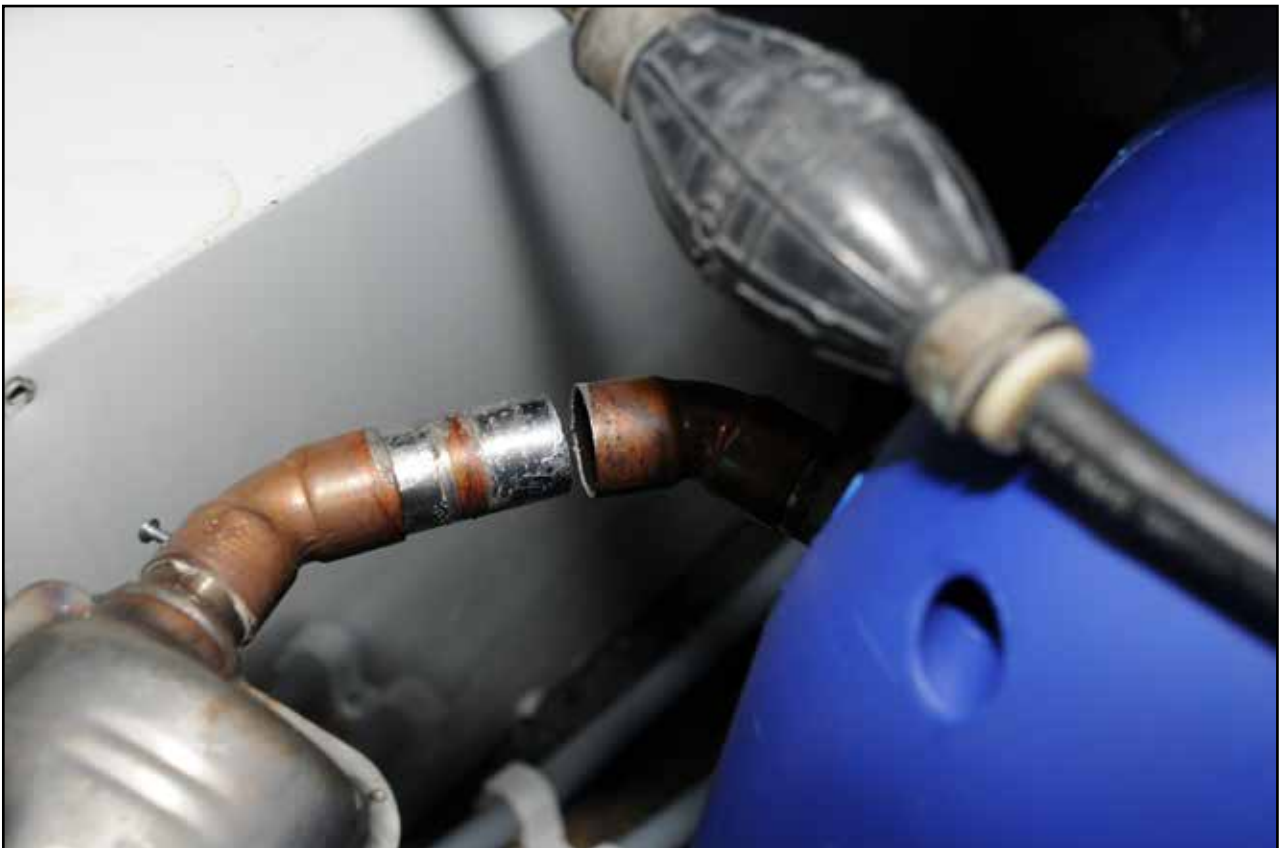
Figure 10: Failed soldered joint

The Test House examination also identified that the failed soldered joint showed signs of having reached a pasty state on a previous occasion (**Figure 21**). The partial separation of the joint is likely to have occurred when the generator was running during the evening of 31 March. On that occasion, the generator was not under load and therefore its exhaust gas temperatures would have been lower. The semi-molten solder would have cooled and solidified soon after the generator was turned off.

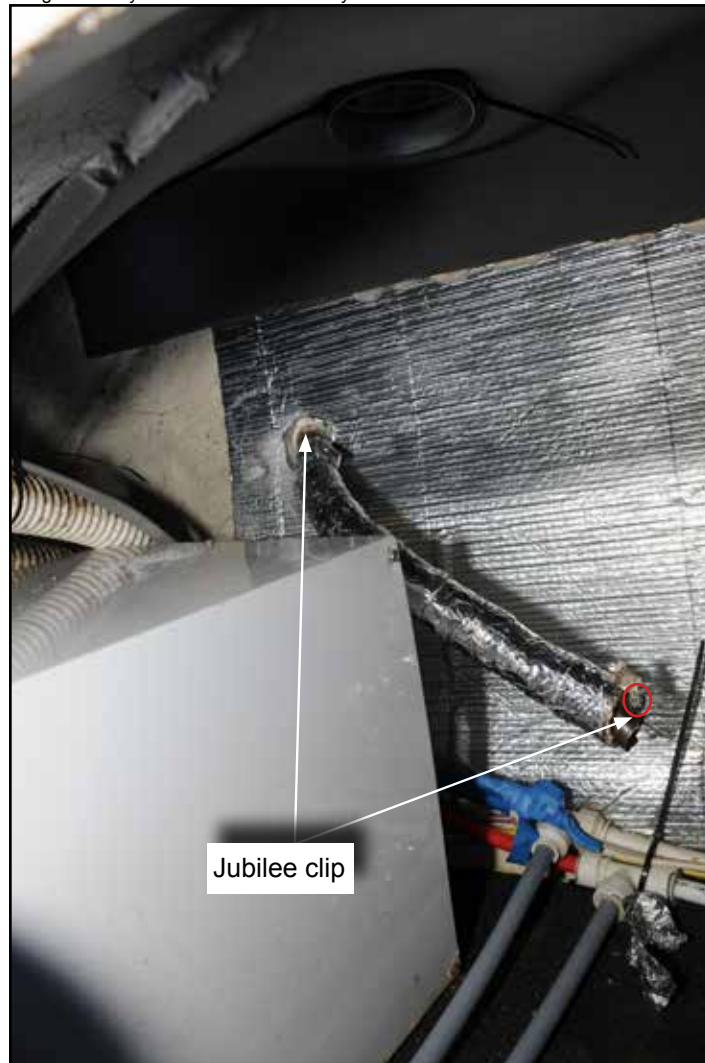
Figure 11: Silencer to through hull fitting

The 24mm stainless steel pipe section of the external exhaust system (**Figure 11**) was 'secured' at both its ends by jubilee clips. Due to the characteristics of the steel pipe, it would have been impossible to compress it to effect a gas-tight seal using this method. Consequently, as shown by the evidence highlighted by The Test House examination of the pipe (**Annex A**) and the reconstruction (**Annex B**), CO was leaking into the engine bay even before the external exhaust system collapsed.

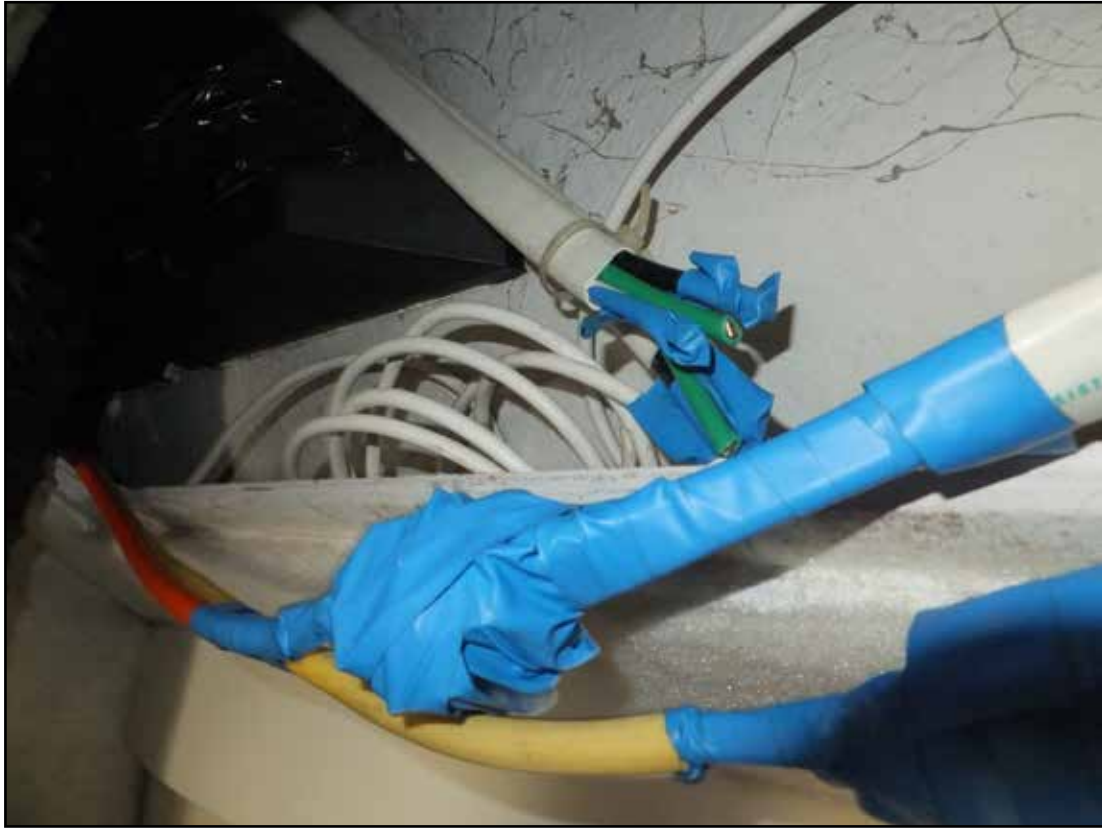
owner then connected two wires, each fitted with a standard UK 3-pin plug, to the cables supplying the distribution panel. The wires were connected using plastic terminal blocks that were wrapped in insulating tape (**Figure 13**). The 3-pin plugs were then connected to the generator to enable 240V power to be supplied to the boat's appliances via the distribution panel.

Figure 13: Electrical wire joints

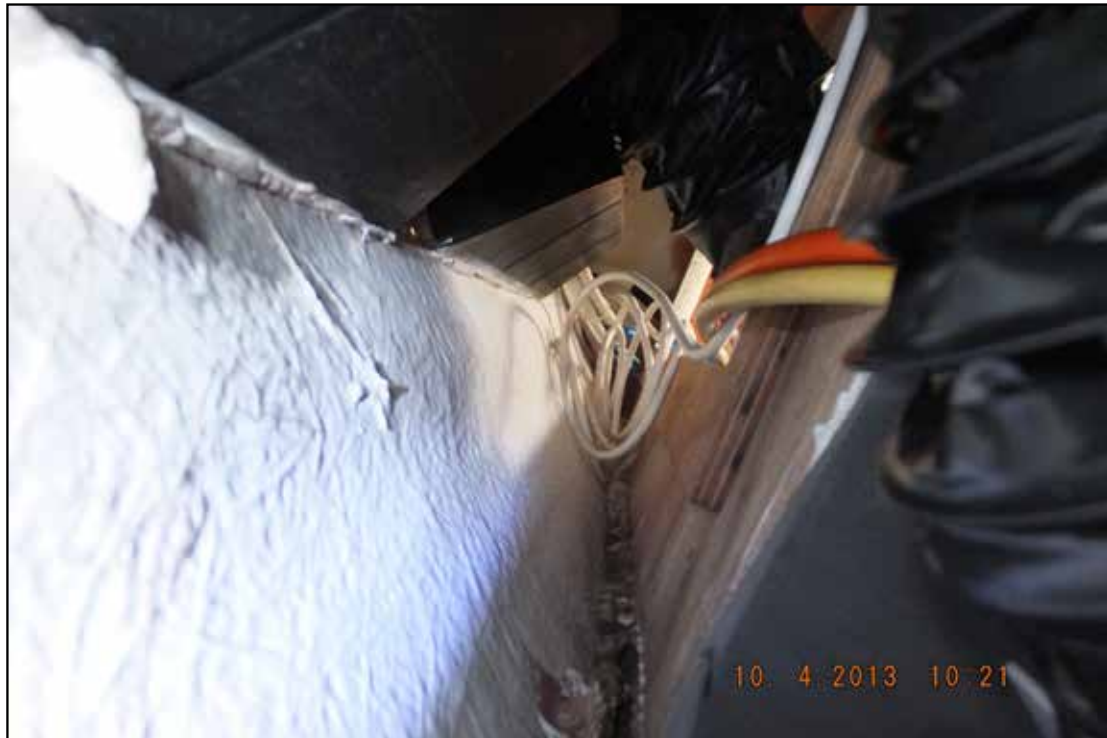
The supply and extraction hoses associated with the fan system, and the 240V electrical supply cables, were routed from the engine bay through a large opening (**Figure 14**) in the top corner of the common bulkhead between the engine bay and the port side of the aft cabin.

Figure 14: Bulkhead penetration

The aft cabin where Kelly and Lauren went to sleep shared a common bulkhead with the engine bay (Figure 3). The bulkhead was not gas-tight. It had large openings (Figure 14) through which electric cables and pipework were routed. These openings allowed the exhaust gases from the generator to flow from the engine bay into the aft cabin (Figure 22). The extensive staining found on the deckhead lining of the aft cabin (Figure 23) indicates that the atmosphere in the engine bay had been venting into the accommodation for a prolonged period.

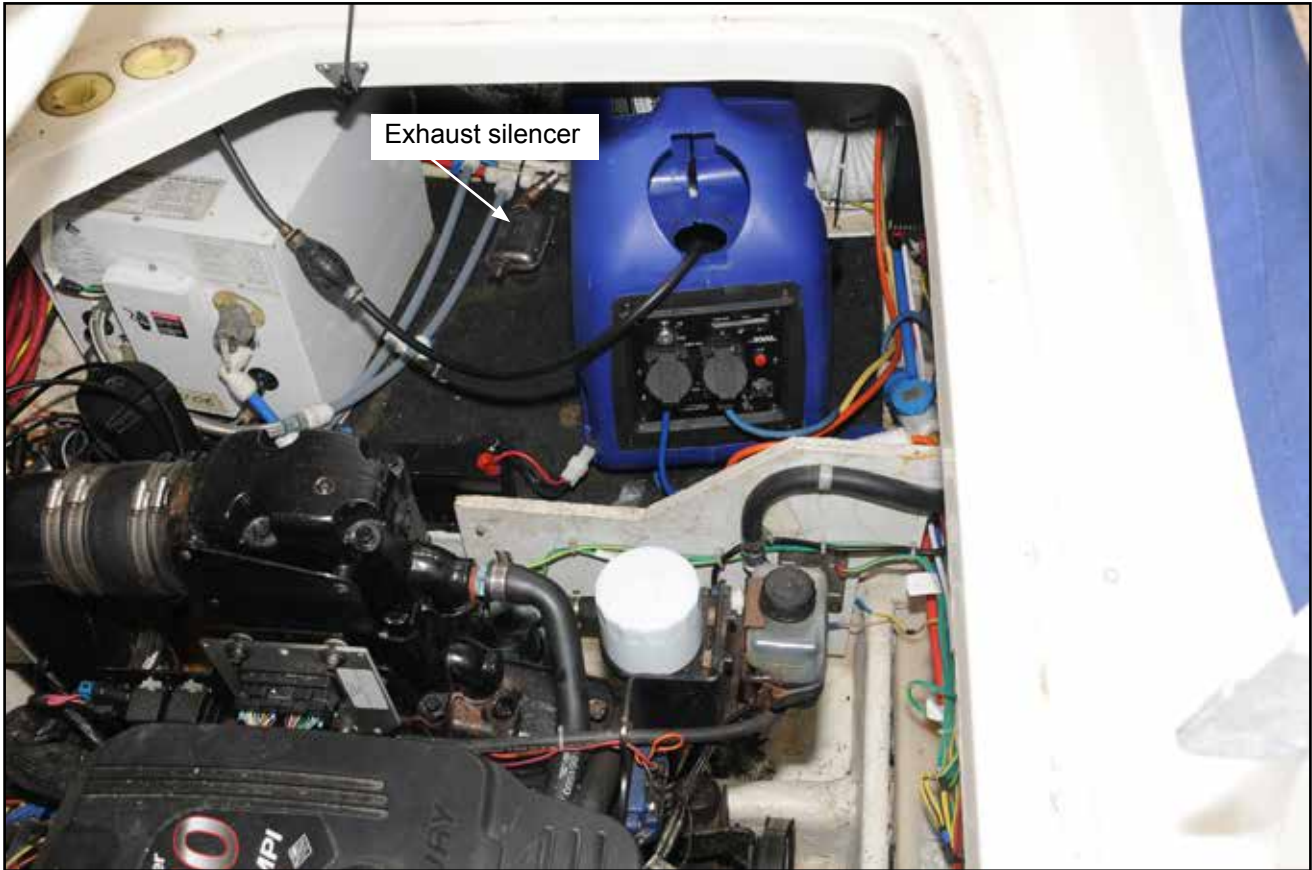
Figure 15: Showing approximate position of detached exhaust silencer

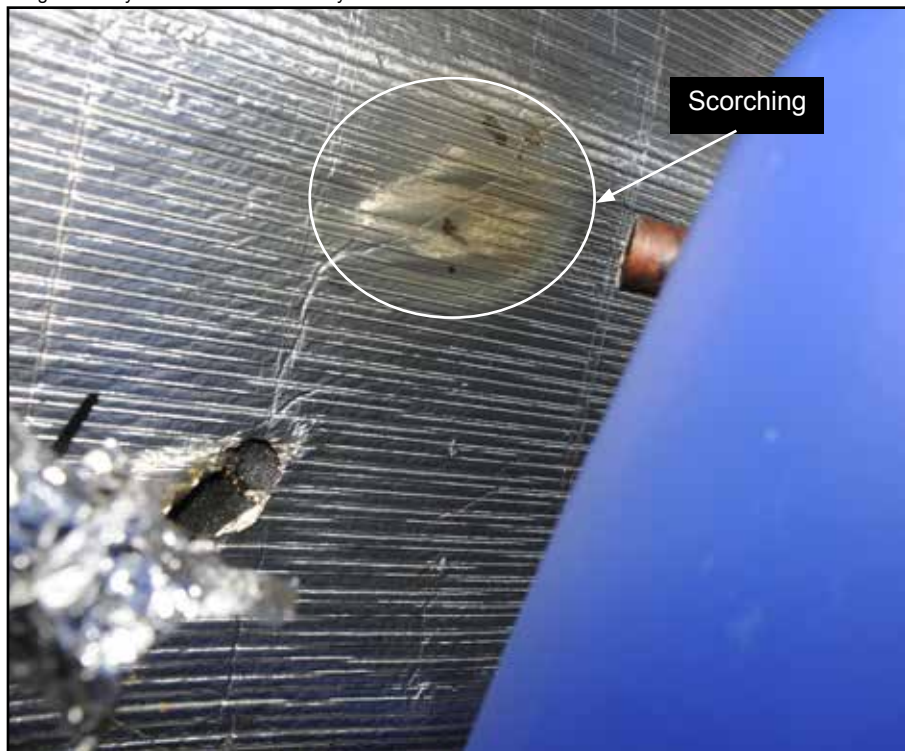
- 'Scorch' marks (**Figure 16**) and evidence of solder 'splash' (**Figure 17**) were found on the heat resistant bulkhead lining adjacent to the exhaust outlet pipe on the generator.

Figure 16: "Scorch" marks engine bay on bulkhead

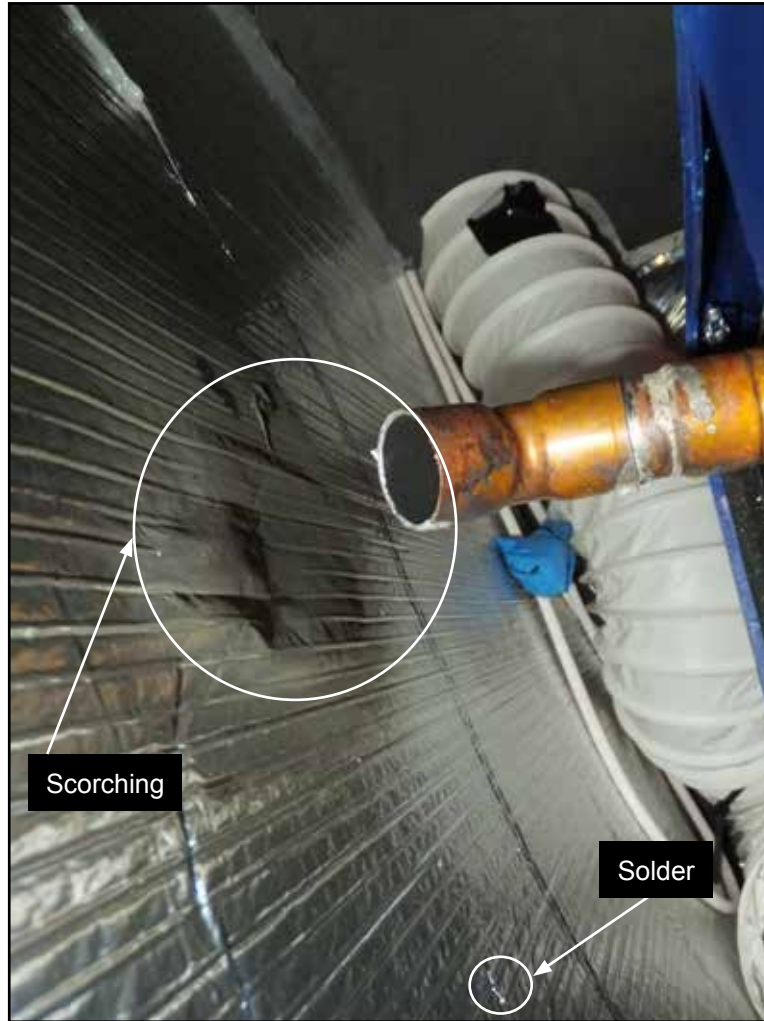
Figure 17: Solder splash on engine bay bulkhead

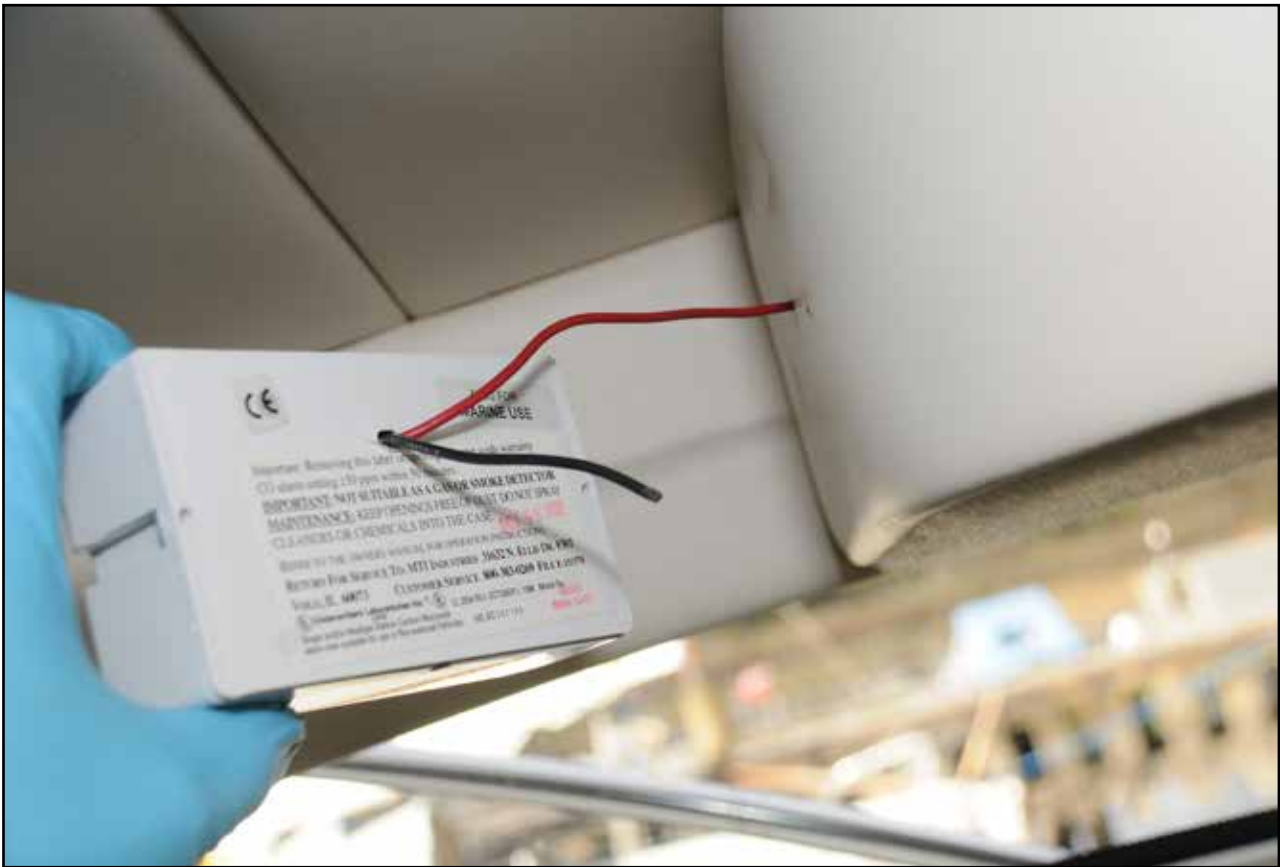
- Both CO alarms had been disconnected from the power supply (**Figure 19**) and were not fitted with internal batteries.
- *Arniston* was also fitted with several stickers (**Figure 20**) that warned of the hazards of CO. The stickers were required in order for the boat to comply with the NMMA build standard in the USA.

Figure 19: Disconnected CO alarm

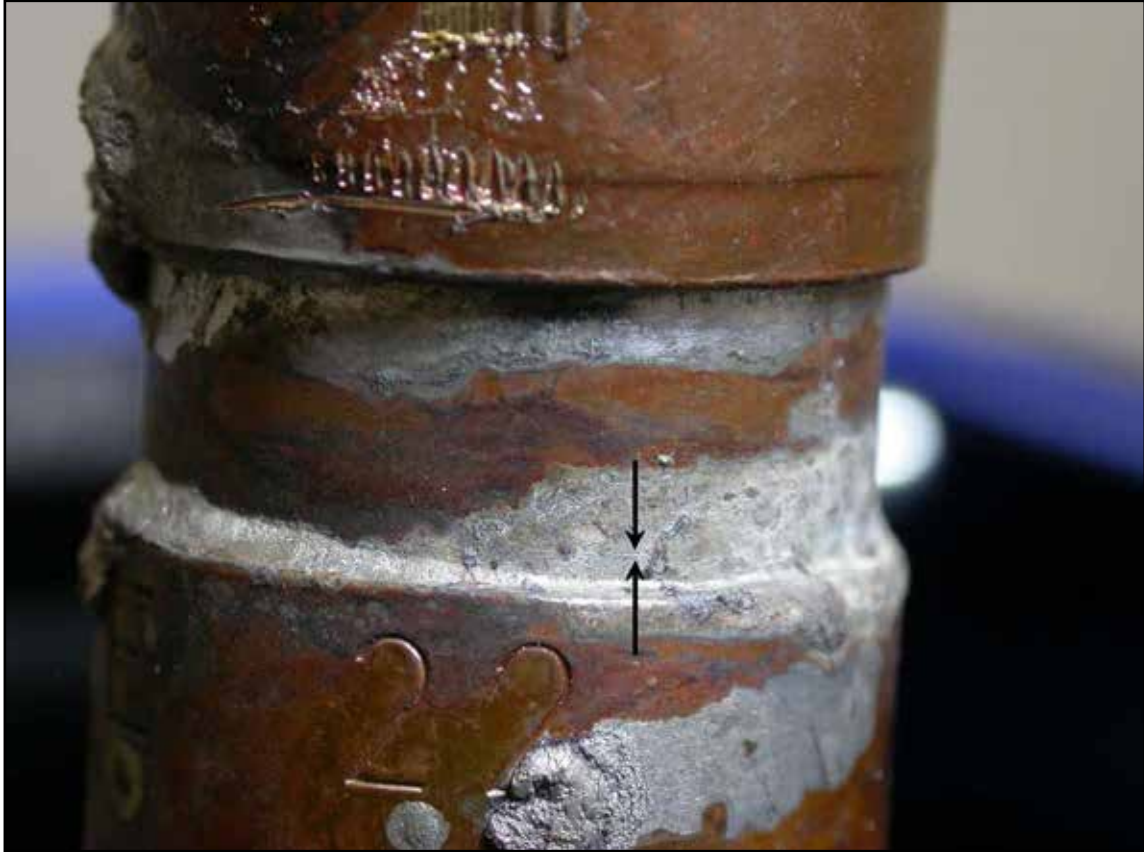
Figure 21: Previous partial failure

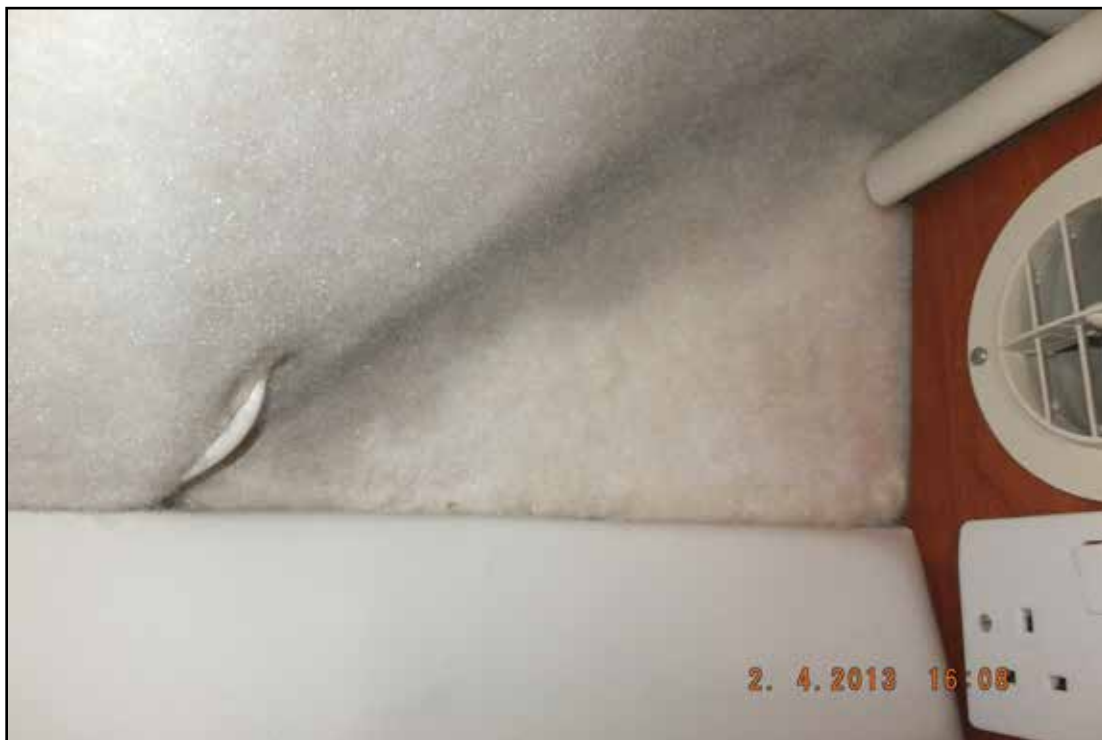
Figure 23: Deckhead lining - gas staining

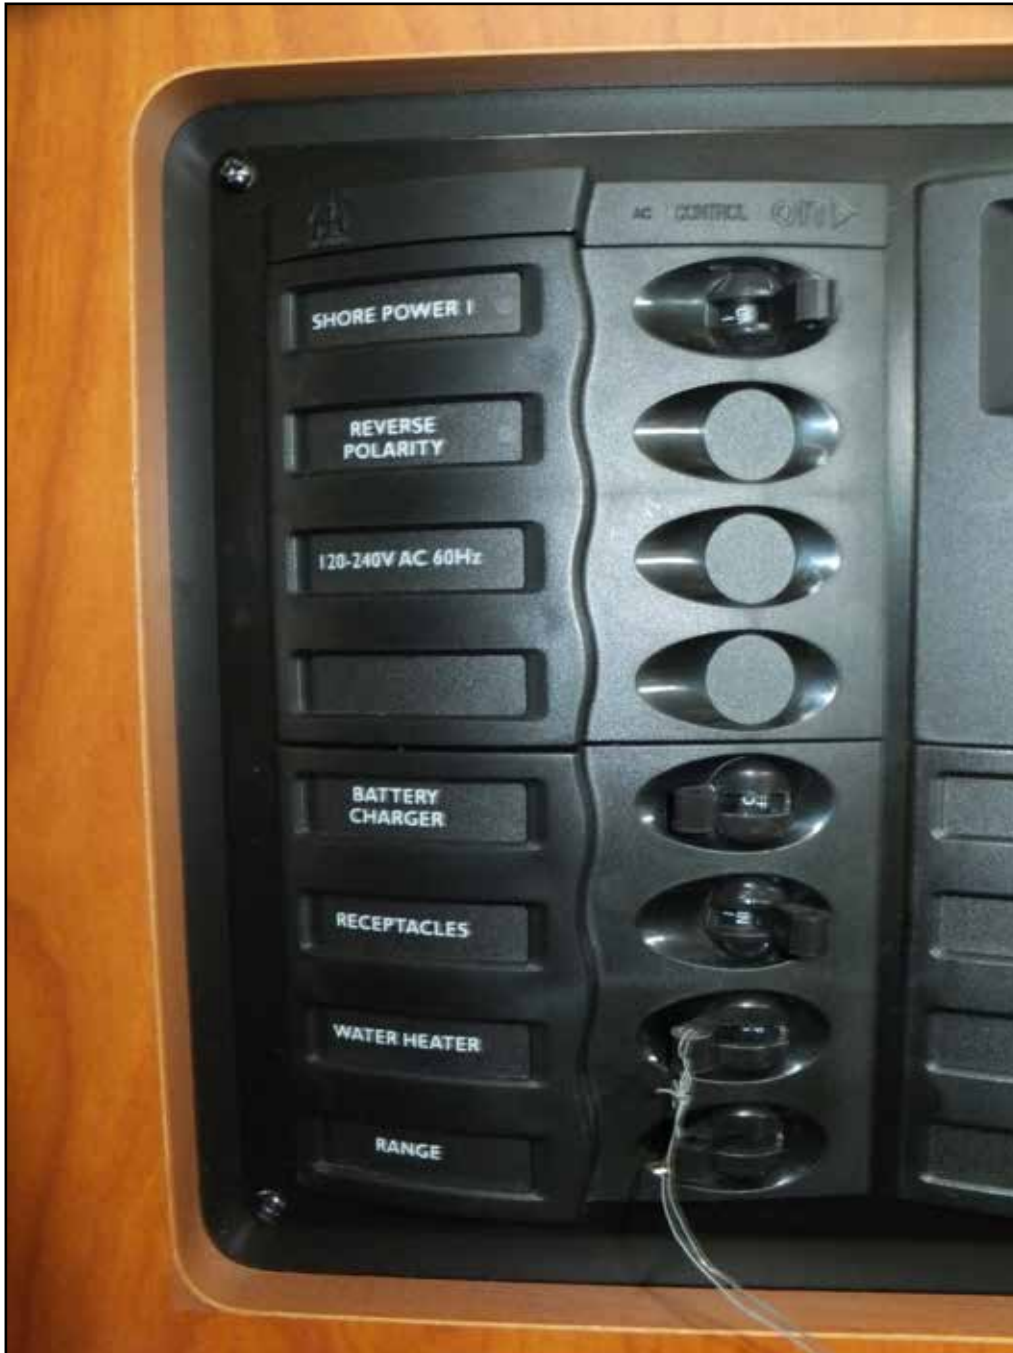
The circulation fans in the engine bay were reported to be on during the afternoon of 1 April. However, when MAIB inspectors and police examined *Arniston* on 2 April 2013, the power supply switch to the fans, which was shared with the battery charger, was found to be in the off position (**Figure 24**). Therefore, there is some doubt whether the fans were operating or not. It is possible that the switch was inadvertently knocked to the 'off' position by the emergency services during the rescue attempt or that the fans were not operating at the time of the accident.

Figure 24: Battery charger/fans switch position
