Inboard 28mm steel wire ramping rope test certificate

The Test House report and selected photographs

LABORATORY BASED EXAMINATION AND FAILURE ANALYSIS ON THE FWD STARBOARD 28 mm DIAMETER ZINC PLATED STEEL WIRE ROPES AND CORRESPONDING MEZZANINE DECK SECTION FROM THE RORO FERRY ST HELEN

**THE TEST HOUSE (CAMBRIDGE) LTD REPORT REFERENCE: T41192
PURCHASE ORDER No. 8000132510
RECEIPT DATE: 5 August 2014
REPORT DATE: 18 September 2014**

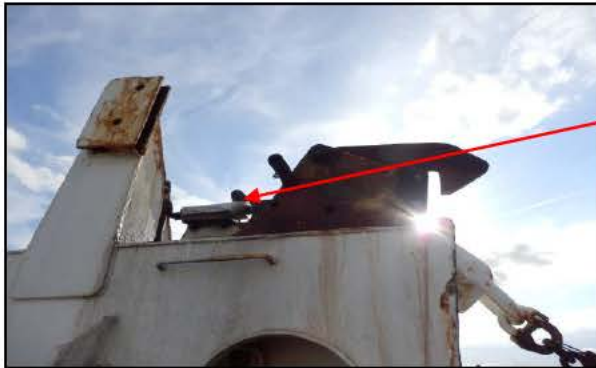
- 1.1 When operated no visible warning light or audible siren noted.
- 1.2 When closing the ramp the cleat hooks appeared worn with visible lateral movement.
- 1.3 The port side locking cleat cylinder is leaking oil from the gland seal.
- 1.4 The sealing arrangement is considered in poor condition with a heavy permanent set along with the compression bar having no apparent clean edge to seal against.
- 1.5 Arrester chains port and stb are twisted which when fully open places a slight twist in the ramp.

Ref. 1.2 Cleat hook worn

- 1.2 Hook cleats to be measured for wear and replaced if necessary.
- 1.3 Port side locking cylinder to be removed for overhaul.
- 1.5 Chains to be disconnected and de twisted and re connected.

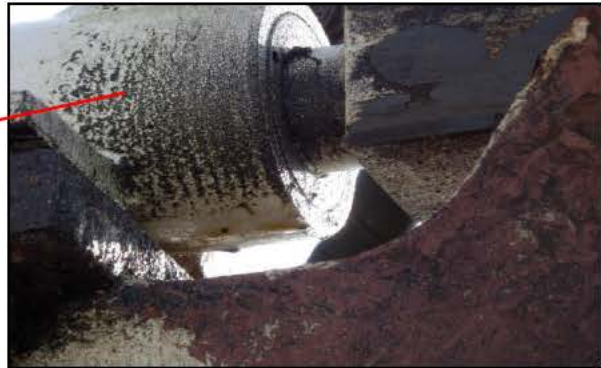
Ref. 1.3 Cleat cylinder leaking

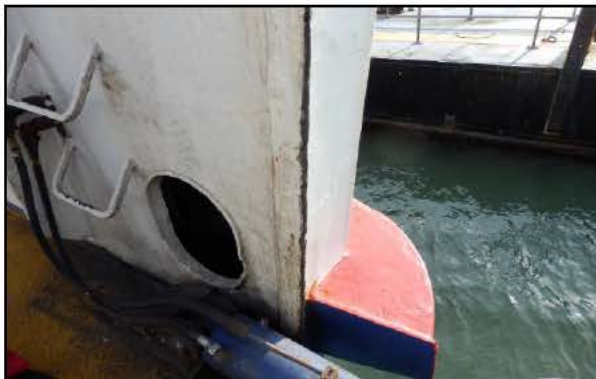
Ref. 1.4 Compression bar edge poor

- 1.1 Audible siren and visible light to be replaced or repaired to give adequate warning to all passengers and staff that the equipment is being operated.
- 1.4 All of the sealing arrangement to be replaced with new. Hose test to confirm weather tightness. Sealing bar to be stripped back to its original condition and not painted.

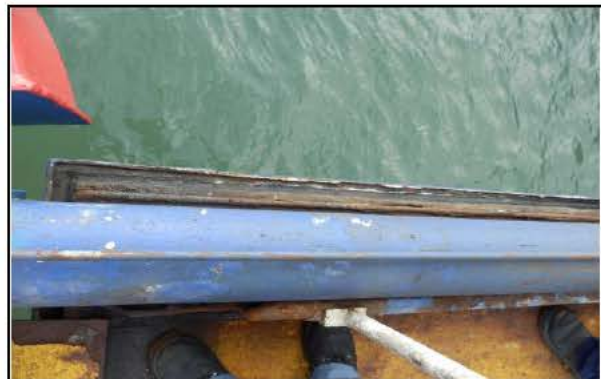
Ref. 1.4 Sealing arrangement

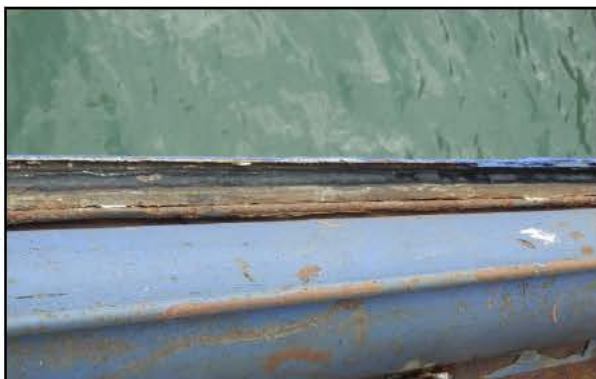
Ref. 1.4 Seal has permanent set

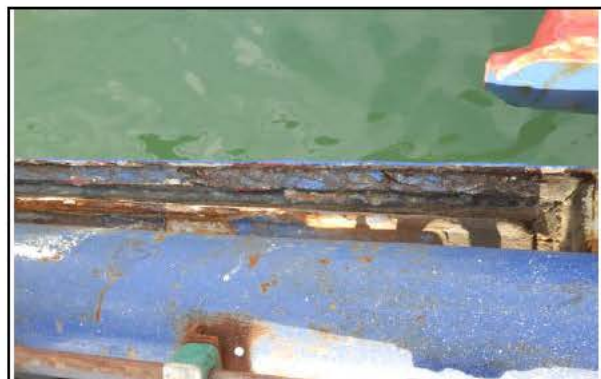
Ref. 1.4 Seal cracked and painted

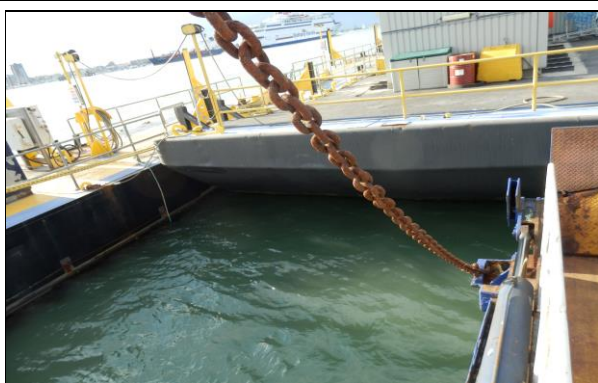
Ref. 1.5 Stb Chain twisted

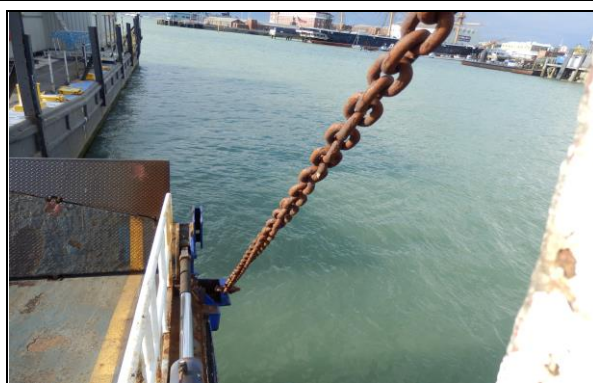
Ref. 1.5 Port Chain twisted

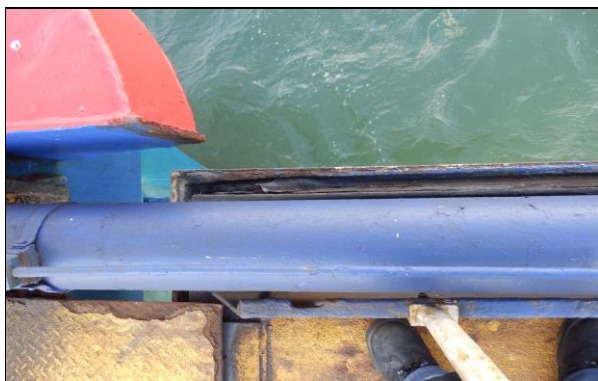
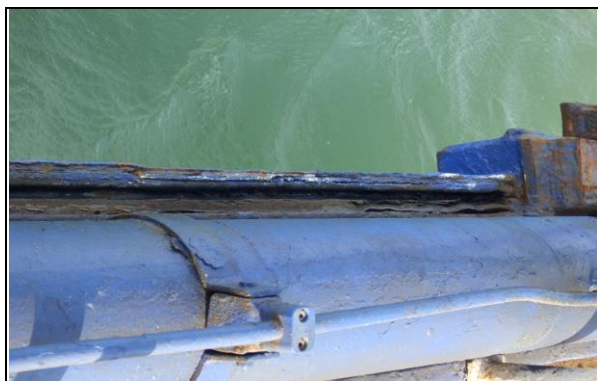
- 2.1 Arrester chains port and stb are twisted which when fully open places a slight twist in the ramp.
- 2.2 The sealing arrangement has failed; parts of the seal are no longer present.

Ref. 2.2 Seal condition

- 2.2 All of the sealing arrangement to be replaced with new. Hose test to confirm weather tightness.

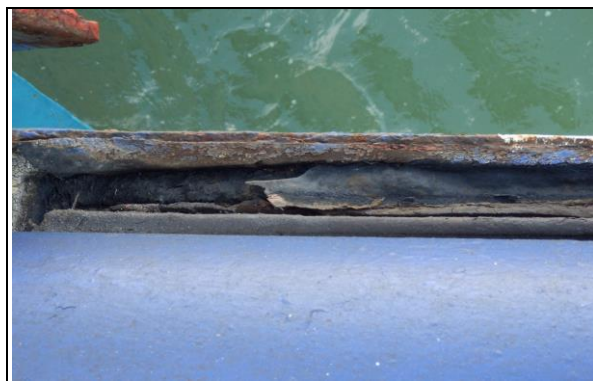
Ref. 2.2 Seal missing outer skin

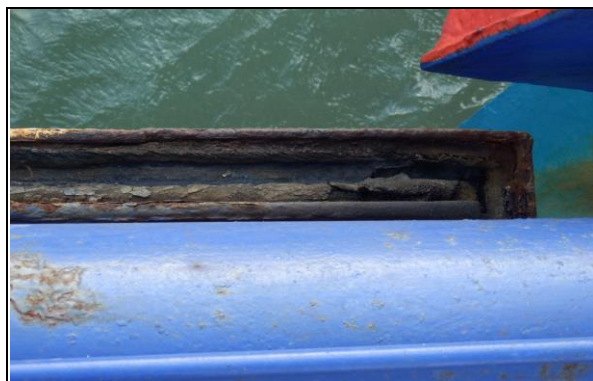
Ref. 2.2 Corner damaged

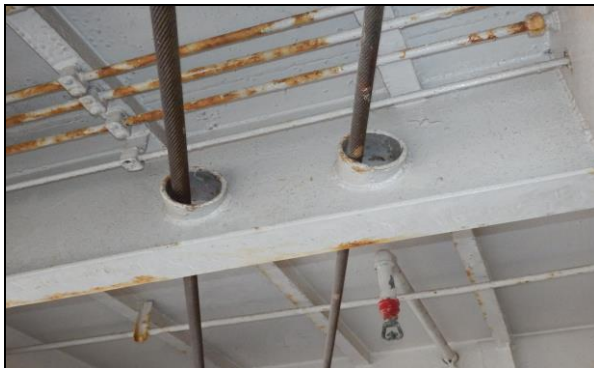
- 3.1 Wire ropes have no protection to prevent corrosion.
- 3.2 All wire rope sheaves are heavy with corrosion with some showing signs of heavy wear in the sheave groove and a visible imprint from the wire rope.
- 3.3 Many of the hydraulic pipe runs to the locks are corroding.
- 3.4 The Jigger cylinder is leaking oil from the gland seal.
- 3.5 The jigger head guide rail has material missing and distortion along the rail.
- 3.6 The inboard vertical guide rail is damaged.
- 3.7 During operation no audible siren was noted.
- 3.8 Wire rope is fouling on the penetration holes when under tension.
- 3.9 Wire rope is fouling on the side frame when under tension.

Ref. 3.1 No protection on wire ropes

- 3.1 Wire ropes need protection against corrosion. Adequate greasing will help prevent corrosion.
- 3.3 Hydraulic pipe runs to be replaced with seamless stainless steel.
- 3.4 Jigger to be removed for overhaul and pressure tested to confirm.
- 3.5 Jigger head guide rail to be cropped and replaced.
- 3.6 Inboard vertical guide rail to be cropped and replaced.
- 3.8 All penetrations to be adjusted to give adequate clearance when the wire is under tension.
- 3.9 Frame to be adjusted to give adequate clearance when the wire is under tension. Wire appears to be damaged on the outer core.

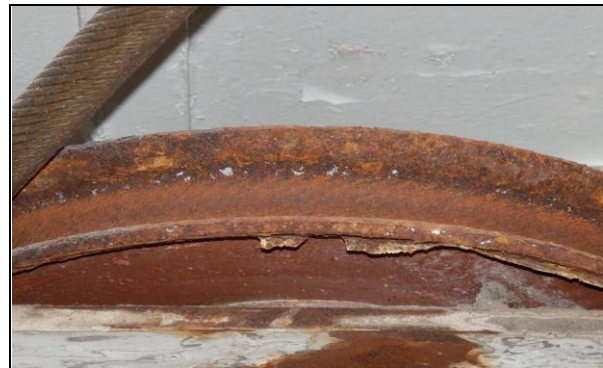
Ref. 3.2 Example of corroded/worn sheave

- 3.2 Heavy sheave wear will shorten the wire ropes lifespan and also damage the wire rope. Sheaves in this condition need to be replaced.
- 3.7 Siren to be replaced or repaired to give adequate warning to all passengers and staff that the equipment is being operated.

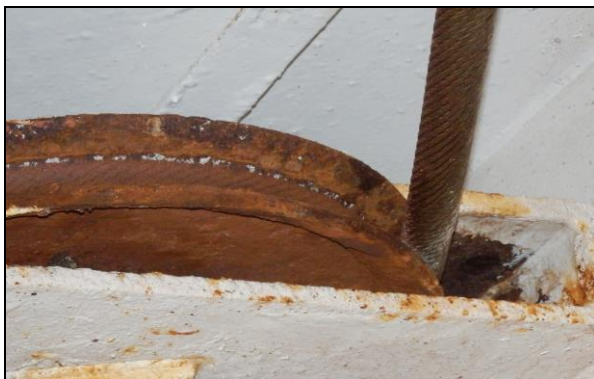
Ref. 3.2 Example of corroded/worn sheaves

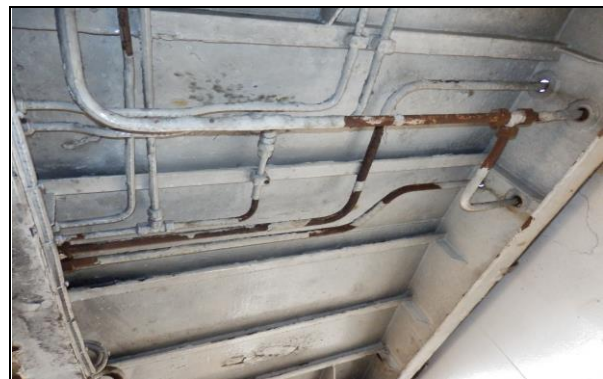
Ref. 3.3 Example of corroding pipe runs

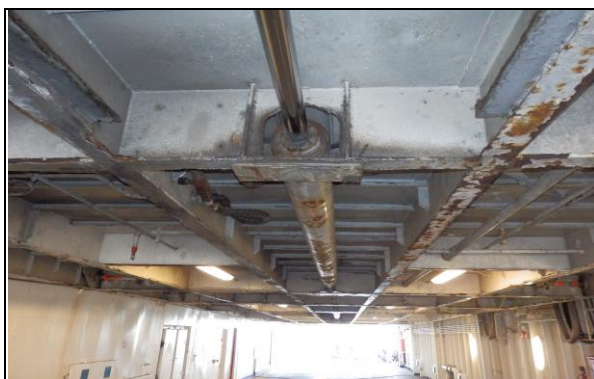
Ref. 3.4 Jigger cylinder overview

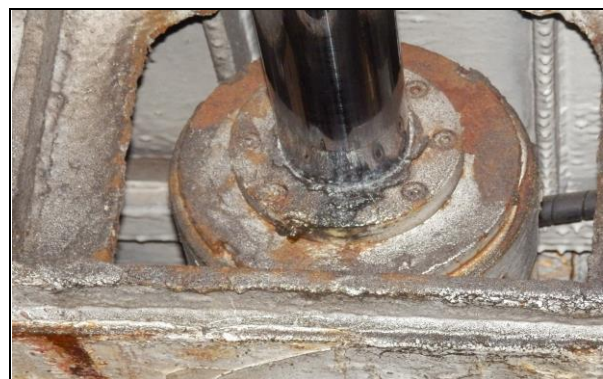
Ref. 3.4 Gland seal leaking

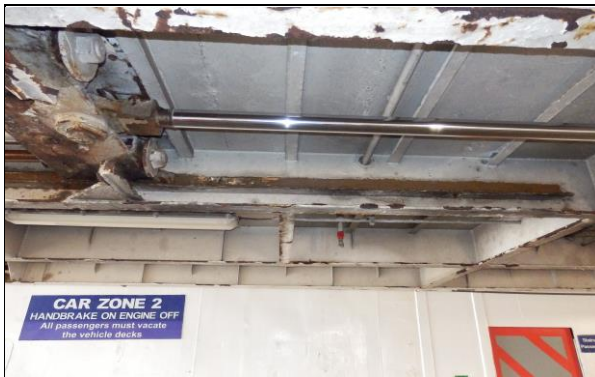
Ref. 3.5 Jigger guide rail

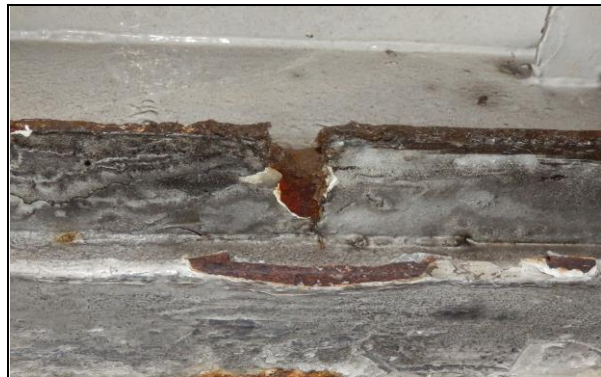
Ref. 3.5 Guide rail piece missing

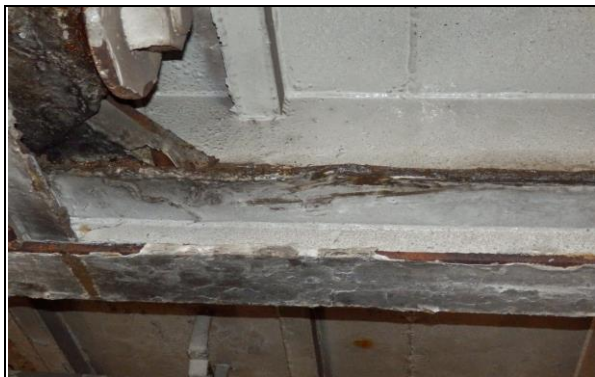
Ref. 3.5 Guide rail distorted

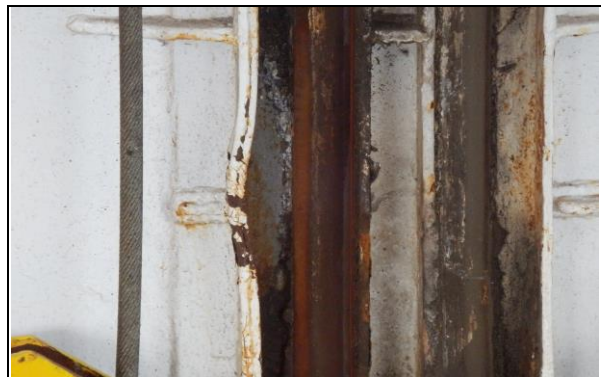
Ref. 3.6 Vertical rail damaged

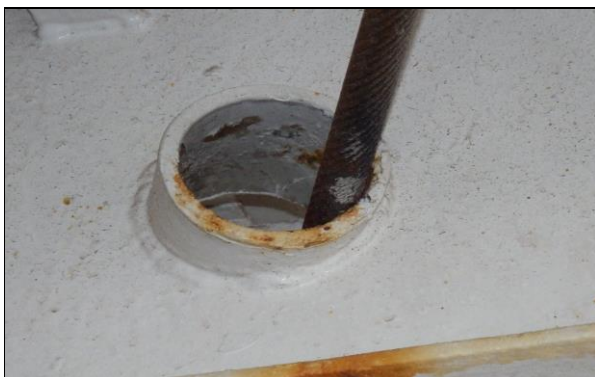
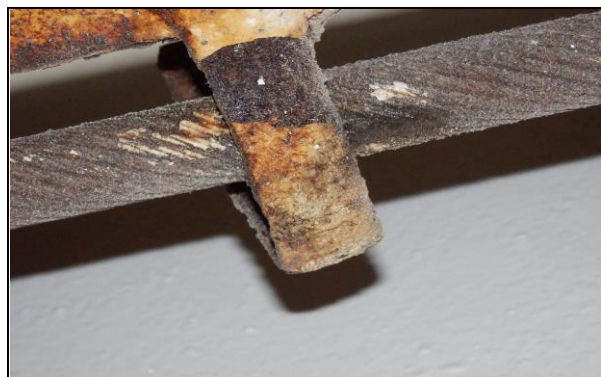
Ref. 3.8 Example of wire fouling

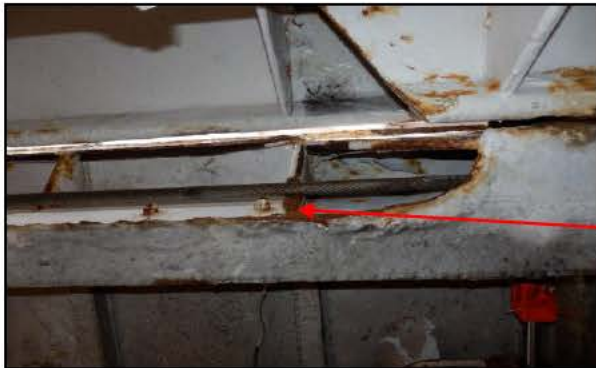
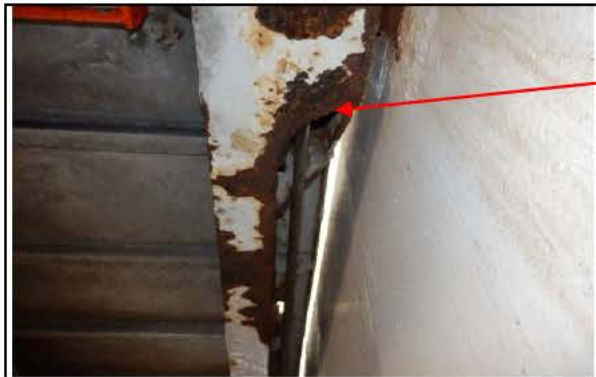
Ref. 3.9 Wire fouling

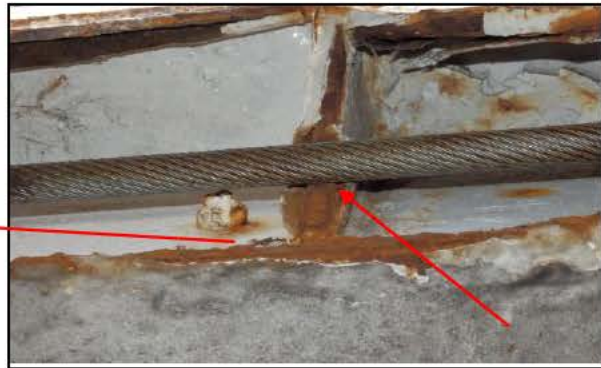
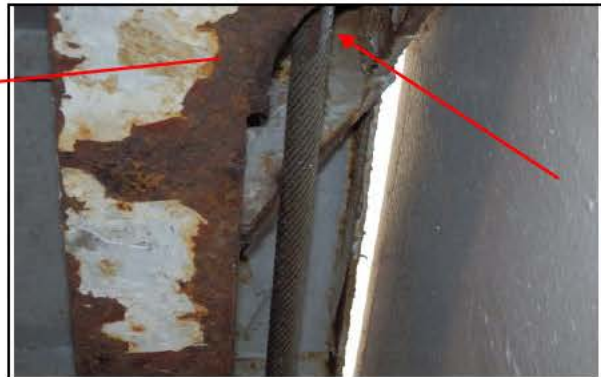
Ref. 3.9 Wire fouling under tension

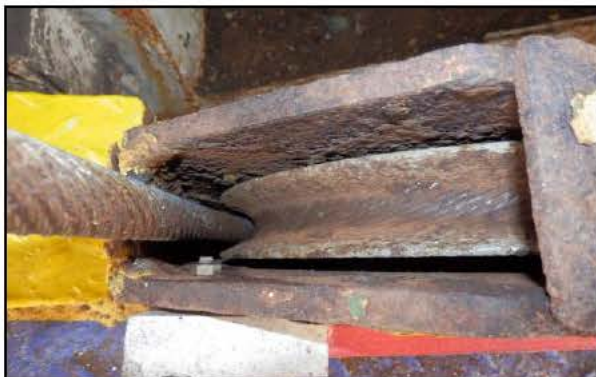
- 4.1 All wire rope sheaves are heavy with corrosion with some showing signs of heavy wear in the sheave groove and a visible imprint from the wire rope. The wire rope is in poor condition with heavy corrosion.
- 4.2 Many of the hydraulic pipe runs to the locks are corroding.
- 4.3 The inboard wire supports foul the wire rope when under tension.
- 4.4 During operation no audible siren was noted.

Ref. 4.1 Example of wear in sheaves

- 4.1 Heavy sheave wear will shorten the wire ropes lifespan and also damage the wire rope. Sheaves in this condition need to be replaced. Wire rope to be replaced, unable to ascertain true condition due to the corrosion.
- 4.4 Siren to be replaced or repaired to give adequate warning to all passengers and staff that the equipment is being operated.

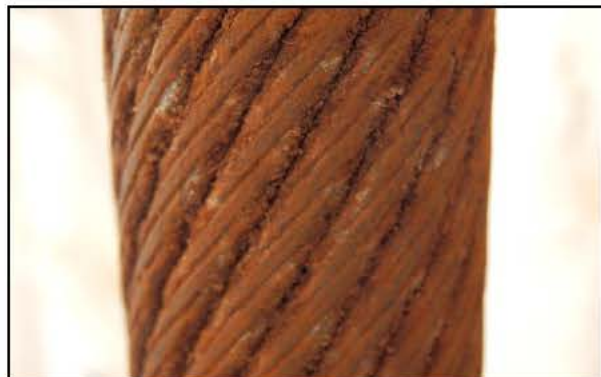
Ref. 4.1 Wire rope condition

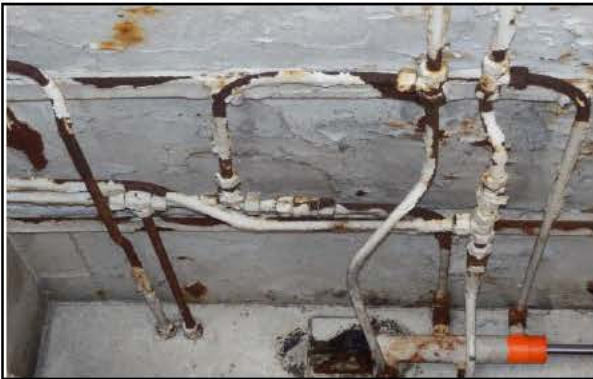
Ref. 4.2 Example of hyd. Pipe condition

- 4.2 Hydraulic pipe runs to be replaced with seamless stainless steel.
- 4.3 Wire supports to be adjusted to give adequate clearance when the wire is under tension.

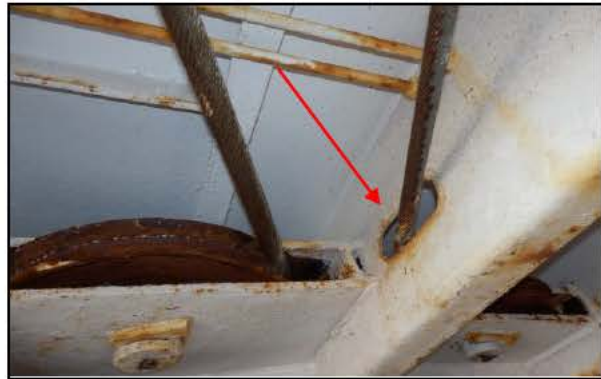
Ref. 4.3 Example of wire fouling

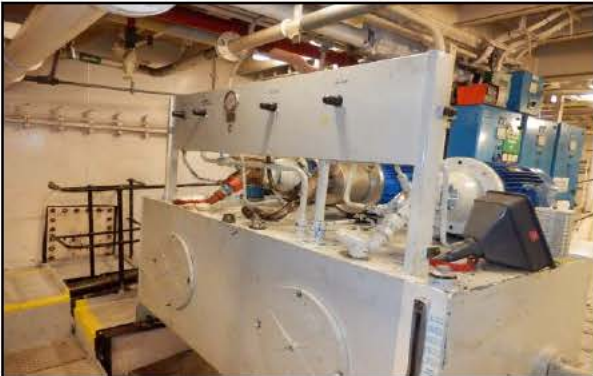
- 5.1 A sample of oil medium was attempted but no sample point present. Oil medium was drawn through a pipe from the air breather which was considered inadequate for an accurate measurement though a laser particle analyser.

Ref. 5 HPU no sample point
