Report on the investigation of
a fatal man overboard from the Reflex 38 yacht
Lion

14.5 miles south of Selsey Bill, West Sussex

18 June 2011

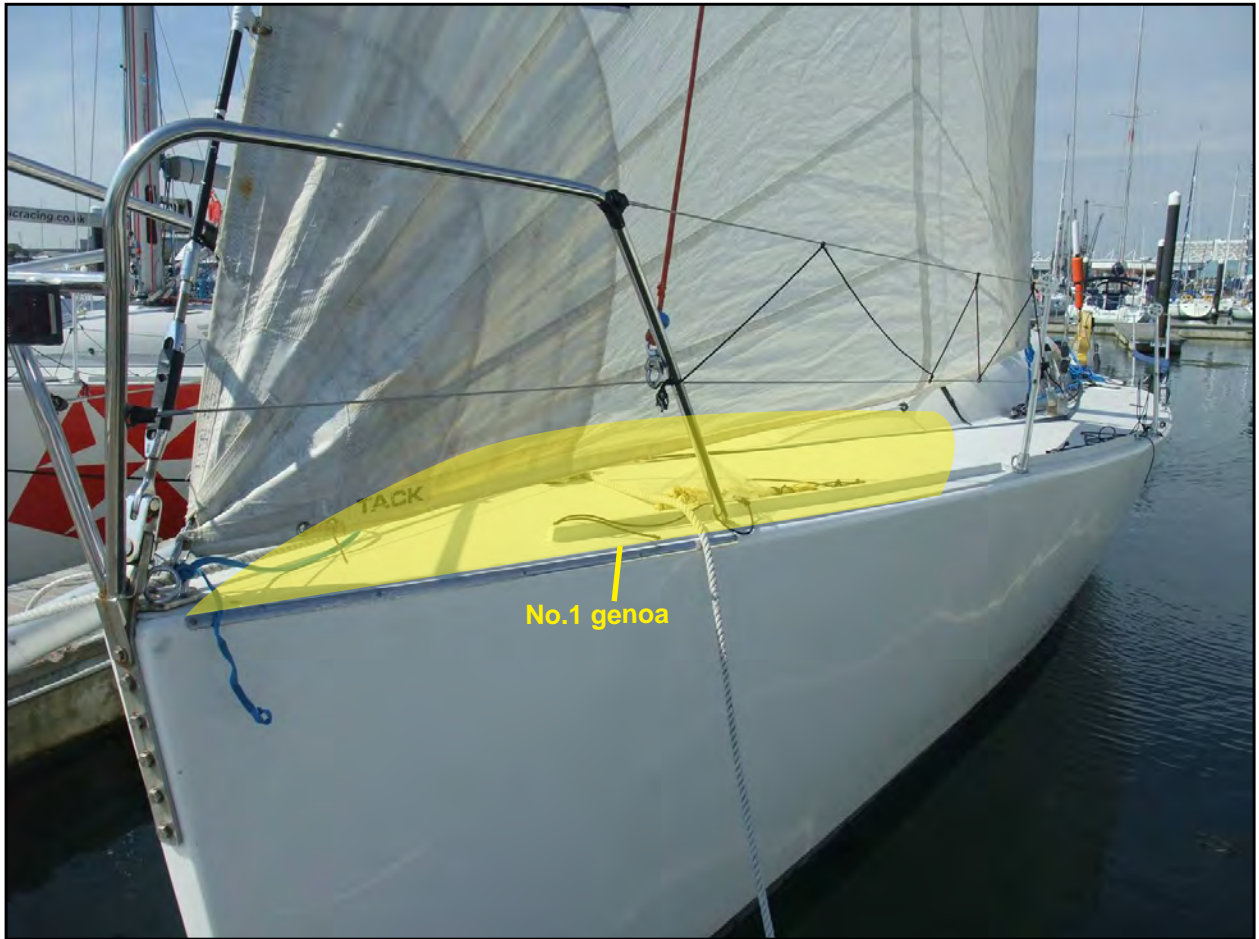
Figure 3: Position of the lashed No.1 genoa

As the weather deteriorated, trimmer 2 noticed that the No.1 genoa was slipping from its lashings. He clipped his tether to the starboard jackline, went forward up the starboard side and used two additional sail ties to re-secure it.

At 0027, the helmsman felt the yacht's handling characteristics change. At the same time, he noticed that the No.1 genoa had slipped from its lashings and was streaming down the port side of the yacht. However, the tack remained secured to the forward pad eye, which prevented the sail from floating away. The skipper called the bow and mast men to the deck to help recover the sail if required. Meanwhile the helmsman concentrated on maintaining a steady course to assist the recovery operation. As the mast man entered the cockpit he noted the wind speed indicator was reading 38 knots. The yacht was heeling to port with her toerail dipping into the water.

Following a sail change, it is good practice to immediately stow the replaced sail below deck unless it is likely to be required again very soon after the change. Given that the wind strength when the sails were changed was above 30 knots, it was most unlikely that the No.1 genoa would have been used again during the race.

Stowing sails that are not in use below deck keeps the working deck free of clutter and eliminates the risk of high value sails being lost overboard. It also reduces the need for crew members to spend time in the forward, high-risk area during hostile weather and rough sea conditions. However, the skipper may have perceived that it was safer to have secured the No.1 genoa on deck in the prevailing circumstances, given that *Lion* was about to round Owers light buoy and sail upwind. This would have increased pitching and angle of heel.

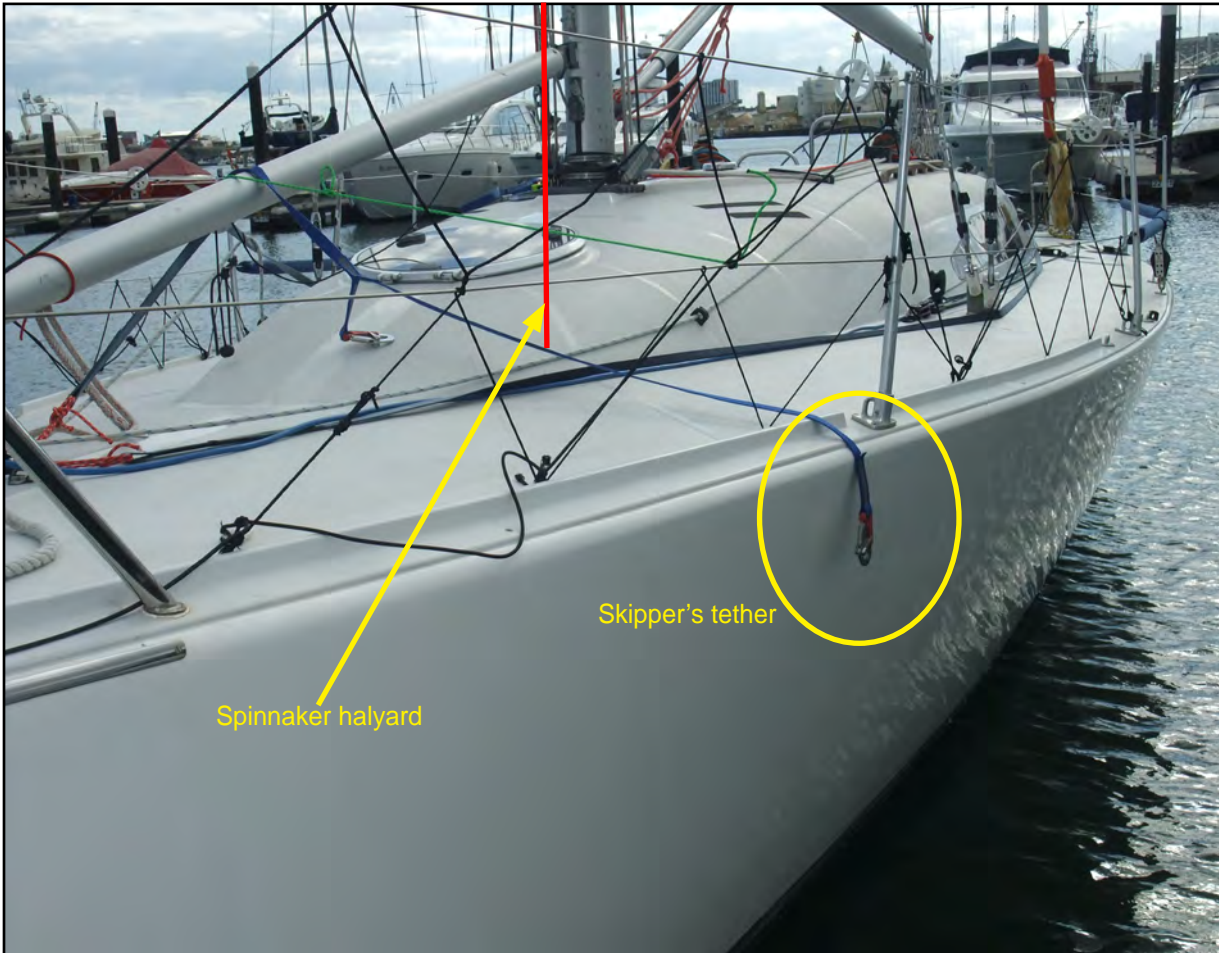
Figure 8: Pictorial interpretation of the spinnaker halyard connected to the skipper's tether

The skipper was found in the water on the port side with his lifejacket inflated and the lifejacket bladder over his head, obscuring part of his face. His tether was still connected to the starboard jackline and had passed over the spinnaker pole and under the lower guard wire between the pulpit and the first vertical stanchion (**Figure 7**). The mast and bow men went to the port side and attempted to pull the skipper out of the water. Trimmers 1 and 2 remained on the starboard side; they leant across the spinnaker pole and hauled on the skipper's tether. The team managed to raise the skipper's head above water, but there was no reaction from him. Attempts by the mast man to clear the skipper's airways and check for signs of life proved very difficult because of the obstructing lifejacket bladder.

At about 0052, the skipper was recovered to the deck. The final effort and load on the halyard pulled the lifejacket up and over his head. However, the recovery team managed to hold onto the skipper's clothing to prevent him from falling overboard again.

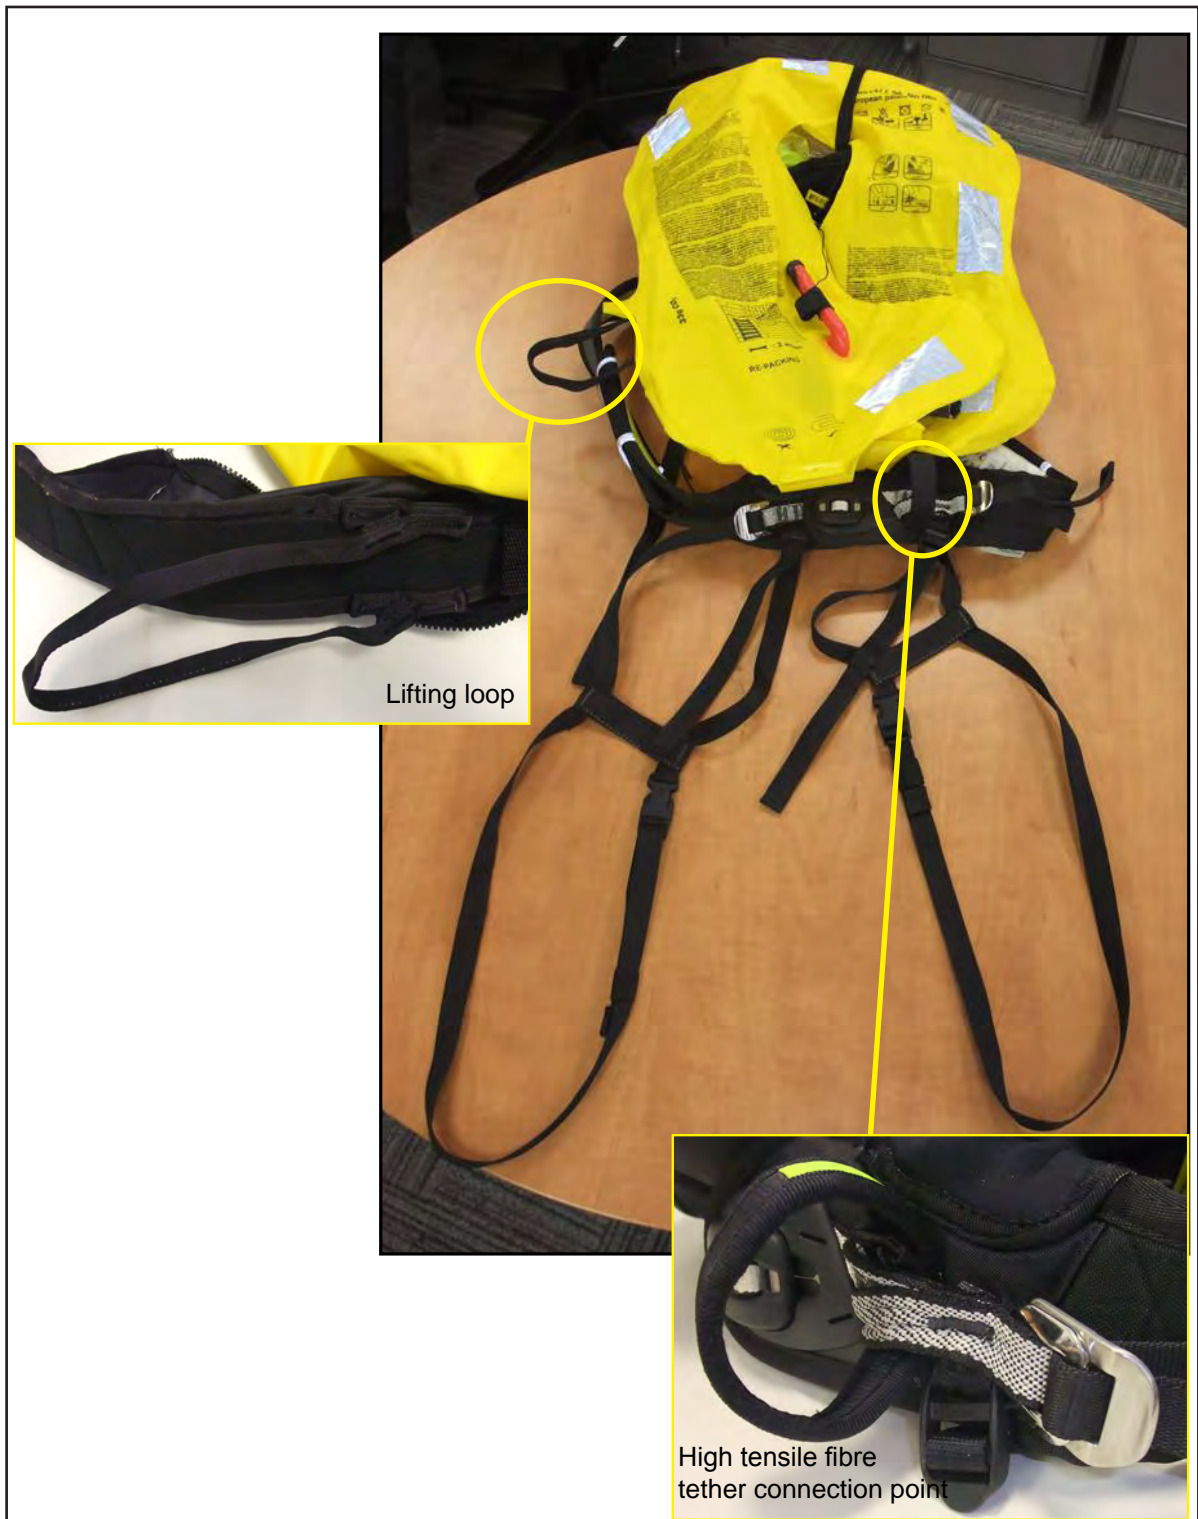
Following the accident it was noted that the thigh strap side release buckles were easily unclipped under straight load tension, and especially so under rotational load. Straight pull load tests showed that the left and right thigh strap buckles released when a load of 20 kilogram-force (kgf) and 40kgf was applied respectively. It is understood from the lifejacket manufacturer that the buckles should withstand a 50kgf load before unfastening.

On inspection following the accident, the lifejacket, harness and thigh straps were found to be in good condition with no obvious damage to their components. The arrangement is shown at **Figures 12** and **13**.

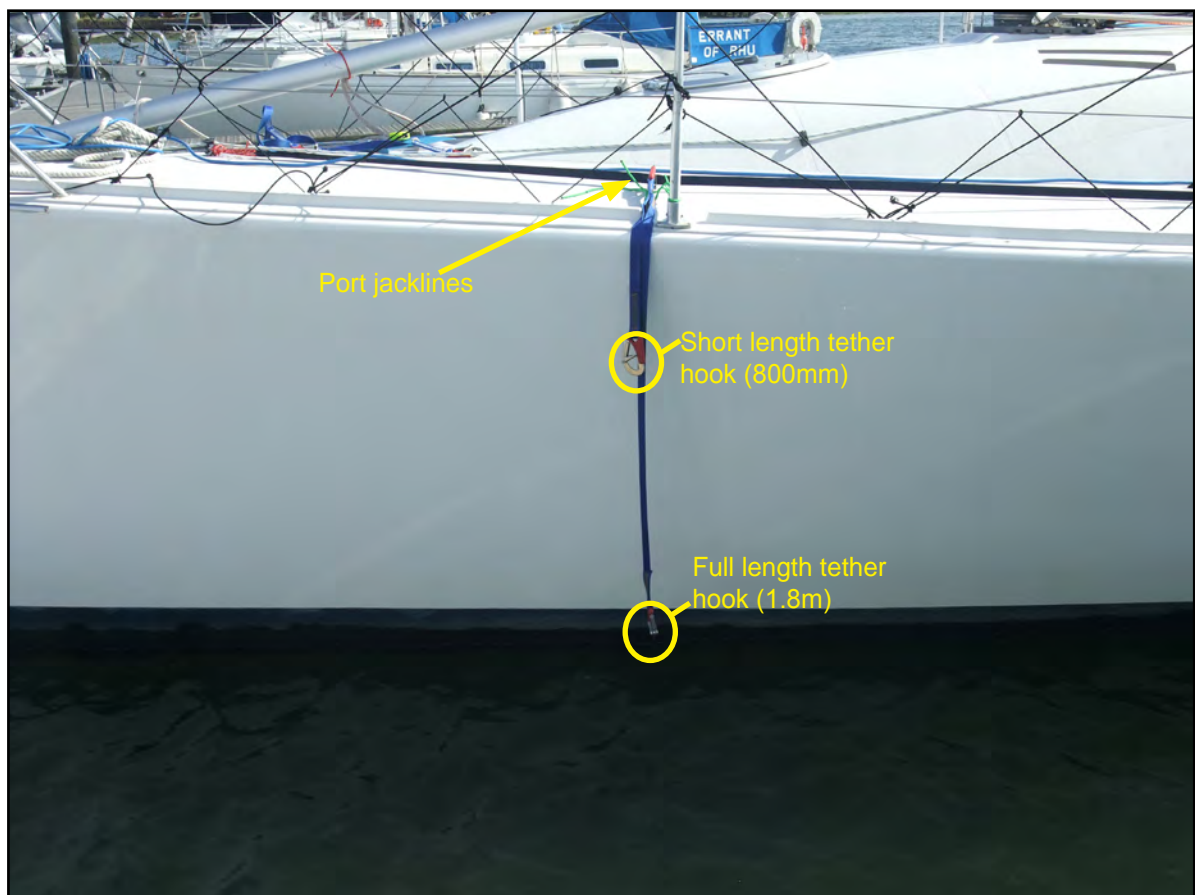
Figure 16: Three-hook tether connected to the port jackline

When a three-hook tether was connected to the deflected port jackline, the long and short tethers extended 1.2m and 500mm over the port deck edge respectively (**Figure 16**).

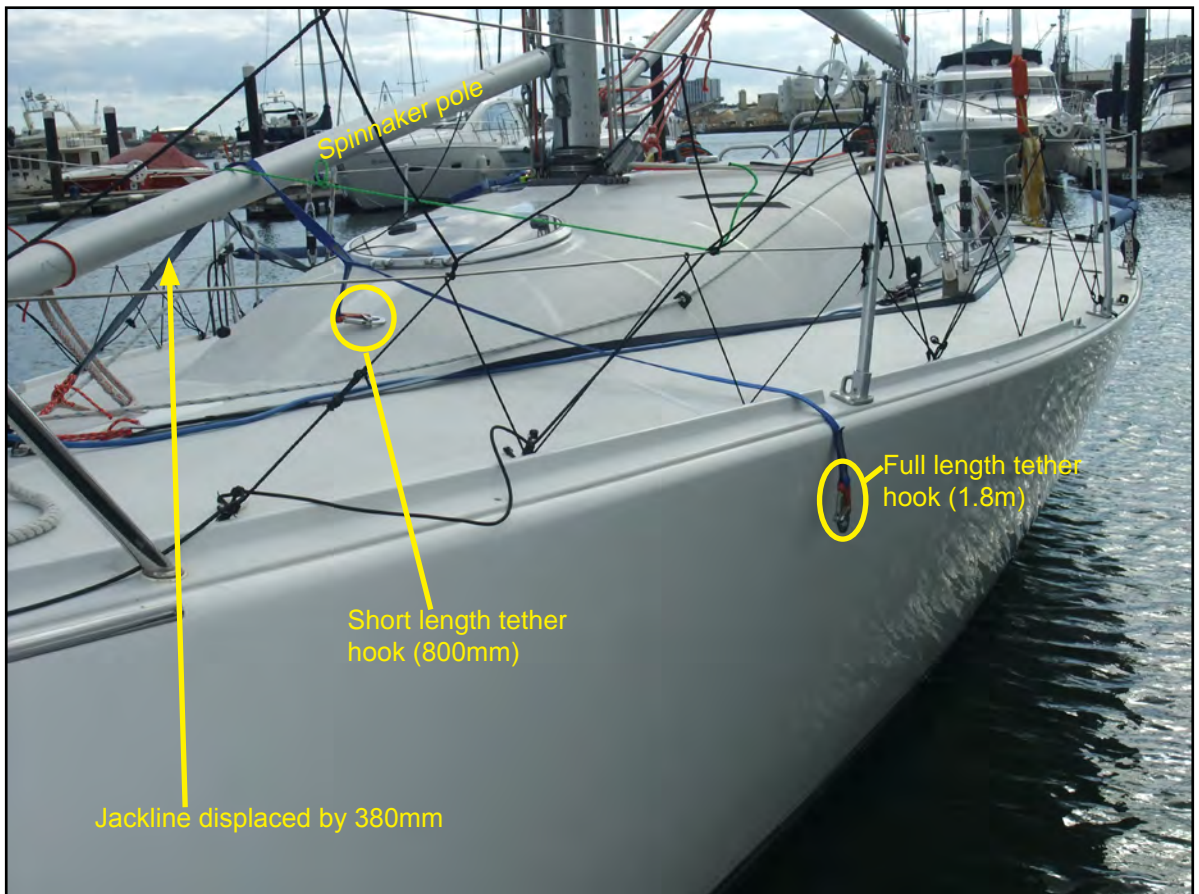
When the same three-hook tether was connected to the starboard jackline and passed under the spinnaker pole, the long tether extended 450mm over the port deck edge. When passed over the spinnaker pole it extended 250mm over the port deck edge (**Figure 17 and 18**). In both cases the short tether hook remained well clear of the port deck edge.
