Vector 40R powerboat, contact with a navigation buoy

in Southampton Water

13 May 2015

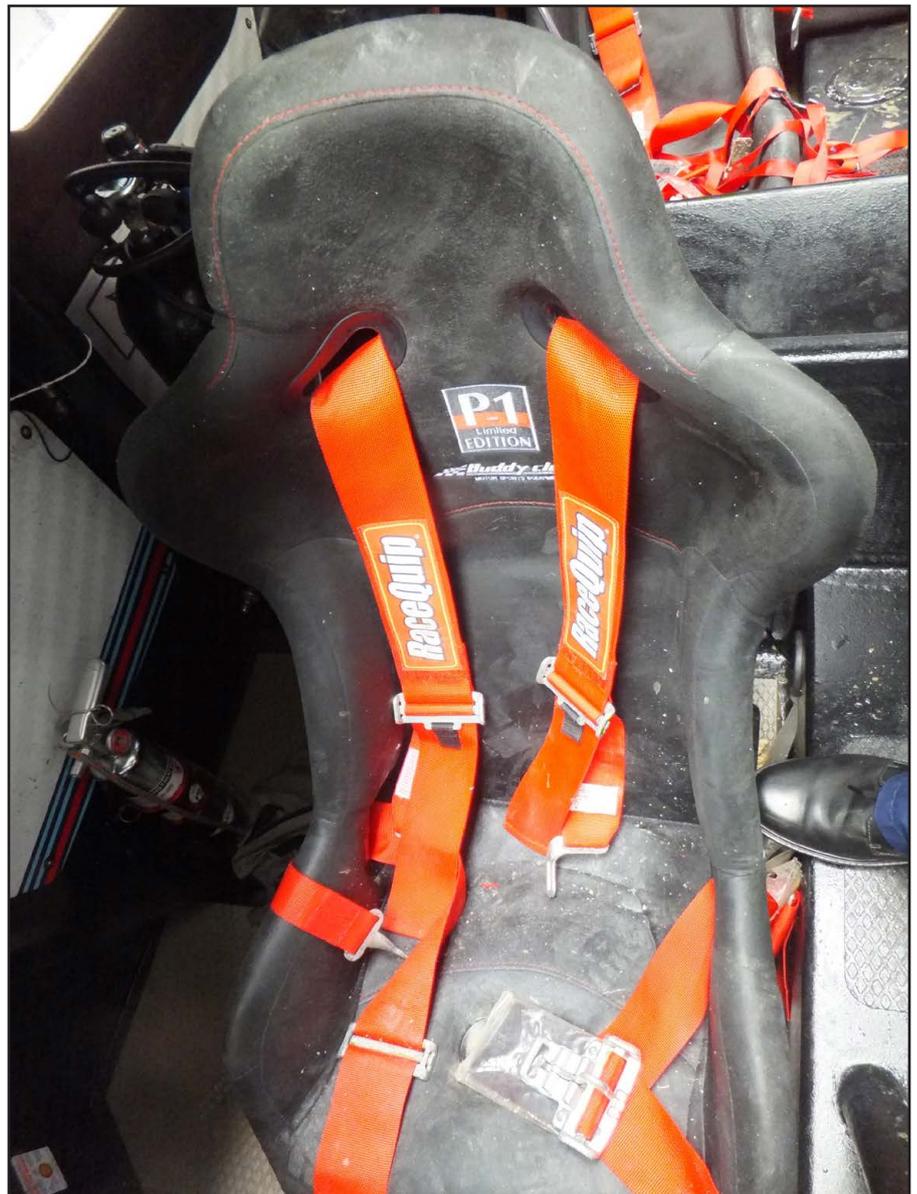
Figure 2: Harnesses (5 point) fitted to each seat

The control measures undertaken were insufficient in that the relevant harbour authority was not notified in advance and the passengers and crew were not wearing seatbelt harnesses or helmets for the test, during which the boat reached a top speed of 87kts (100mph).

Travelling at high speeds during tests, or for the experience such rides provide, can exert forces on individuals similar to those experienced during racing. Had the boat been entered for a race, the use of harnesses and helmets would have been mandated by the race organisers: this requirement would have been well known to the driver and co-driver. The purpose of the helmets and harnesses is to help protect the boat's occupants from injury in the event of an accident. Had the crew and passengers of the Vector 40R been strapped in and wearing helmets during this accident, it is likely that their injuries would have been less significant.

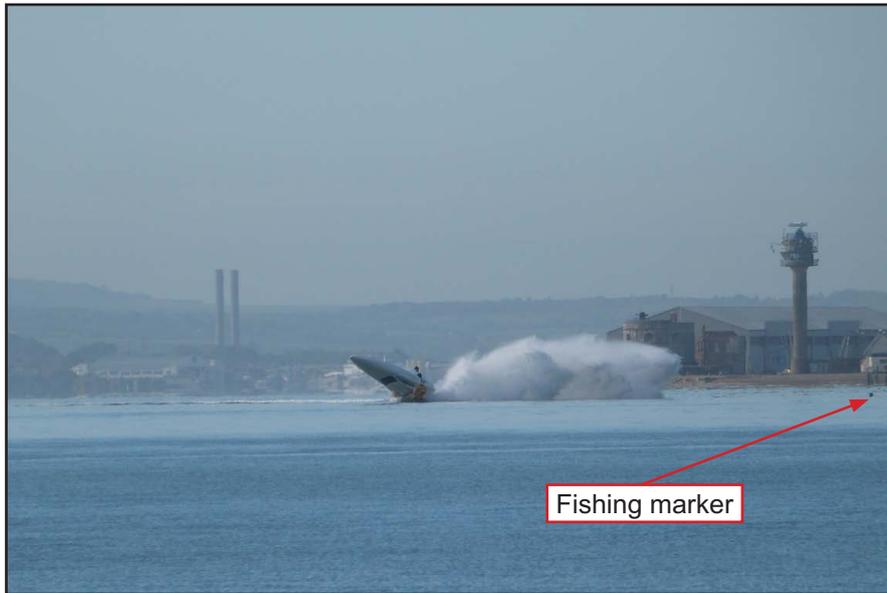
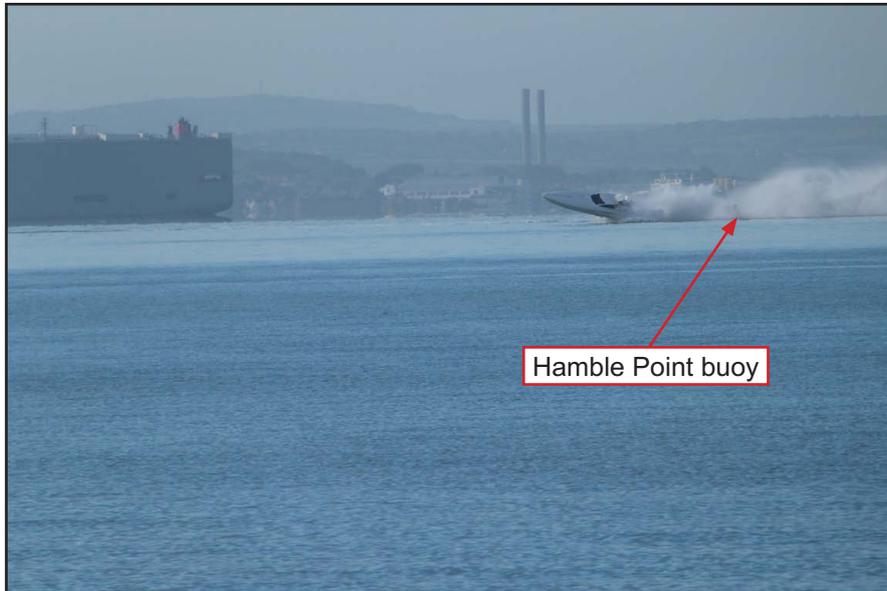
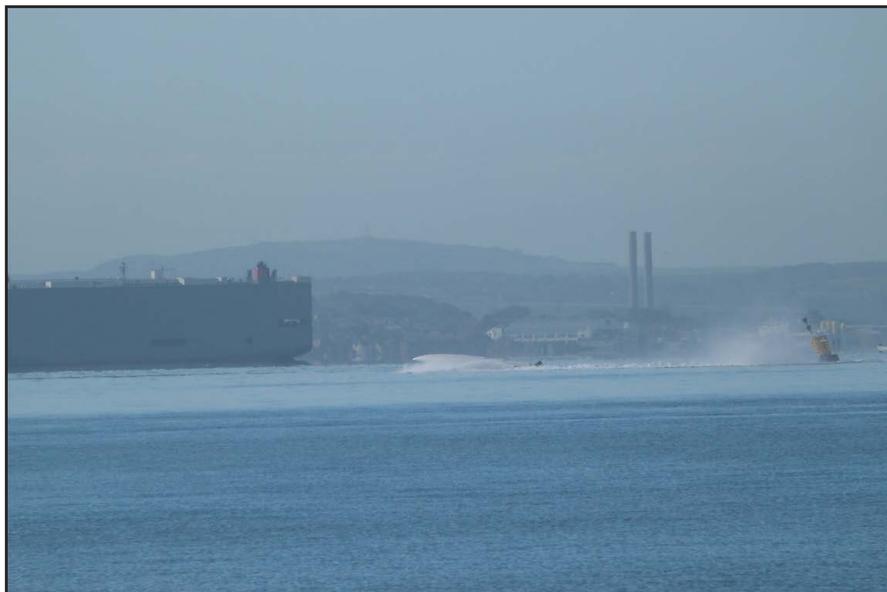
Figure 5: Accident sequence

As the additional helm was applied the boat hooked⁴ violently and turned and heeled to starboard towards the *Hamble Point* buoy. Although the driver reduced throttle speed, and eased the helm, the boat rolled violently back to port, inverted and became airborne, striking the *Hamble Point* buoy (**Figure 5**).

After the contact, still airborne, the boat began to roll to starboard until it landed heavily in the water on its port side. It then settled, inverted, on the surface of the water (**Figure 5**).

The boat was being turned to starboard still travelling at high speed while on the plane when the driver saw the fishing gear markers, and tightened the turn. It is possible that this coincided with the hull coming into contact with the wash waves seen earlier by the driver but, in any event, the lateral forces generated went beyond the capabilities of the hull, causing the keel to lose traction with the surface of the water and the boat to hook.

The transverse acceleration forces generated when the slide stopped, as the keel regained traction with the water, caused the hull to roll violently back to port, become airborne and invert. It was while the boat was inverted that it struck the navigation buoy.

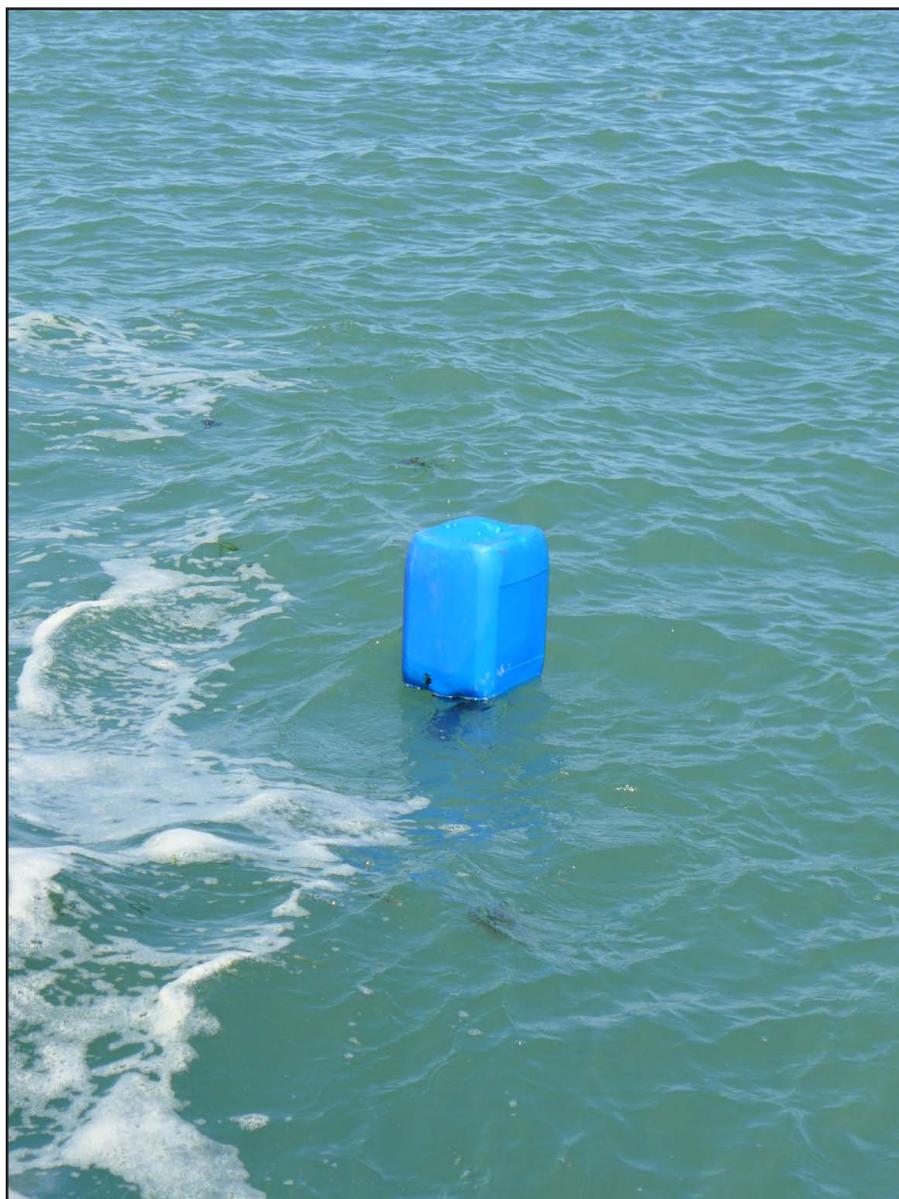
Figure 6: Fishing gear marker

The two floats seen by the driver as he turned the boat to starboard before the accident occurred, and which he thought were divers' marks, were in fact fishing gear markers that had been laid earlier that day

by a fisherman to mark a string of pots. The fisherman had operated in the same area for several years and had used similar 5 litre plastic containers to mark the location of his fishing gear throughout that time (**Figure 6**).

The markers that the driver saw did not comply with the harbour authority's requirements. Had the harbour authority been able to enforce its requirements there would have been a greater likelihood that the fishing gear would have been marked appropriately, making it significantly more visible.
