ACCIDENT

Aircraft Type and Registration:	BAe 146-200, G-RAJJ	
No & Type of Engines:	4 ALF502R-5 turbojet engines	
Year of Manufacture:	1988 (serial number E2108)	
Date & Time (UTC):	23 February 2015 at 1854 hrs	
Location:	Guernsey Airport, Channel Islands	
Type of Flight:	Commercial Air Transport (Passenger)	
Persons on Board:	Crew - 4	Passengers - 47
Injuries:	Crew - None	Passengers - None
Nature of Damage:	Shock absorber damaged beyond economic repair, damage to left main landing gear and No 1 tyre burst	
Commander's Licence:	Airline Transport Pilot's Licence	
Commander's Age:	58	
Commander's Flying Experience:	8,428 Hours (of which 5,300 were on type) Last 90 days - 32 hours Last 28 days - 23 hours	
Information Source:	AAIB Field Investigation

Synopsis

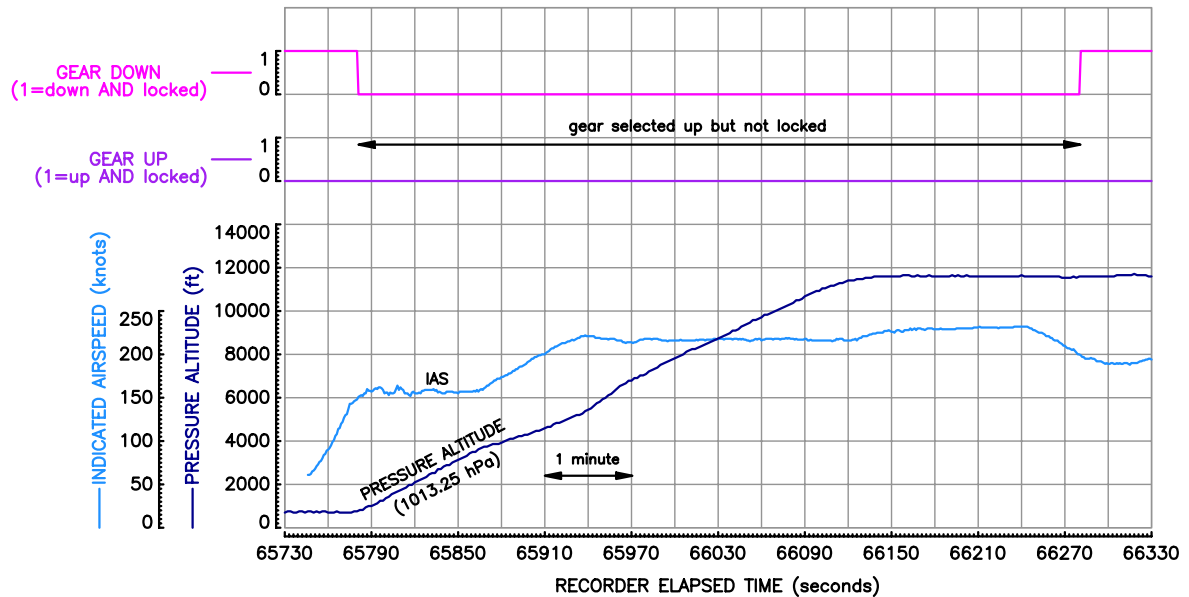
Figure 1

A time history of the salient parameters from the QAR for the takeoff from Gatwick Airport is shown at Figure 1. The data shows that during the climb, at between 75 ft and 99 ft agl, the landing gear was no longer down-and-locked, which was consistent with the gear selector

being moved to the UP position. However, the landing gear did not go into the up-and-locked position, which was consistent with the position indicators showing red. The gear returned to the down-and-locked position just over eight minutes later, when the aircraft was at about FL120, which was consistent with the gear selector being moved to the DN position and the position indicators showing green. The landing gear remained in this state for the rest of the flight.

G-RAJJ salient flight data from QAR

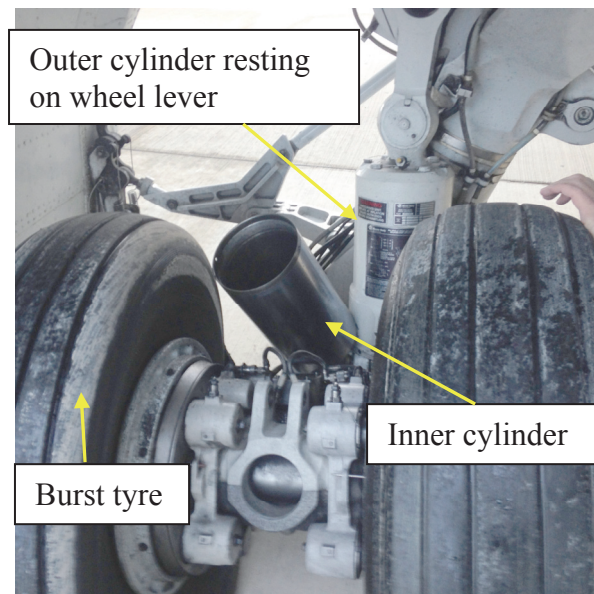
Figure 6
Left main landing gear

Following the accident the shock absorber inner cylinder was found to have separated from the outer cylinder, Figure 6. The top surface of the wheel lever had sustained damage as a result of contact with the outer cylinder. The inner cylinder had made contact with the No 1 brake pack Green hydraulic system quick release pipe, causing it to detach from its connecting union. The operator's engineers later established that the Green hydraulic system had only lost one litre of fluid.

The inner cylinder also rubbed against the inner sidewall of the outer tyre (No 1 mainwheel), which had punctured and deflated. The frame, which runs down the centre of the lower fuselage between the main landing gear bays, had been damaged. Tyre marks indicate that the No 2 mainwheel caused this damage during the retraction sequence. The sheared bolt head attached to a long section of locking wire recovered from the runway was identified as being from one of the shock absorber diaphragm locking bolts. There was no damage to the bottom of the wheel lever.

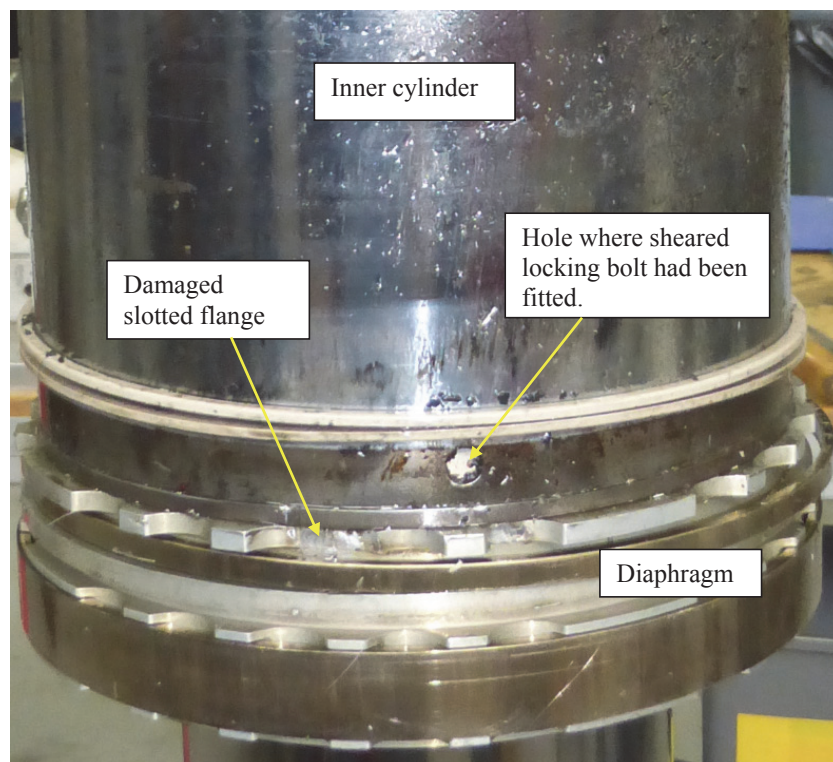
Figure 7
Inner cylinder and diaphragm

- One of the slotted flanges had broken away from the diaphragm. It was concluded from the damage to the flange that the sheared diaphragm locking bolt head had become trapped between the flange and the outer cylinder bore causing the flange to break, Figure 7.

- Mechanical damage on the diaphragm, shim, recoil ring and outer cylinder, was assessed as having been caused by the bolt head, which suggests that the locking bolts had sheared some cycles before separation of the shock absorber.

- One small area of fatigue cracking was seen in the threads on the diaphragm, in the first full thread immediately below one of the locking bolt holes. The cracking consisted of two fatigue cracks, one on each side of the thread. This damage was consistent with the threads on the diaphragm and inner cylinder having been cyclically loaded in both tension and compression.
- The hardness of the diaphragm and inner cylinder materials were within specification. The locking bolt hardness was slightly above specification, but this is not thought to have contributed to its fracture, or separation of the shock absorber.
- The material microstructures of the diaphragm and inner cylinder were normal.
