**ACCIDENT**

<b>Aircraft Type and Registration:</b>	Alpi (Cavaciuti) Pioneer 400, G-CGVO	
<b>No &amp; Type of Engines:</b>	1 Rotax 914F piston engine	
<b>Year of Manufacture:</b>	2011	
<b>Date &amp; Time (UTC):</b>	3 January 2015 at 1528 hrs	
<b>Location:</b>	Near Popham Airfield, Hampshire	
<b>Type of Flight:</b>	Private	
<b>Persons on Board:</b>	Crew - 1	Passengers - 2
<b>Injuries:</b>	Crew - 1 (Fatal)	Passengers - 2 (1 Fatal) (1 Serious)
<b>Nature of Damage:</b>	Destroyed	
<b>Commander's Licence:</b>	Private Pilot's Licence	
<b>Commander's Age:</b>	50 years	
<b>Commander's Flying Experience:</b>	201 hours (of which 5 were on type) Last 90 days - 7 hours Last 28 days - 2 hours	
<b>Information Source:</b>	AAIB Field Investigation

**Synopsis**

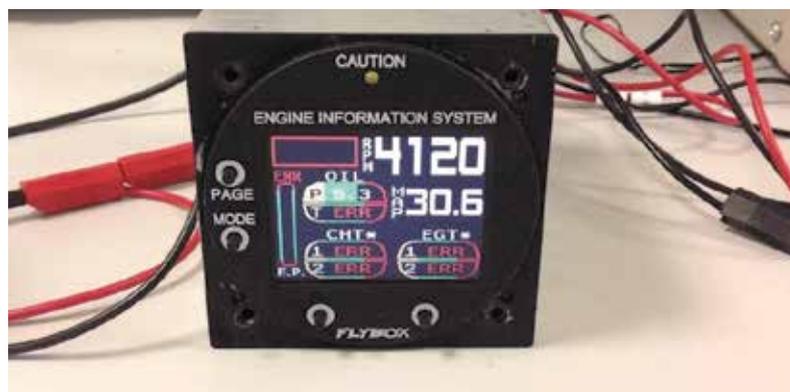
**Figure 3**

The aircraft instrument panel was equipped with a small Engine Information System (EIS) display (Figure 3). This was a user-configurable display that provided information such as flight time, fuel flow, exhaust gas temperature and other relevant parameters relating to the engine. It provided the only display of engine manifold pressure, which was sensed directly by the EIS from an air pressure tapping on the manifold<sup>4</sup>. The EIS also displayed engine rpm, which was an electronic tachometer signal generated by a magnet on the engine flywheel passing a coil. The signal was fed to the EIS via the TCU. The rpm display could be configured so that it changed to yellow, then red as it passed trigger thresholds set by the user. In the case of G-CGVO these were set at 5,770 and 5,800 rpm respectively. The manifold pressure display did not have any form of limit exceedence warning. The rpm signal was also supplied from the EIS to a traditional rpm dial gauge on the aircraft instrument panel.

EIS on test bench showing rpm and manifold pressure display

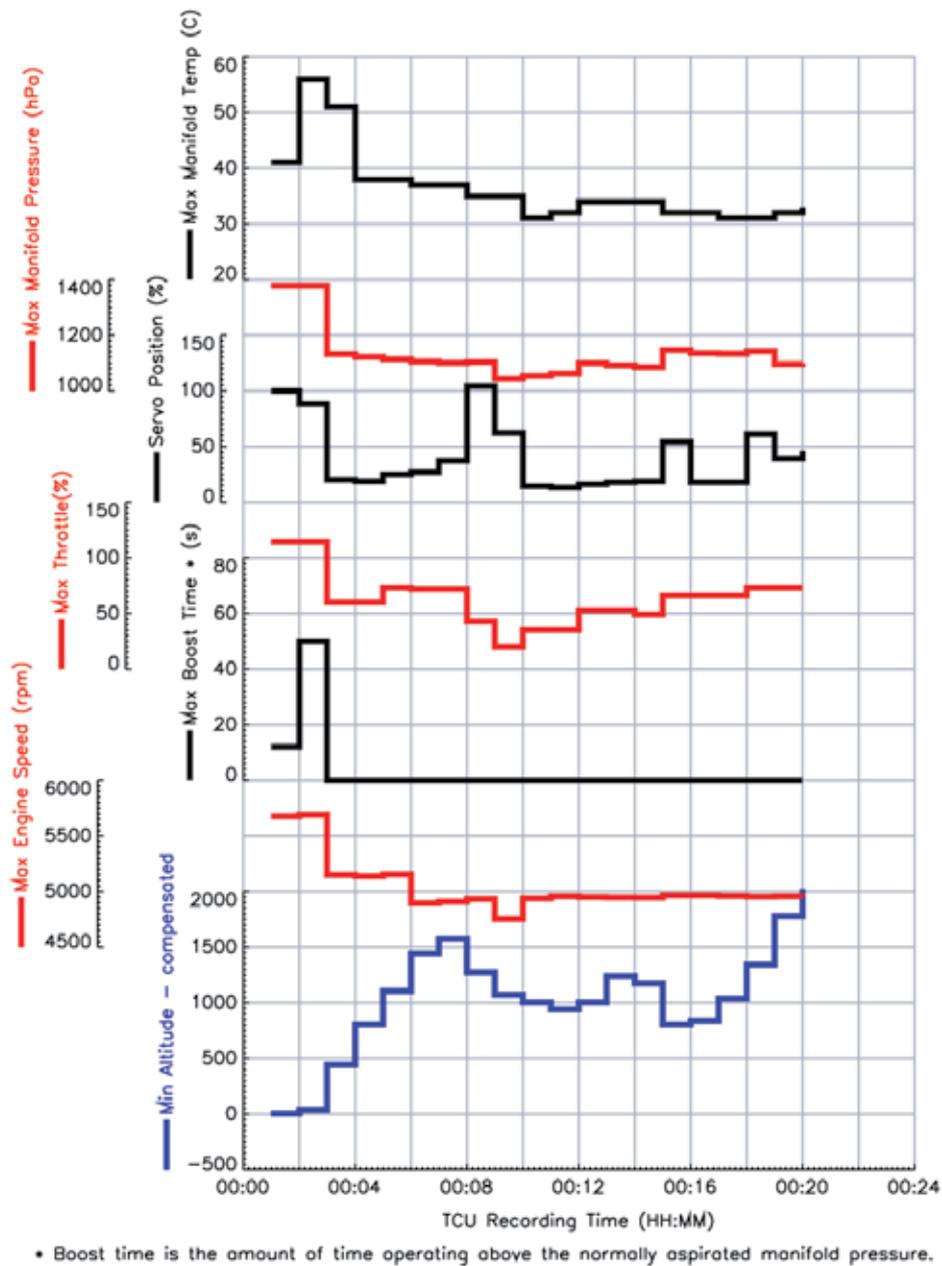
**Figure 4**

The TCU records alerts triggered by engine parameter exceedences. All 42 recorded alerts had been triggered by a manifold pressure that exceeded the 1,350 hPa threshold. The level of exceedence varied but was mostly within the 1,400 – 1,500 hPa range, with the maximum pressure recorded as 1,542 hPa. The TCU does not provide a warning to the pilot for exceedences below 1,550 hPa. The exceedences all occurred with a throttle position above 100%, but the associated wastegate servo position was not always recorded as being 100% (fully closed). No reference to these exceedences was found in

TCU download of the last 20 minutes of recorded operation

either the engine or aircraft log books. The manufacturer requires that such exceedences are recorded but unless the exceedences are observed whilst they are displayed on the MAP readout on the EIS screen, the pilot may be unaware they had occurred.

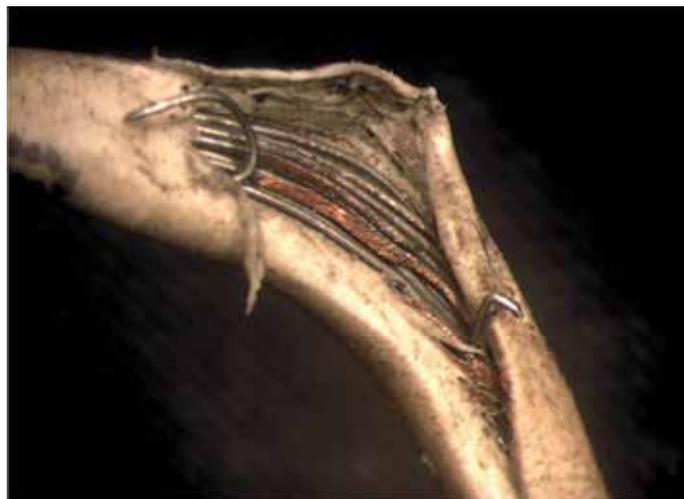
**Figure 6**

A detailed inspection of the aircraft instrument panel and aircraft wiring was also carried out to identify any defects which may have resulted in the loss of power supply or tacho signal to the TCU. The power supply circuit breaker for the TCU was found in the open position, although several other circuit breakers close to it on the panel were still in the normal closed position. The wiring looms on the engine and behind the instrument panel had suffered damage during the accident sequence, but there was full continuity for the TCU rpm and power supply wiring. However, one of the wires from the throttle position sensor to the TCU was damaged approximately three centimetres from the sensor connector, in a manner that was not consistent with the other examples of impact damage. On closer inspection the inside of the wire's insulation was found to be coated with residue. Inspection of the wire under a microscope showed that the copper conducting wires had been worn flat, with the surface covered in microscopic striations oriented in slightly different directions. (Figure 6)

Magnified image of damaged throttle position sensor wire

The damage to the wire from the throttle position sensor to the TCU is consistent with it having chafed on an adjacent part of the engine. This would have created a ground on the wire, causing the TCU to drive the wastegate of the turbo fully closed and trigger the orange flashing TCU warning light on the instrument panel. It is also likely that engine manifold pressure and rpm would have increased in response to the turbo becoming active, although with the throttle below the takeoff power position, it is unlikely the engine would have exceeded any operating limitations at this point.

In light of the chafing damage identified on the engine wiring, the following Safety Recommendation is made:

#### **Safety Recommendation 2016-030**

It is recommended that BRP-Powertrain GmbH & Co. KG reviews the wiring installation design and guidance for the Rotax 914 engine to optimise the routing and protection for wiring looms to minimise the likelihood of damage from chafing.
