Fatality of shore worker while disembarking from *OLDENBURG* Ilfracombe Harbour 3 August 2015

SUMMARY

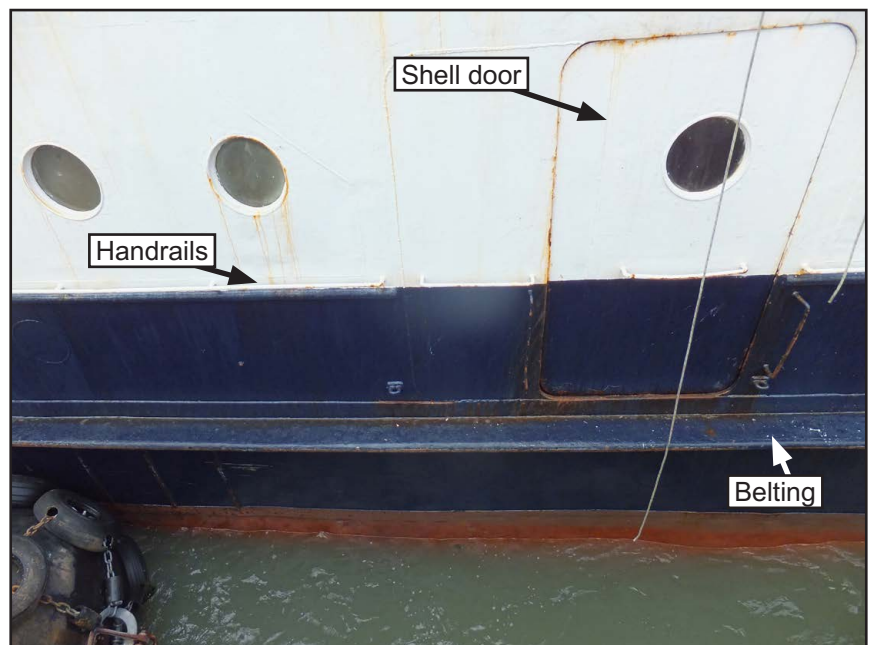
The vessel was fitted with shell doors in the hull on its port and starboard sides at main deck level. A ship's side belting or rubbing strake, with handrails above, was also fitted on each side (**Figure 1**) to protect its hull while lying against harbour walls.

Figure 1: Shell door, ship's side belting and handrails

The 240mm wide belting ran from forward to aft along most of the hull sides. Handrails of 15mm diameter had been fitted to the hull 1.20m above the belting for the crew to hold on to while carrying out maintenance. The outer edge of the handrails protruded 75mm from the hull side, so when the vessel was tight alongside a vertical face the gap between the handrail and the face was 165mm.

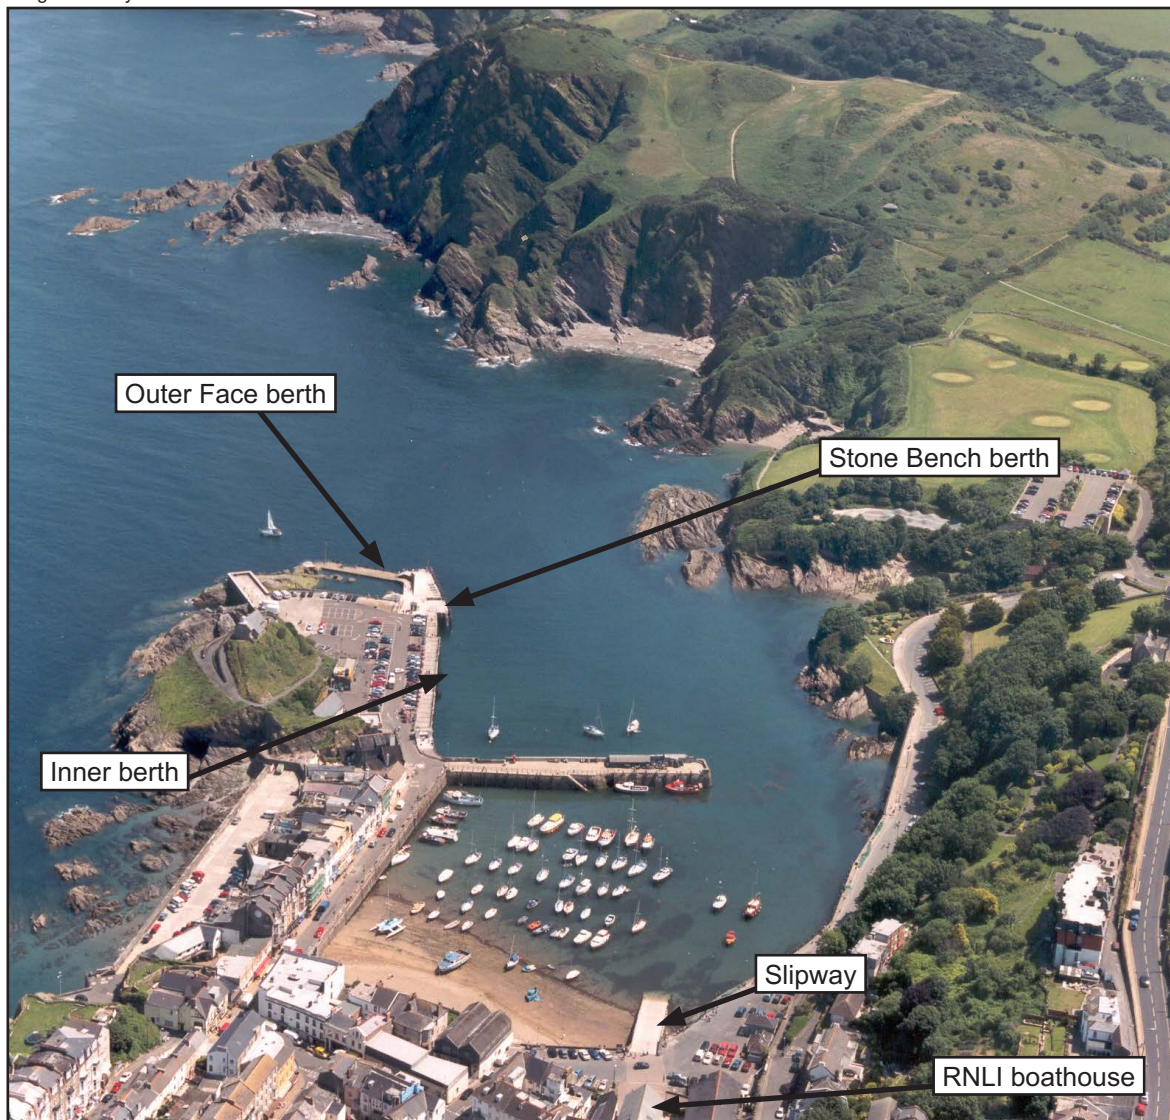
Figure 2: Ilfracombe harbour

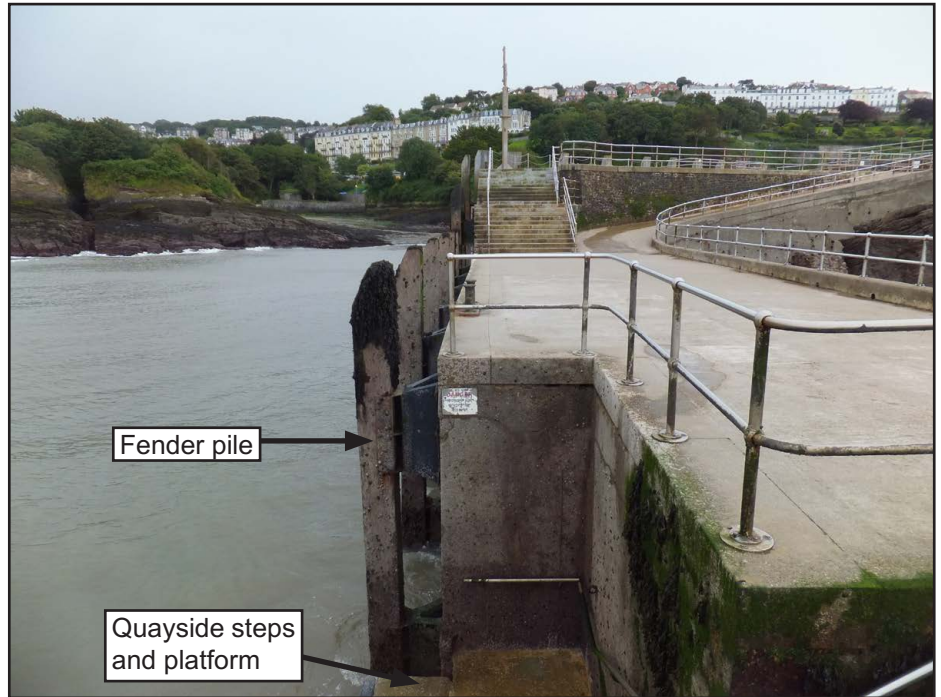
Figure 3: Outer Face berth

The Outer Face berth was close to the harbour entrance and exposed to the open sea. The vessel was moving up to 1.0m fore and aft and 0.5m transversely off the berth due to the influence of the prevailing swell.

The harbour authority had undertaken a berthing assessment in 2001, which stated that the Outer Face berth *“is in a position within the harbour area that has no shelter, except when Westerly to South Easterly weather systems occur. If there is any swell, it is normally funnelled around and along the face making its use difficult”*.

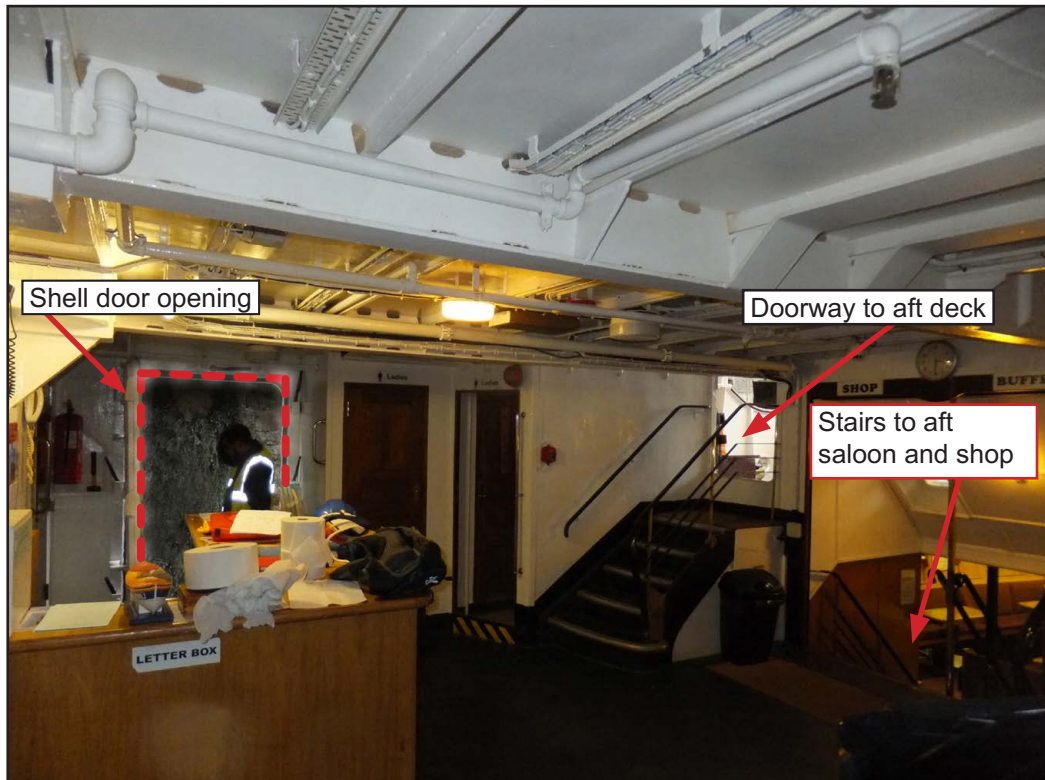
The crew had left Nick in the saloon area, adjacent to the starboard shell door (**Figure 4**). This door had been left open and unguarded following its use as an access point for the vessel's gangway at the Stone Bench berth.

Figure 4: Starboard shell door opening, from saloon area

Oldenburg's starboard shell door was open and the opening was unguarded at the time of the accident.

The shell doors were frequently left open when the vessel was alongside, without passengers embarked, to improve ventilation through the saloon and lower deck areas. However, no risk assessment had been undertaken for this situation and the hazard created by the unguarded openings had not been recognised.

Had the risks associated with leaving the shell doors open in port been appropriately assessed, the dangers of an unguarded opening would have been realised and suitable control measures - such as barriers and signage – could have been put in place.

- Installed barriers and signage in way of the shell doors to prevent unauthorised use of the doors.
- Introduced a code of practice for visitors to the vessel.
- Revised rope handlers' training to incorporate a record of training provided, and to include means of access and egress to/from the vessel.
- Reviewed its risk assessments for means of access and for maintenance tasks involving use of the shell doors and ship side belting.
- Undertaken crew training relating to the above actions and to emphasise the crew's responsibilities for supervision of visitors to the vessel.
- A ship safety committee meeting was held to consider the above actions.

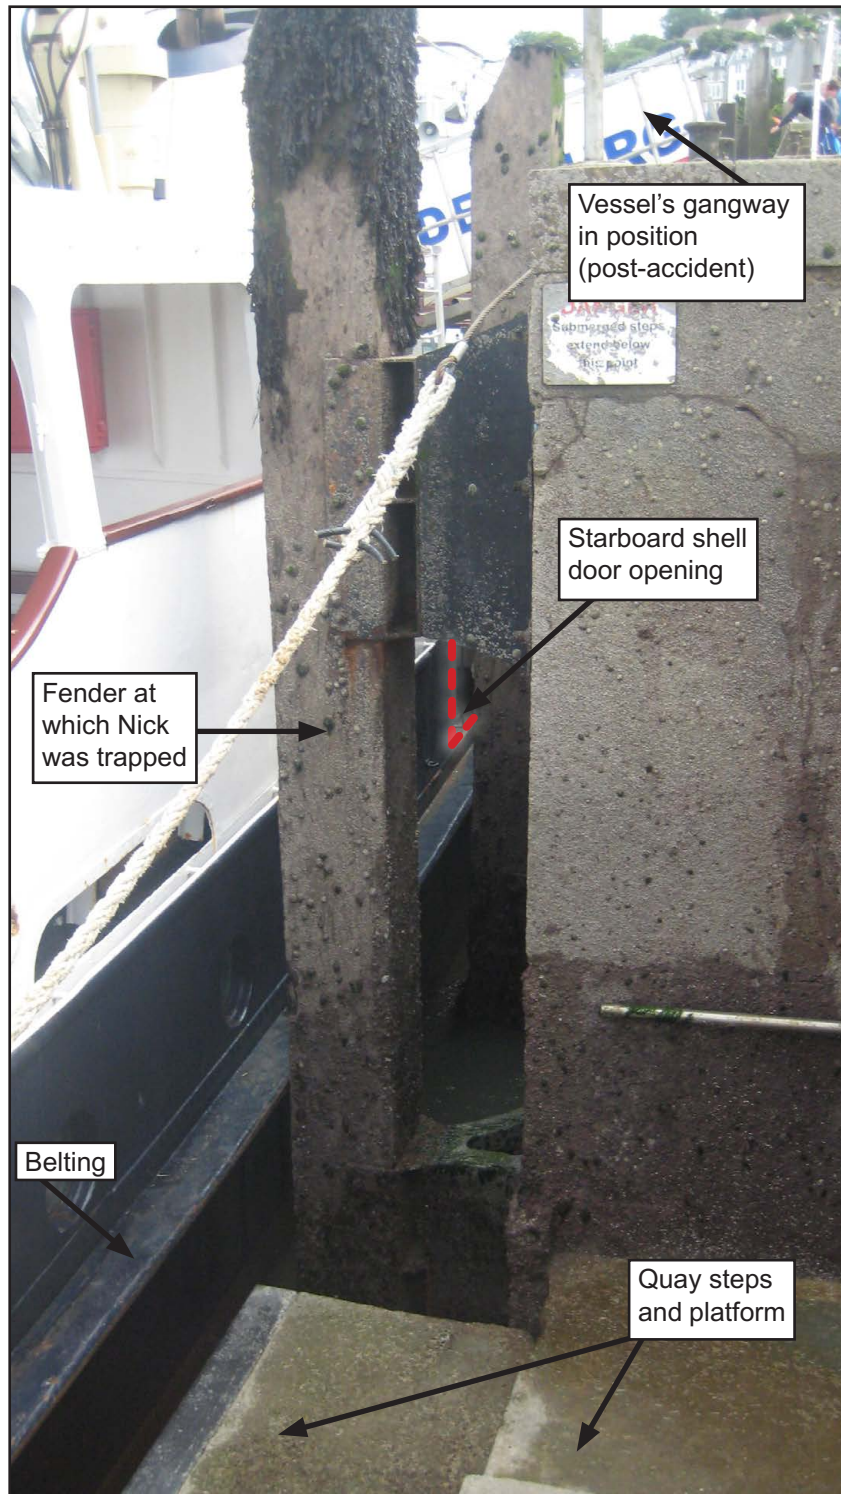
The two crewmen had been on the starboard bridge wing for a few minutes when they heard a cry from that side of the vessel. They looked down and saw Nick trapped between the vessel's side and one of the quayside vertical pile fenders (**Figure 5**).

Figure 5: Location of entrapment

The fenders installed at the berth were 500mm x 500mm hardwood piles that were positioned vertically on rubber core mountings. The spacing between the fenders was 3.0m and the fender at which Nick became entrapped was 4.30m from the shell door opening and 1.0m from the quay steps and platform **(Figure 5)**.

The vessel was moving up to 0.5m laterally away from the quayside due to the prevailing swell, such that the gap between the fenders and the ship's side might have appeared, at times, to be wide enough to reach the quayside platform and steps. Nick had succeeded in getting past the first fender before becoming trapped at the second fender, probably when the gap closed to just 165mm as *Oldenburg* was pushed back alongside by the swell.
