Rail Accident Investigation Branch

# Rail Accident Report

## **Passenger trapped in train doors and dragged at Clapham South station 12 March 2015**

Report 04/2016  
March 2016

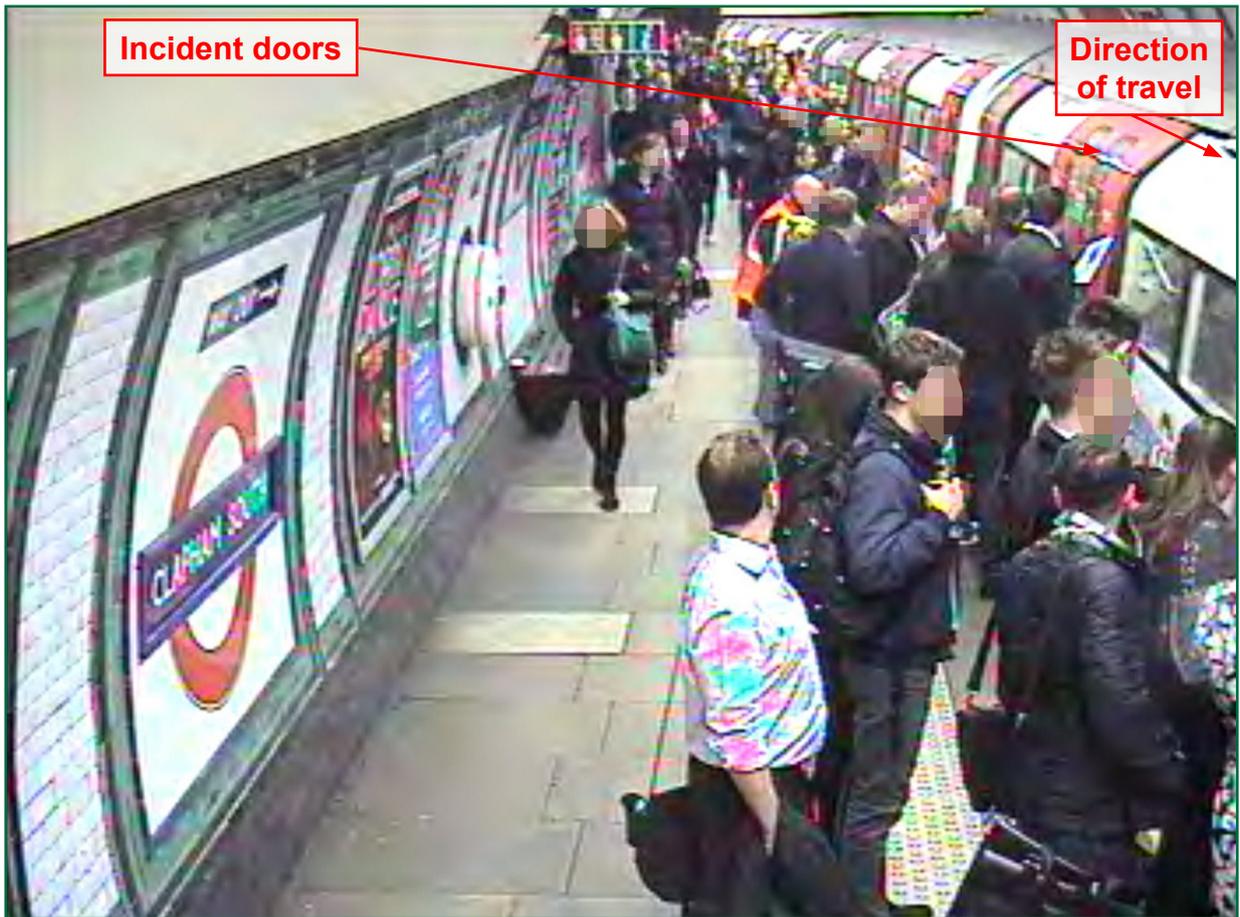
Figure 2: Platform scene at the time of the accident (station CCTV courtesy London Underground)

- 4 The *train operator* saw unusual movements on the platform (figure 2) after the train had started moving and he immediately stopped the train. The electrical power supply to the train was switched off and the emergency services attended to the passenger.
- 5 The passenger sustained a broken arm, and injuries to her shoulder and face. There was no damage to the train, or to the railway infrastructure, and London Underground staff authorised reopening of the station at 09:11 hrs.

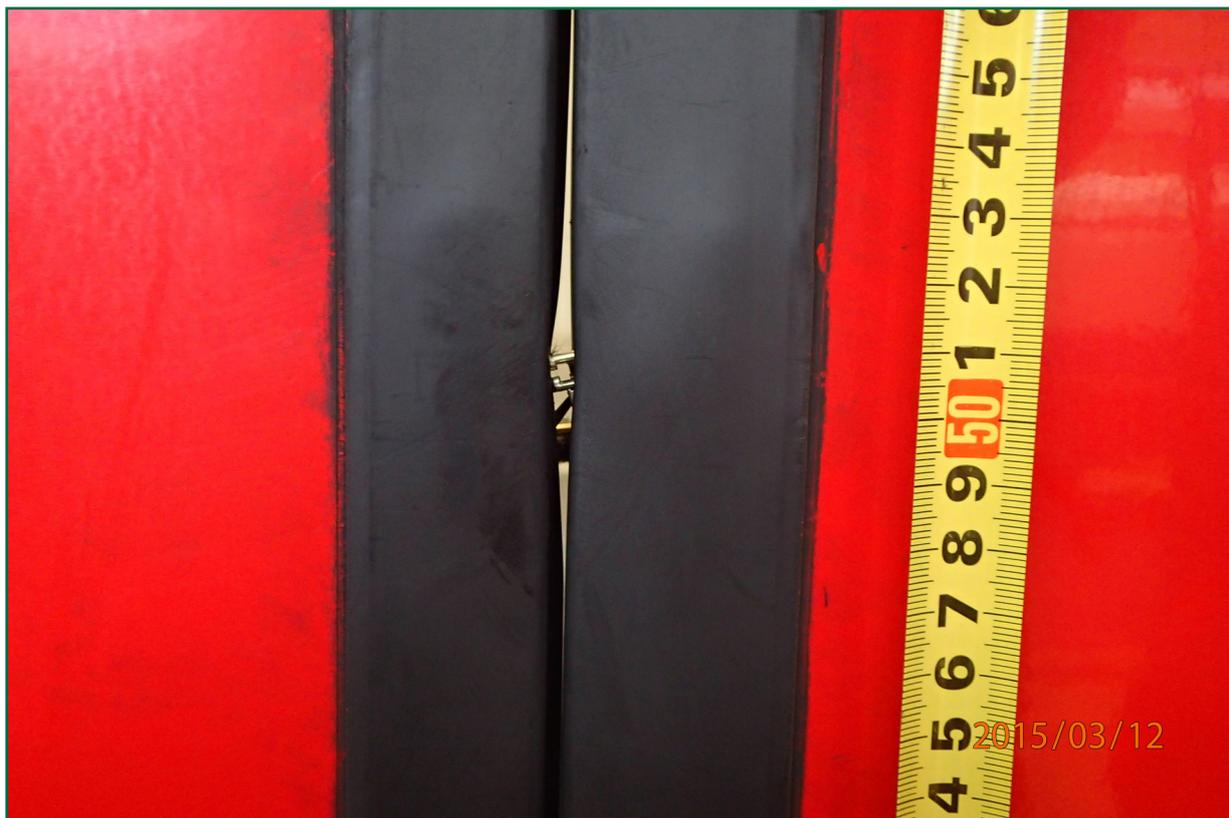
Figure 7: Zip slider, as found in door showing height above train floor

- 39 The zip slider was found trapped between the door leaves at about 0.5 metres above the train floor after the accident (figure 7). There is no evidence to show at what point during the accident sequence the coat was pulled from the position in which a large part of the corner was trapped, to having only the zip slider trapped. It is possible that this happened while the passenger was being dragged.

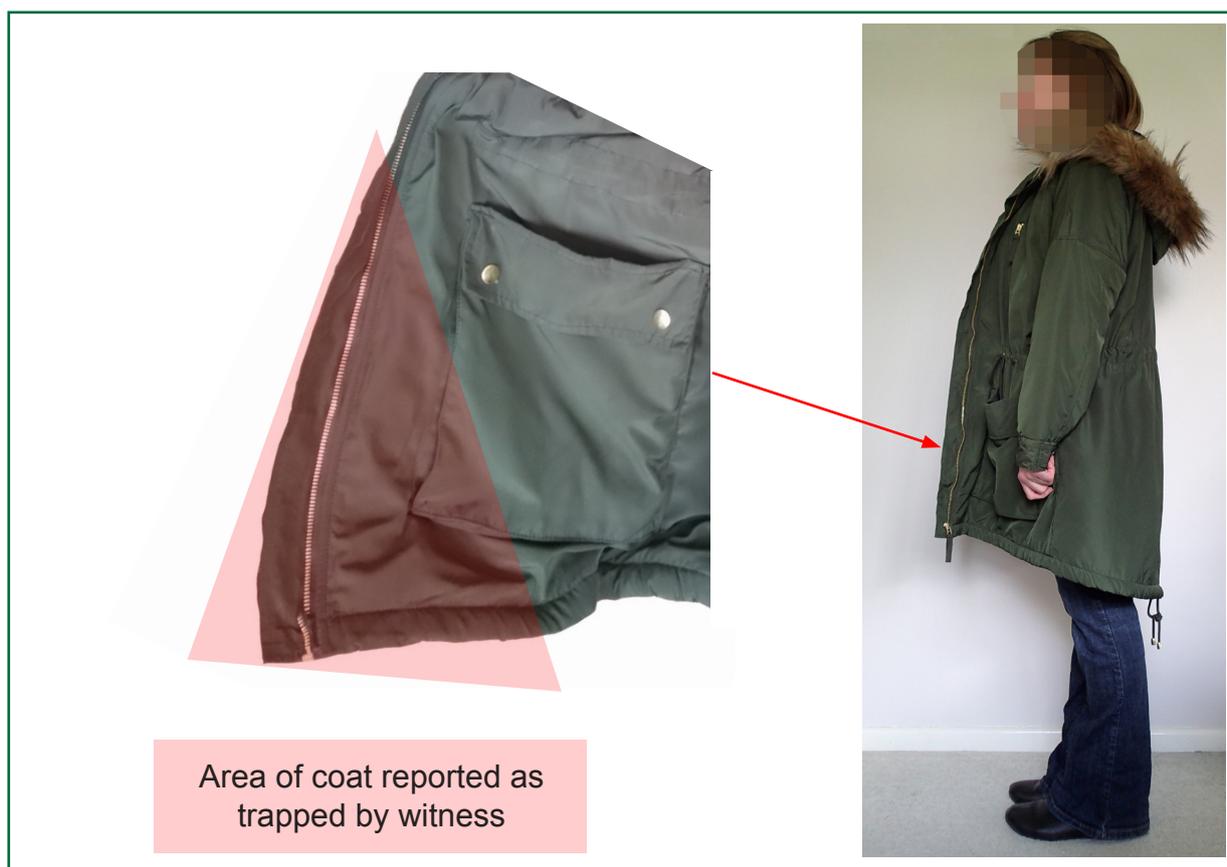
Figure 8: Coat hanging forward when unzipped

- 38 The passenger was wearing a mid-length parka type coat which was unzipped at the time of the accident and so the lower part hung in front of the passenger. The bottom left corner of the coat, including part of a pocket, was trapped in a position which is consistent with the passenger stepping back off the train onto the platform (figure 8).

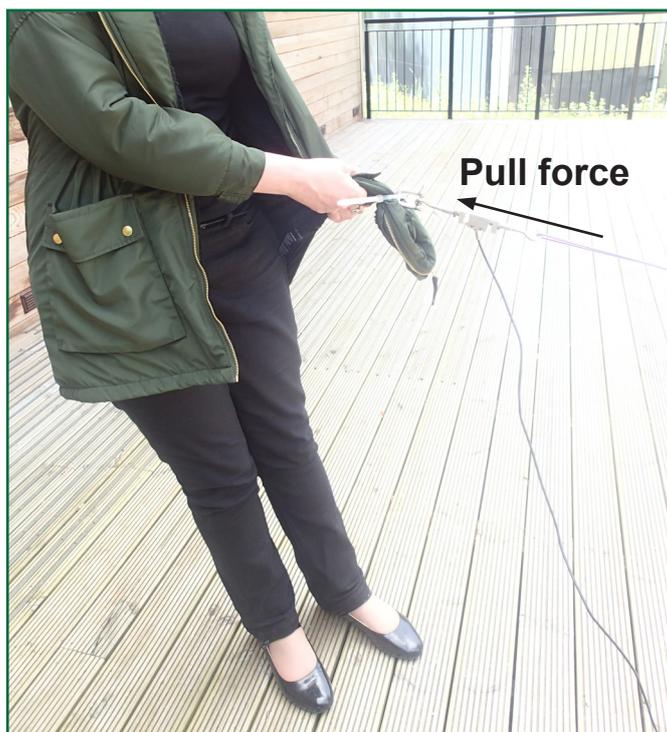
Figure 12: Testing pull-out force applied by person wearing incident coat

50 RAIB tests showed that a female of similar build to the passenger, and wearing a coat of the same type, could pull on the coat corner with a force of up to about 350 N (figure 12)<sup>4</sup>. However, the passenger only had a limited time (less than 5 seconds) to recognise her predicament before the train started to move and, until then, did not realise that the train would move with her still trapped. The force she could apply was probably limited because she was physically constrained to remain in the small space between the train and the passengers standing along the yellow line.

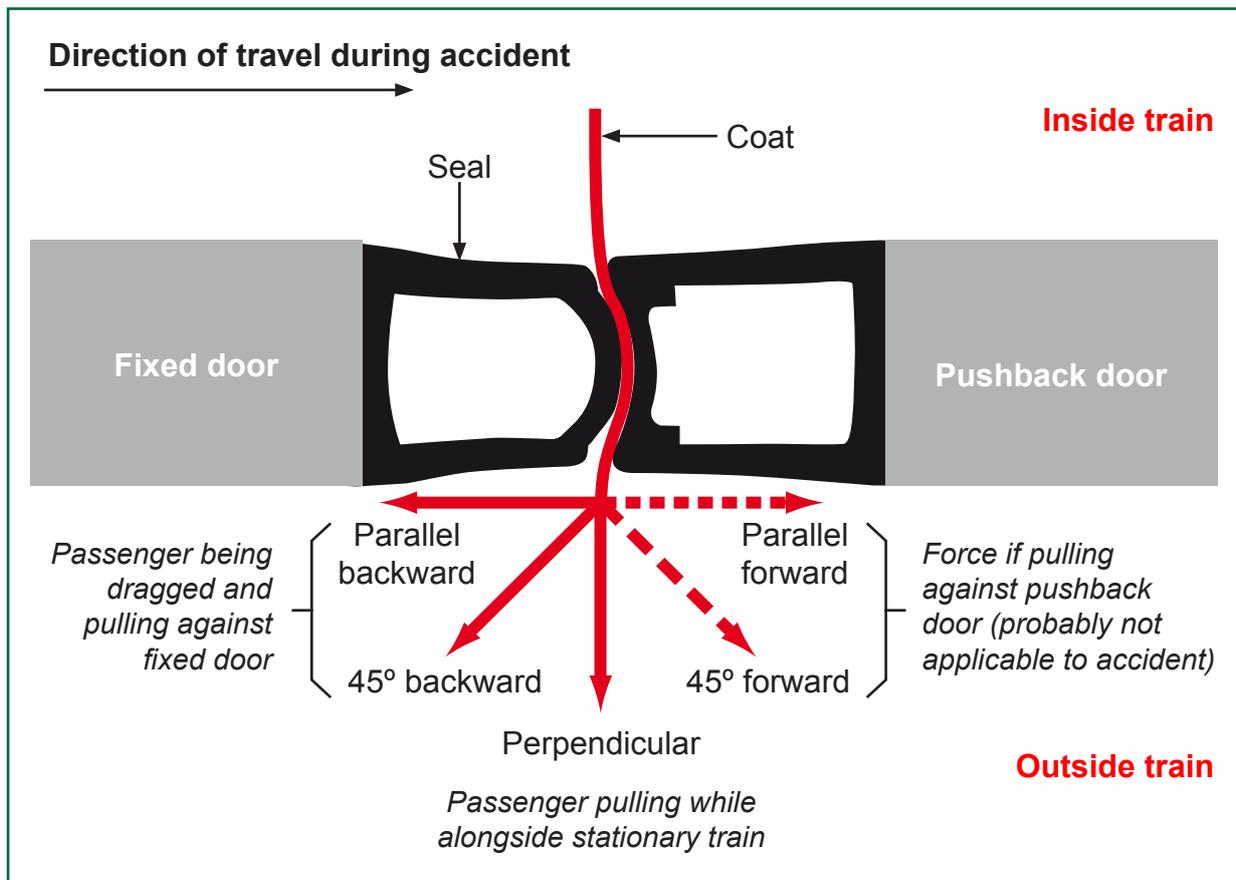
Figure 13: Pull test directions

- 57 The tests involved pulling the coat in a number of directions relative to the door faces (figure 13). These modelled the passenger pulling directly away from the train (the direction she probably pulled before the train started moving) and the passenger pulling towards the rear of the train (the likely situation while she was being dragged). Tests were also undertaken with forces applied towards the front of the train to demonstrate the differing responses of the fixed and pushback leaves.

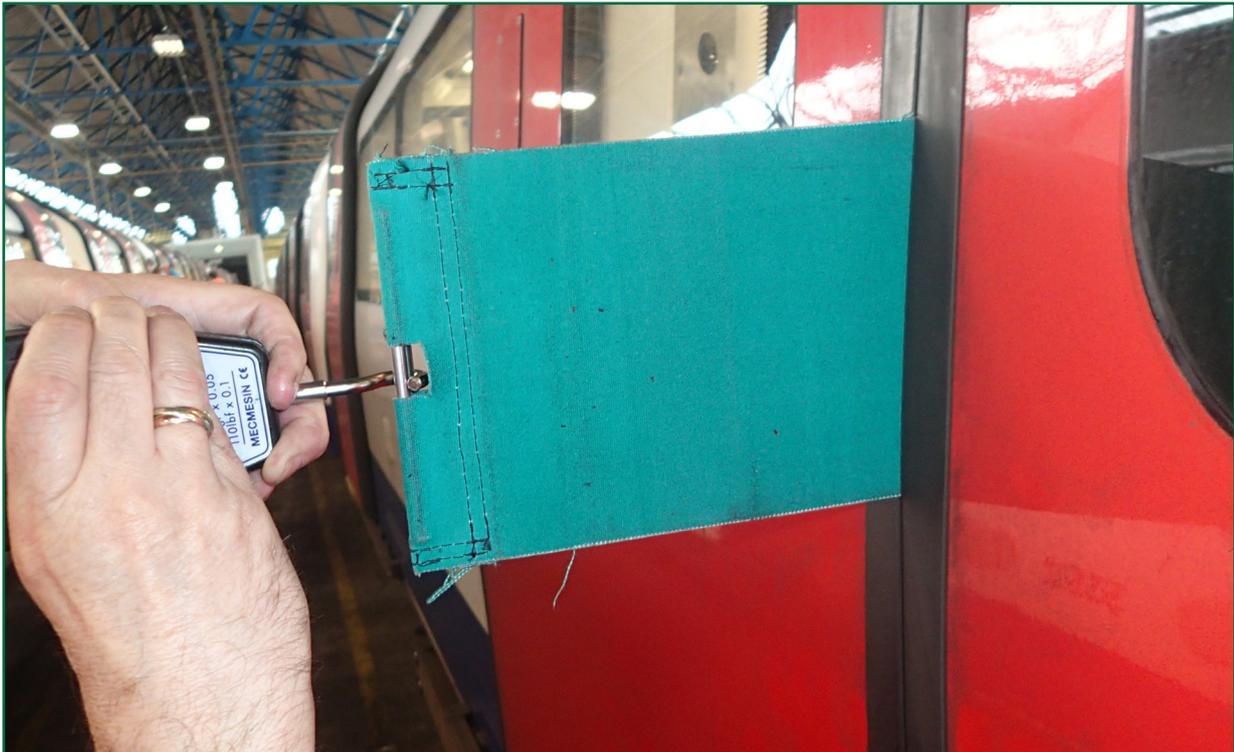
Figure 14: Pull-out testing with canvas piece

- 60 Tests with the canvas test piece (figure 14) showed that, for each direction of pull, the canvas could be pulled out with a lesser force than the coat. This difference is because the canvas piece was smoother and thinner than the coat.

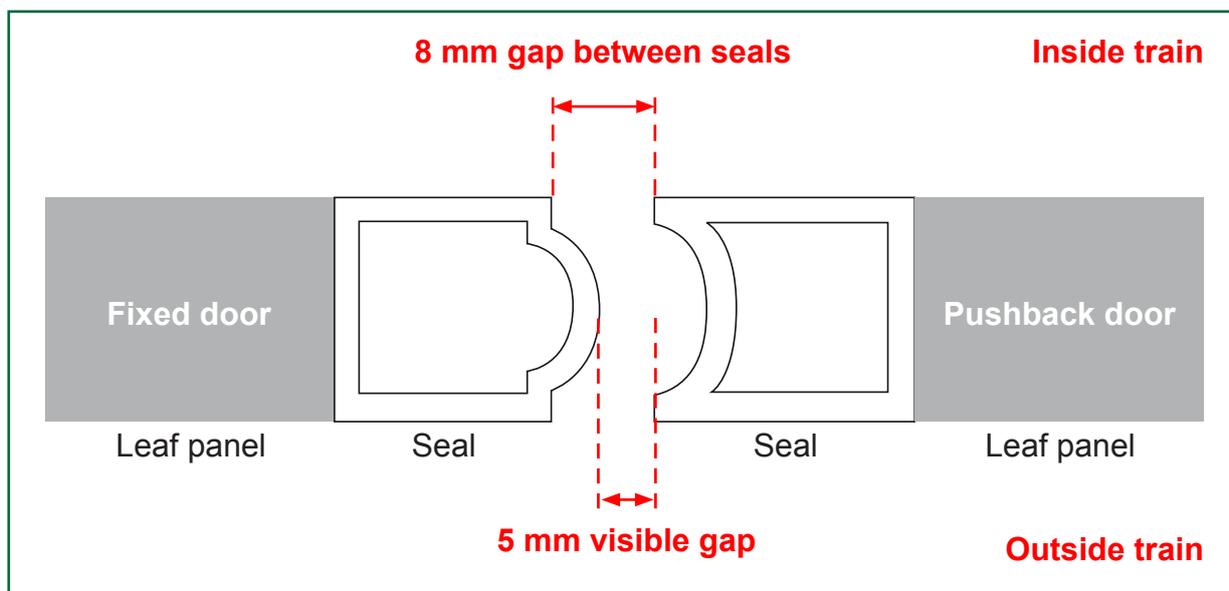
Figure 15: Door seal gap for loss of interlock

66 The design and maintenance of train doors is intended to ensure that they will not be detected closed (ie interlock will not be obtained) if there is an 8 mm gap, or more, between the door seals. Because of the profiles of the rubber seals, this equates to a 5 mm visible gap between the door seals when these are not compressed (figure 15).

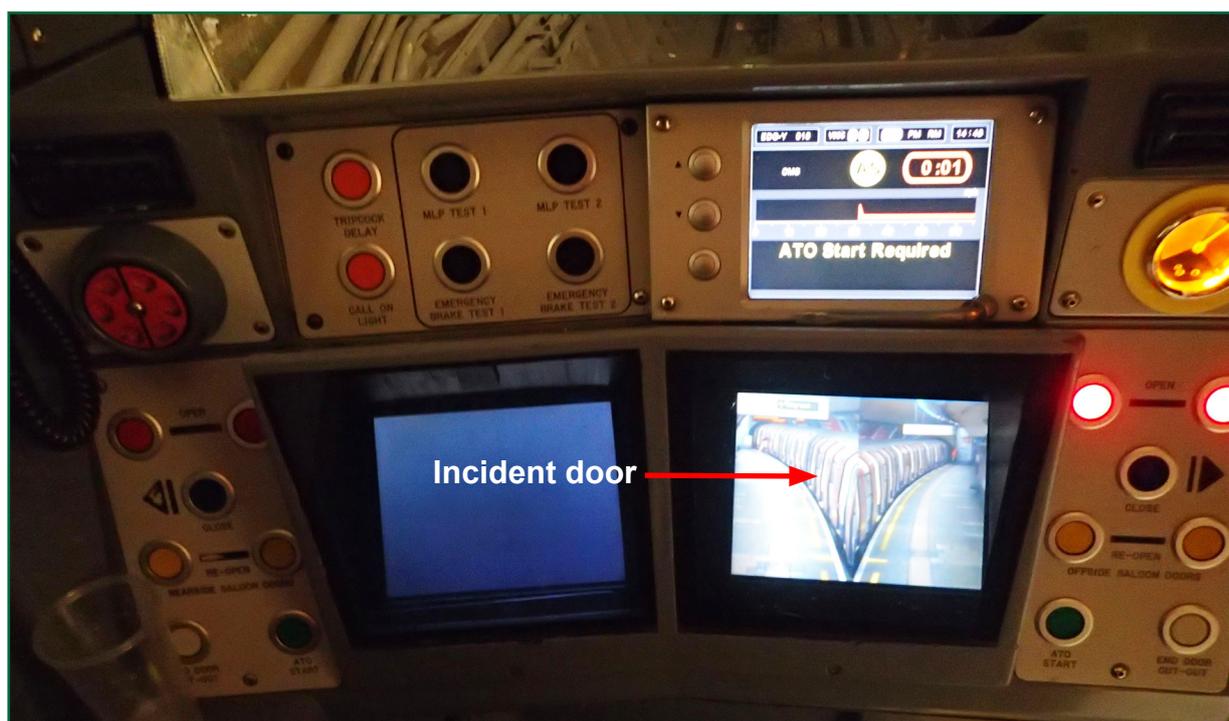
Figure 16: Train operator cab display at Clapham South station (image does not show accident situation)

- 72 The number of cameras varies depending on the station layout and the curvature of its platform. The northbound platform of Clapham South station is convex but less curved than some others on the Northern line. Two cameras are positioned near the station roof, close to the centre of the platform, facing opposite directions with overlapping views, each covering the length from the mid point to the end wall. The two camera views are arranged side by side on a single in-cab monitor which shows a view from one end of the train to the other (figure 16).

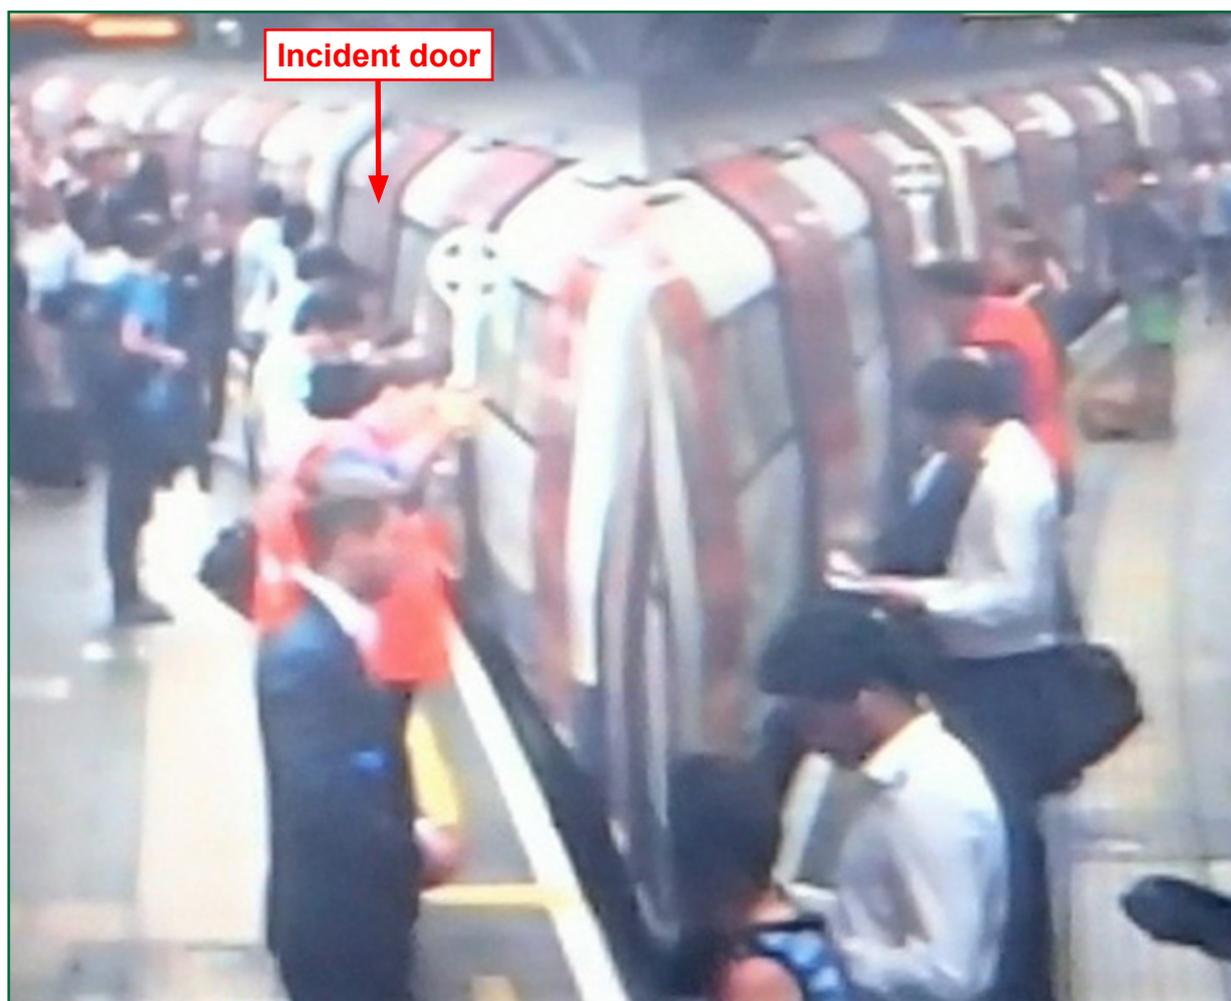
Figure 17: Train operator's view of moderately busy northbound platform at Clapham South (in-cab monitor omitting outer edges of image and not showing accident situation)

- 74 When the platform is busy and some passengers do not board a train, the train operator cannot always see the full height of all of the train doors and so cannot be certain that nothing is trapped. This is because the camera view can be obscured by passengers (figure 17). In these circumstances, train operators are trained to look for unusual passenger behaviour and other signs that indicate a possible problem (paragraph 78).

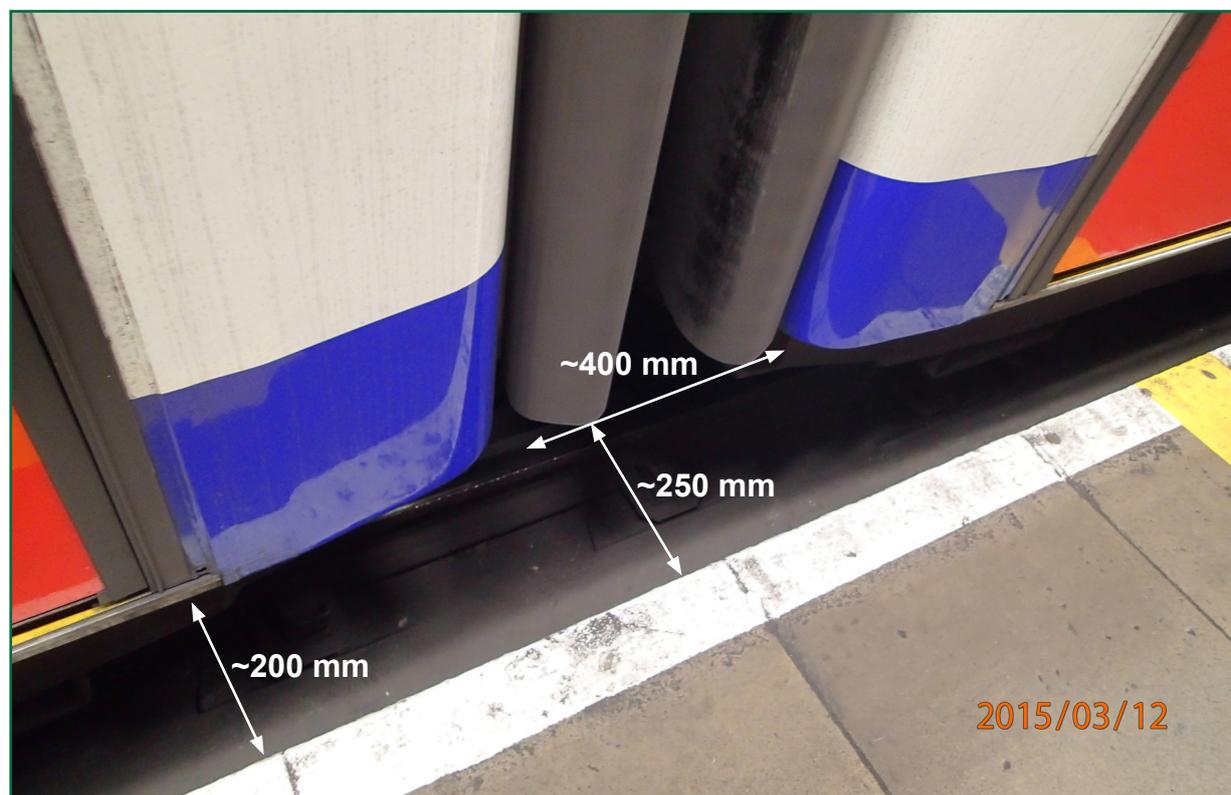
Figure 19: Platform gap at car ends

- 95 The gap between the train and the platform edge varies between 100 mm and 200 mm except at the connection between adjacent cars where there was a clear gap of approximately 250 mm over a length of approximately 400 mm (figure 19). It is probable that she fell between two cars because she would probably have sustained more serious injuries if she had fallen through the smaller gap at other locations. It is uncertain whether she fell between the 4<sup>th</sup> and 5<sup>th</sup> cars or between the 5<sup>th</sup> and 6<sup>th</sup> cars. The nature of her injuries suggest that she fell directly into the recess under the platform (paragraph 96).

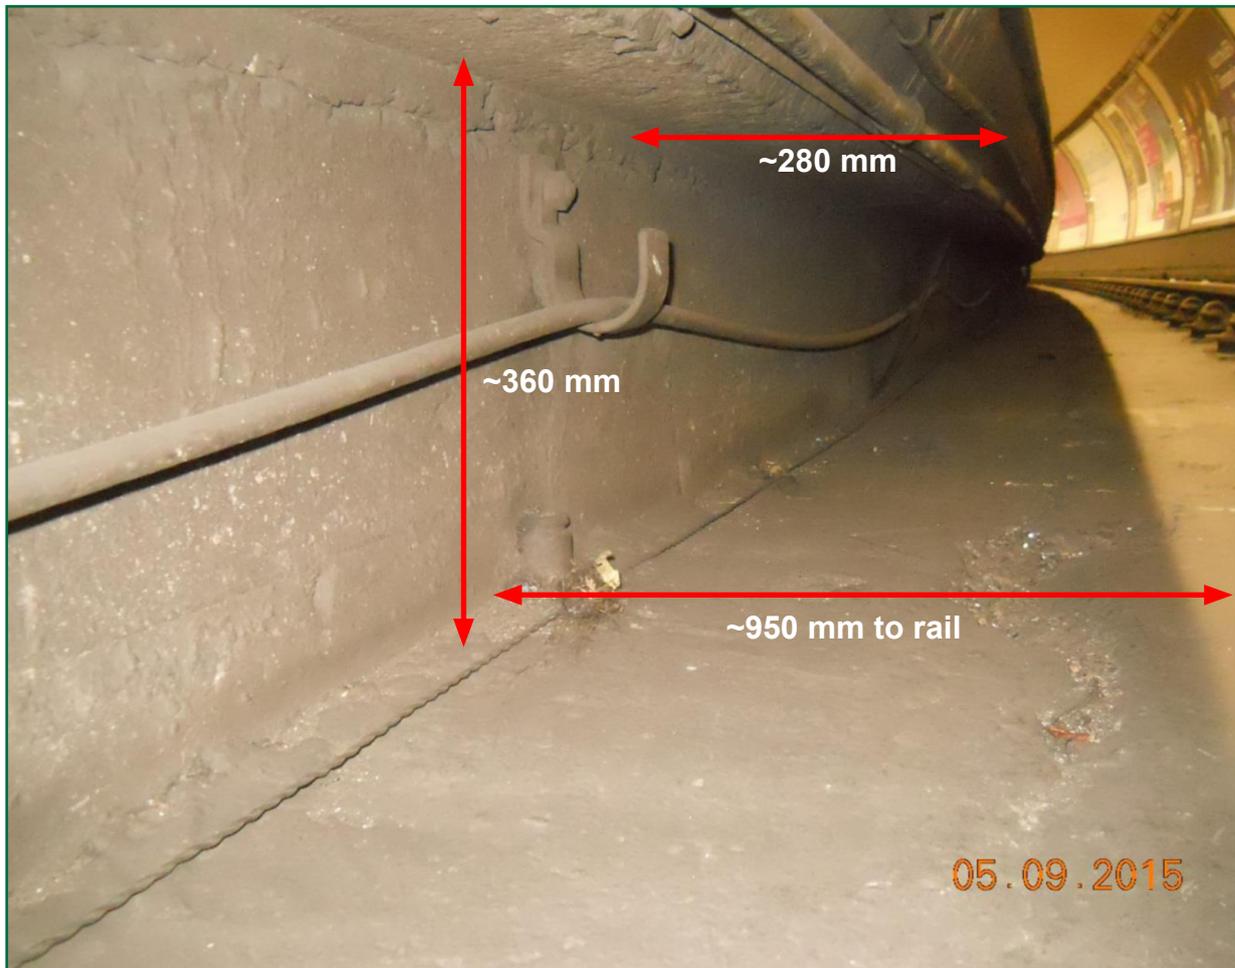
Figure 20: Clapham South platform recess

- 96 **The platform has a recess into which the passenger fell, probably reducing her injuries.**
- 97 London Underground standard S1131 (Premises - Station Platforms) requires a 300 mm wide recess under new and altered platforms to provide a refuge in an emergency, unless platform edge doors are fitted. The northbound platform at Clapham South station pre-dates this standard and has a 280 mm recess (figure 20). Although slightly smaller than current requirements, the recess was sufficient to allow the passenger to be positioned clear of the train after she had fallen from the platform.
