# **AIRCRAFT ACCIDENT REPORT 1/2016**

**Report on the accident to  
AS332 L2 Super Puma helicopter, G-WNSB  
on approach to Sumburgh Airport  
on 23 August 2013**

**Air Accidents Investigation Branch**

Published 15 March 2016

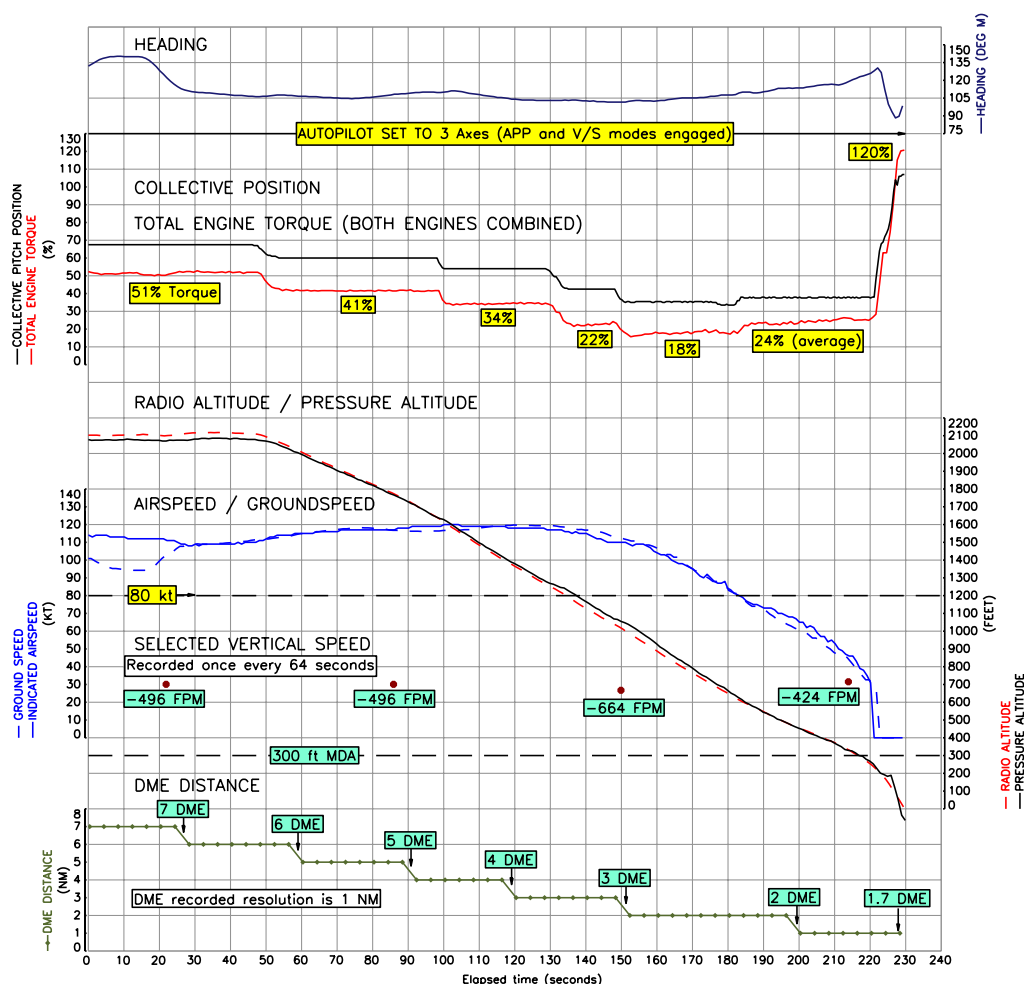
Figure 3

Shortly thereafter the co-pilot drew the commander's attention to the airspeed, which was now about 35 kt and the helicopter was now descending at 1,000 fpm. The commander acknowledged the co-pilot and began to increase the collective pitch. At this point there was a second AVAD 'CHECK HEIGHT' warning.

The commander increased the collective pitch initially to about 63% engine torque. He then made an exclamation and raised the collective pitch lever further, resulting in a maximum value of 120% engine torque. The rate of descent was now 1,800 fpm and he was not able to prevent the helicopter from impacting the water.<sup>9</sup>

#### G-WNSB final approach vertical profile

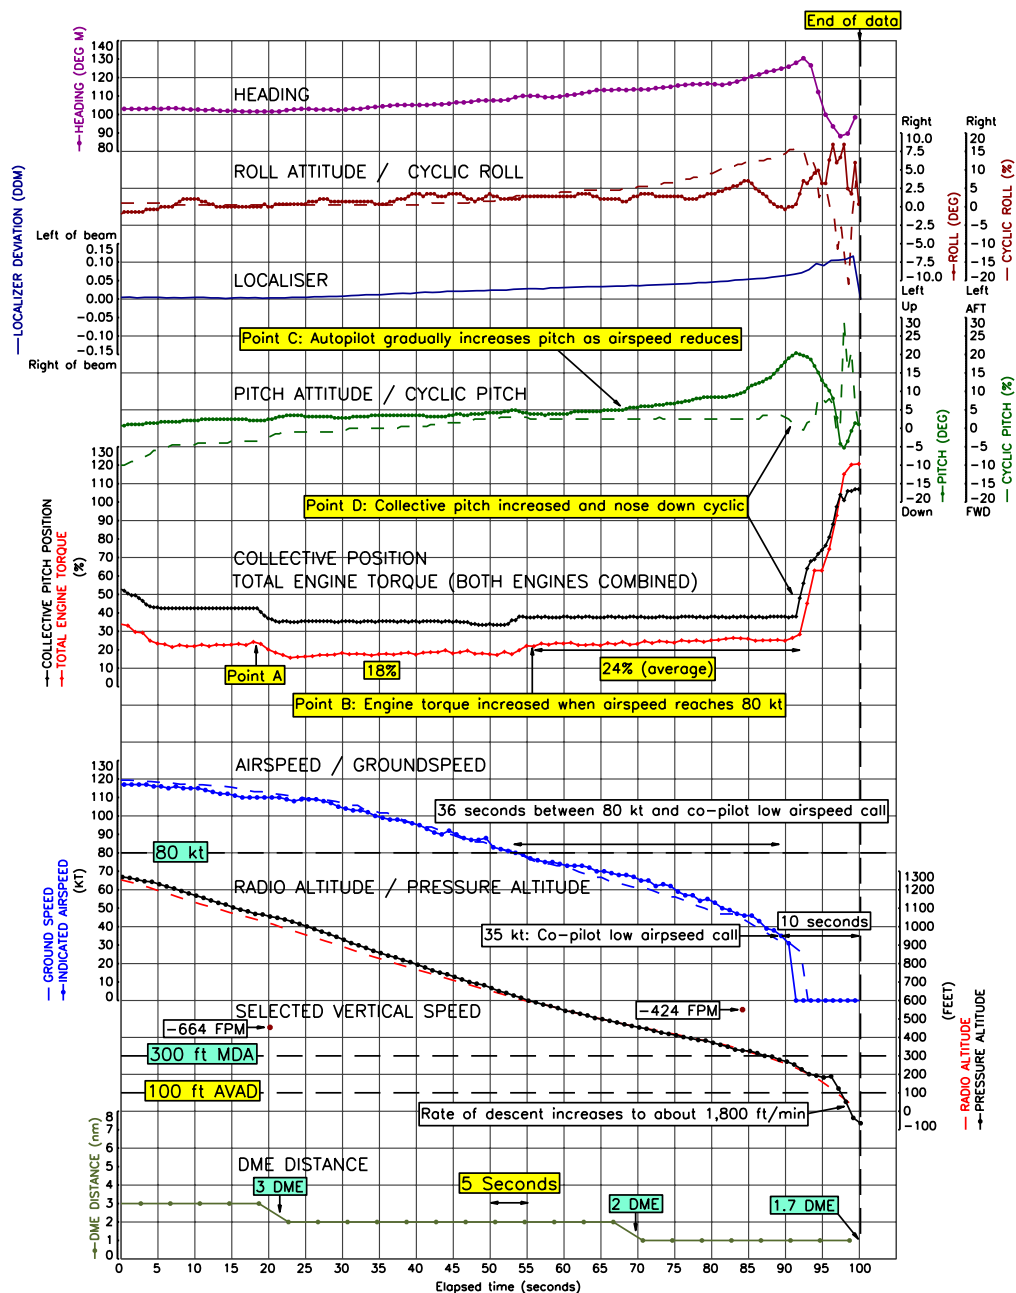
Figure 12

At 3 nm DME the helicopter was at 1,050 ft, 20 ft above the vertical profile, and its airspeed was 110 kt. The selected vertical speed was 664 fpm. Shortly after, at 1715 hrs, the helicopter was cleared to land. The collective pitch was reduced and engine torque stabilised at about 18% (Figure 12, Point A), with airspeed reducing gradually at a rate of about 1 kt/sec.

At 630 ft the airspeed had reduced to 80 kt, at which point there was an increase in collective pitch (Figure 12, Point B), with engine torque increasing from 18 to about 24%. The airspeed continued to reduce gradually at a rate of just less than 1 kt/sec.

G-WNSB vertical descent path, engine torque and airspeed from 1,200 ft

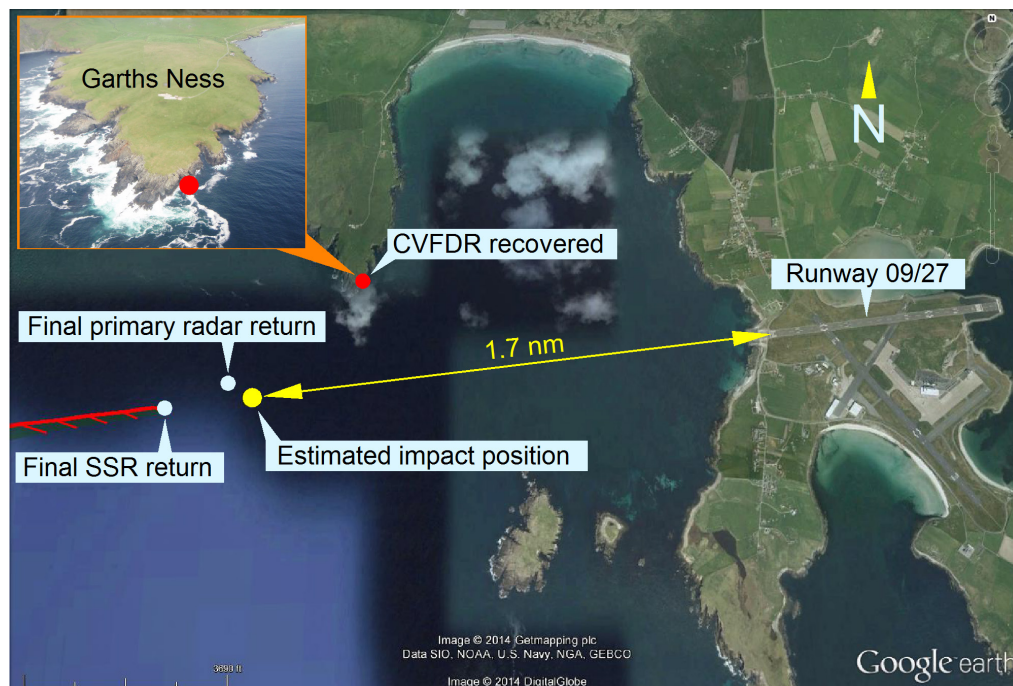
**Figure 14**

G-WNSB estimated impact position

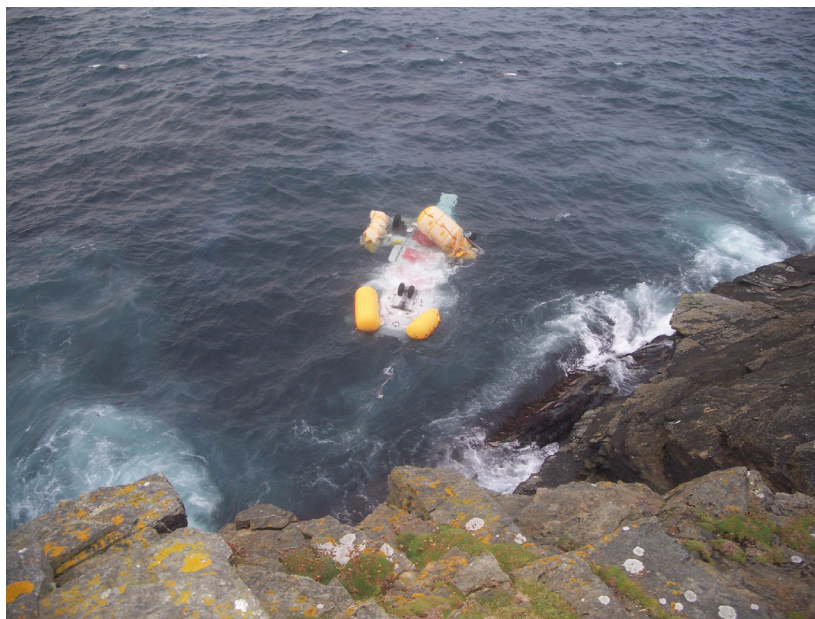
**Figure 15**

As the helicopter had drifted onto the rocky shoreline following the accident, the extent of the damage caused by the impact with the water was difficult to assess from the recovered wreckage. However, a number of other sources of evidence were available, including images of the floating fuselage taken prior to it reaching the coastline. Evidence was also available from survivor statements and the distribution of the wreckage along the coast. Images of the helicopter taken while it was floating inverted showed that it appeared to be largely intact and relatively undamaged; however, the tail section aft of the rear baggage compartment was missing. The main rotor and tail rotor blades were significantly damaged, consistent with high energy contact with the water. Two of the main rotor blades had broken off at the blade root, which remained attached to the rotor head. The remaining blades had detached at their mounting hinge. Statements from the passengers and crew also indicated that most of the windows on the left side of the cabin had been removed by the force of the impact with the water.

Significant additional damage occurred to the helicopter due to repeated contact with the rocks as it drifted onto the shoreline. This resulted in the remaining fuselage breaking into two main sections, failing circumferentially at the forward end of the main cabin doors. It also caused damage to the engines, main rotor head and gearbox, all of which had broken away from the fuselage, along with the right sponson.

G-WNSB wreckage contacting coastline

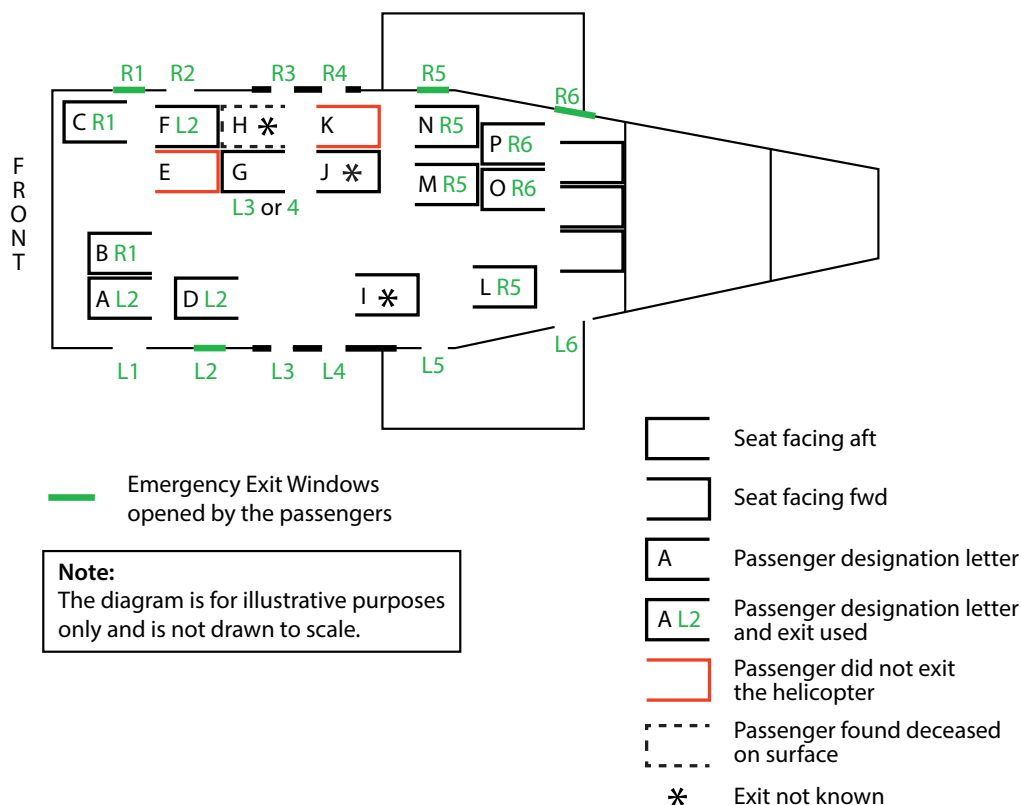
**Figure 16**

Figure 16 shows the passenger seating positions and evacuation exits used. A brief summary of all the occupants' seating positions, together with the survivors' recollections of their escape and exits used, is provided at Appendix G.

Passenger seating positions and evacuation diagram

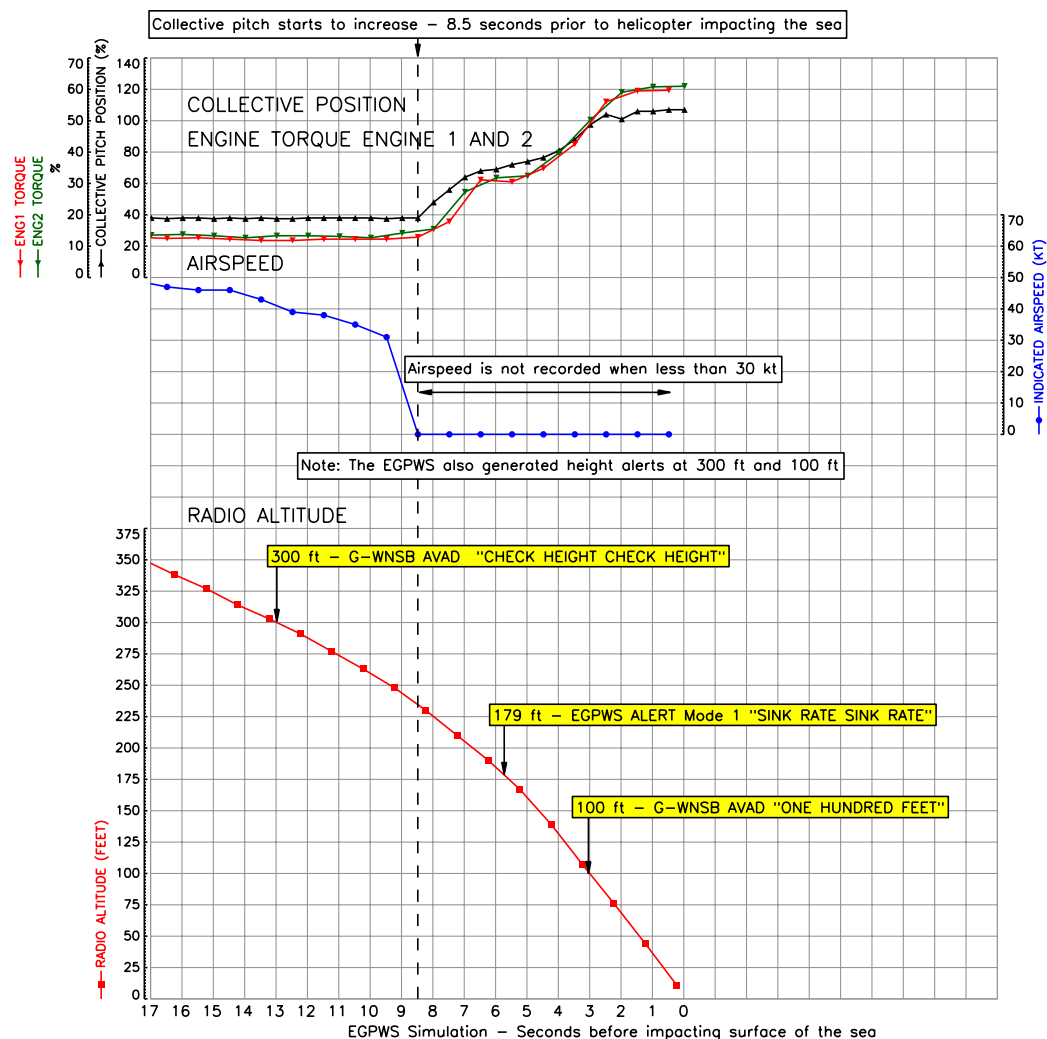
The results of the simulation were that: at a height of 179 ft, about 5.7 seconds before G-WNSB struck the surface of the sea, a Mode 1 'SINK RATE SINK RATE' audio alert would have been generated. Figure 17 provides details of the EGPWS Mode 1 envelope used to trigger the alert and Figure 18 is a time series plot of when the alert would have occurred relative to other alerts and impact with the sea.

EGPWS Simulation with Mode 1 alert triggered at 179 ft

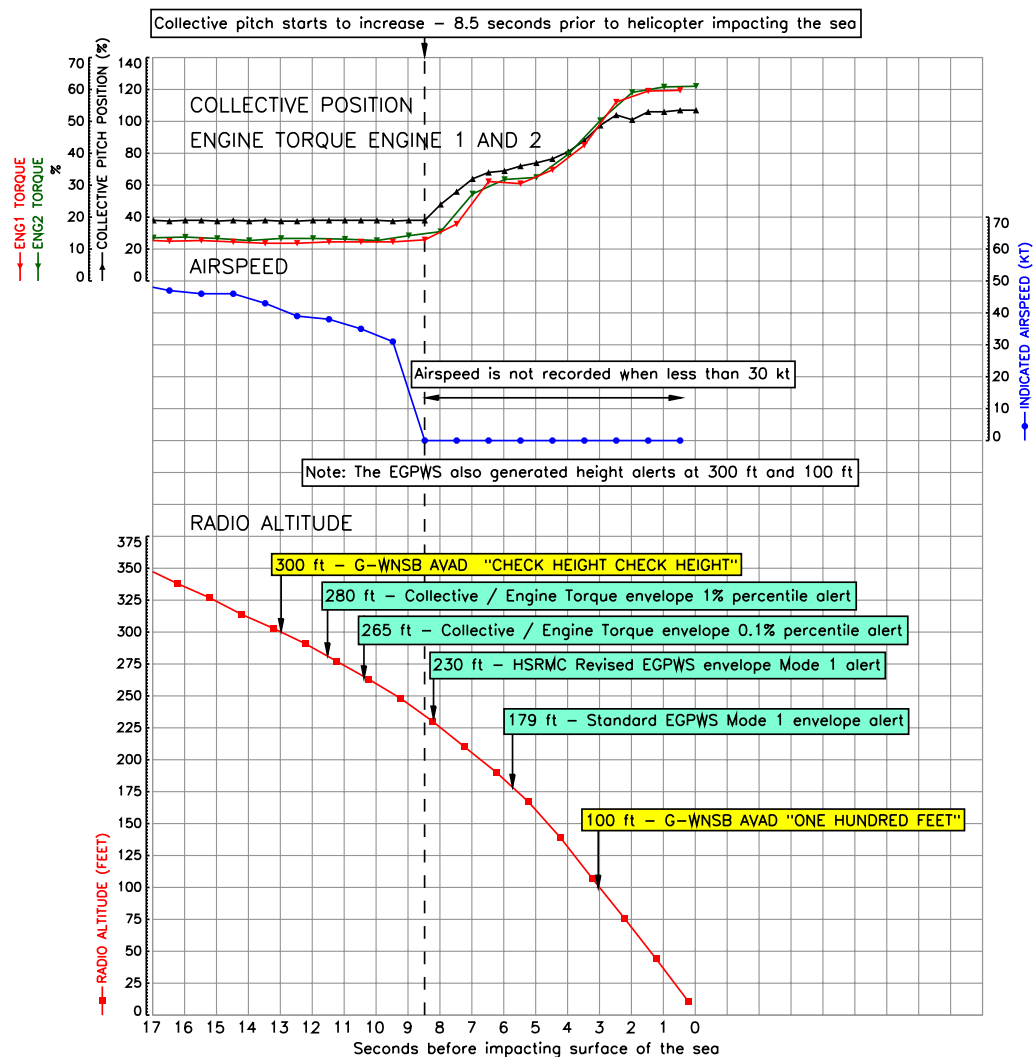
**Figure 19**

Initial research focused on the relationship between engine torque and airspeed during the latter stages of an approach. Two envelopes were created to reflect the statistical measures of 1% and 0.1% percentile, which were then compared against the accident approach of G-WNSB. The 1% and 0.1% envelopes were exceeded 11.5 and 10.5 seconds respectively before the helicopter struck the sea (Figure 19). At 11.5 seconds G-WNSB's airspeed was 38 kt and it was at a height of 280 ft. At 10.5 seconds its airspeed was 34 kt and the height was 265 ft.

The project also analysed other parametric relationships, including collective pitch position and airspeed, to determine if the alerting time could be further improved upon. It was found that the warning based on engine torque and airspeed continued to provide the greatest alerting time for the accident approach profile.

Alert activation times of EGPWS developmental envelope, revised Mode 1 envelope and current Mode 1 envelope

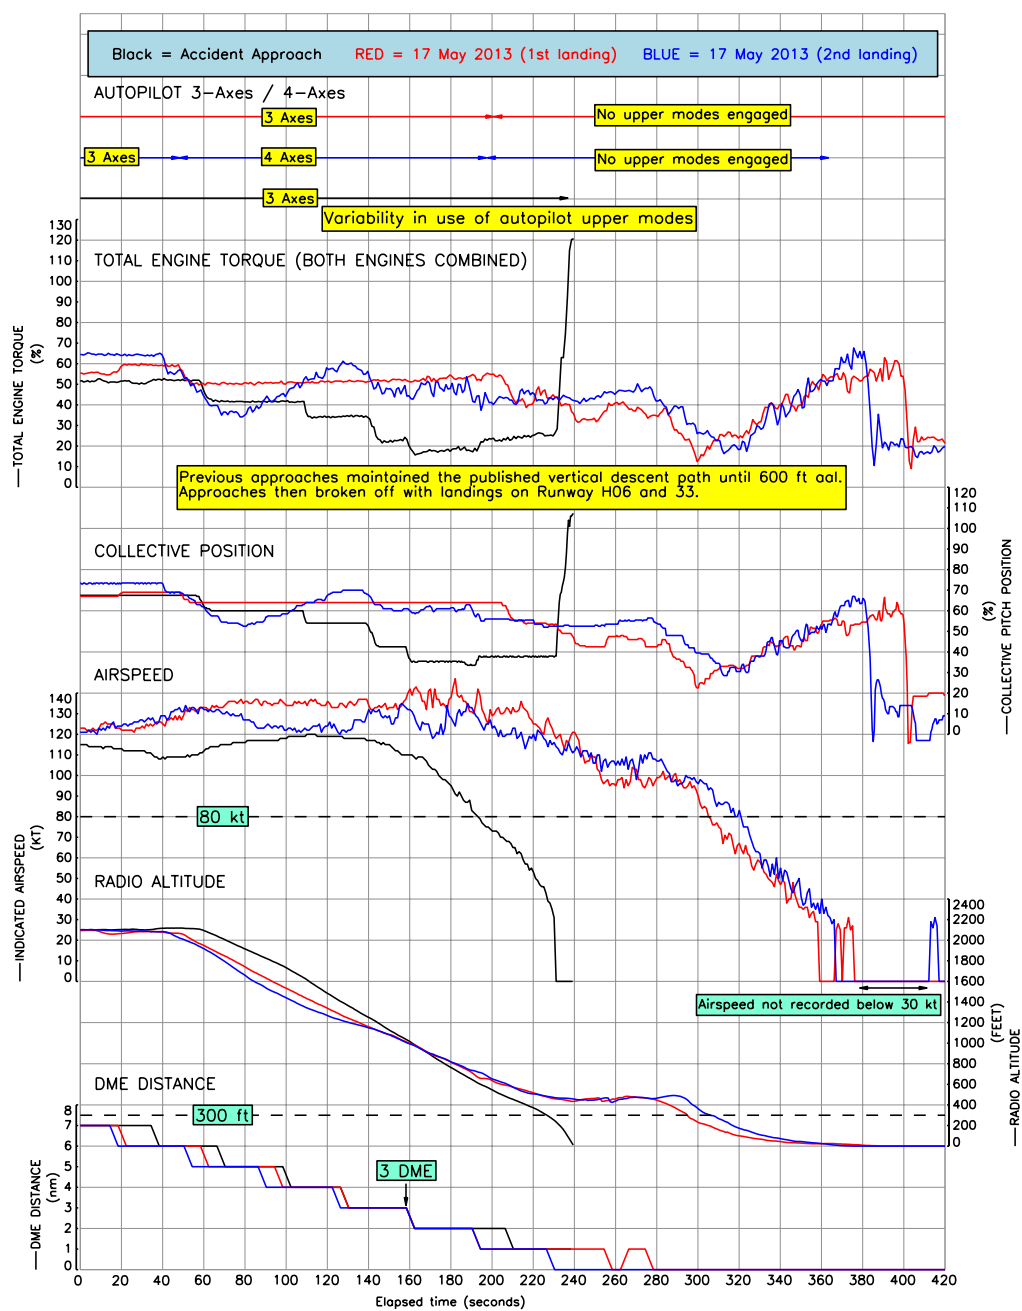
Figure 21

Previous approaches to Sumburgh Airport flown by commander

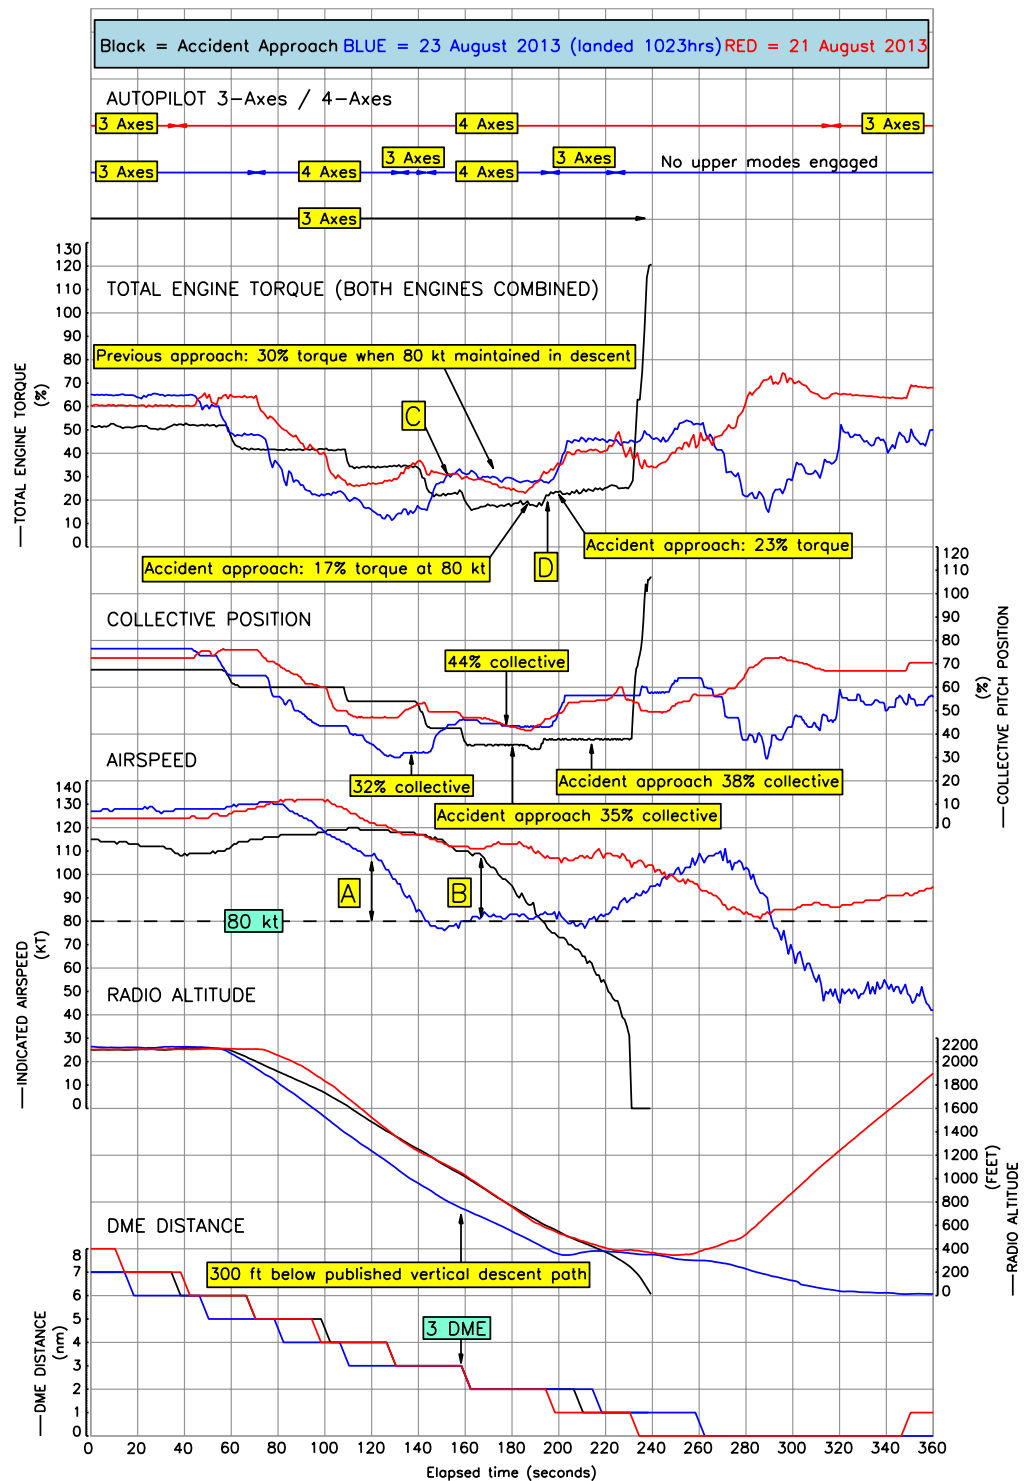
Figure 22

A review of the CVFDR data for a sample of 43 of the above approaches showed that, for those that were flown in 3-axes, V/S mode was selected, rather than IAS mode.

Approaches to Sumburgh Airport Runway 09 by different crew
