Report on the investigation into
the listing, flooding and grounding of

Hoegh Osaka

Bramble Bank, The Solent, UK

on 3 January 2015

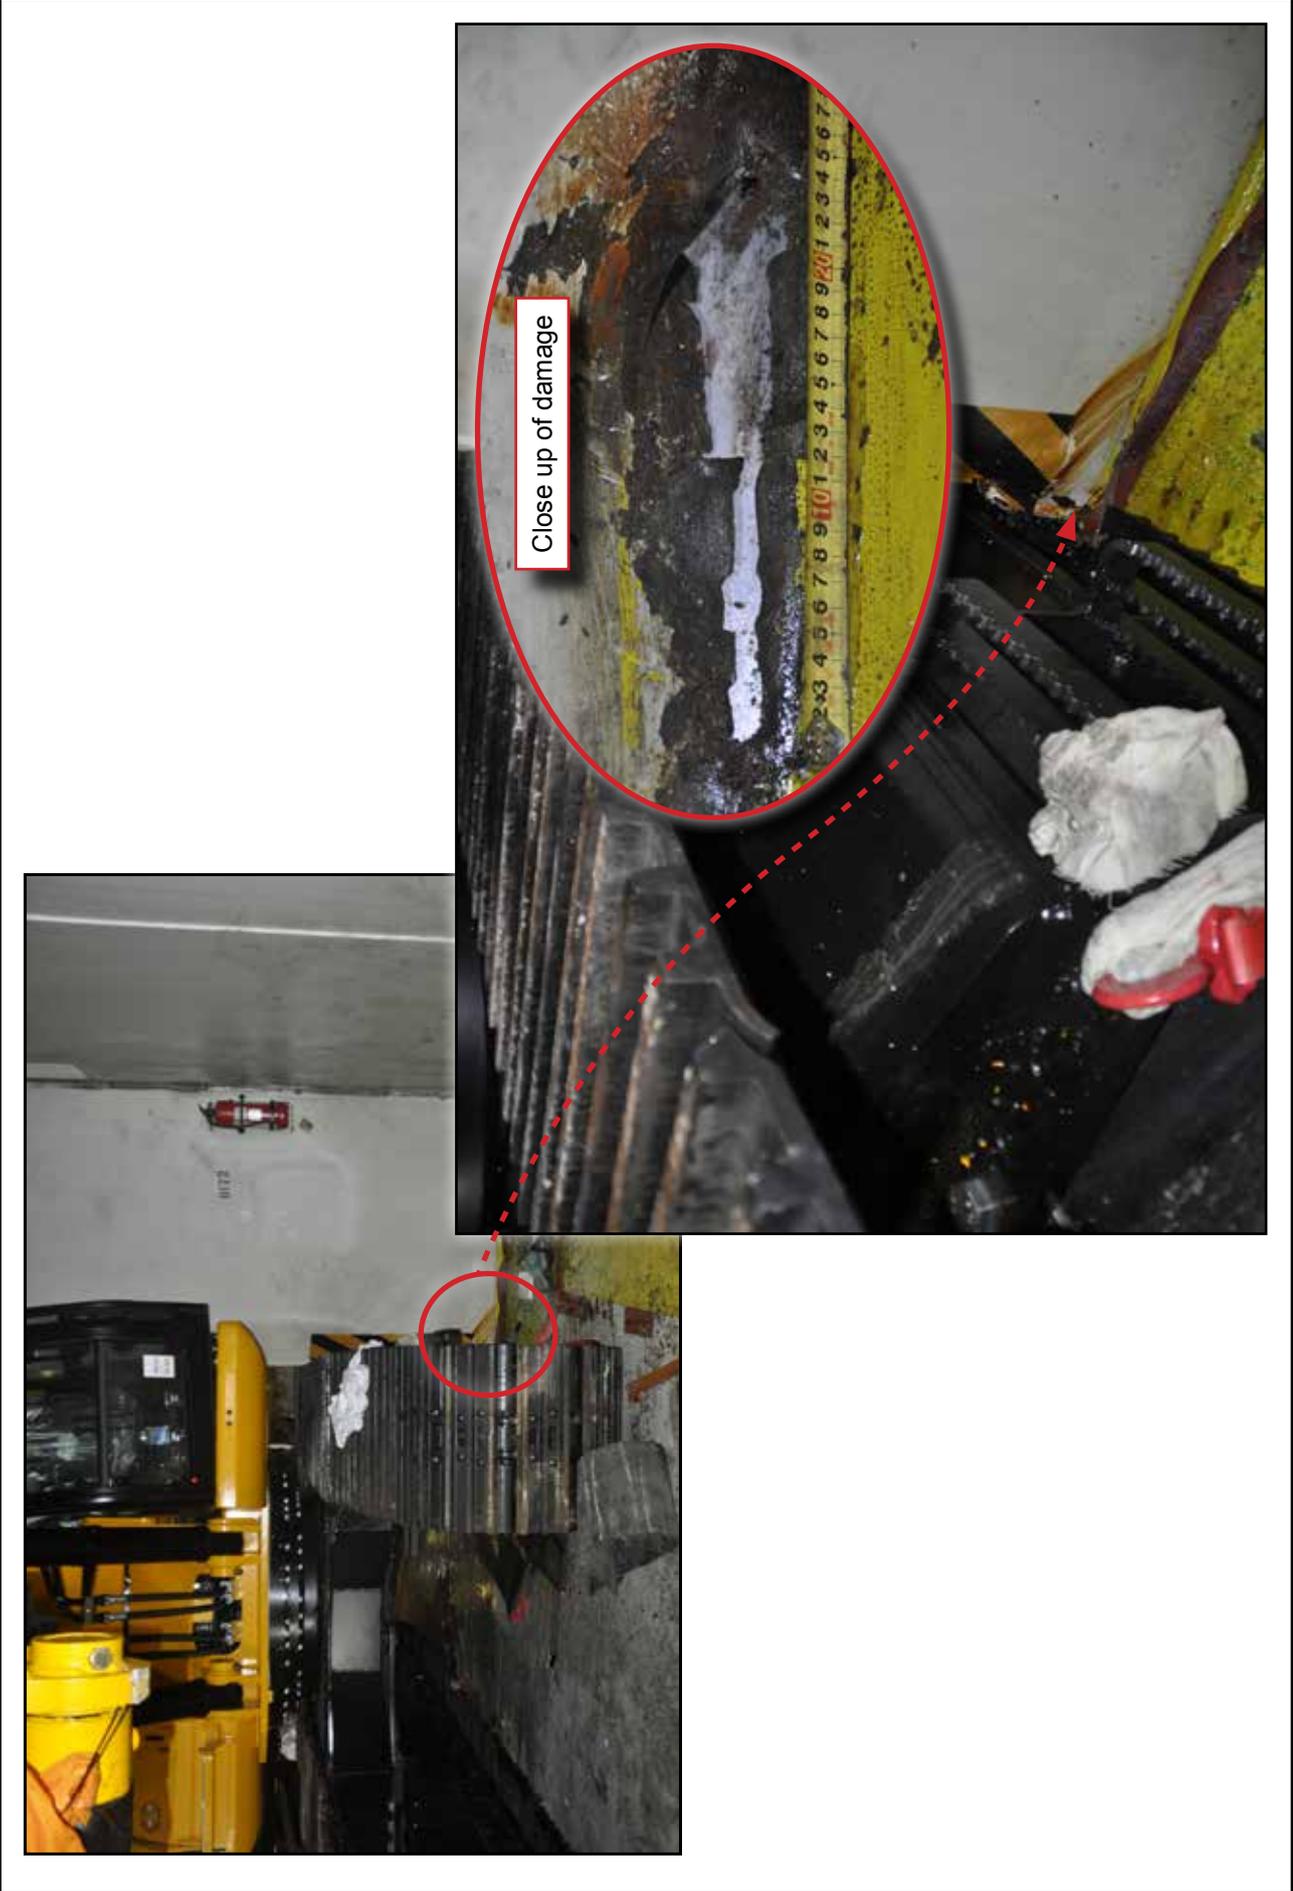
Figure 8: Damage to shell plating caused by JCB tracks

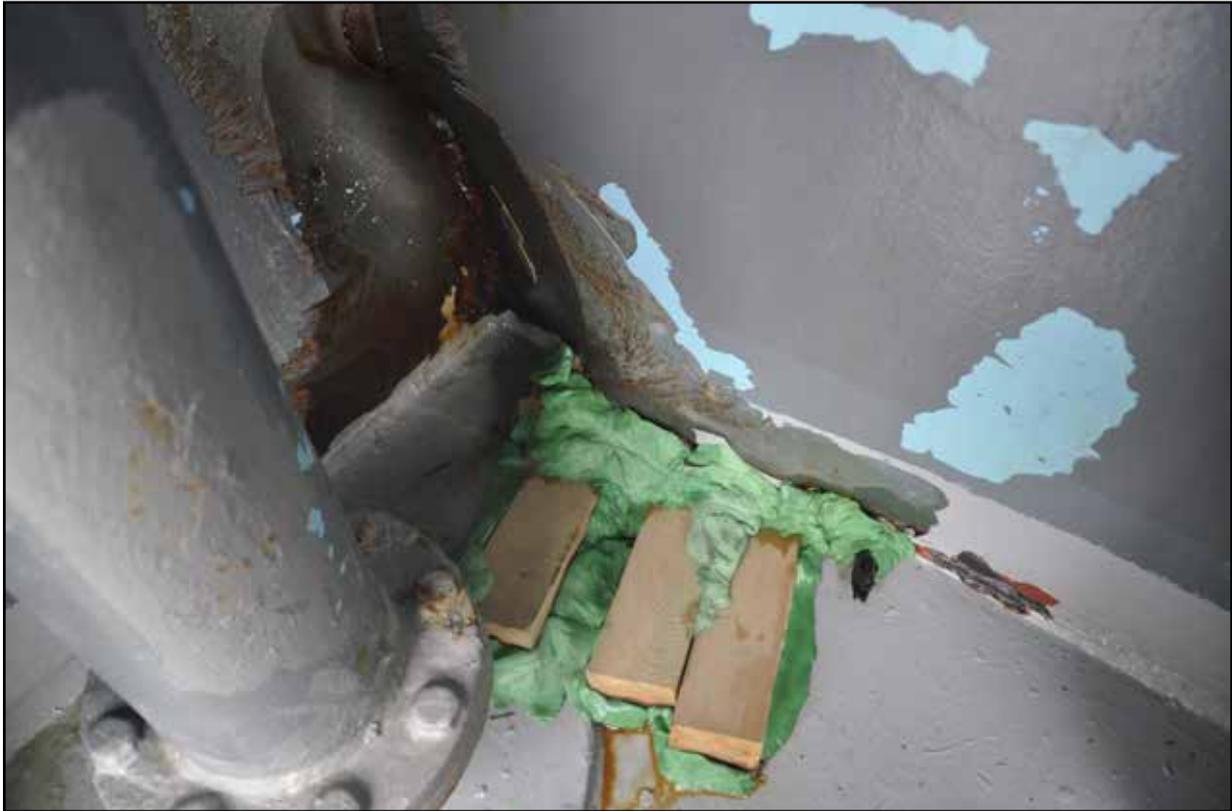
Figure 9: Temporary patch applied to shell damage by salvors

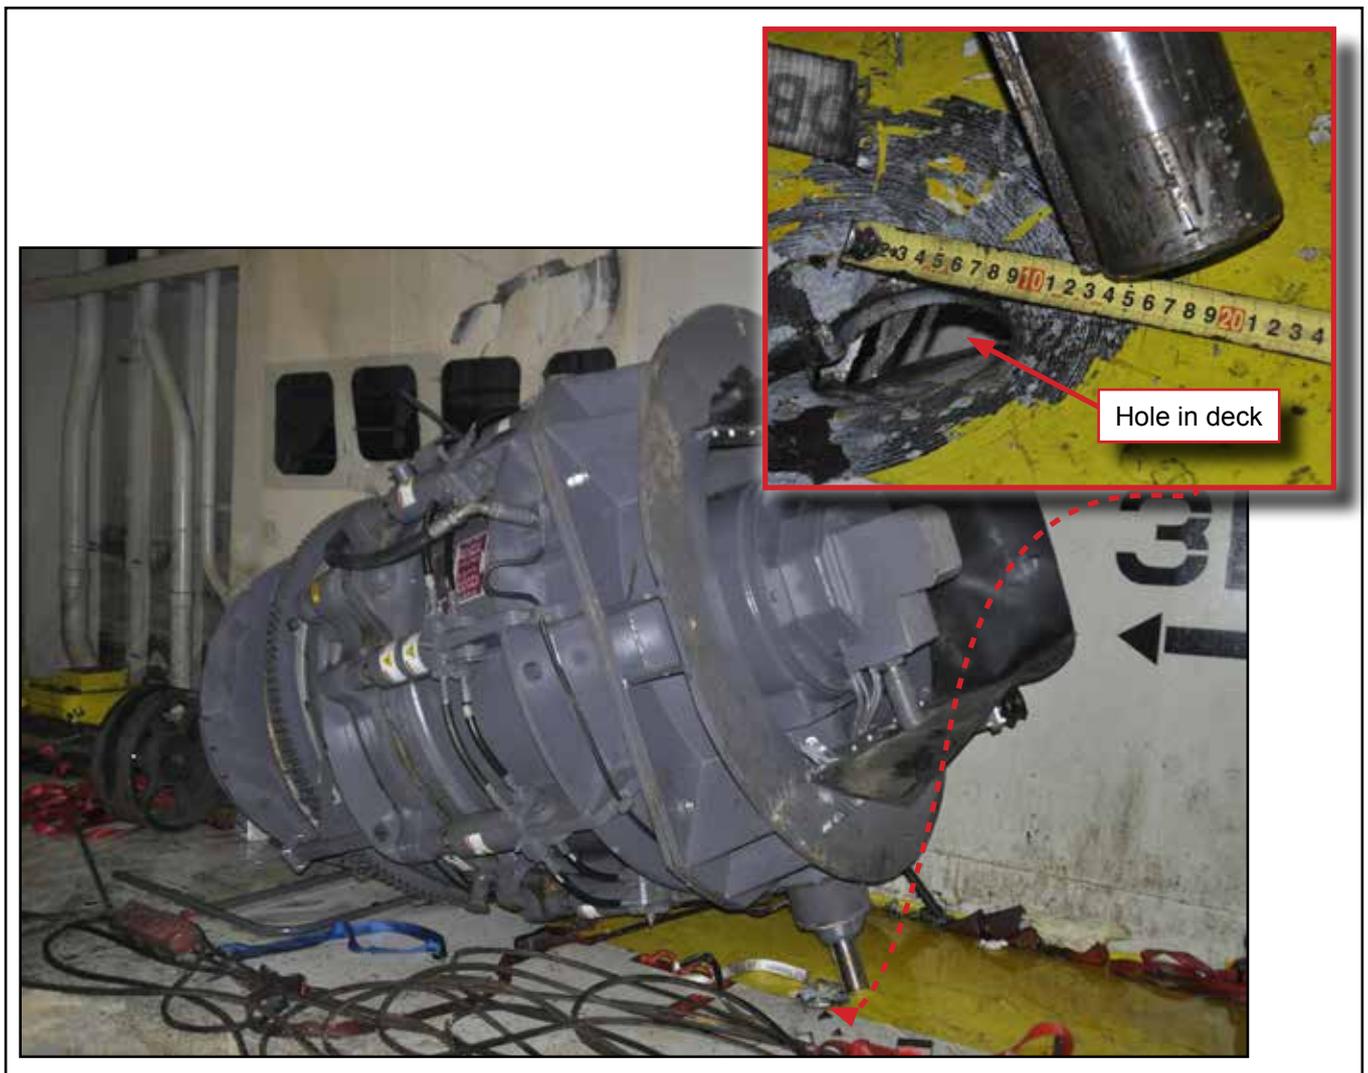
A major component of a stone crusher that had shifted on deck 6, fell onto the watertight deck, puncturing it (**Figure 10**). This allowed flood water on deck 6 to enter the cargo decks below. Approximately 2700t of sea water came on board and formed a wedge of water on the lower decks.

Figure 10: Component from stone crusher that fell onto deck 6

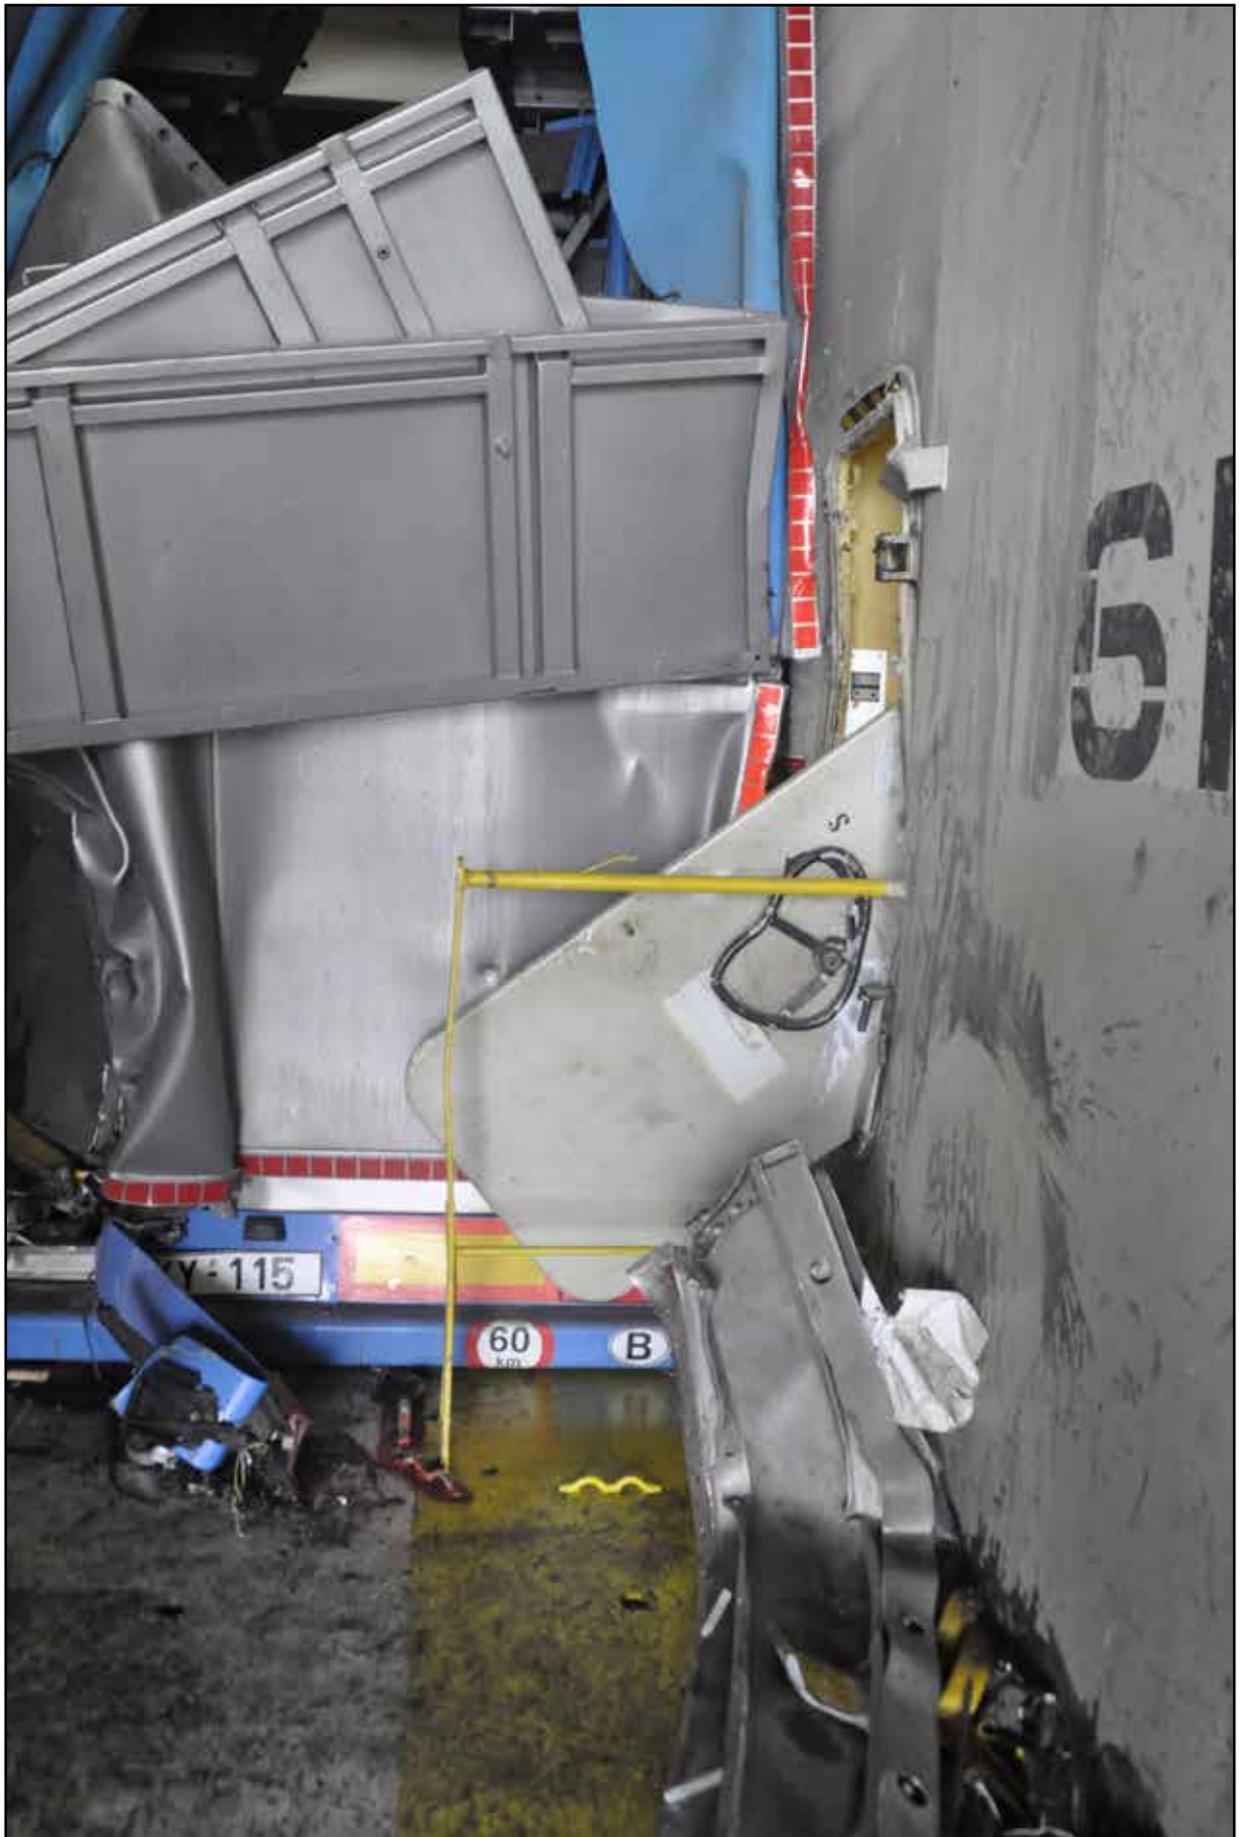
Several areas of the ship's internal car deck structure were damaged to varying extent by moving cargo (**Figure 11**).

Figure 11: Damage to starboard side of deck 6 caused by moving cargo

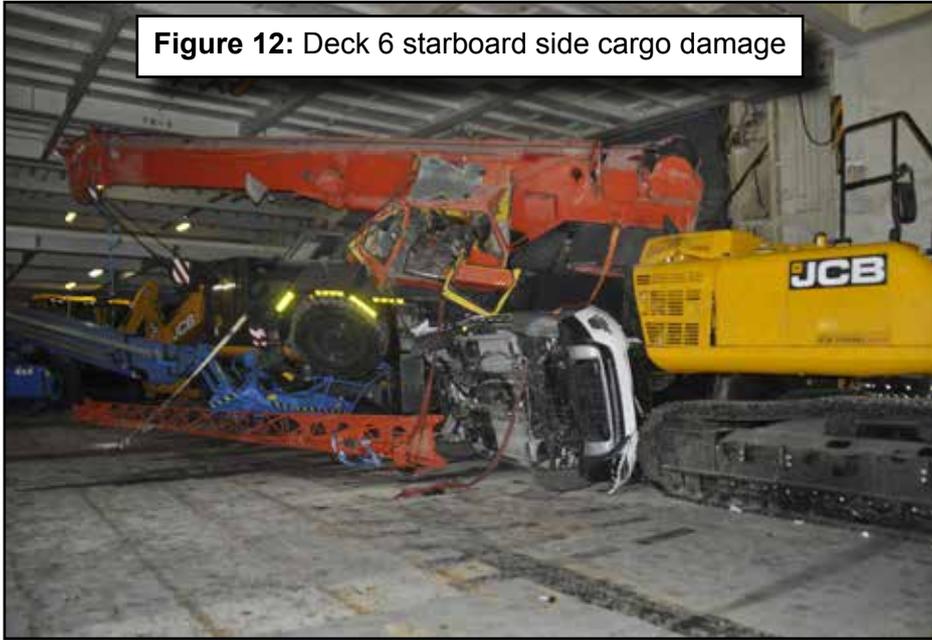
Although the vast majority of cargo remained in position, 27% of the cargo sustained damage (**Figures 12, 13 and 14**), varying from repairable scratches and dents to severe damage resulting in total loss (**Table 1**).

Figure 13: Deck 11 starboard side cargo damage

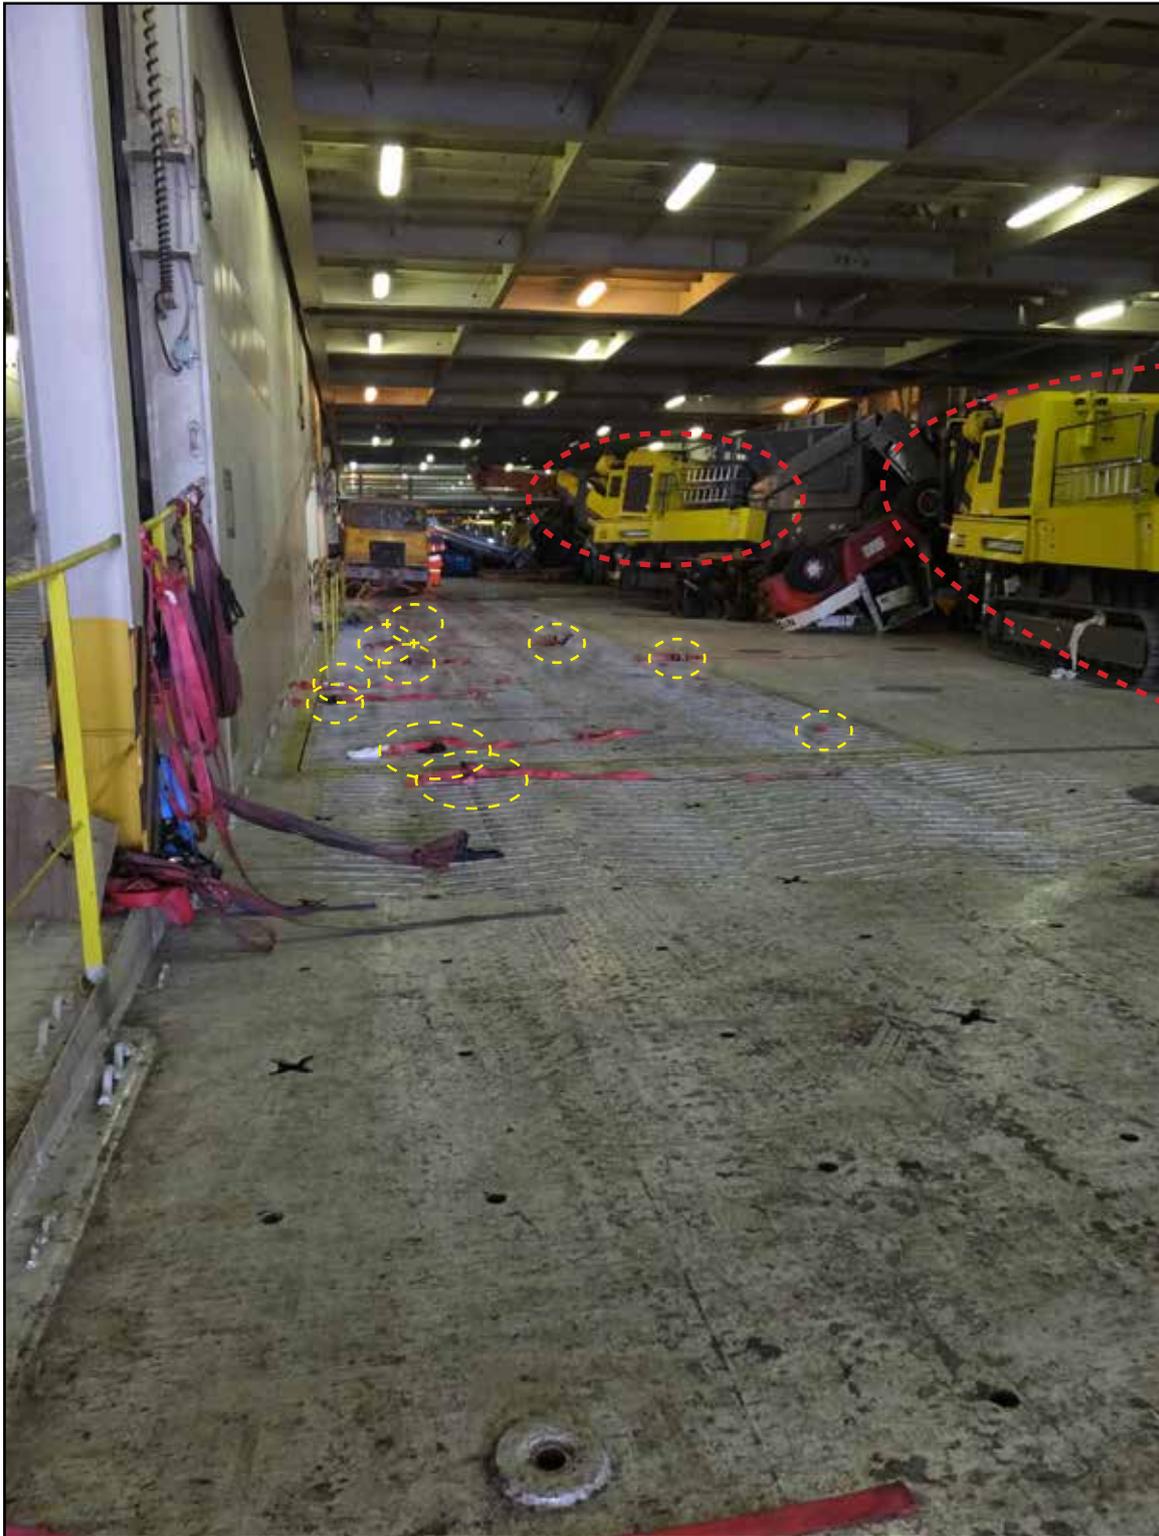
An initial cargo shift occurred as *Hoegh Osaka* heeled; other cargo shifted later. Cars that were damaged were in localised pockets, in general caused by one vehicle breaking its lashings, resulting in a domino effect as the loose vehicle moved into adjacent vehicles. As the majority of the cars were tightly stowed, the build-up of momentum was relatively small, limiting the extent of the damage. However, not all of the high and heavy cargo was tightly stowed. As such, when their lashings released or broke, the size and momentum of the high and heavy cargo caused significant damage to adjacent vehicles (**Figures 15, 16 and 17**).

Figure 17: Original stowage position of two powercrushers, broken lashings visible on deck. Post-shift positions to starboard

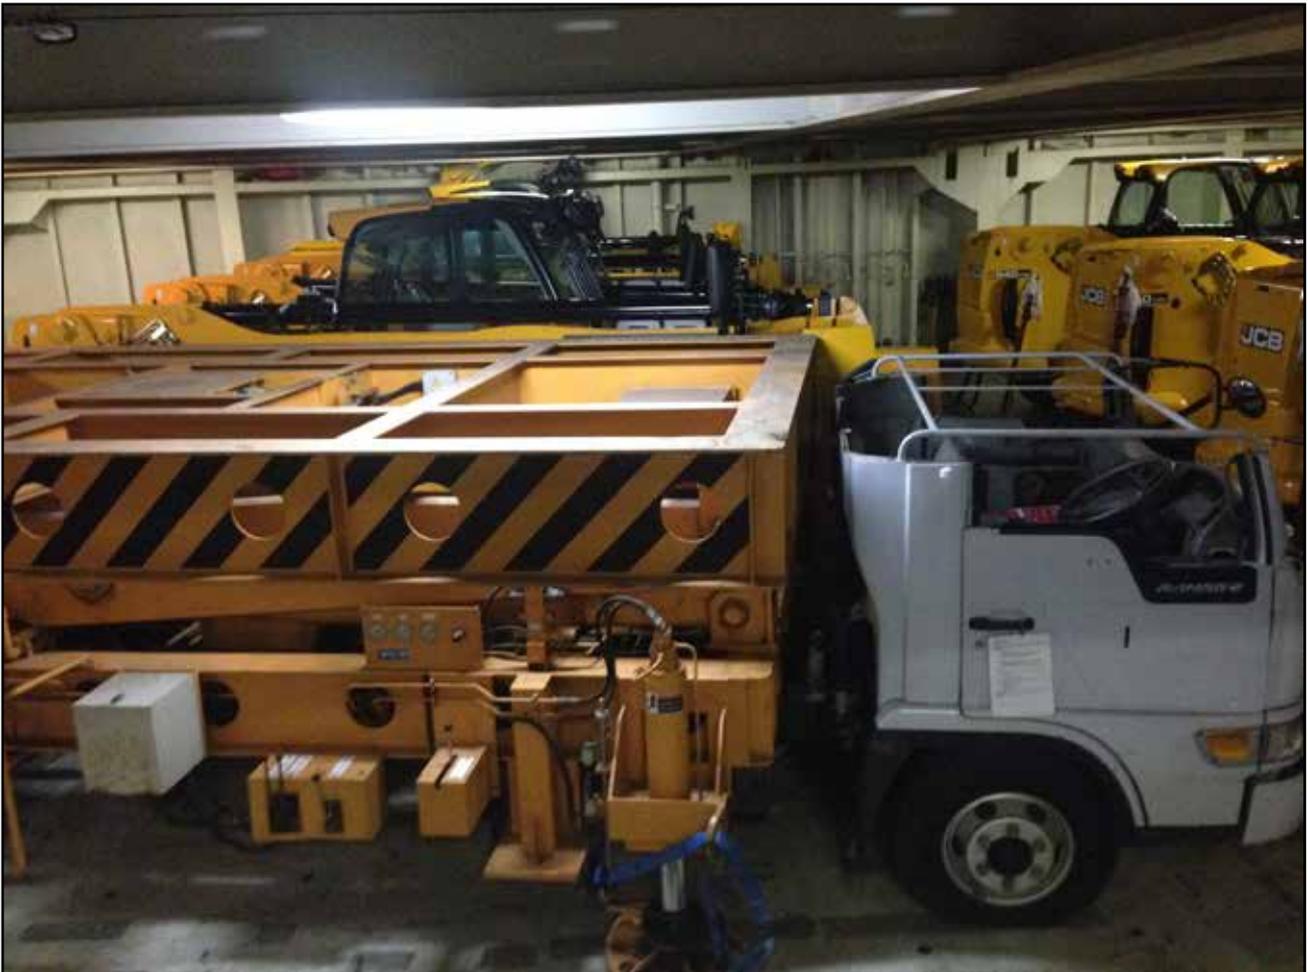
The ship carried two deck lifter machines, self-propelled units used to raise and lower the deck panels. One of these units, stowed on the starboard side of deck 8, was damaged as it shifted (**Figure 18**), and also caused damage to cargo stowed adjacent to it.

Figure 18: Ship's deck lifter machine

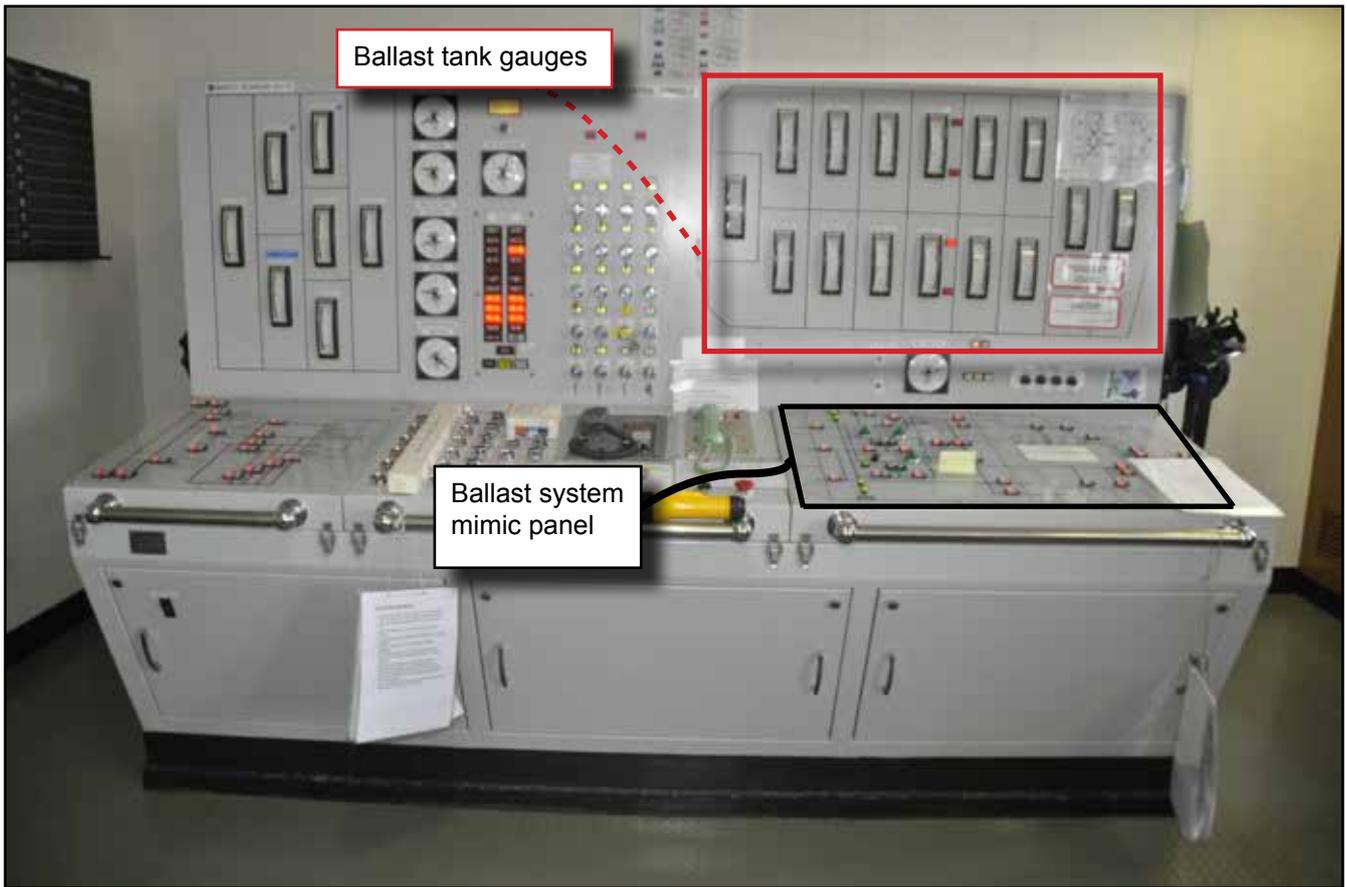
The only gauge that was operating at the time of the accident was that of the fore peak tank. All of the other gauges had been inoperative since *Hoegh Osaka* was taken under Wallem's management in July 2014. The gauges were recorded as defective in the ship's handover survey and also noted as defective during Wallem's technical superintendent's visit to the ship in November 2014. Repair of the defective gauges had not been deemed a priority by Wallem as the ballast tank soundings could be taken manually.

Figure 24: Ballast system control panel and tank gauges

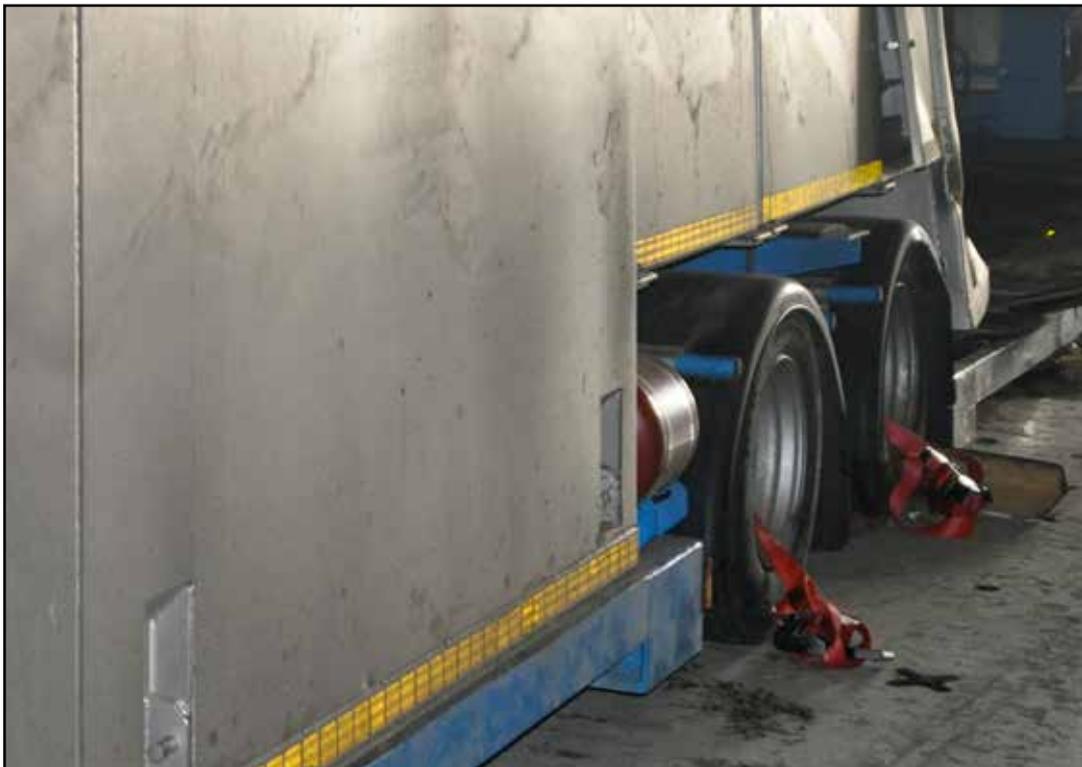
All of the cars carried on board *Hoegh Osaka* were fitted with dedicated securing eyes before they were loaded. Although some of the high and heavy cargo had clearly marked securing points, some did not. In those cases, it was left to the stevedores to select appropriate strong points to which to secure lashings (**Figures 27, 28 and 29**).

Figure 29: A 30t trailer with no securing points, secured by wheels

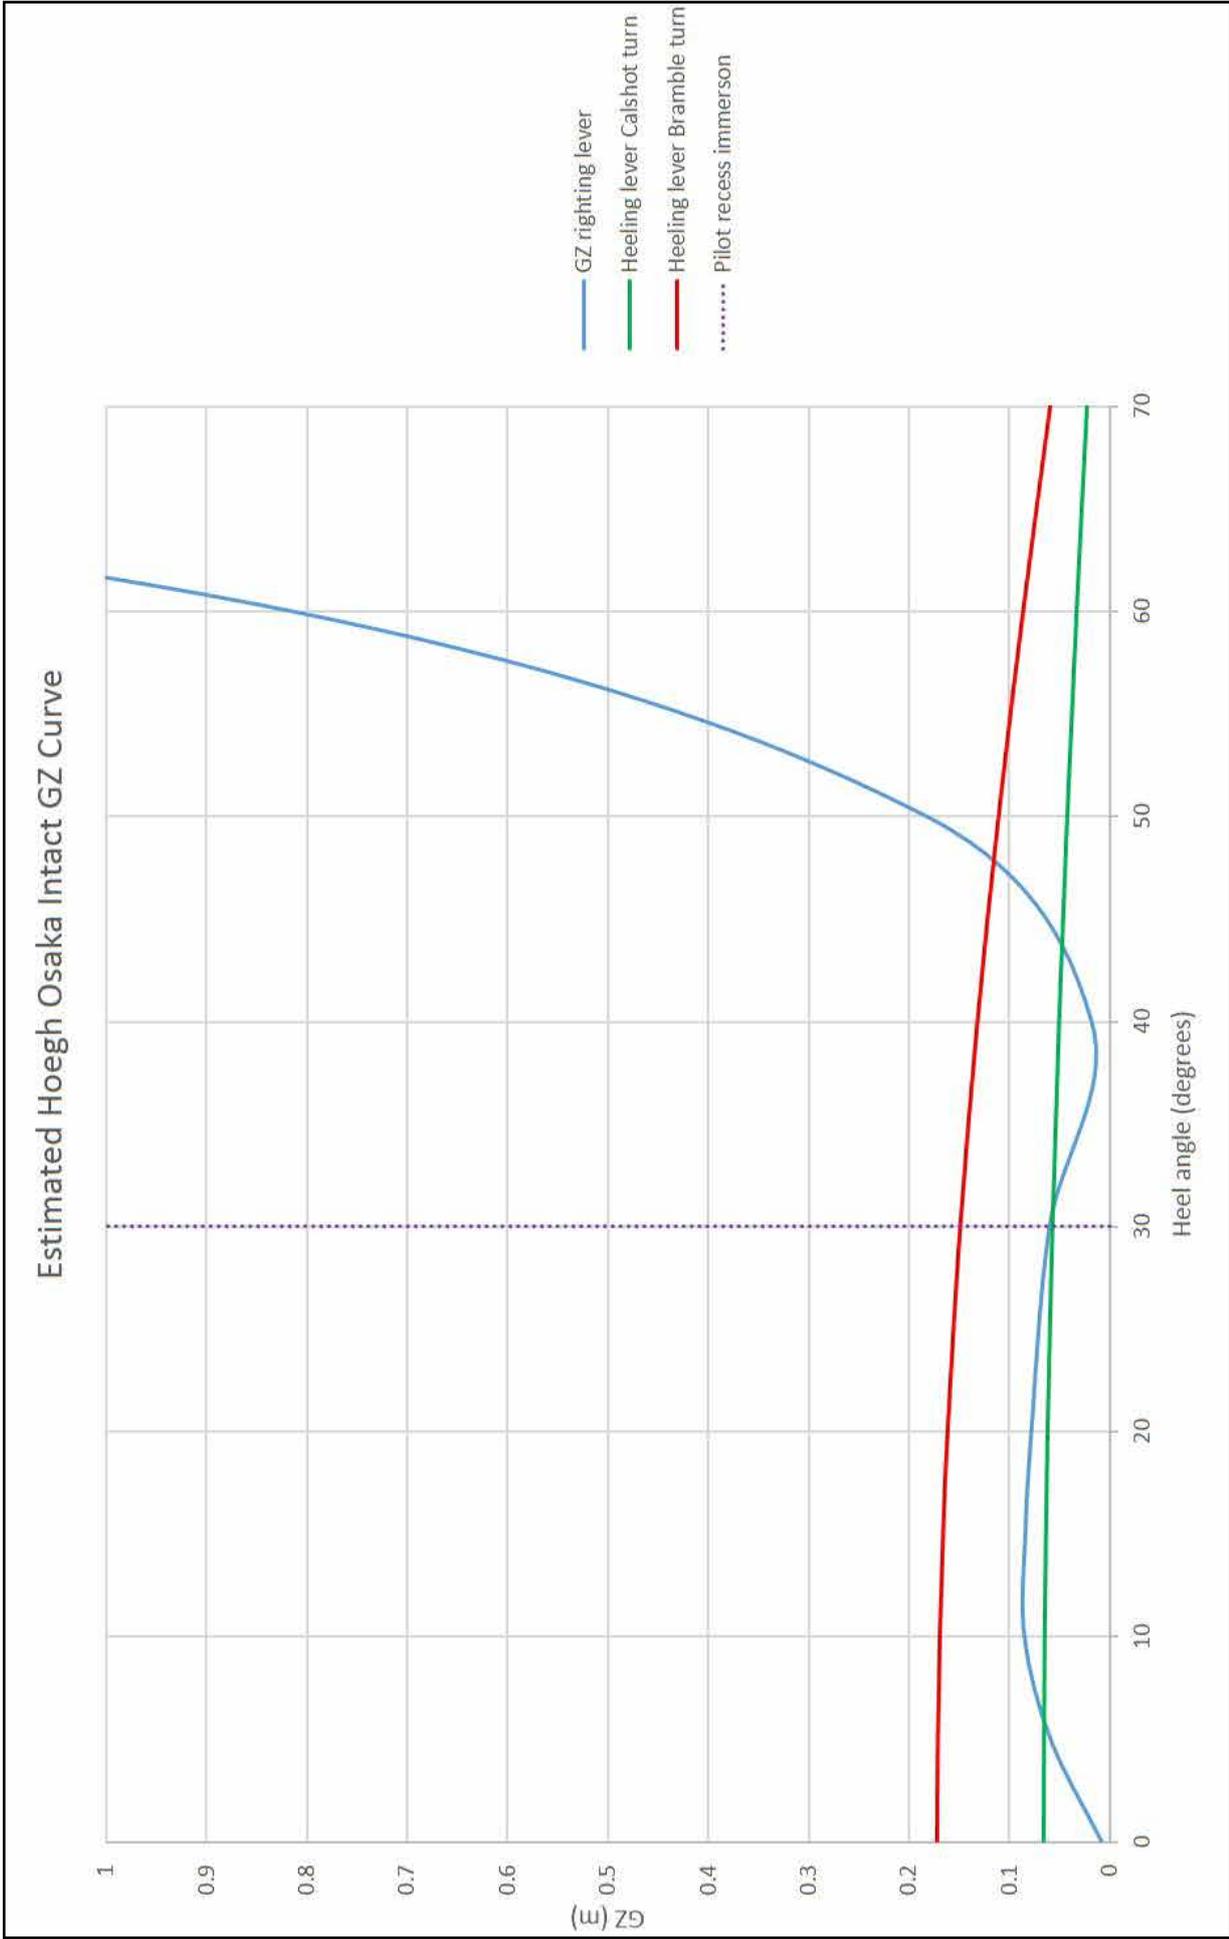
While *Hoegh Osaka* left its berth with positive stability ($GM > 0$), its estimated condition did not comply with IMO stability requirements. The estimated righting lever curve (GZ) is reproduced in **Figure 30**. The very low area under the GZ curve (blue line) is indicative of the righting moment that was available to resist the heeling moment of *Hoegh Osaka* when turning to port in the vicinity of Bramble Bank (red line). However, there was sufficient righting moment to resist the heeling moment at the Calshot turn (green line). The angle at which the shell plating damage in the vicinity of the starboard gangway void was submerged was estimated at 30°, although at what heel angle this damage occurred is unknown. However, at some stage beyond 30° heel, flood water would have entered the ship. As the ship heeled further to starboard, the available righting moment would have increased as the hull side became immersed.

Hoegh Osaka had inadequate residual stability to survive the Bramble Bank turn at 12kt, but had sufficient residual stability to survive the Calshot turn at 10kt. This was because the heeling moment when turning is proportional to the square of the speed (44% greater heeling moment).

Figure 30: Estimated Hoegh Osaka intact GZ curve
