**INCIDENT**

| <b>Aircraft Type and Registration:</b> | Cessna Citation CJ2, D-ISJP | |
| <b>Location:</b> | Warton Aerodrome, Preston, Lancashire | |

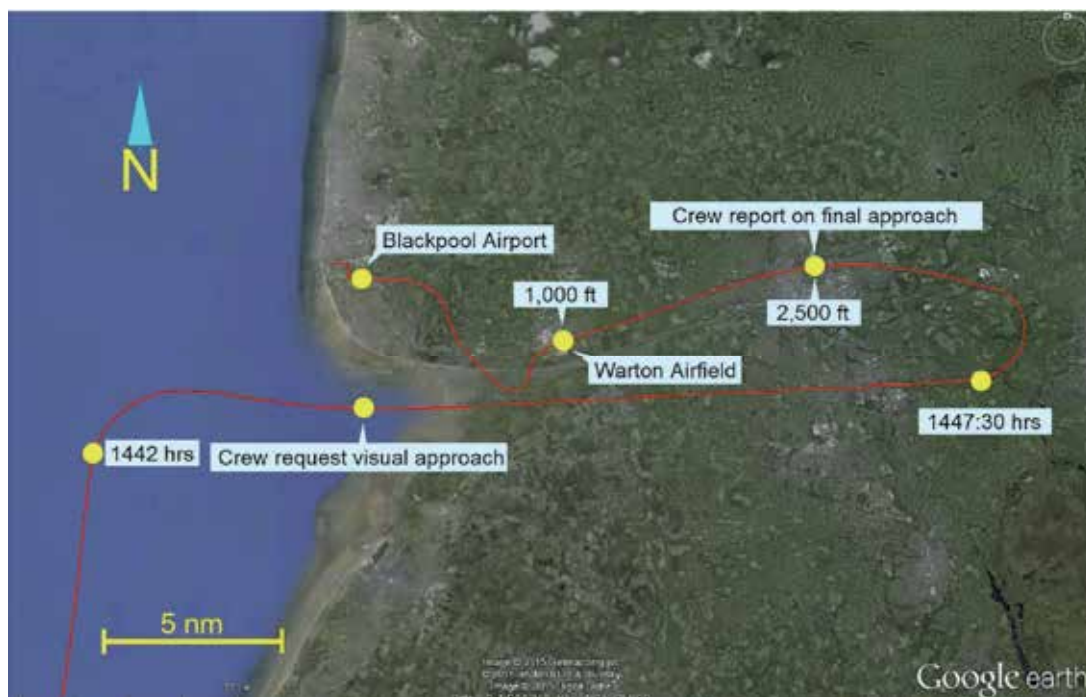
**Figure 1**

The aircraft started a right turn, initially towards the 'BPL', an NDB located at the airfield. However, the turn continued until the aircraft was on an easterly track (Figure 1), heading directly towards the POL VOR (33 nm east of BPL). At 1443 hrs, Blackpool ATC requested the range of the aircraft from the BPL, the reply was "THIRTY EIGHT MILES INBOUND PAPA OSCAR LIMA". This was acknowledged by ATC.

Radar track of approach to Blackpool Airport (altitudes amsl)

Radar information was available from three radar heads. The radar at St Annes, which is located less than 1 nm to the south-east of Blackpool Airport, provided a complete record of the approach and landing (Figure 1). Ground based recordings of RTF communications between ATC and the aircraft, and telephone conversations between controllers at Blackpool and Warton airfields, were also available.
