ACCIDENT

Aircraft Type and Registration:	Folland Gnat T Mk 1, G-TIMM	
No & Type of Engines:	1 Rolls-Royce Orpheus 101 turbojet engine	
Year of Manufacture:	1962 (Serial no: FL519)	
Date & Time (UTC):	1 August 2015 at 1302 hrs	
Location:	Approx 1 mile north of Oulton Park, Cheshire	
Type of Flight:	Aerial Work	
Persons on Board:	Crew - 1	Passengers - None
Injuries:	Crew - 1 (Fatal)	Passengers - N/A
Nature of Damage:	Aircraft destroyed	
Commander's Licence:	Private Pilot's Licence	
Commander's Age:	39 years	
Commander's Flying Experience:	706 hours (of which 218 hours were on type) Last 90 days - 6 hours Last 28 days - 2 hours	
Information Source:	AAIB Field Investigation

Synopsis

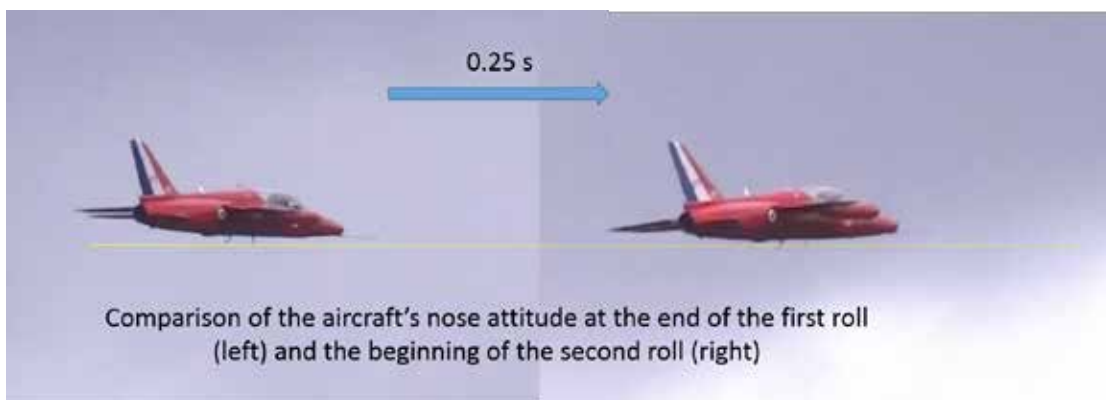
G-TIMM approached the display line from 'crowd left' and commenced a roll about its longitudinal axis, and the left image in Figure 9 shows the aircraft attitude at the end of that manoeuvre relative to the horizontal yellow line. The pilot then appeared to increase the attitude of the aircraft prior to commencing the second roll, as shown in the right image in the Figure, although the increase appeared slight on the video.

Aircraft attitude before the second rolling manoeuvre

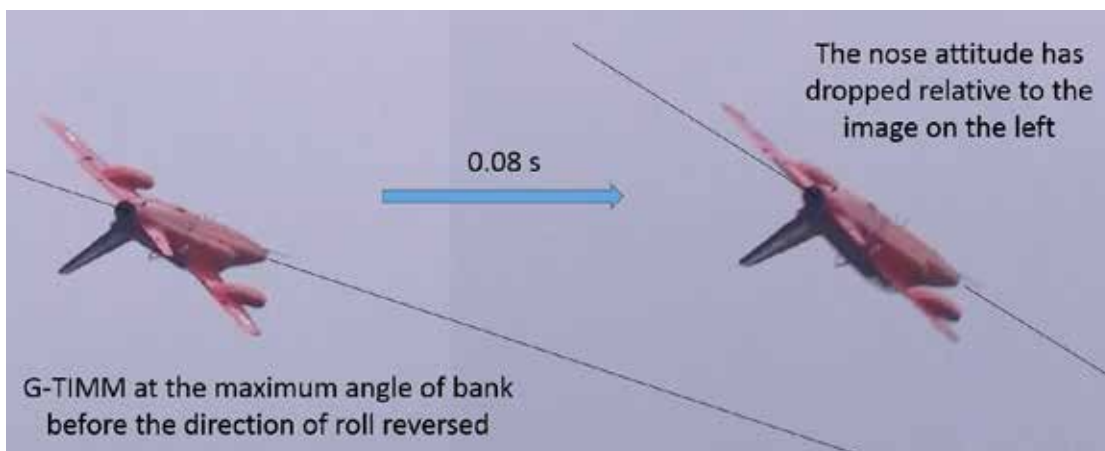
Figure 10

When G-TIMM reached the attitude shown in the left image within Figure 10, the nose attitude dropped relative to the horizon, a drop which was marked on the video. The black lines on the Figure are drawn along a line from the nose of the aircraft through the centre of the jet pipe at its rear to illustrate the drop in nose attitude (shown by the fact that the lines are not parallel).

Comparison of the aircraft attitude during the rolling manoeuvre

The images in Figures 9 to 14 and the information in Table 2 show that the accident sequence began when, with the aircraft at 107° angle of bank to the left, the nose attitude dropped relative to the horizon (Figure 10). The cause of this change in aircraft attitude was not determined.

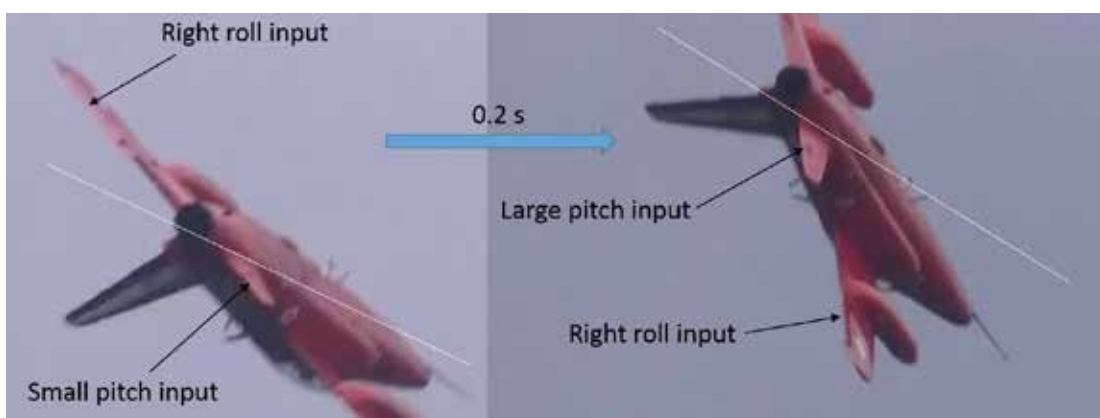
Immediately after the nose dropped, the direction of roll reversed to the right. Control inputs consistent with this are shown in the left image of Figure 11 by the 'upward' deflection of the right aileron (upward relative to aircraft axes) and, in the right image, by the 'downward' deflection of the left aileron (downward relative to aircraft axes). Approximately 0.2 seconds after the direction of roll reversed, a control input was made to the tailplane whereby its trailing edge moved upwards considerably (upwards relative to aircraft axes). The white lines in Figure 11 are drawn through the leading and trailing edges of the tailplane to illustrate its movement (shown by the fact that the white line in the first image crosses the underside of the aircraft forward of the two aerials whereas, in the second, it passes aft of the two aerials).

Reversal of roll direction and increase in pitch input

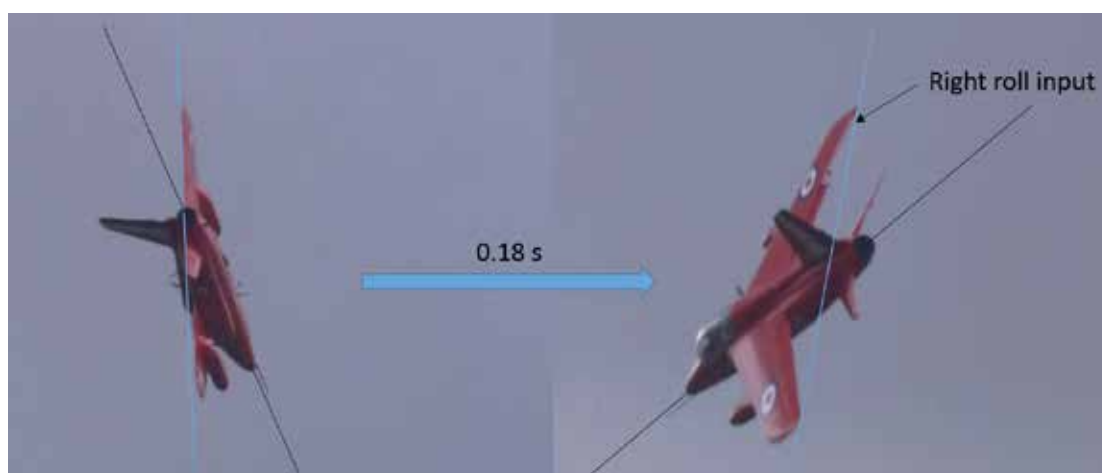
The movement of the tailplane caused the aircraft to pitch (rotate) markedly about its lateral axis. This is shown in Figure 12 by the fact that the first image shows the underside of the aircraft while the second shows its top surfaces. The black lines, once again drawn through the nose and jet pipe, also show the marked change in aircraft pitch attitude.

Increase in pitch attitude and reduction in bank angle

The right aileron in the second image is deflected upward indicating that there is a right roll control input. Reference to the blue lines, drawn through the trailing edges of each wingtip, shows that the angle of bank was reducing in response to this input ie the aircraft was rolling right towards a more upright attitude.

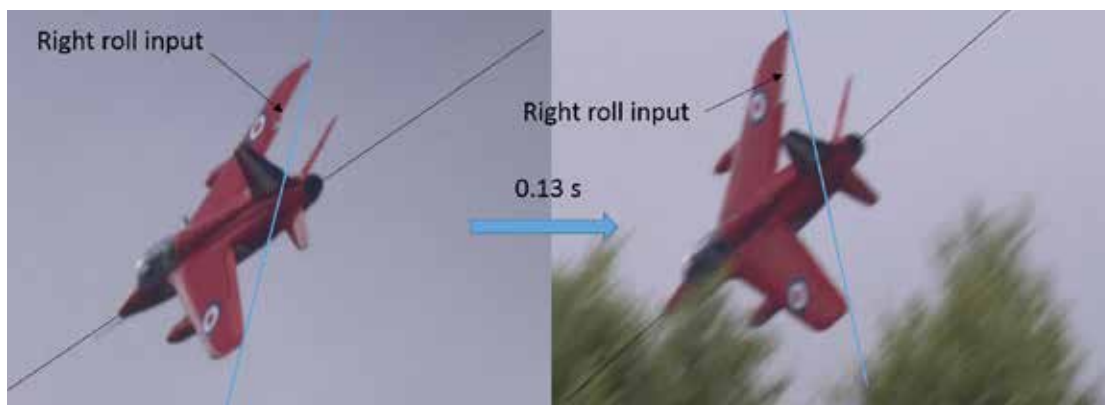
Following the marked change in pitch attitude shown in Figure 12, the nose attitude of the aircraft dropped further, illustrated by the fact that the black lines in Figure 13 are not parallel. The right aileron is still deflected upwards, indicating a control input for right roll. However, a comparison of the two blue lines shows that the aircraft was rolling left as it descended towards tree-top height.

Left roll with right roll control input

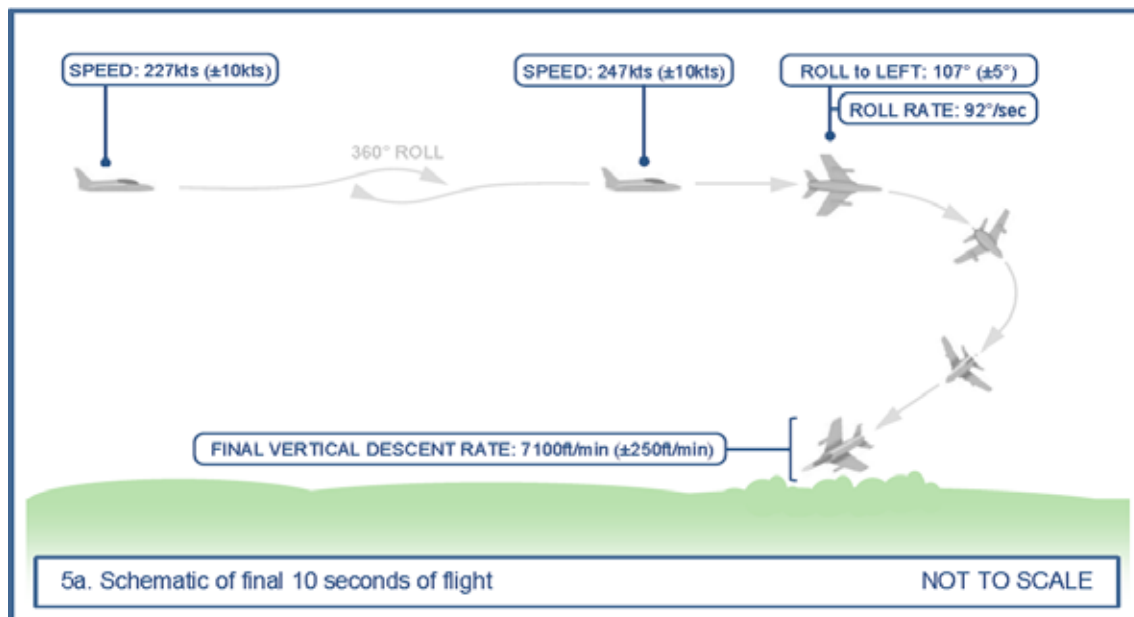
**Figure 14**

Schematic representation of the final 10 seconds of flight

Figure 14 shows that the first rolling manoeuvre was flown at 227 kt ± 10 kt, approximately 73 kt below the usual entry speed of 300 kt, and the second rolling manoeuvre at 247 kt ± 10 kt, approximately 53 kt slower than the usual entry speed. These speeds were below the recommended minimum speed of 280 kt (although the Pilot's Notes suggested that pilots with experience could fly aileron rolls at unspecified slower speeds). Aircraft rolling at lower speeds have an increased tendency for the nose attitude to drop during the manoeuvre and, if this is not anticipated, it can lead to a lower-than-normal nose attitude at the end of the roll. This can influence the following manoeuvre especially if, as video evidence suggested in this case, the nose attitude was raised only slightly ahead of the second roll. A lower-than-normal nose attitude at the beginning of the second roll, combined with a speed still below the recommended minimum, might account for the drop in nose attitude during the manoeuvre. However, other possibilities for the drop in nose attitude could not be discounted, such as disorientation, visual illusion or distraction.
