ACCIDENT

| Aircraft Type and Registration: | Schempp-Hirth Duo Discus T, G-SAXT | |

Synopsis

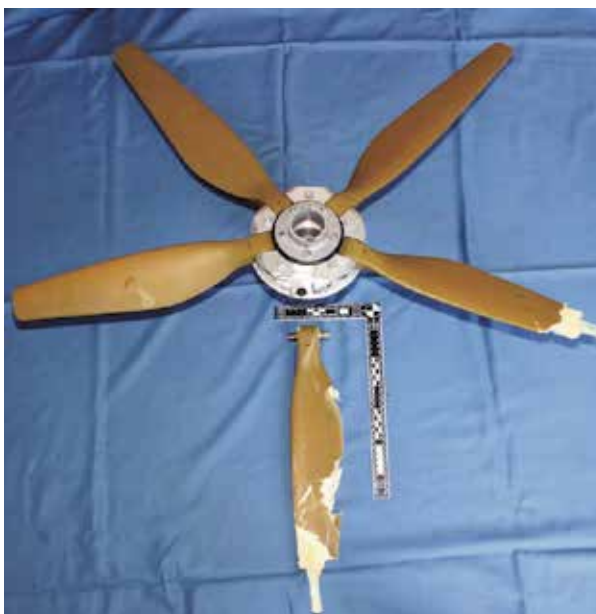
Figure 1

Apart from the detached propeller blade, which had embedded itself in the left wing root causing damage to the aileron control circuit in that area, the adjacent blade had been badly damaged, apparently due to being struck by the departing blade. It was immediately apparent that the blade had detached due to failure of the metal hub blocks which locate it (Figures 1 and 2).

Photograph of propeller showing detached blade and damage to adjacent blade

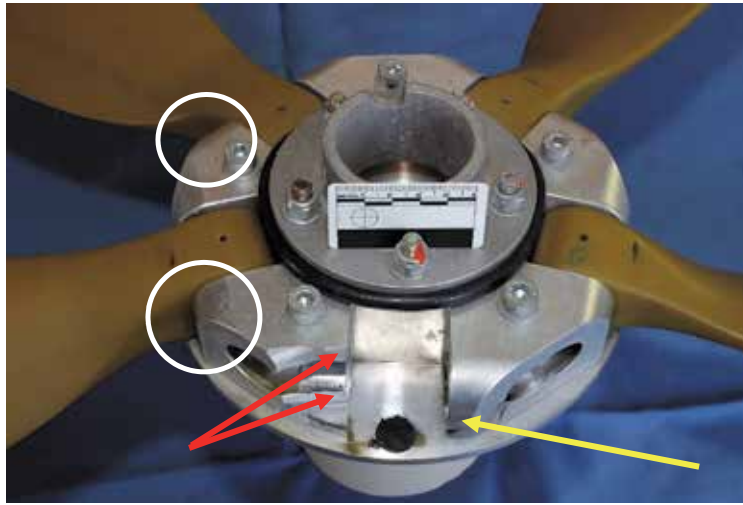
Figure 2

The propeller was removed and sent to a materials laboratory for detailed examination. The metallurgical report states that the blade had detached due to pre-existing fatigue cracking of the metal hub blocks which retain it (Figure 2).

Photograph showing fractured hub blocks. Yellow arrow points to the initial crack origin and double red arrows point to secondary cracking resulting from released section of right-hand block. Additional cracks were found at the locations circled

Analysis of the fracture showed that the first crack to appear had originated on the outside of the block at the location arrowed in Figure 2. This then propagated inwards towards the blade trunnion bore. As this crack lengthened, the stresses created another crack at right angles propagating rearwards and eventually releasing a quarter-circular arc of the block. The out-of-plane loads this generated caused two more cracks to grow outwards from the bore of the other block until another, larger, section of metal broke off and the blade was released.

Cracks were also noted in the block retaining the trunnion for two other blades. Breaking these open confirmed that they were also fatigue cracks. The cracks were consistent with high frequency oscillations and did not appear to be associated with material defects.

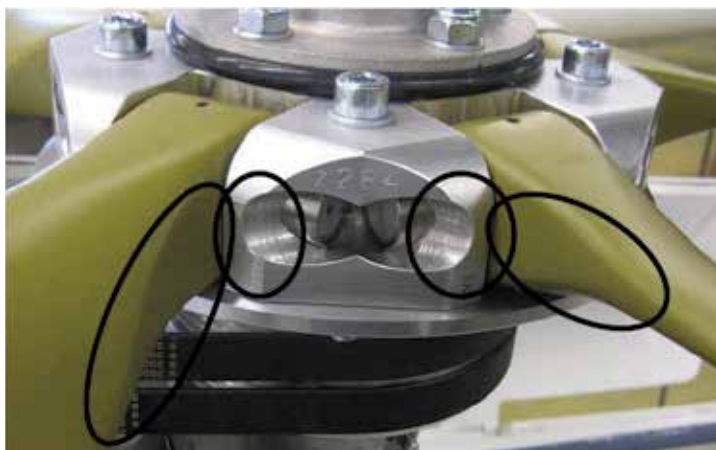
Check propeller hub and propeller blades for cracks or other damage, in particular also the area near the blade bearing marked in the following picture:
