Rail Accident Report

**Signal passed at danger on approach to
Wootton Bassett Junction, Wiltshire
7 March 2015**

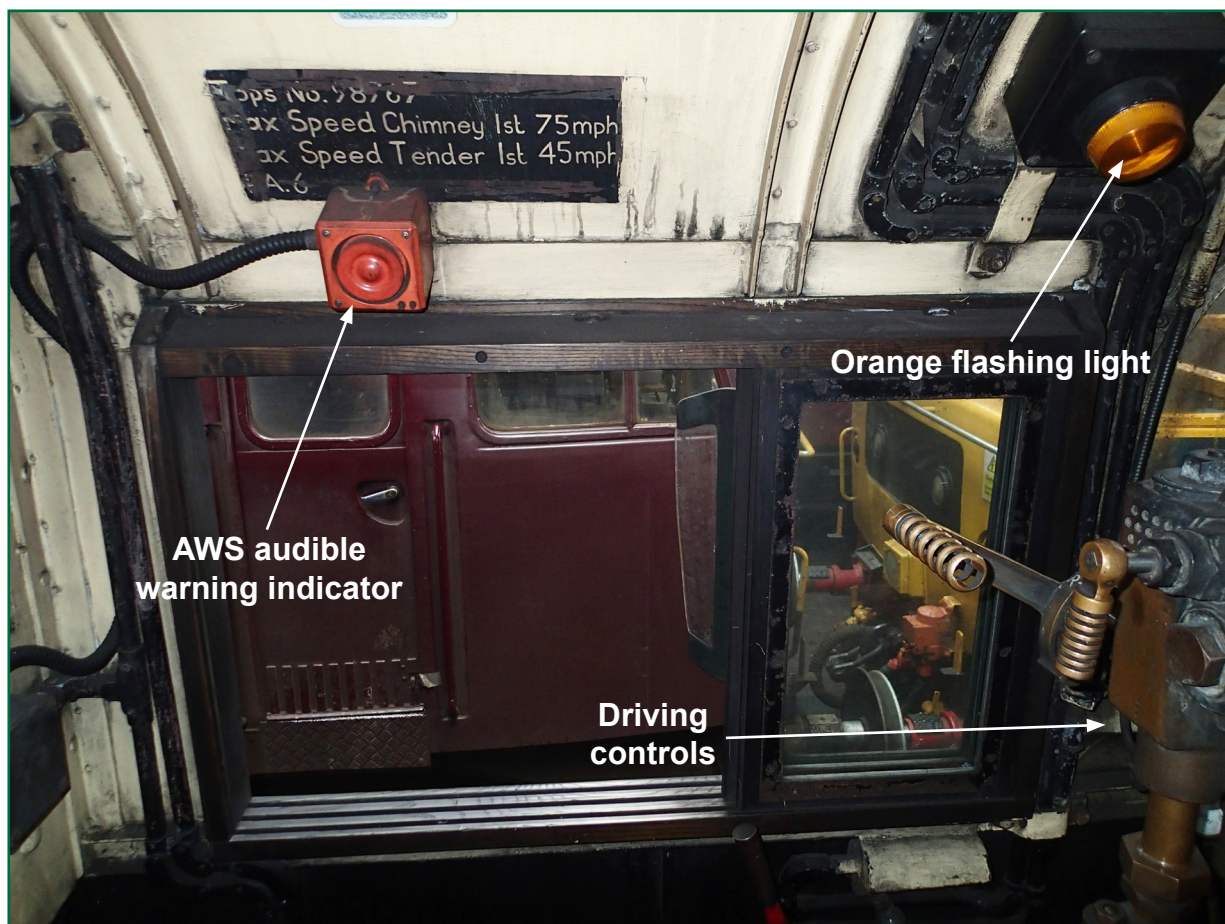
- 15 At the time of the incident, the AWS audible warning indicator on Tangmere was positioned on the inside of the cab roof, just above the *driving position* (which is on the left-hand side of this locomotive) and towards the rear of the driver's side window. The orange flashing light was also positioned on the inside of the cab roof, slightly higher than the audible warning indicator and to the front of the driver's side window (figures 8 and 9). The AWS visual indicator (commonly called the 'sunflower') is mounted in front of the driving position just above the main driving controls, with the TPWS display panel positioned directly above it (figure 9).

Figure 8: The position of the AWS audible warning indicator unit and flashing light on 7 March 2015
