ACCIDENT REPORT

Report on the investigation into the girding and capsizing
of the mooring launch

Asterix

at Fawley Marine Terminal, Southampton, UK

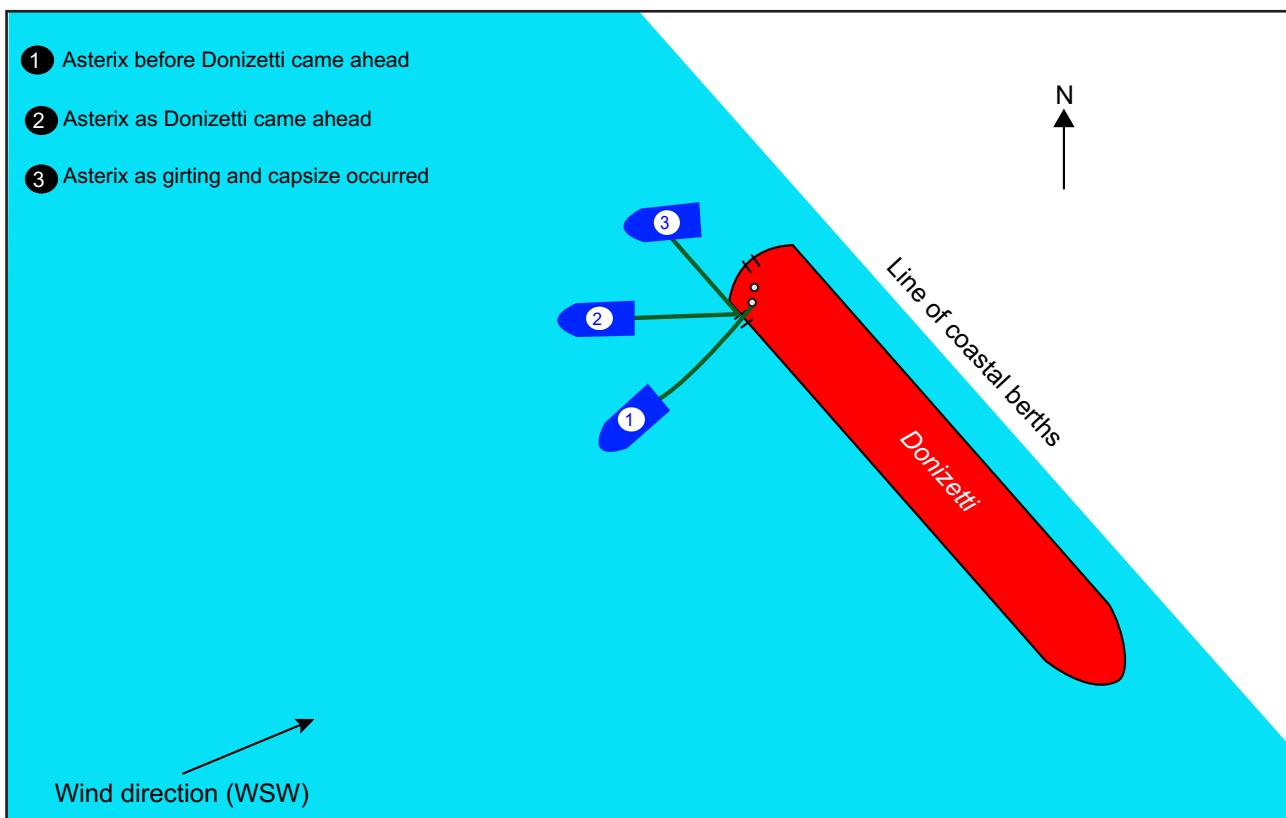
Figure 2: Indicative relative movement of *Asterix*

At around 1600, *Donizetti* completed cargo discharge and commenced preparations for departure, which was scheduled for 2000. At 1945, a pilot boarded and, shortly afterwards, there was an exchange between the pilot and the master. The pilot advised of his intention to utilise a tug to assist in manoeuvring the vessel off the berth. He considered that with a wind speed gusting to 25 knots and pushing the vessel onto the berth, an obstruction astern and another vessel berthed 30m ahead of *Donizetti*, it would be prudent to employ a mooring launch to assist, if necessary, in lifting the vessel's stern off the berth. At approximately 2000, *Asterix* came alongside and, at the request of the launch coxswain and with the agreement of the pilot, the towline was made fast through *Donizetti*'s starboard quarter fairlead (**Figure 2**).

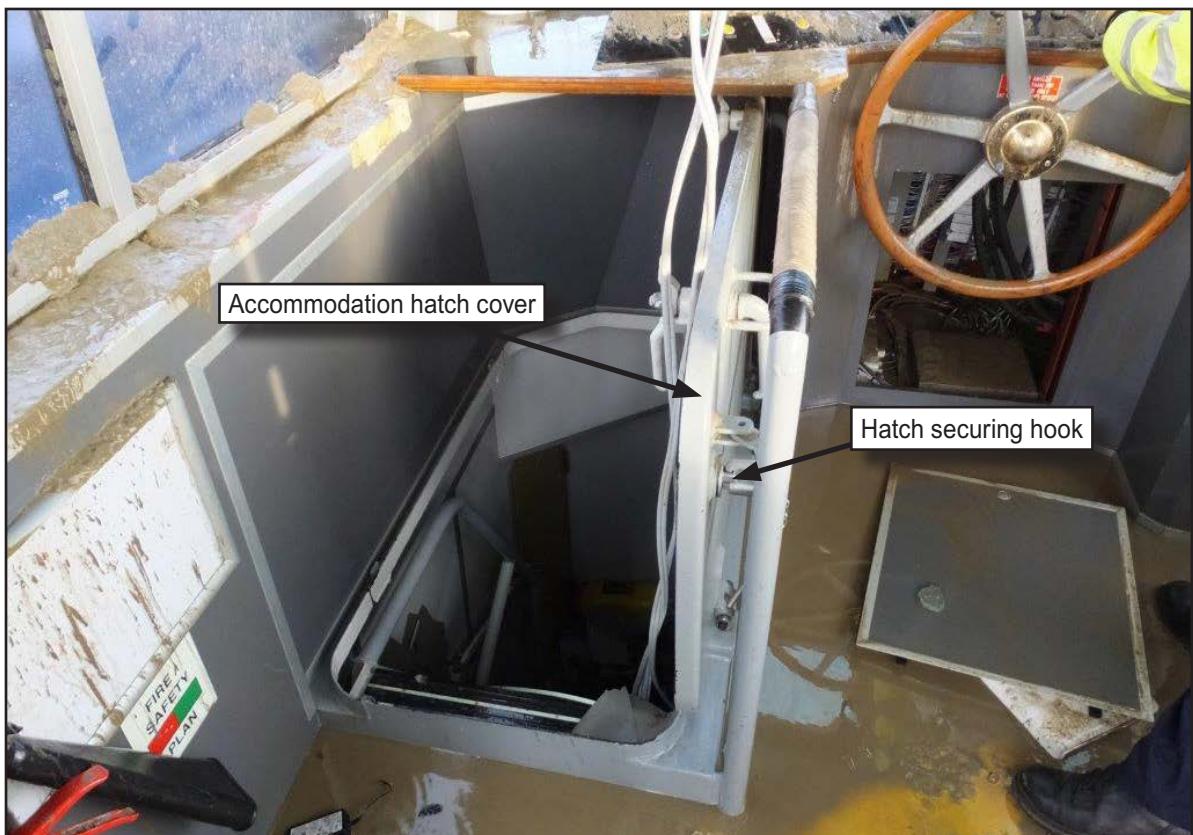
Figure 4: Accommodation hatch cover (hooked open)

At the time of the sinking, all hatch covers and doors were closed and secured with the exception of the accommodation entrance hatch cover in the wheelhouse and the wheelhouse entrance door, both of which were found hooked open when the launch was later recovered (**Figures 4 and 5**).

Asterix capsized due to girding, which caused the vessel to heel to an angle that resulted in deck edge immersion with floodwater then entering the wheelhouse through the open entrance doorway. This in turn led to the vessel's inversion. With the vessel upturned, floodwater was able to enter the machinery spaces through the now submerged compartment vents. As the vessel began to roll, water from the wheelhouse was able to enter the accommodation through the open entrance hatchway, compounding the machinery space flooding.

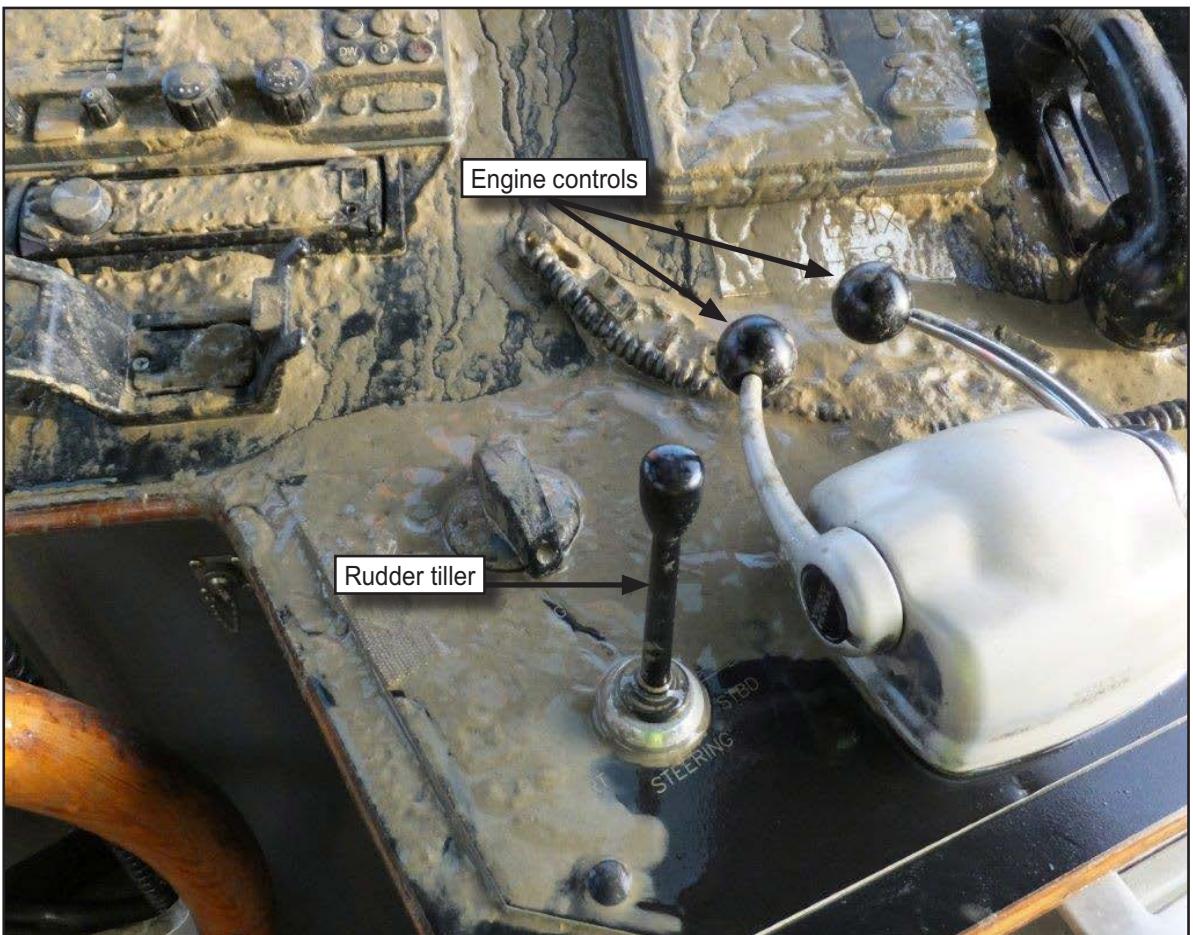
Figure 6: Asterix manoeuvring controls

Each of the main engines was a Volvo marine propulsion engine model D9 MH driving a fixed pitch propeller through a reduction gearbox. Main engine speed and ahead/astern gearbox position was achieved through electronic remote control with one handle for each engine located on the wheelhouse control console. When the vessel was salvaged, both handles were found in the 'full ahead' position (**Figure 6**).

console. At the time of the accident, the steering was being controlled using the tiller (**Figure 6**). When the vessel was recovered, the rudder indicator showed 10° to port, which corresponded to the actual rudder angle.

Asterix was designed with a forward-facing conning position. The rudder tiller and engine controls were located on a console in such a position that, when manoeuvring the launch, it was natural for the coxswain to face away from the tow. Furthermore, owing to the proximity of the oil pollution boom and adjacent shallow water, it was important that the coxswain was able to concentrate on the positioning of the mooring launch relative to these hazards. Consequently, the coxswain needed the assistance of the deckhand in order to monitor the situation effectively.

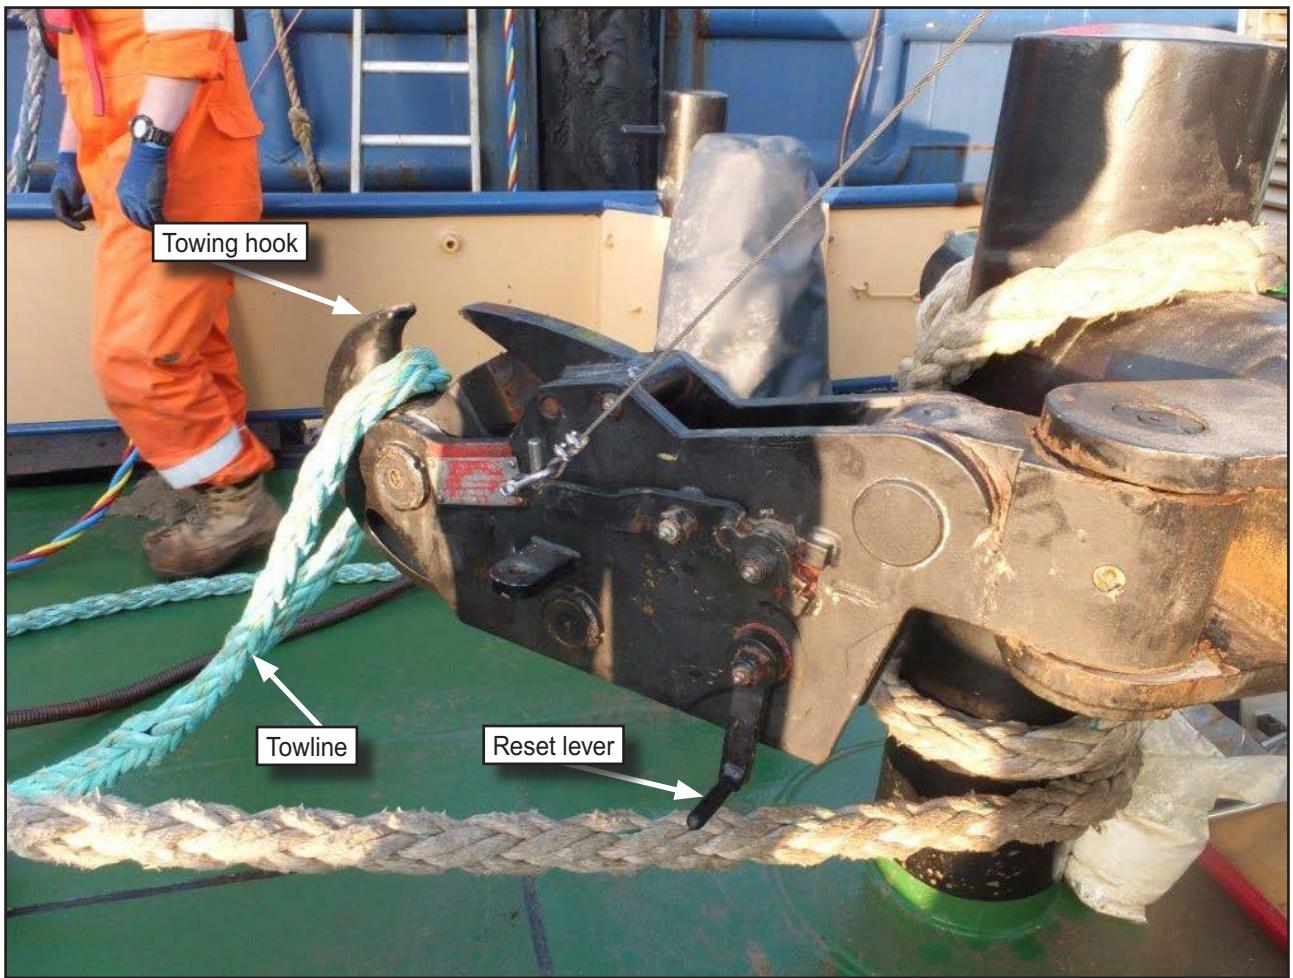
Figure 7: Towing hook (as found following salvage)

The launch was fitted with a Mampaey quick-release disc type towing hook located on the main deck just aft of the wheelhouse. The hook was designed to rotate through approximately 180° with a tow attached (**Figure 7**). The towing hook had a safe working load of 15t with a test load of 30t. It had an emergency release mechanism, which was activated by pulling on a wire. The wire was connected to an operating handle suspended from the deckhead of the wheelhouse and ran through a raised pulley forward of the towing hook before connecting to the hook release mechanism (**Figures 8, 9 and 10**). This model of towing hook could be fitted with either air or hydraulic actuators to complement the manual emergency release, but these options had not been specified for the build of *Asterix*. When the vessel was salvaged, the towing hook release mechanism was found to have only partially activated, with the towline's eye still located on the closed hook.

After the 30t release, the hook did not fully reset. Investigation revealed that a build-up of corrosion on the mating face of the hook and the roller release weight prevented the hook from fully resetting. Notwithstanding the incomplete reset, the emergency release remained functional.

When *Asterix* was salvaged, the towing hook release mechanism was found to have only partially activated, with the towline's eye still located on the closed hook.

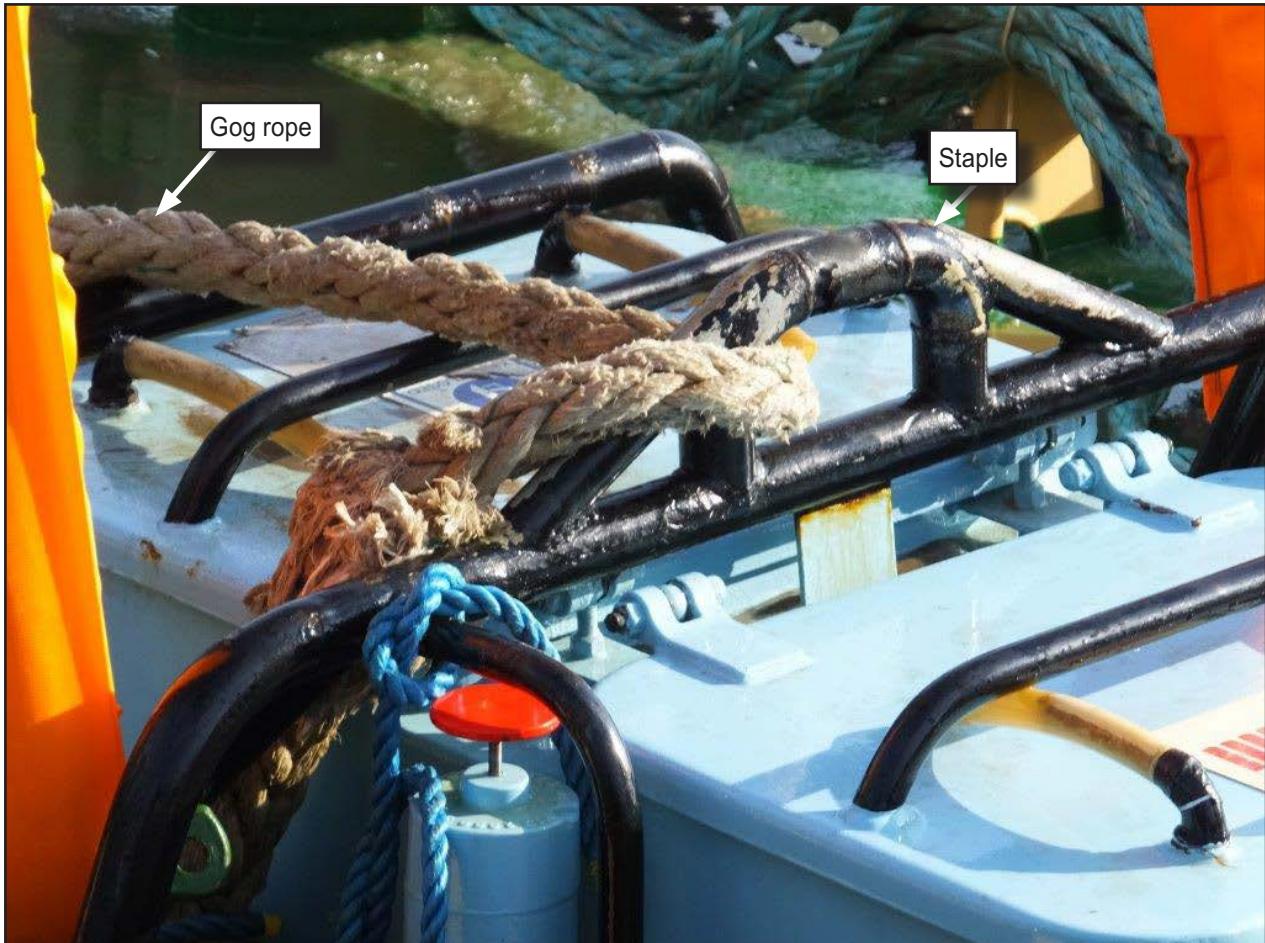
Figure 11: Gog rope staple

Shortly after *Asterix* was delivered, at the request of the owner, the manufacturer had fitted a bracket and staple between the engine room and aft peak hatches. The purpose of the staple was to allow the use of a gog rope to move the towing point further aft. An H-shaped bit, the structure of which supported the towing hook, was used to secure one end of the gog rope. When the vessel was recovered, the gog rope was found leading through the staple, with one end secured to the bit and the towline passing through a ring attached to its other end (**Figures 11 and 12**).

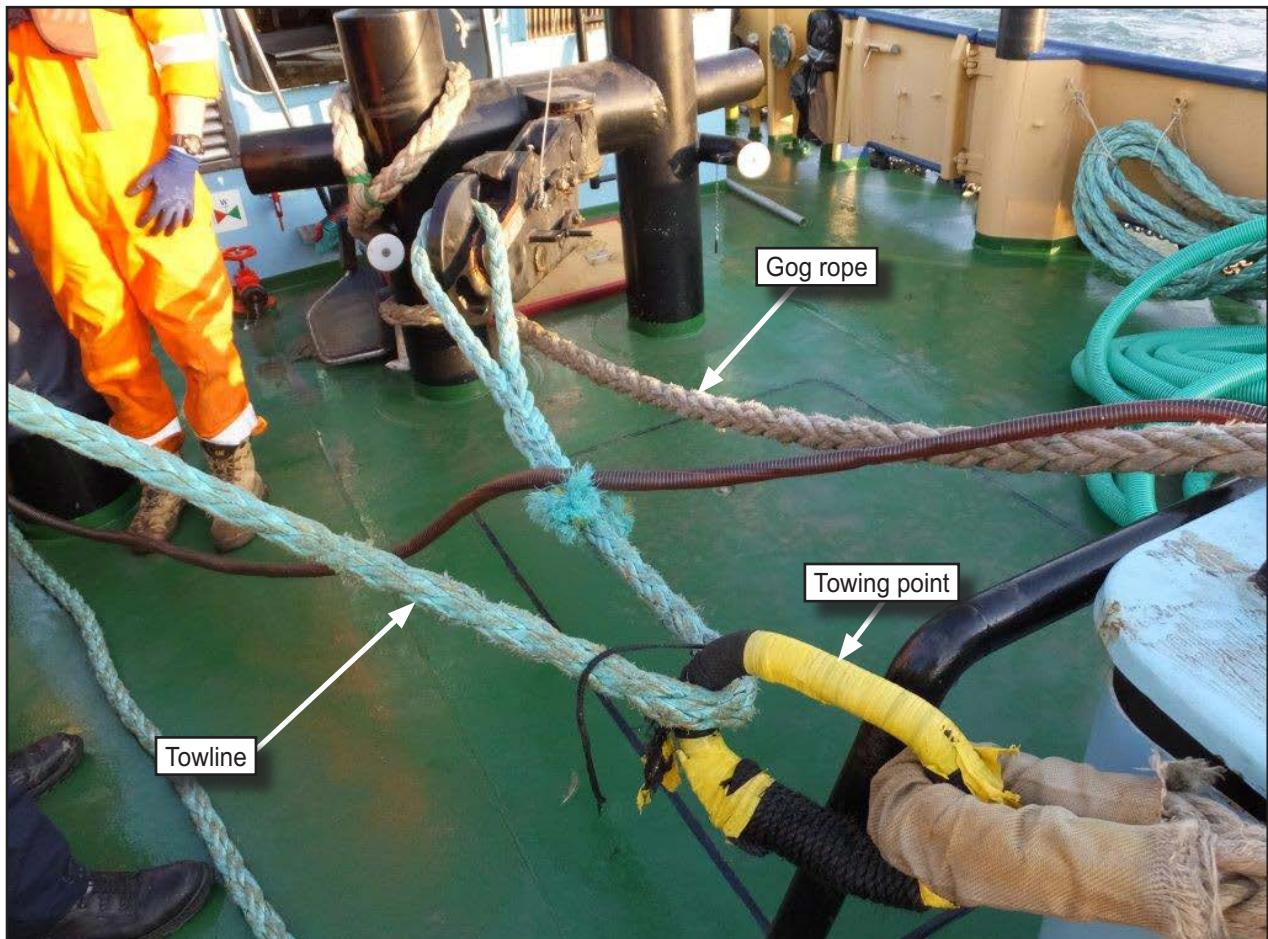
Figure 12: Gog rope arrangement (as found following salvage)

Østensjø Rederi AS's risk assessment of mooring launch operations at FMT recognised girting as a hazard. The company chose to mitigate against girting by instructing the crews to use a gog rope on every tow, and a bracket and staple had been retrofitted to Asterix for this purpose. The requirement to use a gog rope on every tow assumed that a risk of girting existed on every tow, and that the launch crews were proficient in adjusting the gog rope to maximise its preventive effect.

- Review and enhance its risk assessment relating to the hazard of girting.
 - Introduce comprehensive instructions and guidance relating to operations requiring the use of a gog rope.

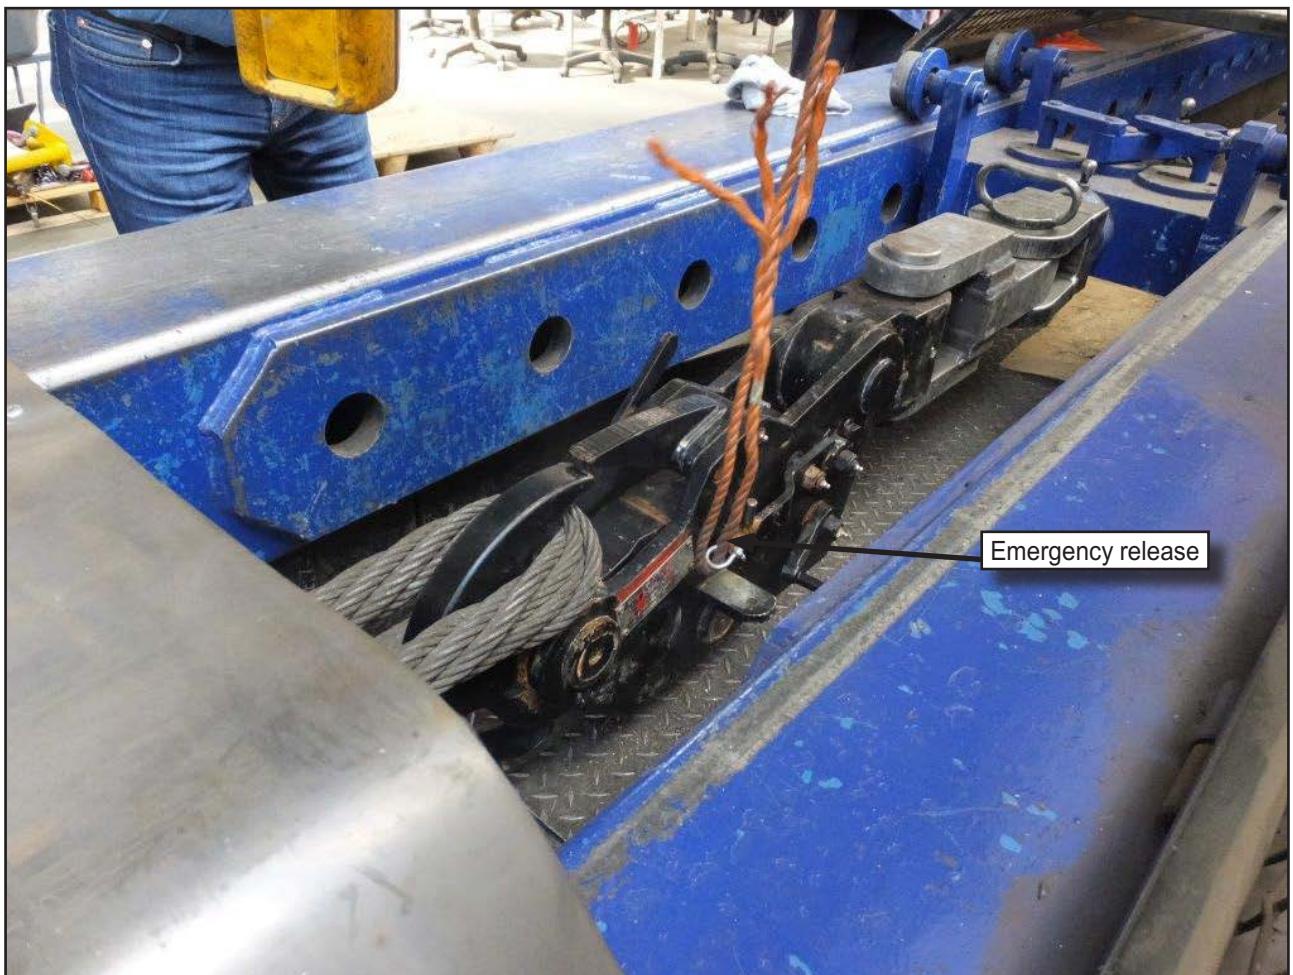
Figure 13: Towing hook emergency release testing

It was noted that the loading needed to manually operate the emergency release increased in a linear relationship to the load applied to the hook. A load cell attached to the release mechanism lever with a manual pull to operate the release gave the following readings:

- At a hook loading of 15t the required release load was 18kg.
- At a hook loading of 20t the required release load was 24kg.

Following the 20t test, the hook was greased and the release cord attached to an electric hoist to demonstrate the effect of a steady pull on the release wire as opposed to a rapidly applied manual pull. In this case the load required during a steady pull against a 20t hook load varied between 42kg and 44kg.

With no mechanical assistance, the emergency release relied on the crew to operate the manual pull in order to release the towline. Tests of the hook demonstrated that, under load conditions, a steady pull required significantly more force to operate the release mechanism than a sharp pulling action, and that the required effort increased in proportion to the loading on the hook.
