**SERIOUS INCIDENT**

<b>Aircraft Type and Registration:</b>	Bombardier DHC-8-402, G-FLBC	
<b>No &amp; Type of Engines:</b>	2 Pratt & Whitney Canada PW150A turboprop engines	
<b>Year of Manufacture:</b>	2009	
<b>Date &amp; Time (UTC):</b>	16 December 2014 at 1832 hrs	
<b>Location:</b>	En route Glasgow to Belfast	
<b>Type of Flight:</b>	Commercial Air Transport	
<b>Persons on Board:</b>	Crew - 4	Passengers - 76
<b>Injuries:</b>	Crew - None	Passengers - 1 (Minor)
<b>Nature of Damage:</b>	Damage to left engine and engine nacelle	
<b>Commander's Licence:</b>	Airline Transport Pilot's Licence	
<b>Commander's Age:</b>	36 years	
<b>Commander's Flying Experience:</b>	7,847 hours (of which 6,820 were on type) Last 90 days - 185 hours Last 28 days - 59 hours	
<b>Information Source:</b>	AAIB Field Investigation

**Synopsis**

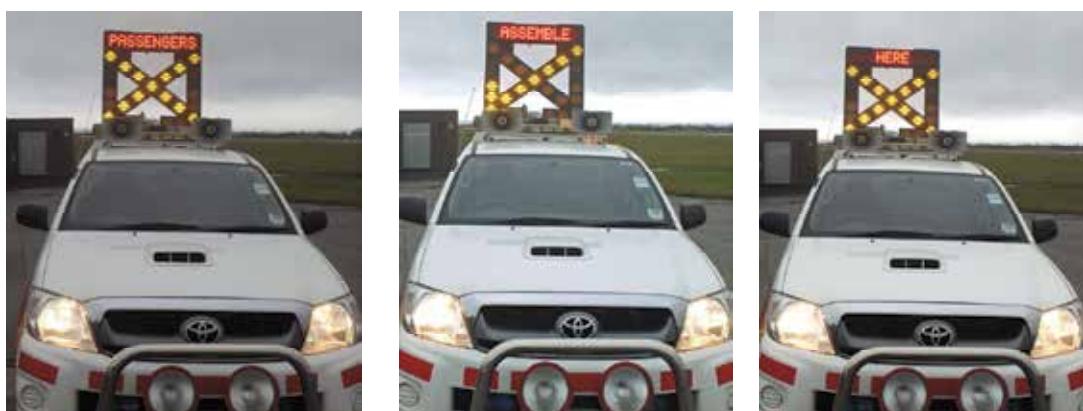
**Figure 1**  
Airport 'Assemble Here' vehicle

There was an airport vehicle on the runway with a large illuminated sign on its roof, which read: "PASSENGERS ASSEMBLE HERE" (see Figure 1). The same message was also broadcast through the vehicle's loudspeakers. Some of the passengers, particularly those who evacuated from the rear right exit, were confused as to where to go after leaving the aircraft. Most of the fire crew were on the left side of the aircraft, where the fire had been, and within a few minutes all of the passengers were safely on board airport buses, out of the rain. A head count was conducted and, initially, it appeared that a passenger was missing. This was quickly resolved, once it was realised that the positioning First Officer had remained with the crew.

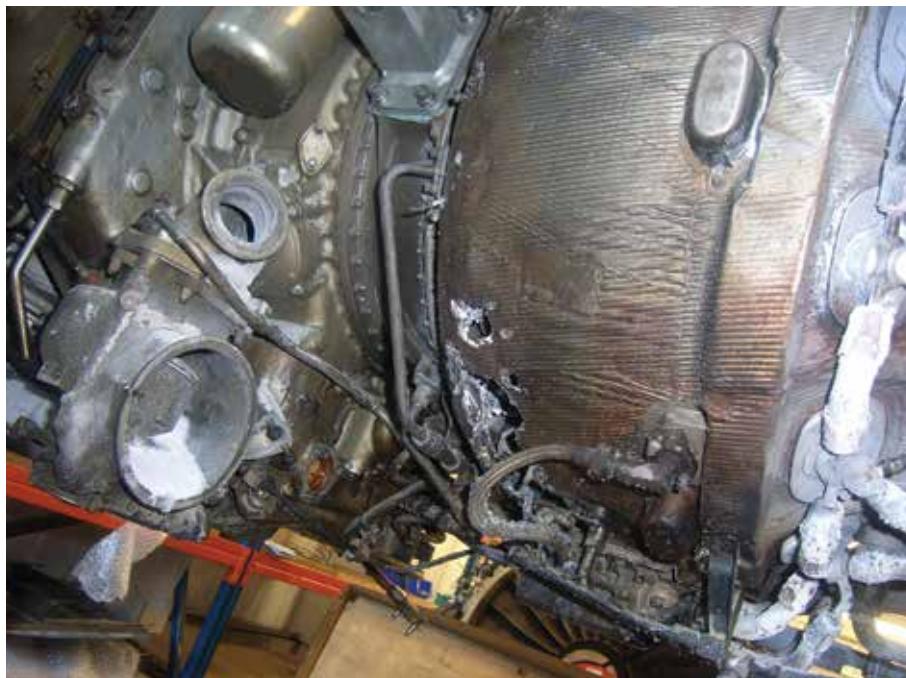
**Figure 5**

The engine was transported to the operator’s engineering base for examination. The complete nacelle structure and the cowlings, from the firewall forward, were similarly transported to enable detailed examination to take place. Once the engine was suspended, without the intake system decking in position, it was possible to see the damage to the combustor area more clearly and large holes in the insulating cover could be observed close to the 6 o’clock position (see Figure 5).

Substantial burn damage and disruption was evident to pipes, cables and other services external to the engine casing at a number of locations. In particular, a hole was evident in a fuel pipe adjacent to the large hole in the combustor. The pipe in this area was coated in metal splatter.

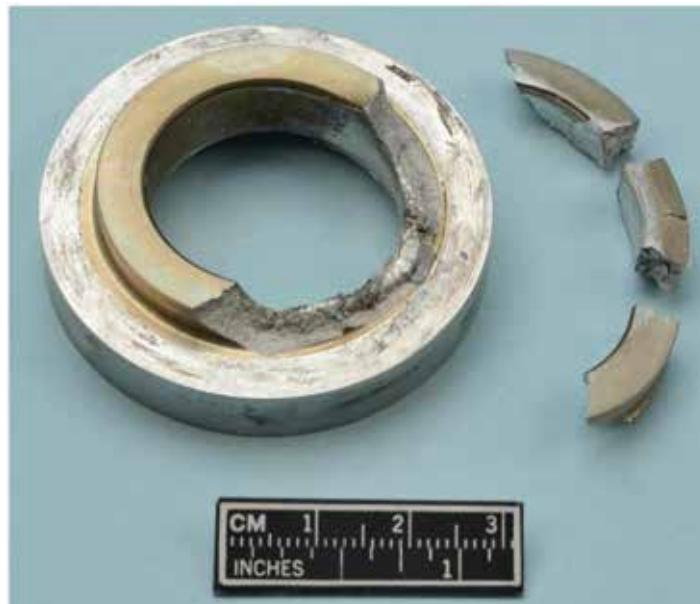
**Figure 6**

The oil pressure/scavenge pump unit was subjected to X-ray computed tomography (CT) scanning, before being forwarded to its manufacturer for examination. That examination revealed that a lateral breakout failure of the upper bearing of the driven stack (see Figure 6) had allowed its axis to be displaced, permitting disengagement of the gears.

This had resulted in loss of drive to all the scavenge pumps, except for No 2/2.5, 5 and 7, and that for the accessory gearbox. Dismantling revealed that numerous vanes were jammed in their slots in the rotors and evidence of significant overheating was present.

Failed upper bearing  
No 3/4 scavenge pump

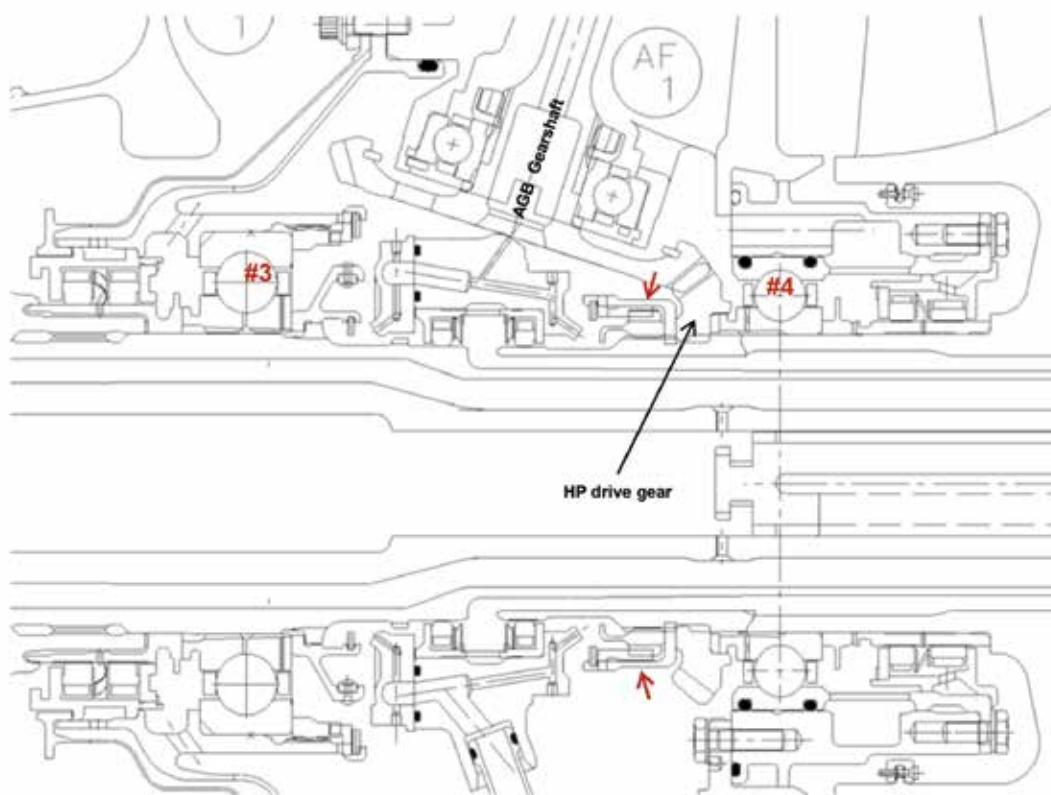
**Figure 7**

The close similarities between features of the above two engines led to a laboratory examination of the key washer salvaged during dismantling of the G-FLBC engine. It was confirmed that fatigue cracking had been present in the component (situated immediately forward of the No 4 bearing - see Figure 7). Consequently, overload failure had ultimately occurred, releasing part of the washer. The released fragment then appeared to have travelled through the gallery to the 3/4 cavity scavenge pump. Such an eventuality would normally result in seizure of the pump assembly and failure of the shear neck on the driveshaft. On this occasion, however, (in G-FLBC) it appeared that the action of lubricant within the pump assembly coupled with the geometry and orientation of the fragment did not create sufficient torque reaction to fail the shaft. Nonetheless, it created sufficient side load on the uppermost 3/4 cavity vaned scavenge pump to fail the top bearing in the driven scavenge pump stack.

Red arrows show position of failed key washer  
(between bearings #3 and #4)

It was confirmed that fatigue cracking had been present in the engine's No 4 bearing key washer (situated immediately forward of the No 4 bearing). Consequently, overload failure ultimately occurred, releasing part of the washer. The released fragment then appeared to travel through the gallery to the No 3/4 bearing cavity scavenge pump in the oil pump assembly. It appeared that the action of lubricant within the pump, coupled with the geometry and orientation of the fragment, created sufficient side load on the uppermost 3/4 cavity scavenge pump to fail the top bearing in the driven scavenge pump stack. On this occasion, the particle did not create sufficient torque reaction to cause a failure of the shear neck on the oil pump's input driveshaft.

On 21 December 2015, the engine manufacturer issued Alert Service Bulletin SB A35325. This requires in situ inspection of the No 4 bearing key washer and the removal from service of engines in which cracked washers are identified.

In addition, the engine manual has been revised to instruct the replacement of the key washer upon access, and SB 35326 has been issued to instruct replacement of the key washer at engine shop visits, regardless of the reason for engine removal. Furthermore, the engine manufacturer introduced a new improved key washer in February 2016, per SB 35327.
