SERIOUS INCIDENT

Aircraft Type and Registration:	Cessna 525A, Citationjet CJ2, G-TBEA	
No & Type of Engines:	2 Williams International FJ44-2C turbofan engines	
Year of Manufacture:	2003 (Serial no: 525A-0191)	
Date & Time (UTC):	9 January 2016 at 1807 hrs	
Location:	Norwich International Airport	
Type of Flight:	Commercial Air Transport (Passenger)	
Persons on Board:	Crew - 2	Passengers - 3
Injuries:	Crew - None	Passengers - None
Nature of Damage:	Landing gear, landing gear doors and under side of aircraft	
Commander's Licence:	Airline Transport Pilot's Licence	
Commander's Age:	41 years	
Commander's Flying Experience:	4,190 hours (of which 732 were on type) Last 90 days - 87 hours Last 28 days - 22 hours	
Information Source:	Aircraft Accident Report Form submitted by the pilot

Synopsis

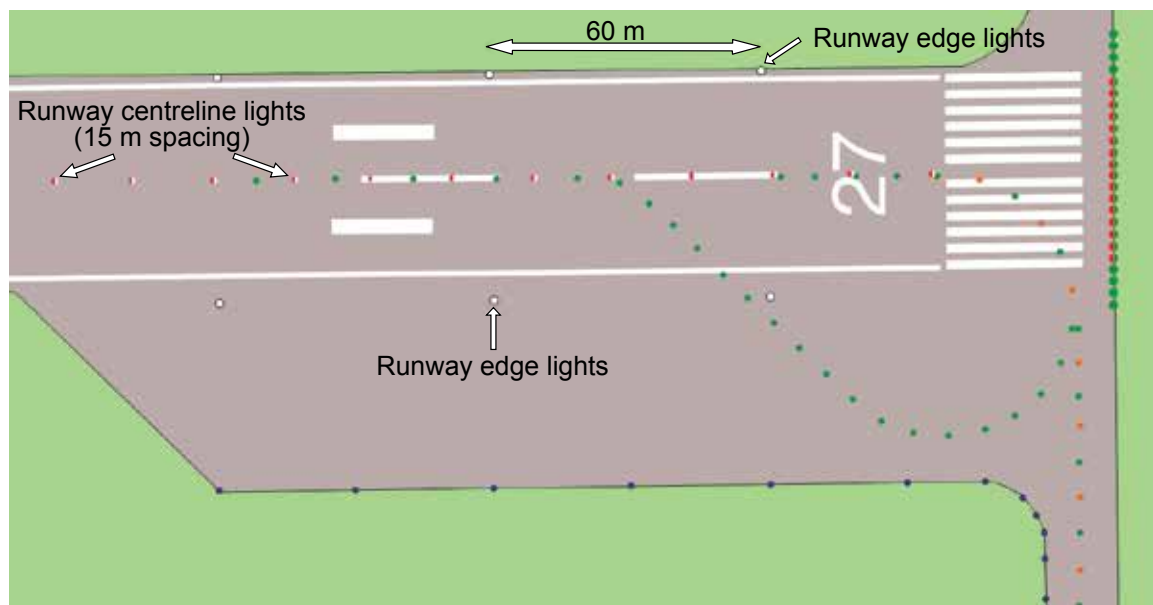
Figure 1

The aircraft had been lined up with the runway's left edge lights, having not followed the green turning circle taxiway lights to their conclusion.

and wait on Runway 27. As the aircraft entered the runway the commander initially followed the runway centreline lights and then the green turning circle taxiway lights on the threshold of Runway 27, to the right (see Figure 1). The aircraft then turned to the left to line up on what the crew believed was the runway centreline, and was cleared for takeoff.

Runway 27 turning circle lights

At both ends of rwy 09/27 its width is twice that of the associated edge lights due to extra pavement at one side.'

He believes that he lined the aircraft up with the runway's left edge lights having not followed the green turning circle taxiway lights all the way around, but having "undercut them". Due to the extra pavement parallel to the runway, he did not realise he was lined up on the left edge prior to takeoff.

4. *When cleared to line up brief on what you expect to see.*
5. *Once lined up, carry out a gross error and sense check:*
 - a) *Confirm heading indications against runway orientation*
 - b) *Confirm lined up on the centreline ie a dashed and not a solid line.*
 - c) *If at night, compare centreline lights (if applicable), edgeway lights, taxi light etc are what you expect to see in accordance with the plate.*
