SERIOUS INCIDENT

Aircraft Type and Registration:	Dassault Falcon 20D, G-FRAR	
No & Type of Engines:	2 General Electric Co CF700-2D-2 turbofan engines	
Year of Manufacture:	1969 (Serial no: 209)	
Date & Time (UTC):	21 September 2015 at 1500 hrs	
Location:	Lyme Bay, South of Dorset	
Type of Flight:	Aerial work	
Persons on Board:	Crew - 3	Passengers - None
Injuries:	Crew - None	Passengers - N/A
Nature of Damage:	Minor damage to upper surface of horizontal tailplane	
Commander's Licence:	Airline Transport Pilot's Licence	
Commander's Age:	51 years	
Commander's Flying Experience:	8,737 hours (of which 4,423 were on type) Last 90 days - 127 hours Last 28 days - 68 hours	
Information Source:	Aircraft Accident Report Form submitted by the pilot

Synopsis

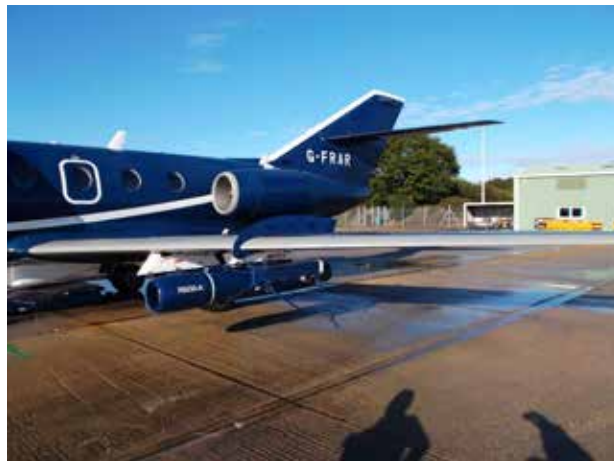
Figure 1

Image of aircraft showing winch and tail plane

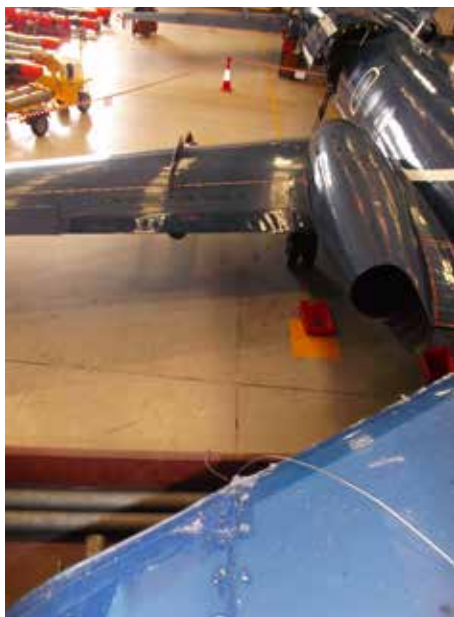
Figure 3

Image showing damage to the tailplane leading edge

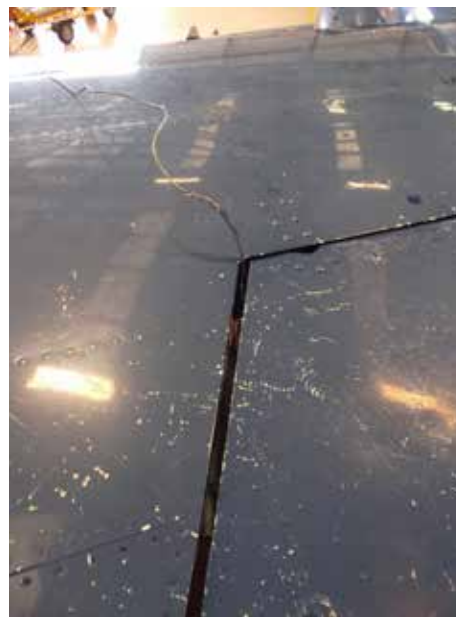
Figure 4

Image showing cable lodged in the gap between the horizontal tailplane and the elevator

Although the cable became lodged between the elevator and the horizontal tailplane, there was no evidence that it had restricted the operation of the elevator.
