Report of Thorough Examination of Loader Crane

**LABORATORY INVESTIGATION REPORT**

***Report on the Failure  
of the  
Holding Down Fasteners on a Crane***

Report completed for  
Marine Accident Investigation Branch

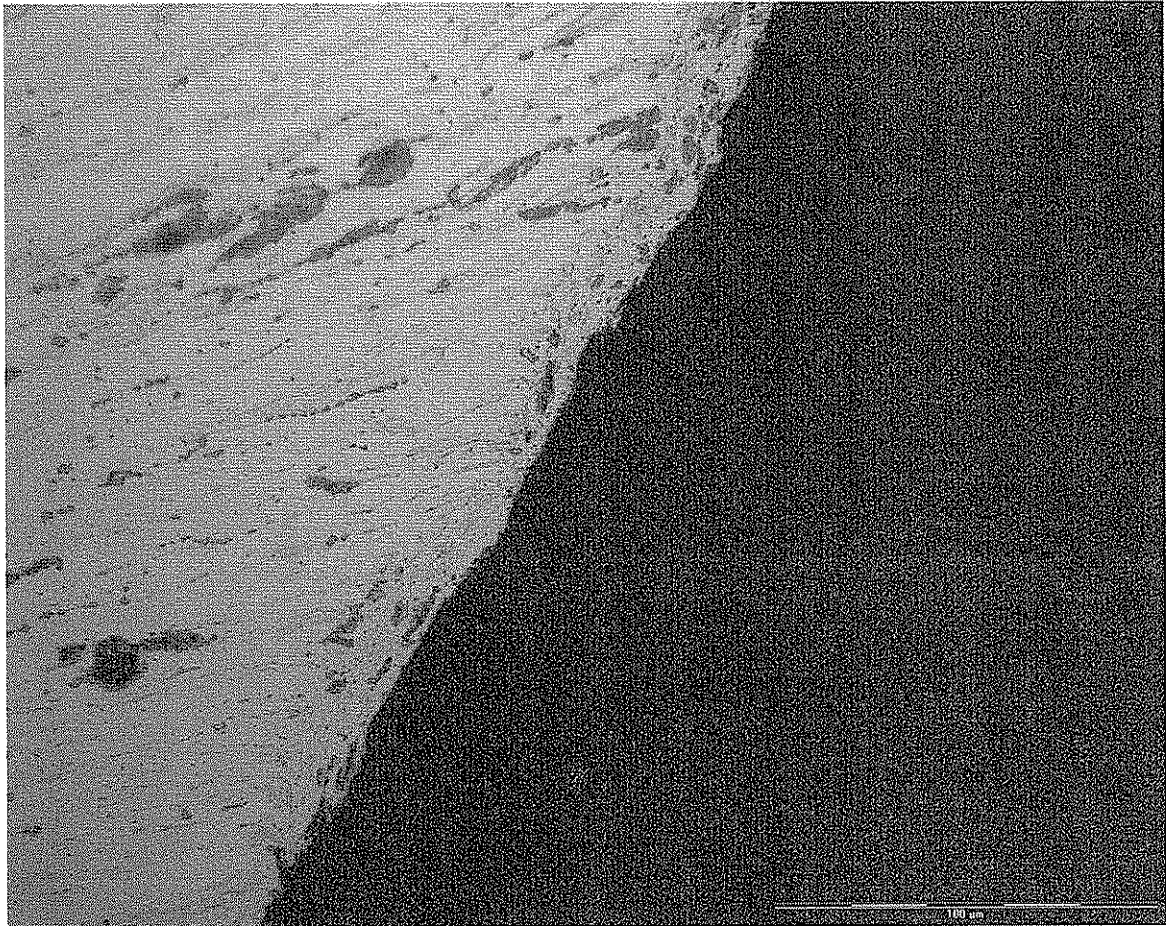
Results (mm)	
EXTERNAL SURFACE	UPTO 0.0488
THREADED PROFILE	Nil

**PHOTO 1 X 500 MAGNIFICATION – SURFACE COATING OF THREADED PROFILE**

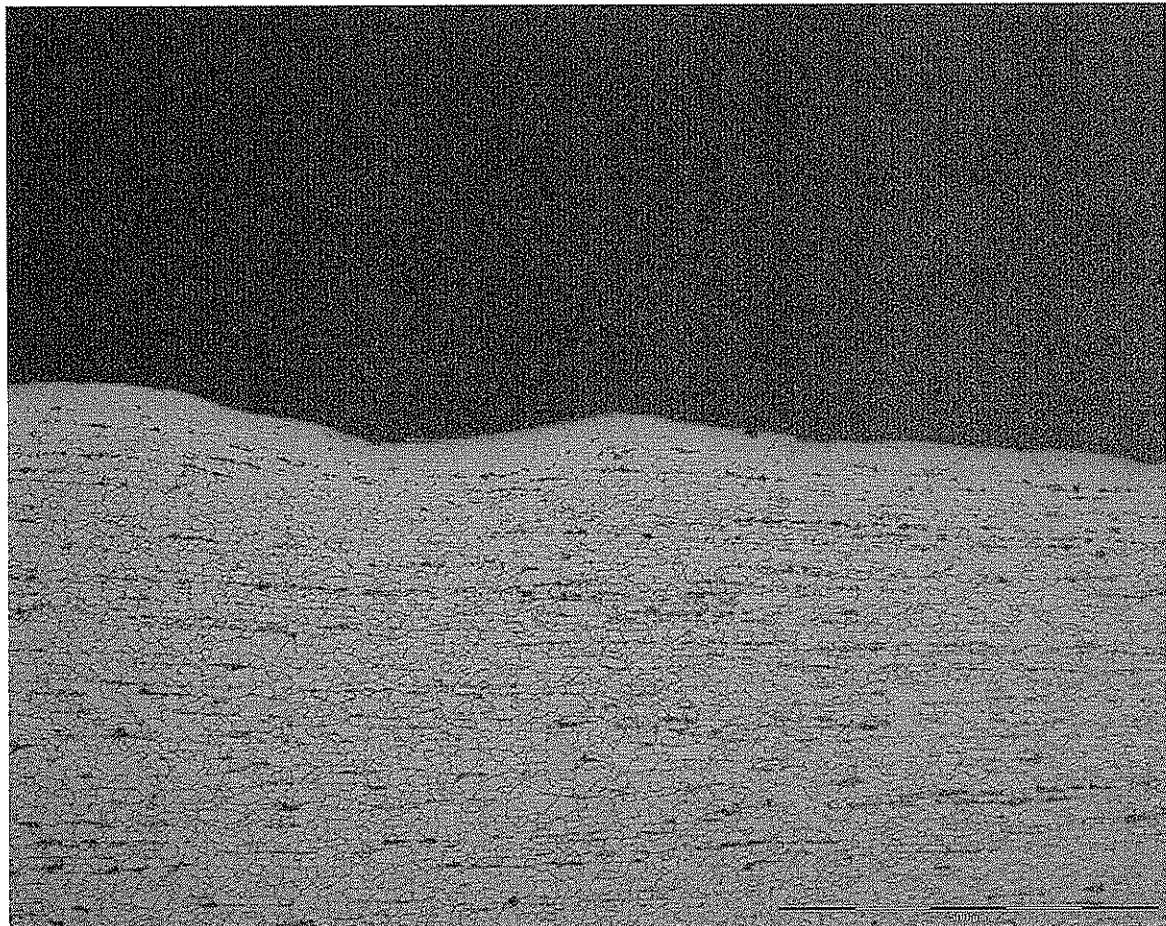
**PHOTO 2 X 100 MAGNIFICATION – COATING THICKNESS EXTERNAL SURFACE**

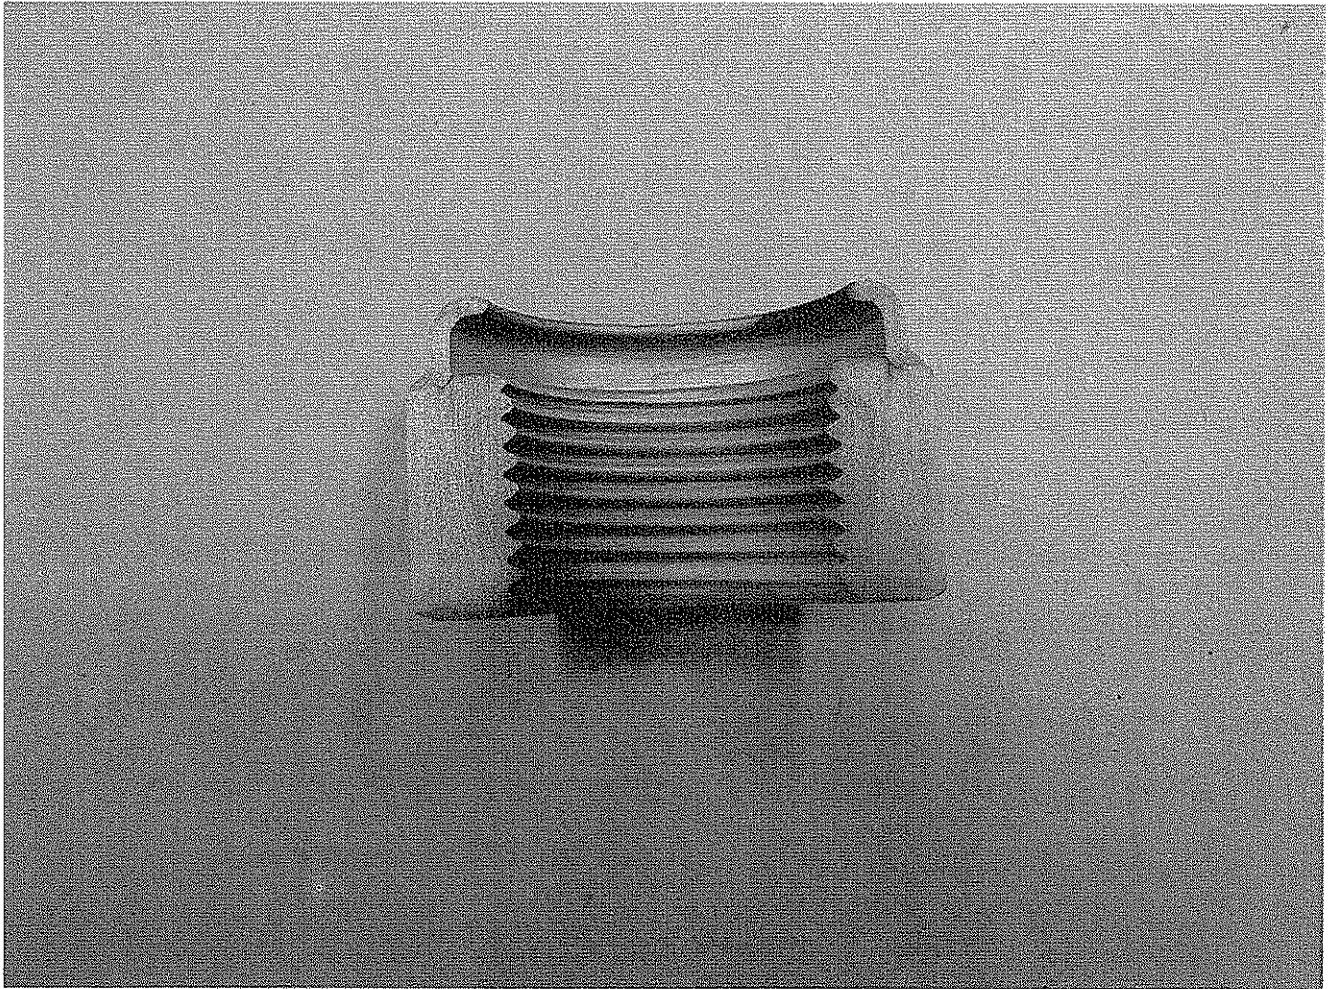
A longitudinal section was taken from the sample and subjected to a Macro etch in 50% HCL to boiling point for a time of approximately 8 minutes.

PHOTO 3 - ETCHED IN 50% HCL

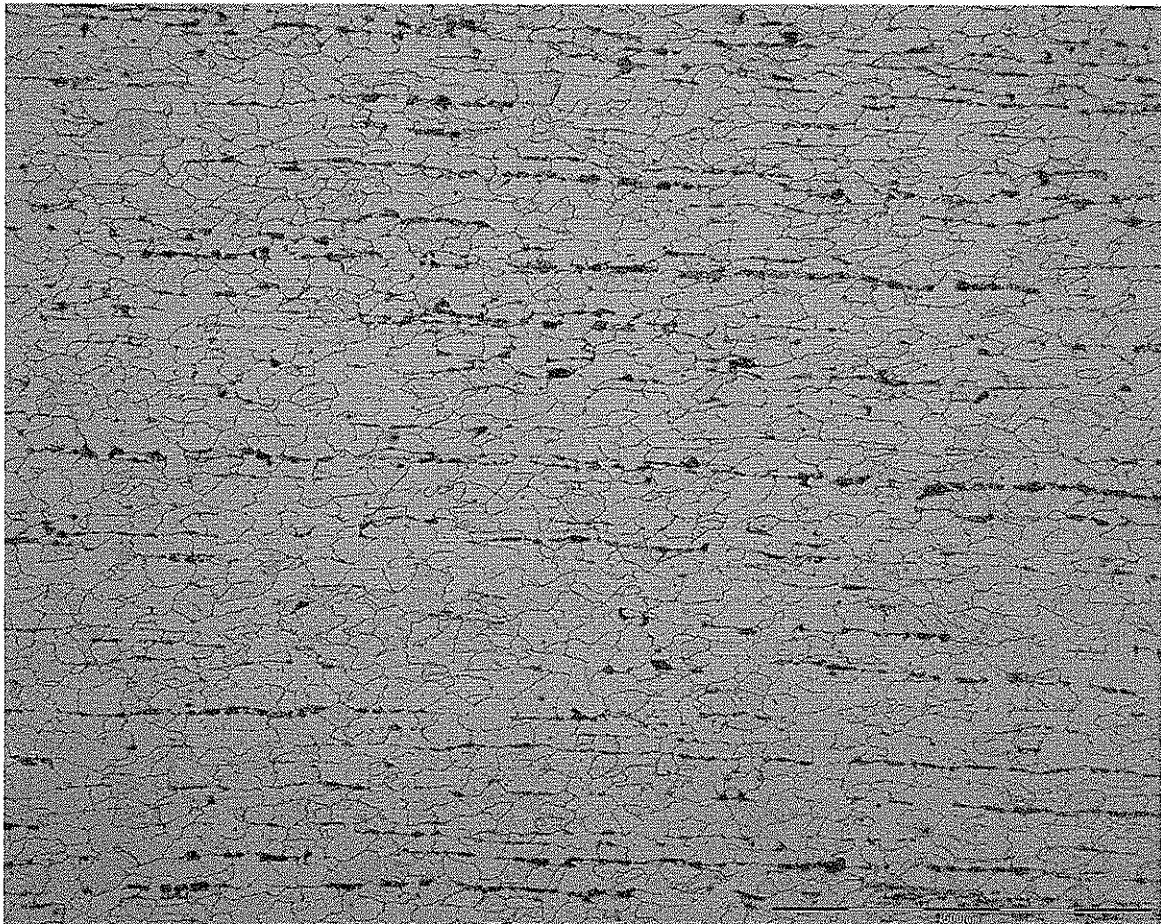
A longitudinal section was taken from three samples and polished, then etched in 2% Nital.  
 Photo's 4, 5 and 6 – Non heat treated structure was evident that of a ferrite/pearlite structure.

Micro evaluation of the nut established that the nut had been supplied in the NON heat treated condition i.e. Displayed a ferrite and pearlite structure and not that of the tempered martensitic structure that would have been evident for a grade 8 nut.

PHOTO 4 - FERRITE/PEARLITE STRUCTURE X100 MAGNIFICATION

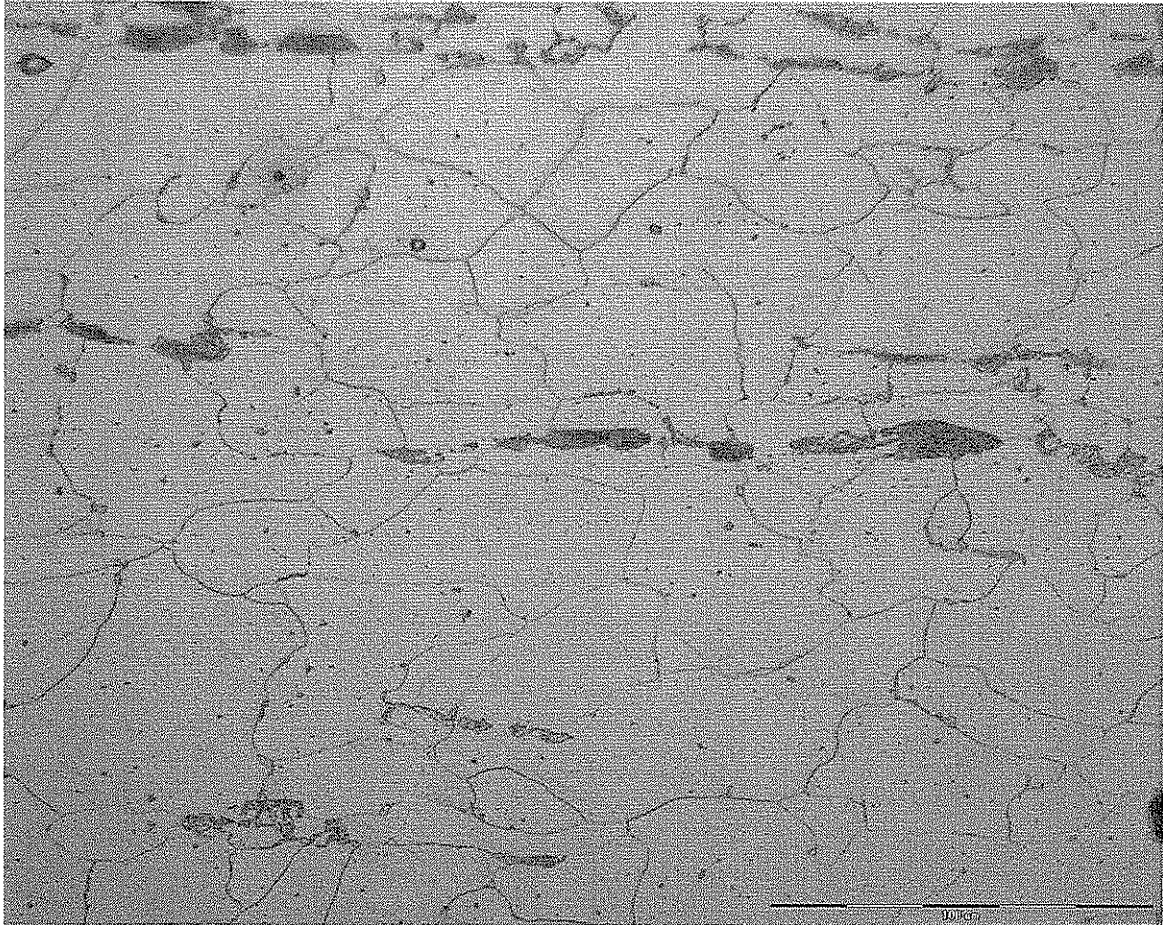
PHOTO 5 - FERRITE/PEARLITE STRUCTURE X500 MAGNIFICATION

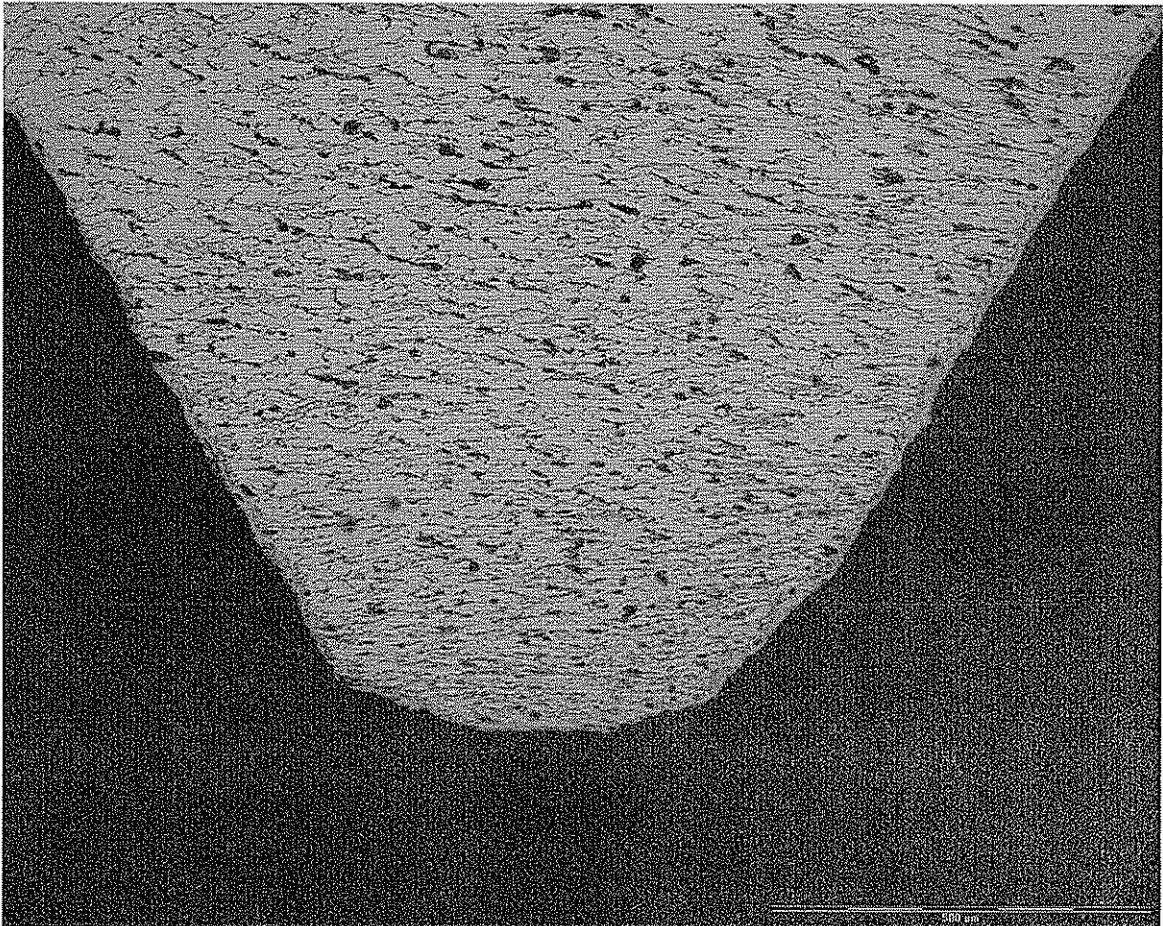
Examination of the section showed no evidence of decarburization.

No decarburization was detected, due to material had not been heat treated.

PHOTO 6 - X100 MAGNIFICATION – SURFACE PROFILE OF THREAD

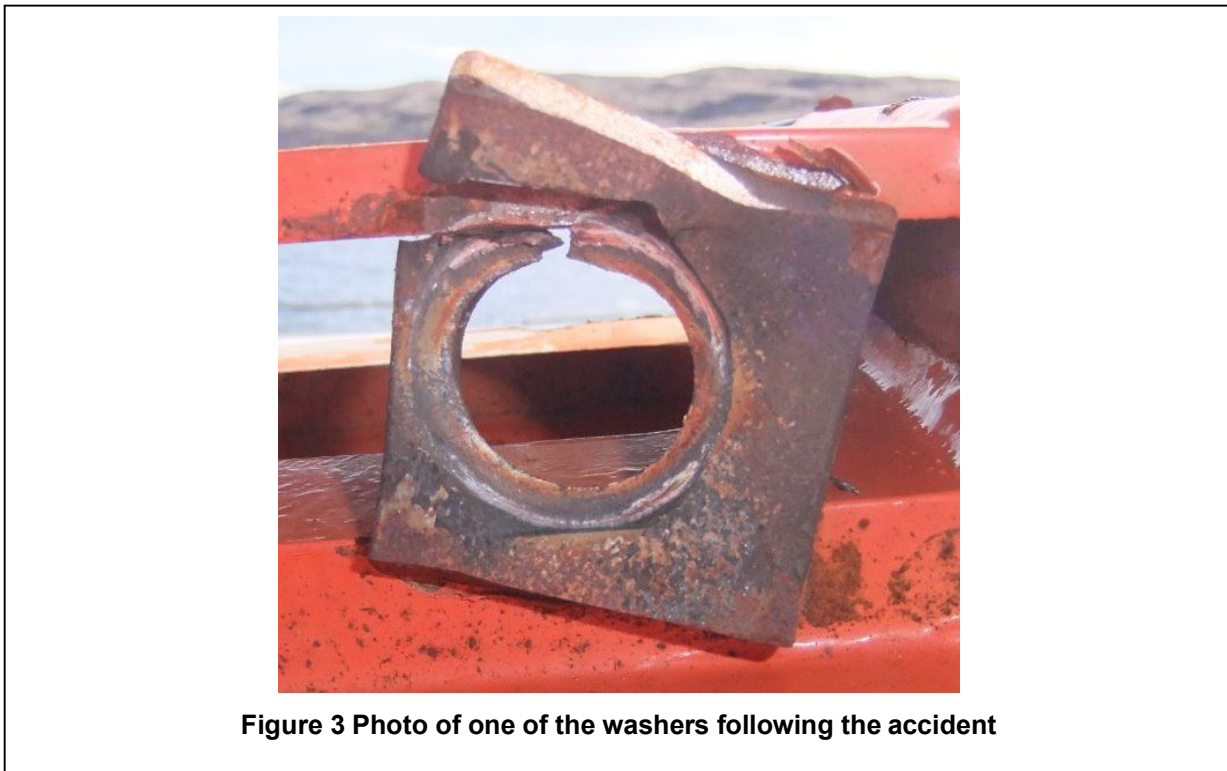
As can be seen in figure 3, one or more of the washers had been severely distorted, before or as a result of the accident.

It is uncertain whether the collapse of the washer occurred during tightening or was damaged during the collapse of the crane. If the deformation of the washer occurred when the nuts were initially tightened, which is a distinct possibility, it would point towards the preload in the fastener being high. My understanding is that the washer is made from mild steel. The limiting surface pressure for mild steel depends upon the specific steel used. For a low strength mild steel (tensile strength 340 N/mm<sup>2</sup>), the limiting surface pressure<sup>11</sup> is 490 N/mm<sup>2</sup>. This would point towards the preload value approaching or exceeding the thread stripping load.

The large gap under the washer would also result in bending stresses being incurred by the washer in addition to the direct bearing stresses. If the washer distorted during tightening an uneven loading would occur in the threads, resulting in the thread stripping load being lowered. Such loading is not represented in a standard proof load test or in the calculations presented in this report. The author has previously observed such a reduction on an offset pull test on a fine threaded fastener.

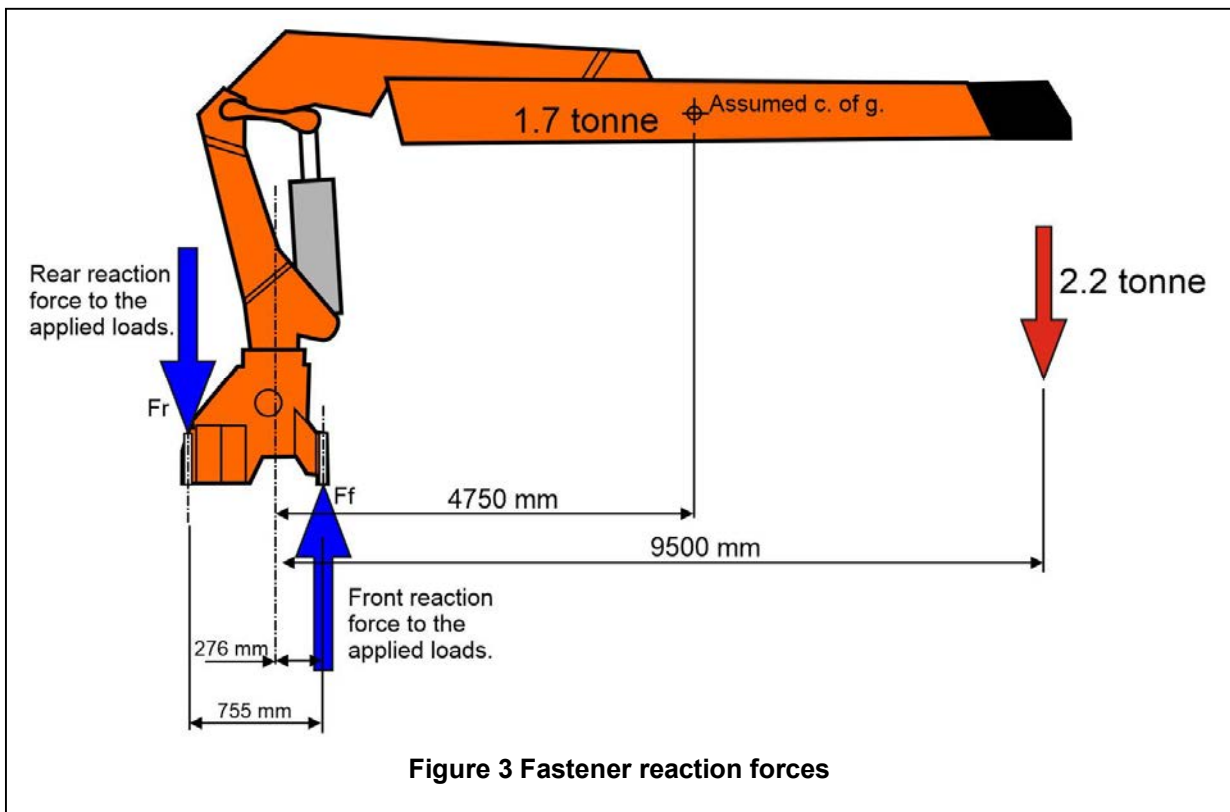
Just prior to the failure, the fasteners would sustain the load/moment from the crane as direct axial forces. On the side which the fasteners failed the loading would be tending to push the nut off the stud. The assumed dimensions, to allow an estimate of the axial force acting on an individual fastener are shown in figure 4.
