Report on the investigation of the grounding
of the cruise ship
Hamburg
in the Sound of Mull, Scotland

11 May 2015

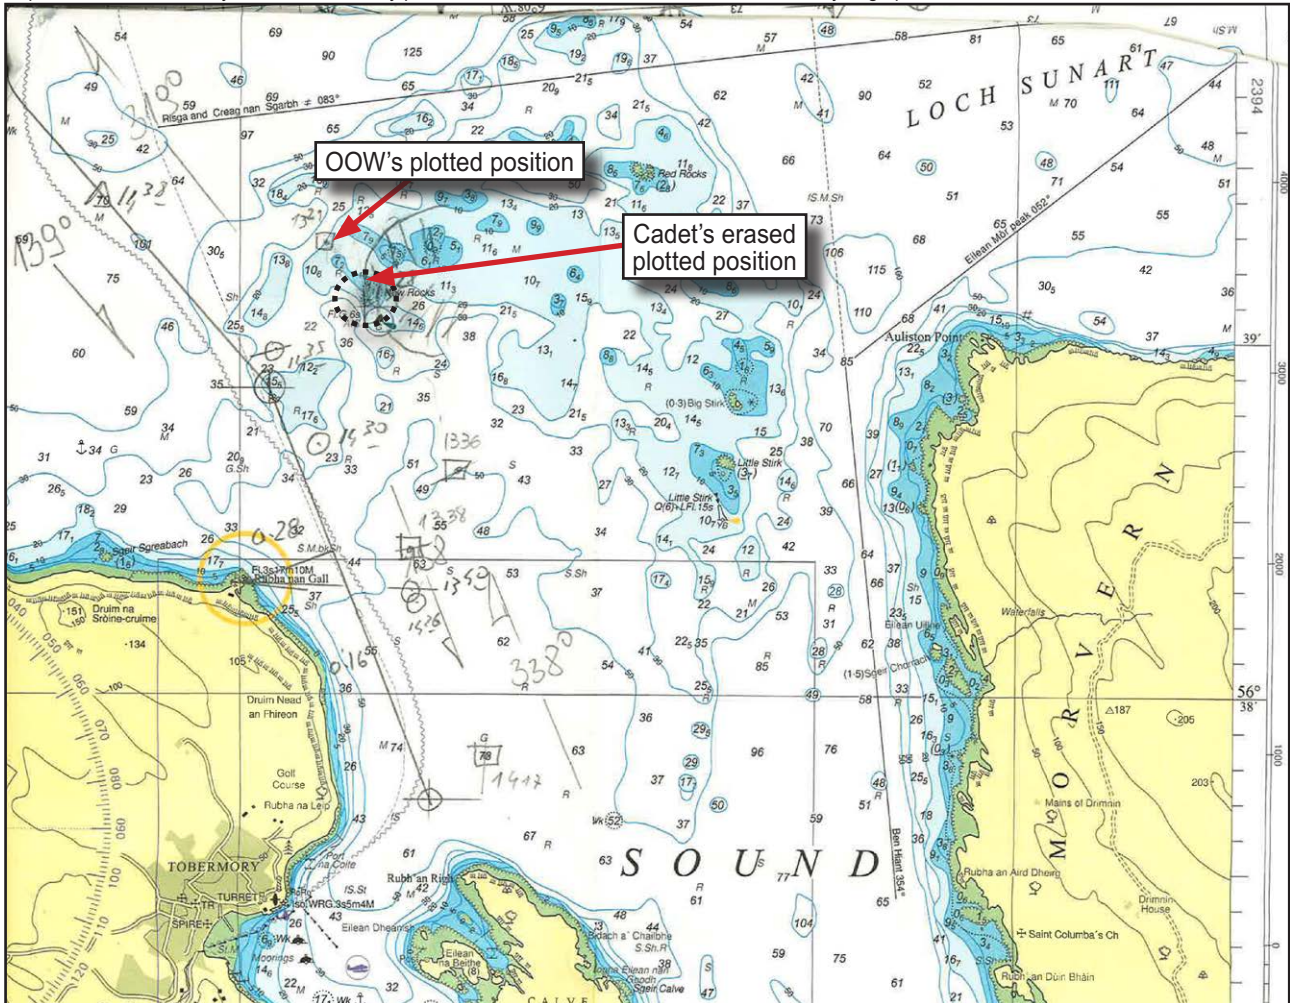
Figure 5: Extract of chart BA 2392 showing plotted position at 1321

At 1321 both the OOW and the cadet plotted *Hamburg*'s position on the chart (**Figure 5**). The cadet saw that his plotted position was some distance away from the OOW's position but closer to the New Rocks shoal. Without consulting the OOW, the cadet assumed his own position was incorrect and removed it from the chart using an eraser. At 1322:55 the OOW reduced the starboard radar display to the 1.5nm setting (**Figure 6**).

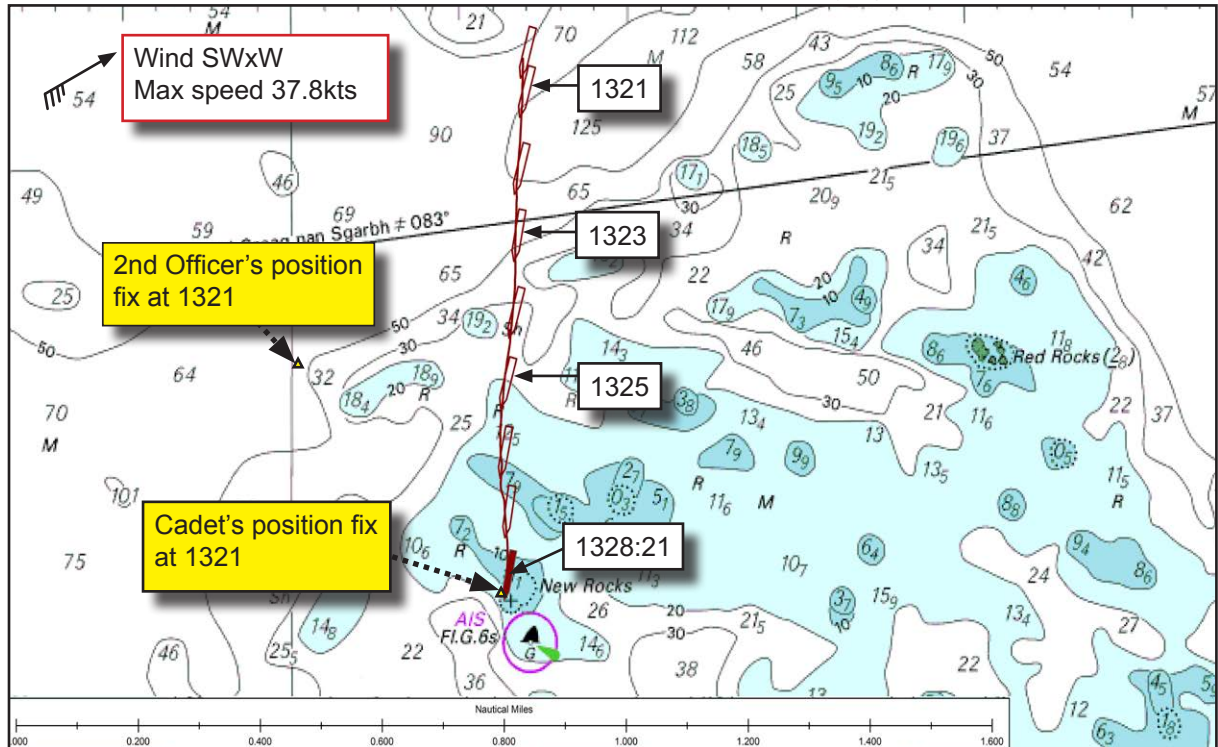
Figure 8: Extract of chart BA 2392 showing *Hamburg's* track and relative headings between 1321 and 1328

The expected CPAs between the three vessels and *Hamburg* remained very close at less than 0.2nm. The master was preoccupied with the traffic situation but he was also aware that *Hamburg* was approaching the New Rocks buoy. At 1328, the safety officer arrived on the bridge again and the master asked him to visually check the vessel's position off the New Rocks buoy. The safety officer went onto the port bridge wing to take a bearing of the buoy's position and, at 1328:21, as he returned to the bridge, *Hamburg's* port quarter grounded to the north-east of the New Rocks buoy with a SOG of 6.37kts.

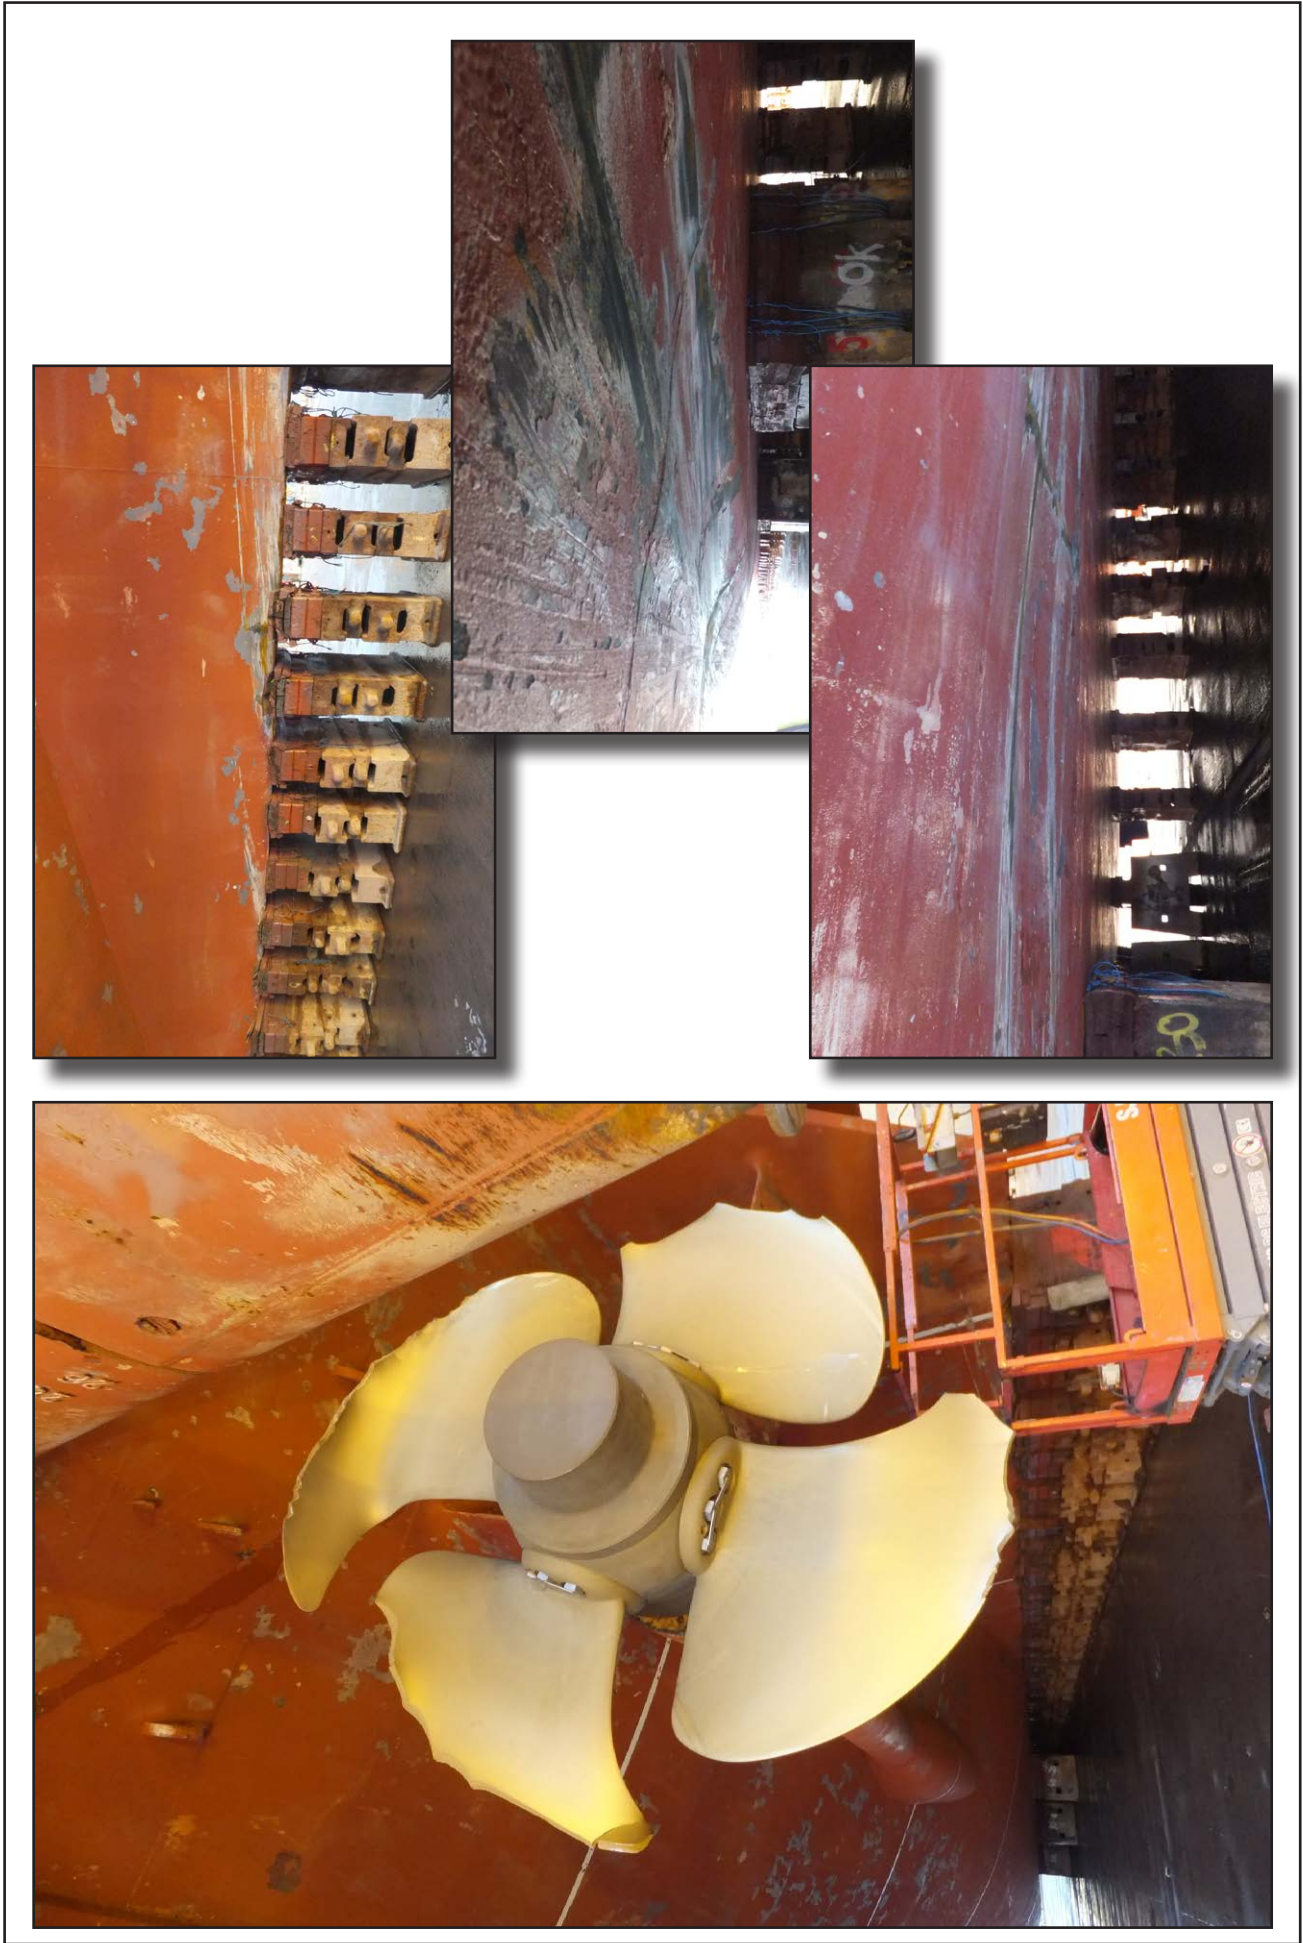
Figure 11: Photographs of hull and propeller damage

At 1824 on 12 May *Hamburg* arrived at Belfast and an underwater inspection was completed. This indicated that the damage attributed to the grounding appeared to be substantial but, due to the poor water visibility, the exact extent of damage could not be ascertained. The surveyor from the vessel's classification society, Det Norske Veritas Germanischer Lloyd (DNV GL), and representatives from V.Ships and HCSA agreed that the cruise ship needed to be dry docked in Belfast. Later that day, the cruise ship entered the dry dock, where significant damage to the port propeller, port propeller shaft, port propulsion auxiliary equipment, port rudder/rudder stock and hull were identified (**Figure 11**).

On 13 May, the DNV GL surveyor directed that *Hamburg* should remain in Belfast for temporary repairs. Consequently, the remainder of the cruise was cancelled and passengers were repatriated from the vessel that day. *Hamburg* remained in dry dock at Belfast until 30 May, when the cruise ship sailed under a single voyage safety certificate to Bremerhaven for permanent repairs. *Hamburg* returned to service on 10 August 2015.

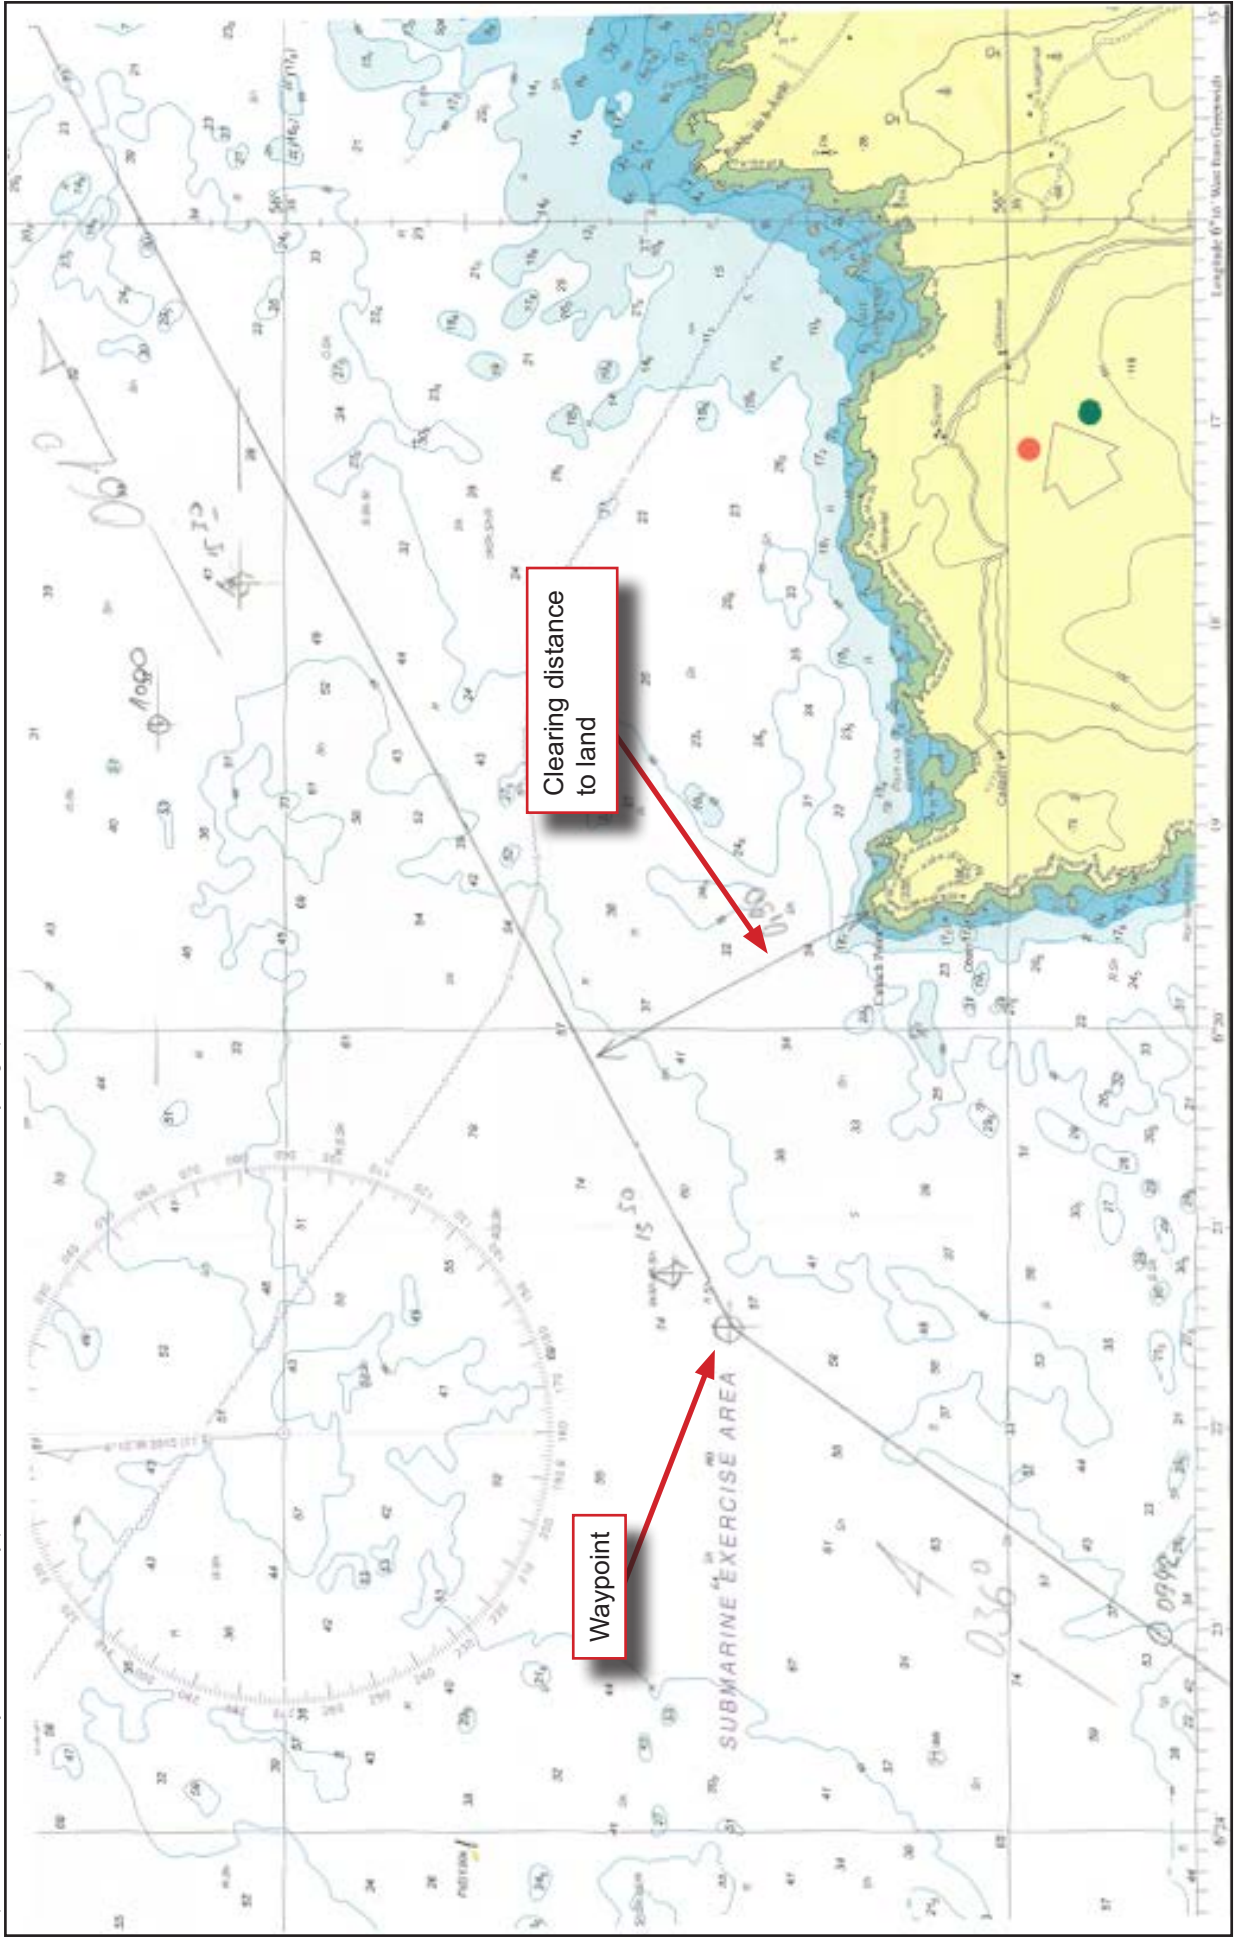
Figure 13: Extract of chart BA 2392 showing passage planning details

- None of the cross track margin, check lines and red and green condition boxes had been marked as checked.
- The minimum distance from land was stated to be *'As Per Captains Order'*. [sic]
- There were several notations directing the user to *'See Charts'*.

- Under keel clearance was stated as per the ‘*Exemptions marked on chart*’ but there were no markings on the charts.
- Position fixing frequency was required to be ‘*1h in deep sea, 30 min in coastal approaches and 15 min in approaches*’.
- No primary or secondary position fixing method was identified for each stage of the passage as required by the SMS.
