ACCIDENT

| Aircraft Type and Registration: | Cessna 150F, G-ATKF | |
| Date & Time (UTC): | 4 September 2015 at 1110 hrs | |
| Location: | Hinton-in-the-Hedges Airfield, Northamptonshire | |

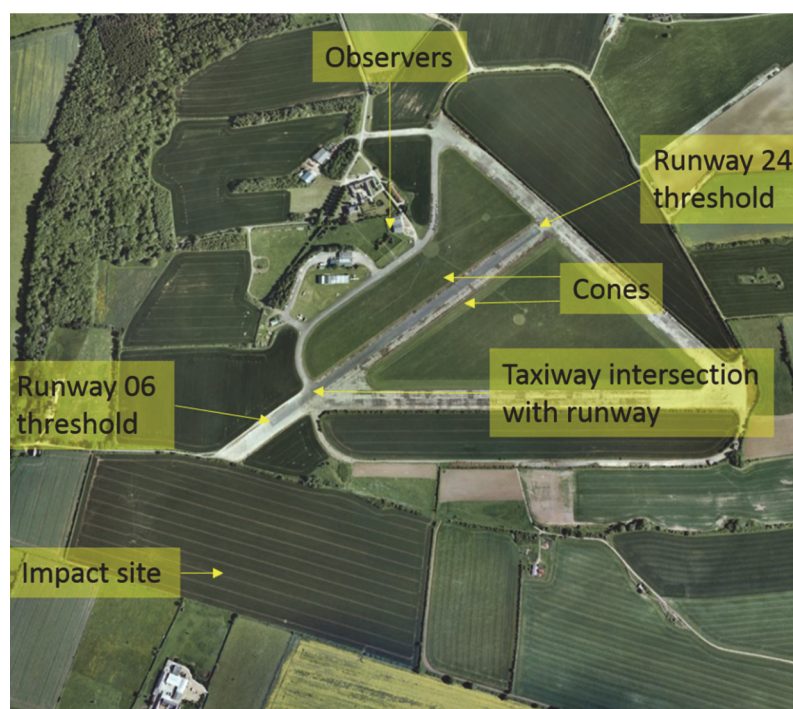
Figure 1

placed one either side of the runway. The aircraft sat back onto its main landing gear, bounced back into the air and, after floating along the runway, touched down again, left main landing gear first, close to the intersection of the taxiways with the runway marked in Figure 1.

Overhead image of the accident site (Google Earth)

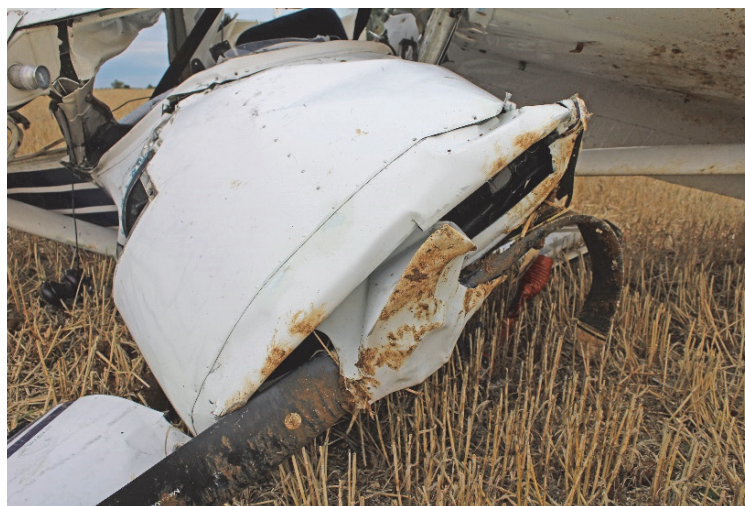
Figure 3
Propeller damage

The damage to the propeller indicates that one of the blades cut into and drew itself deeply into the soil at the point of impact (Figure 3). The extent of the bend of this blade indicates that it was under high power at this point and the relatively little damage to the other blade shows that the propeller was brought to a stop in one revolution or less. The very steep aircraft angle at impact meant the propeller was presented to the soil almost fully face-on and did not exhibit the multiple progressively increasing tip impacts characteristic of a more shallow impact angle. The propeller effectively tried to 'screw' itself into the ground, causing extreme bending and leading to the conclusion that the engine was at a high power setting.
