## ACCIDENT

<b>Aircraft Type and Registration:</b>	Silent 2 Electro, G-CIYA	
<b>No &amp; Type of Engines:</b>	1 x FES-SIL-M100 22 kW brushless electric motor	
<b>Year of Manufacture:</b>	2015 (serial no: 2075)	
<b>Date &amp; Time (UTC):</b>	19 October 2015 at 1457 hrs	
<b>Location:</b>	Husbands Bosworth Airfield, Leicestershire	
<b>Type of Flight:</b>	Private	
<b>Persons on Board:</b>	Crew - 1	Passengers - None
<b>Injuries:</b>	Crew - 1 (Serious)	Passengers - N/A
<b>Nature of Damage:</b>	Aircraft destroyed	
<b>Commander's Licence:</b>	National Private Pilot's Licence	
<b>Commander's Age:</b>	66 years	
<b>Commander's Flying Experience:</b>	154 hours (of which none were on type) Last 90 days - 11 hours Last 28 days - 1 hour	
<b>Information Source:</b>	AAIB Field Investigation

## Synopsis

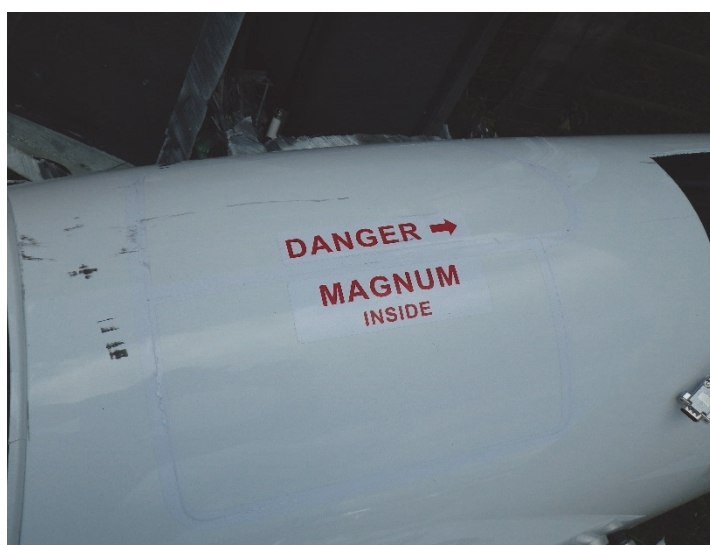
**Figure 1**  
BPRS warning sign

G-CIYA was equipped with the Magnum 300 SSP Ballistic Parachute Recovery System (BPRS). The rocket and parachute were located in a compartment behind the pilot and above the wing spars. The operating handle was located on the right side of the cockpit and had a safety pin to prevent inadvertent operation. A warning placard stating '*Ballistic Parachute Deployment Handle Emergency Use Only*' was attached to the inside of the cockpit adjacent to the operating handle. A second red warning sign stating '*DANGER MAGNUM INSIDE*' was affixed to the BPRS compartment access panel (see Figure 1).

This airworthiness requirement is satisfied by adopting the recommended specification in ASTM F2316 -12<sup>4</sup>. However, along with other SSDR aircraft, G-CIYA was exempt from the requirements of BCAR and the only warning placard on the outside of the aircraft referred to 'Magnum'. It, therefore, may not have been apparent to first responders that a ballistic rocket was fitted to the aircraft. A warning placard, shown at Figure 3, was found in the pilot's documentation, which did appear to conform to the specification in ASTM F2316-12. However, the web site, which was in German, was for a pilot's equipment shop and provided no readily accessible information on how to disarm the BPRS. The telephone numbers were not always answered and the person answering the calls could not always speak English.

It is recommended that the Civil Aviation Authority require that Ballistic Parachute Recovery Systems fitted to Single Seat Deregulated Aircraft comply with Article 38 of the Air Navigation Order and that the installation and placarding meet the same requirements as for aircraft operating on a Permit to Fly.

The UK agent of the Silent 2 Electro has advised the AAIB that the aircraft manufacturer has taken action to attach the correct BPRS placards to their aircraft and trailers prior to delivery.

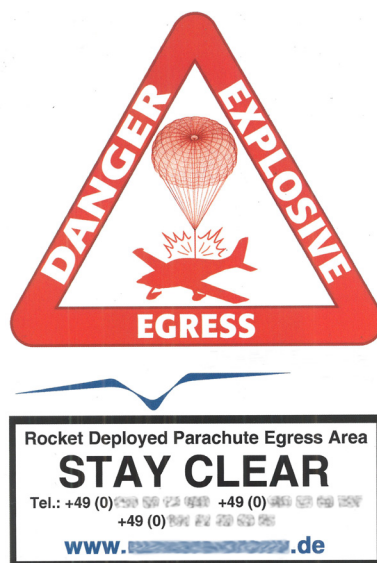
**Figure 3**

Warning placard in pilot's documentation
