Fatal man overboard accident from the fishing trawler *Enterprise* (PD147)

North of Dogger Bank, North Sea
9 July 2015

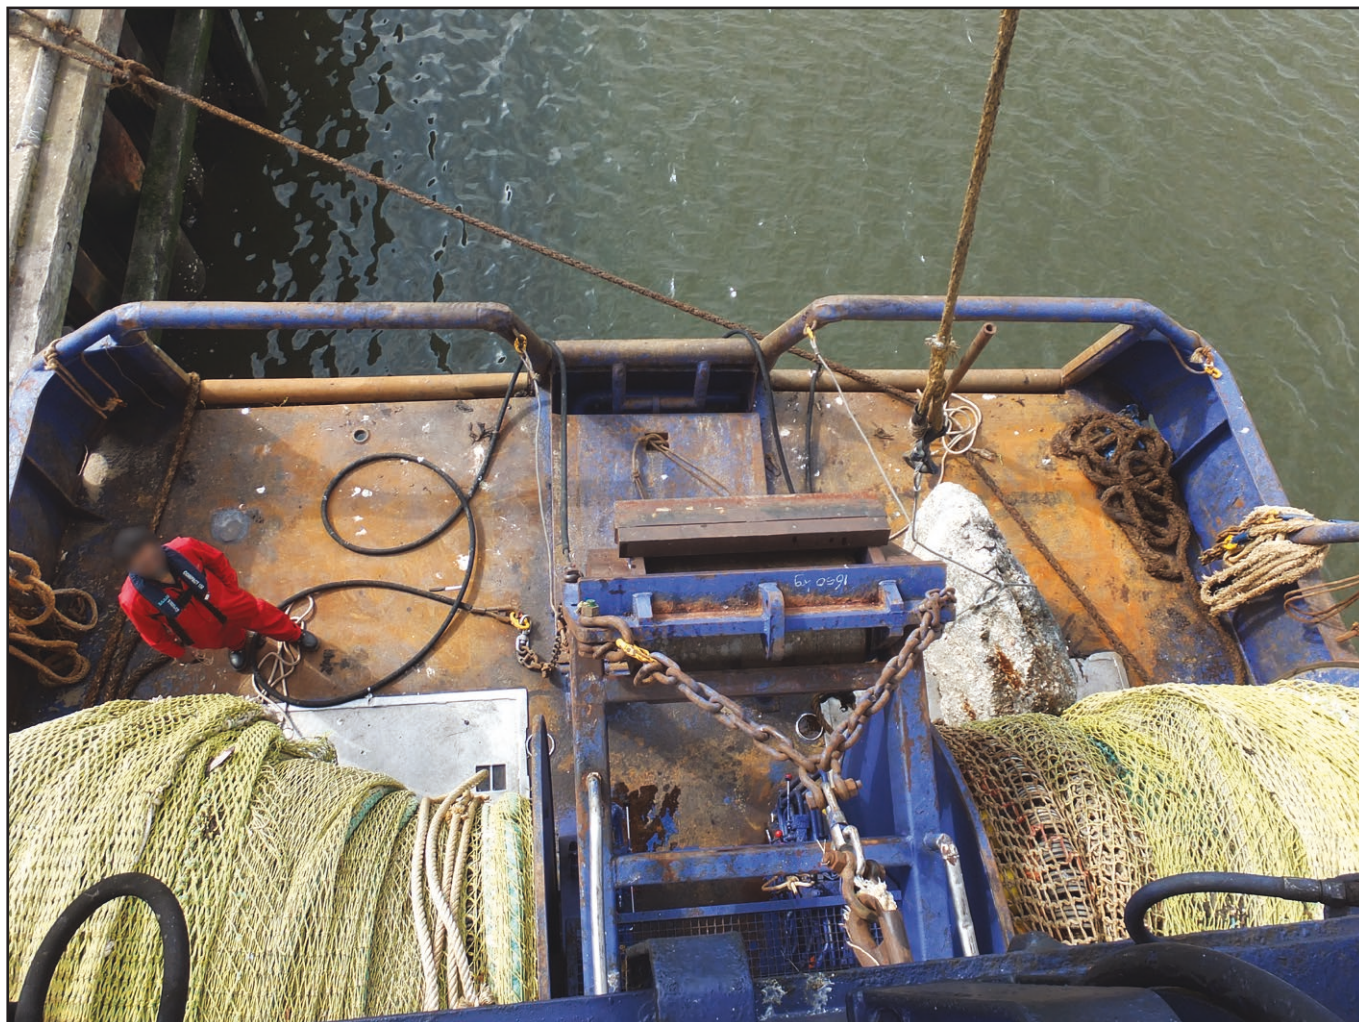
Figure 2: Working space aft of the net drums

The net drums were located in the middle of the poop deck providing 9.5m² working area aft of the drums (**Figure 2**) and 8m² forward of the drums (**Figure 5**). The hydraulic controls for the two net drums were located at the inboard end of each drum. The net repair kit was also stored in this area and the spare nets were being stored in a space directly below the poop deck.

The skipper of *Enterprise*, Jan de Boer, fell overboard through the unprotected net shooting port on the starboard side of the vessel's stern. He had been standing on a fishing net that offered very little traction against the smooth deck, and he was wearing inappropriate footwear. The vessel pitched violently and the net, with the skipper on it, slid, first throwing him forward against the net drum and then immediately aft. With his back to the shooting port, the skipper was unable to stop himself from falling through it into the sea.

The poop deck area aft of the net drums, where the crew were repairing the nets, was the most exposed and dangerous working area on board *Enterprise*, especially in rough seas such as those experienced on the day of the accident. The area immediately forward of the drums was slightly smaller than the area aft of the drums. However, it did offer sufficient space in which to carry out net repairs, and the drums would have provided a barrier against falling overboard through the ports. The vessel also had a large and well protected main deck area (**Figure 2**) that could also have been used for this purpose.

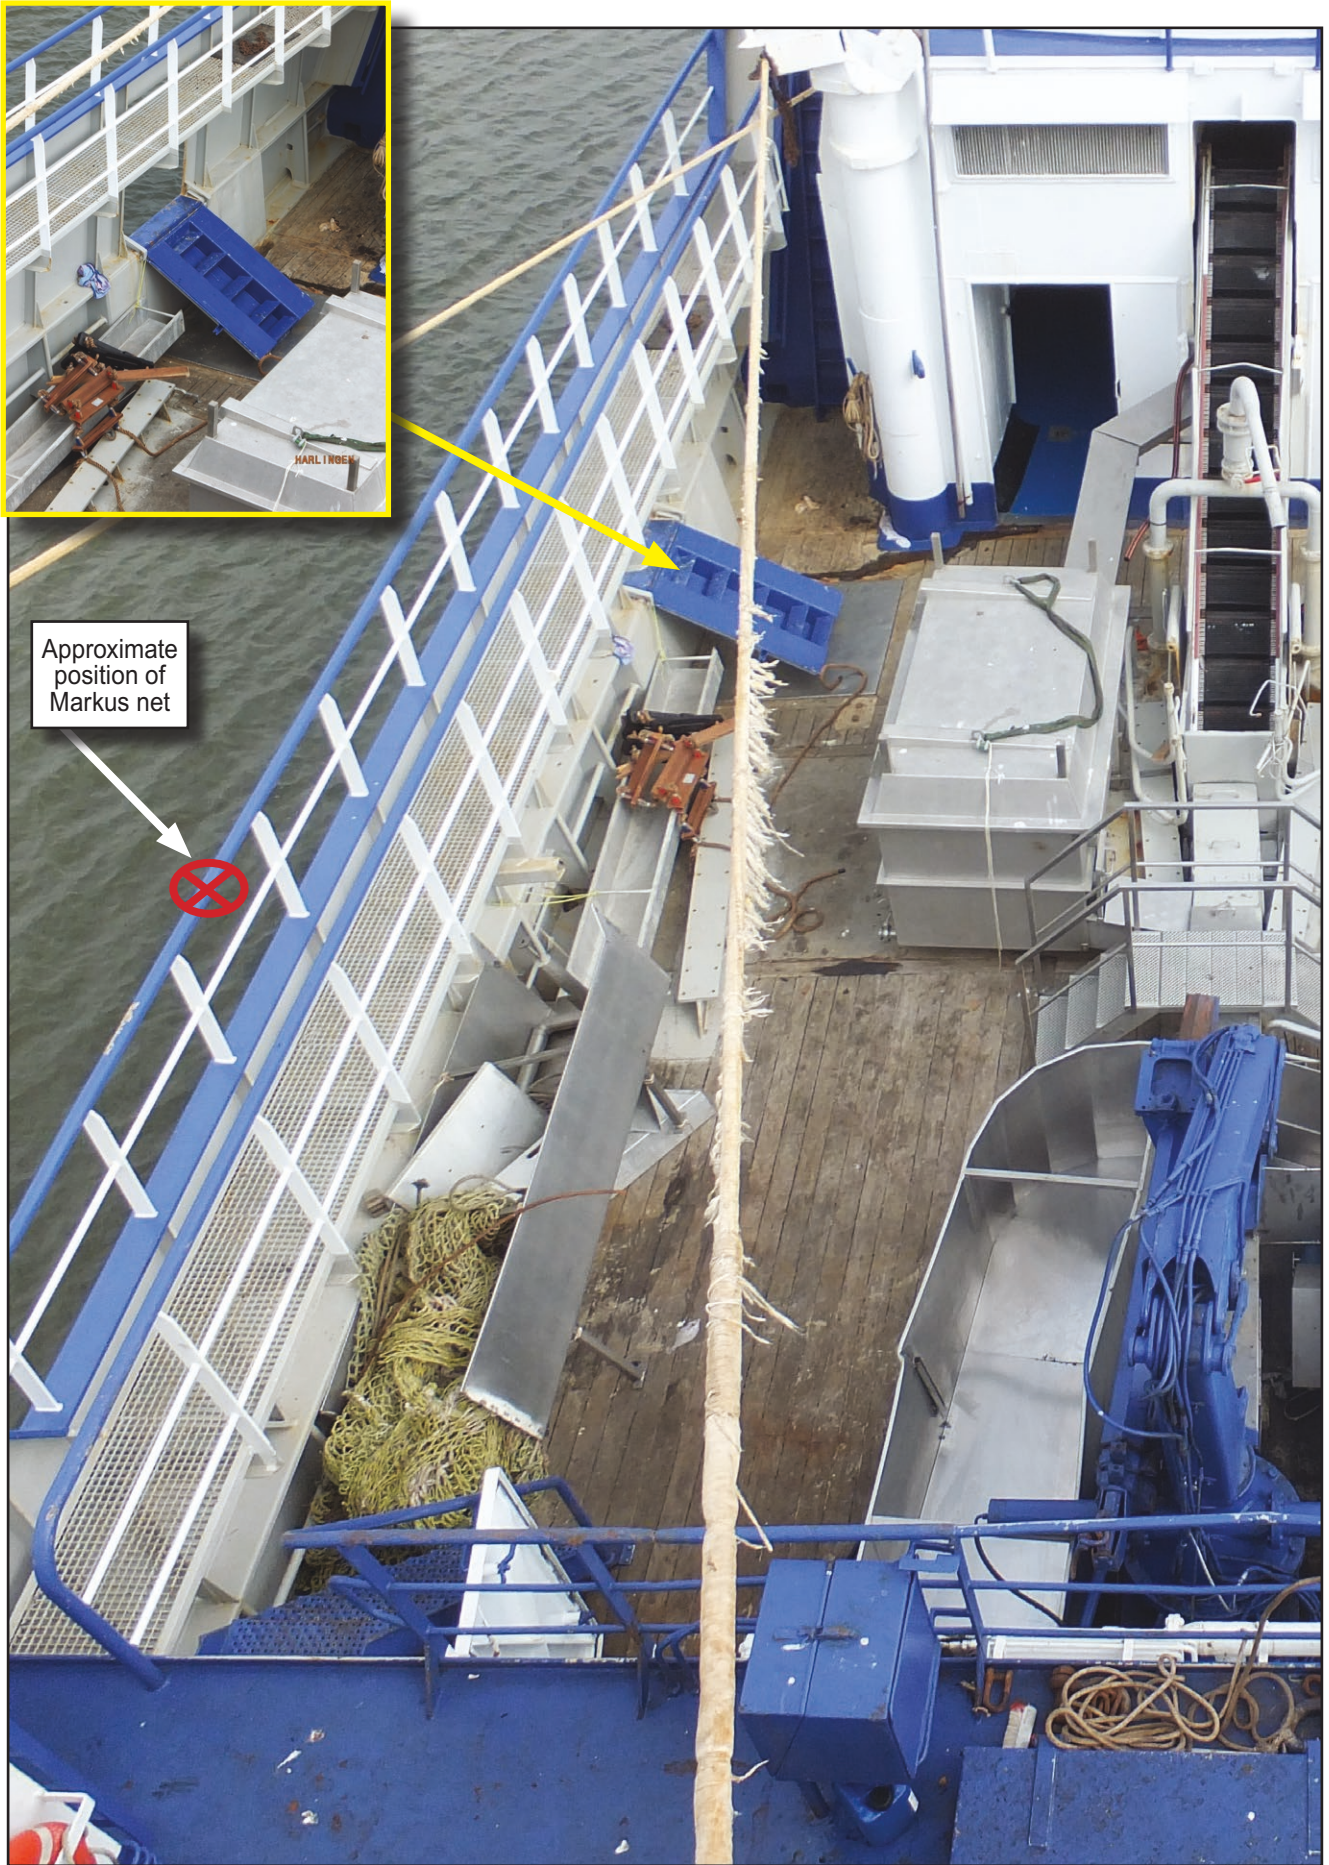
Figure 3: Pilot ladder and Markus net deployment positions (inset: opening for pilot ladder)

The skipper, who was now on the weather side of the vessel, managed to reach one of the lifebuoys and put it around himself. Meanwhile, the cook donned a survival suit, secured himself to the vessel with a lifeline and jumped into the water to help the skipper. The remaining crew members deployed the pilot ladder from the main deck and the vessel's Markus net⁴ from the port catwalk railing, approximately 3m forward of the pilot ladder (**Figure 3**).

The skipper was able to grasp the line from the Markus net and use it to reach the pilot ladder. Understandably, he then chose to let go of the line in an attempt to climb the ladder. However, having been immersed in the cold water (13.6°C) for some minutes, it would not be surprising if he was no longer physically capable of supporting himself, and he lost his grip as the sea fell away from under him. The subsequent failed attempt to lift him using the grab line of the lifebuoy is a clear indication that the crew were becoming increasingly desperate.

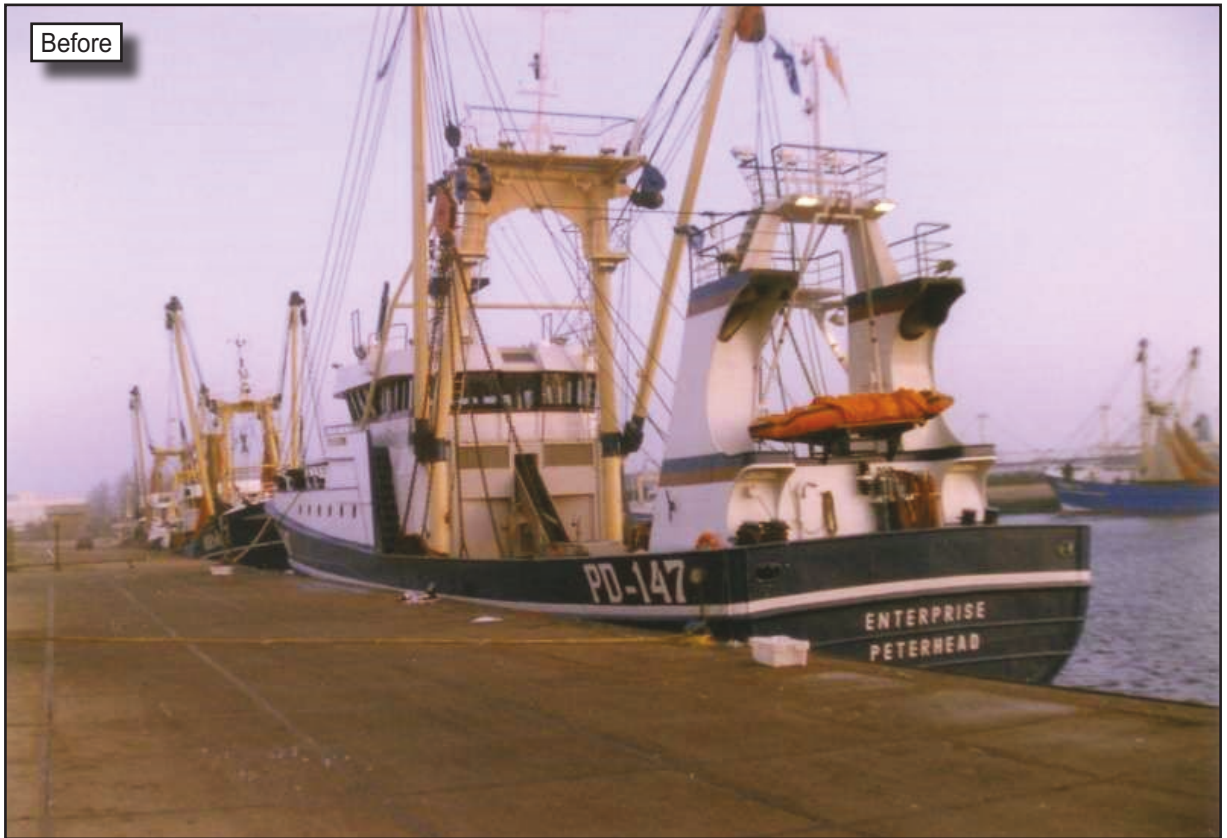
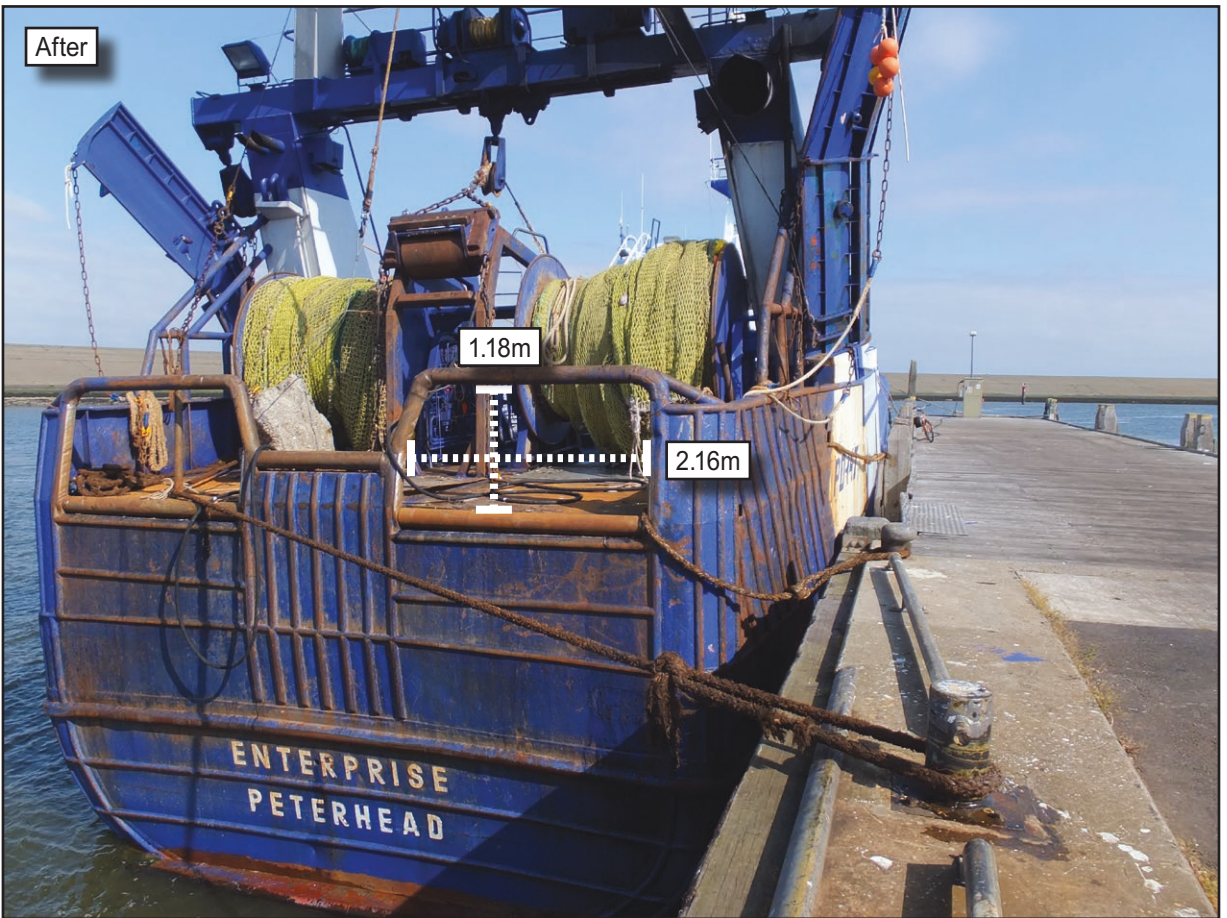
Figure 4: Enterprise before and after conversion to a stern trawler

Enterprise was converted from a beam trawler into a twin rigged stern trawler in 2006 by Kynde & Toft in Denmark (**Figure 4**). The drawings for conversion, including the stern net shooting ports, were subjected to full structural design approval by Lloyd's Register (LR) in Rotterdam. The design was assessed as meeting the Lloyd's Register Rules and Regulations for the Classification of Ships 2005 and, when the modification work was conducted, the work was surveyed by LR surveyors to ensure that it was in accordance with the approved design and that appropriate construction methods were employed.

The net shooting ports were introduced when *Enterprise* was converted from a beam trawler to a twin rigged stern trawler in 2006. Other similar conversions completed by Kynde & Toft had been fitted with temporary closing arrangements so as to make them safe when not in use. However, the shooting ports of *Enterprise* did not include any closing arrangements and so presented a hazardous working area for the crew that did not comply with the legal requirement to provide a continuous barrier around the shooting deck.

- 2016/126** Take steps to ensure that fv *Enterprise* complies with the minimum bulwark height requirements of the Torremolinos International Convention for the Safety of Fishing Vessels as referred to in Council Directive 97/70/EC and in accordance with the revised requirements contained in MSIS 27.
