# Rail Accident Report

**Passenger trapped and dragged by a train at  
Hayes & Harlington station  
25 July 2015**

Report 12/2016  
June 2016

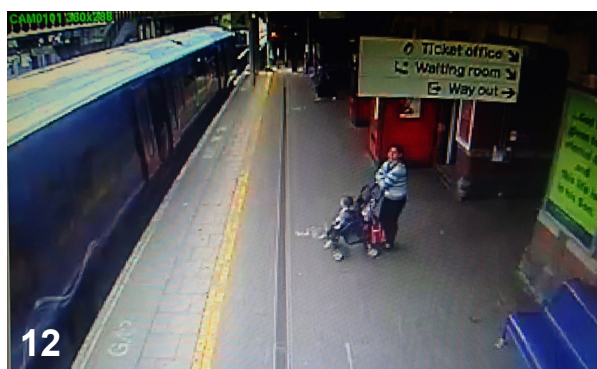
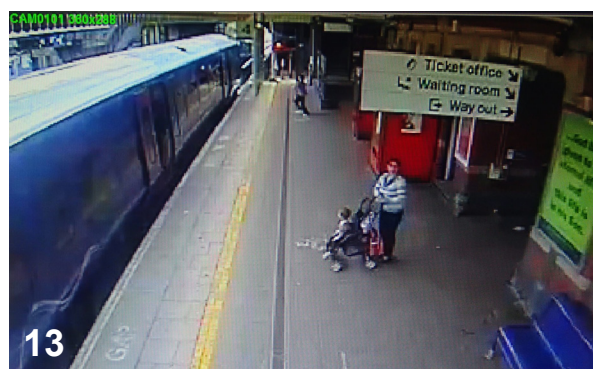
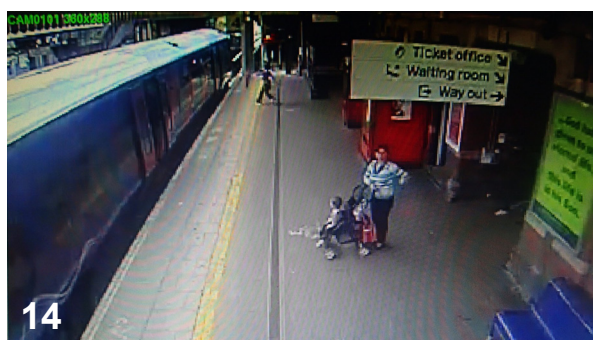
- 16 At 13:09:48 the passenger involved in the accident ran from the stairwell onto platform 4 (figure 12). The RAIB has established using CCTV evidence that this is around the same time at which the train driver pressed the door close button to initiate their closure. The passenger continued to run (figures 13 and 14) towards the train doors which were still open, but with the audible 'hustle' alarm sounding indicating imminent closure.

Figures 12 to 14: CCTV images showing the passenger running from the stairwell and onto the platform towards the stationary train as the doors were closing (courtesy of GWR)

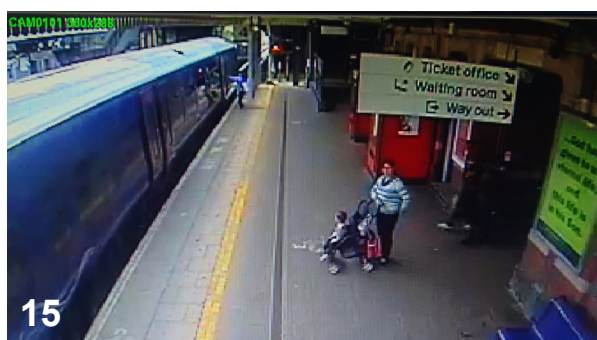
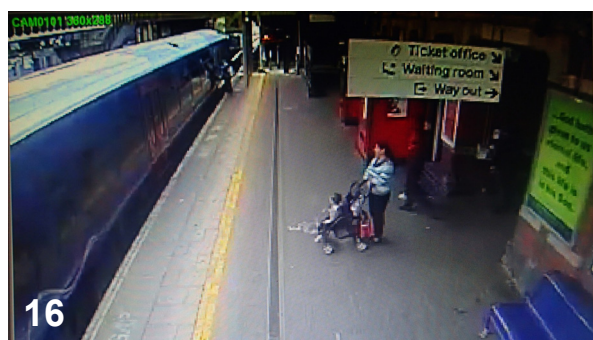
- 17 At 13:09:50 the passenger put her leg and left hand between the rear door leaves (which were by now almost closed) on the last coach of the train, in an attempt to prevent them from fully closing. Almost immediately, she retracted her leg, leaving her left hand in the door (figure 15). At 13:09:51 the *Body Side Indicator light* on the rear carriage was extinguished. The driver's *door interlock light* illuminated in the cab a second or two later, once the safety circuits had identified that all the train doors were closed and locked (figure 16) (the CCTV evidence does not show all of the doors on the train so it is not possible to be precise about the time that the door interlock light illuminated).

Figures 15 and 16: CCTV images showing the passenger running towards the train and trapping her hands in the door of the rear carriage of train 2P48 (courtesy of GWR)

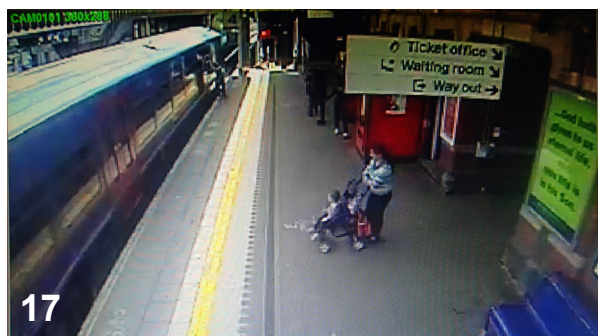
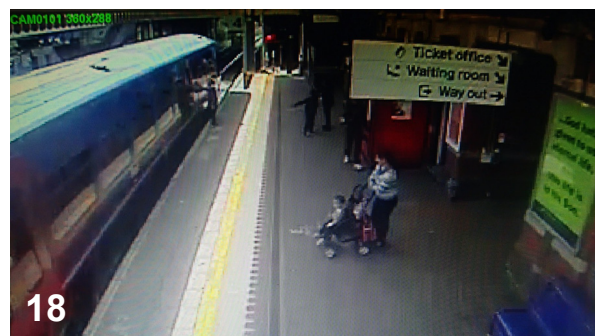
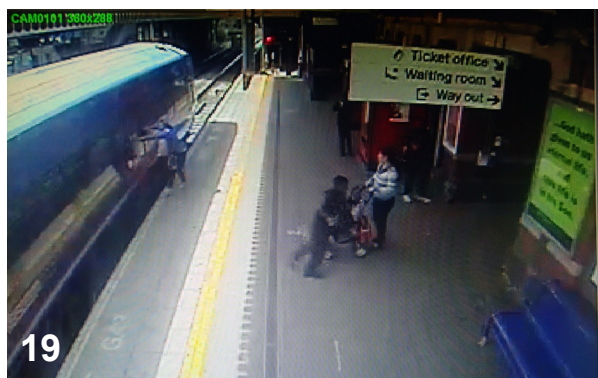
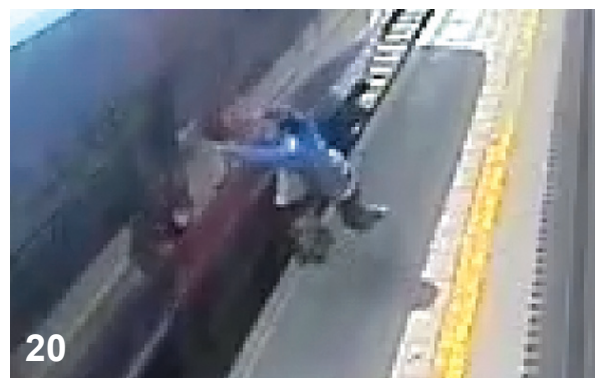
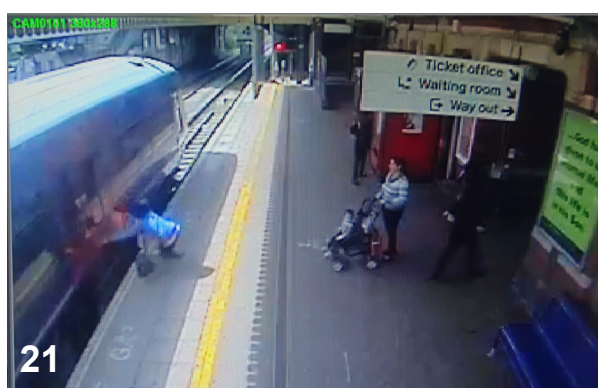
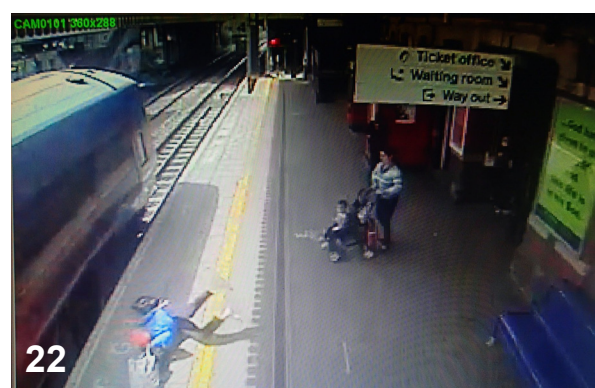
- 19 At approximately 13:10:01, the train started to move. At this time other passengers on the platform became aware of the trapped passenger (figures 17 and 18). The train gathered speed, dragging the passenger along the platform (figure 19) until 13:10:07 hrs, when the speed of the train caused her to lose her footing and she became airborne (figure 20). The weight of her body falling and the angle of her trapped left hand resulted in her hand becoming free from the doors, and she fell heavily onto the platform. Fortunately, she rolled away from the platform edge (figures 21 and 22).

Figures 17 to 22: CCTV images showing the passenger being dragged along the platform and falling away from train 2P48 (courtesy of GWR)

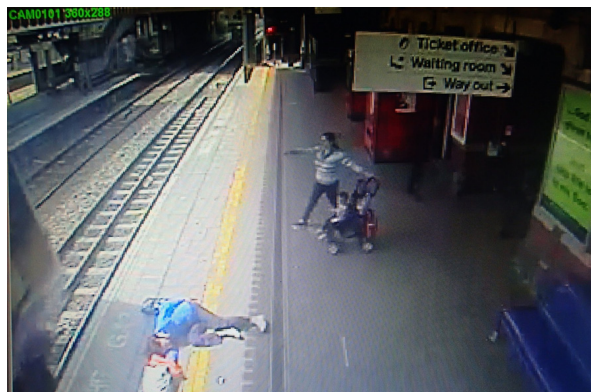
*Figure 23: CCTV images showing the passenger on the platform after falling away from train 2P48 (courtesy of GWR)*

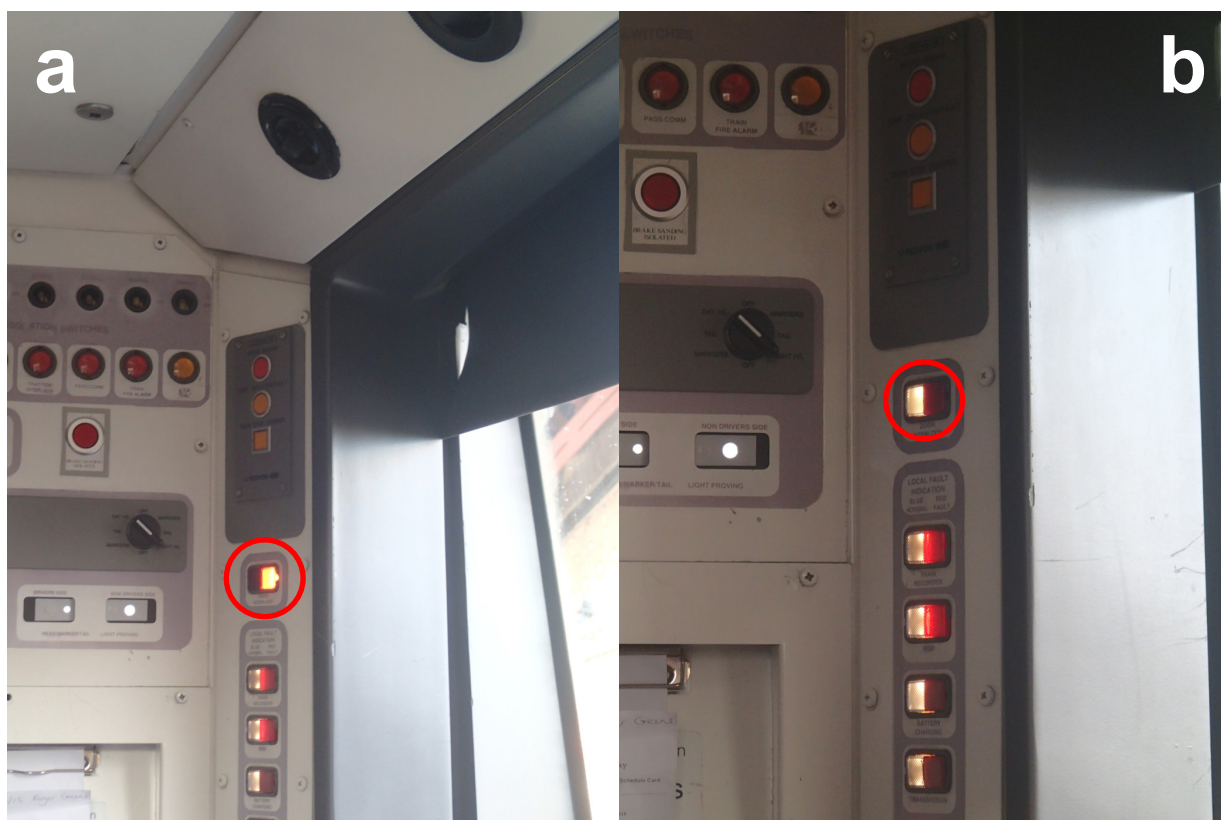
Figure 4: Class 165 vehicle layout and position of passenger attempting to board the rear set of doors of the carriage

Figure 26: (a) Interlock light providing the driver with indication that the doors are closed and locked and (b) interlock not obtained

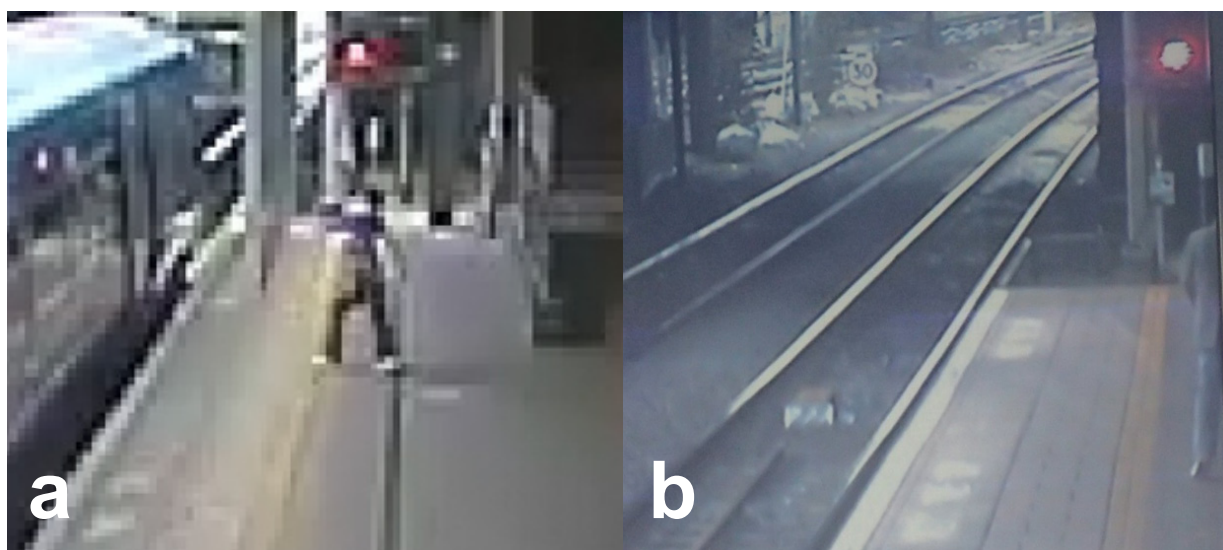
- 68 Analysis of the CCTV evidence shows that at the time the train driver pressed the button to close the doors, he could not see the passenger involved in the accident on the monitors (figures 28 (a) and (b) show that he would not have been able to see the passenger until she crossed the yellow line). He may have formed an expectation, having previously seen an empty platform, that there would be no-one in the vicinity of the train once the doors were closed and locked. As a consequence of this expectation, when he checked the monitors before starting the train he only glanced at them without really noticing what they were showing.

Figure 28: (a) showing Platform CCTV images of the rear portion of the train (note the position of the passenger running towards the train and yellow line) and (b) image of the same location on platform 4 from the drivers view of monitor 4L36 (note the position of the yellow line) (courtesy of GWR)

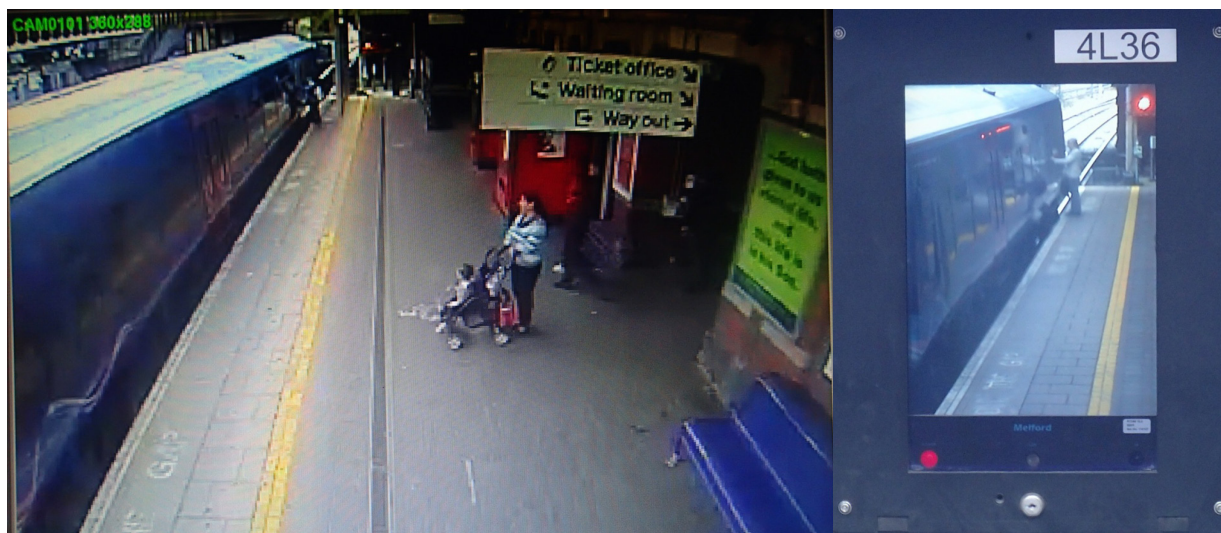
- 75 Analysis of CCTV evidence from the platform shows that as the train driver pressed the door close button, the passenger was not visible in the CCTV monitors. However after the passenger had reached the train door, she would have been clearly visible in the centre of one of the screens during the time of the train driver's safety check (figures 29a and 29b).

Figure 29: (a) showing the passenger at the rear portion of the train on the platform CCTV image (courtesy of GWR), and (b) an image taken during the RAIB reconstruction of the events at the same location on platform 4 (from the driver's view of monitor 4L36)

- 76 Although the CCTV monitors would not have been clear enough to show the train driver that the passenger's hand had become trapped, they would have shown that she was in very close proximity to (and possibly touching) the train over a period of 8 to 9 seconds.

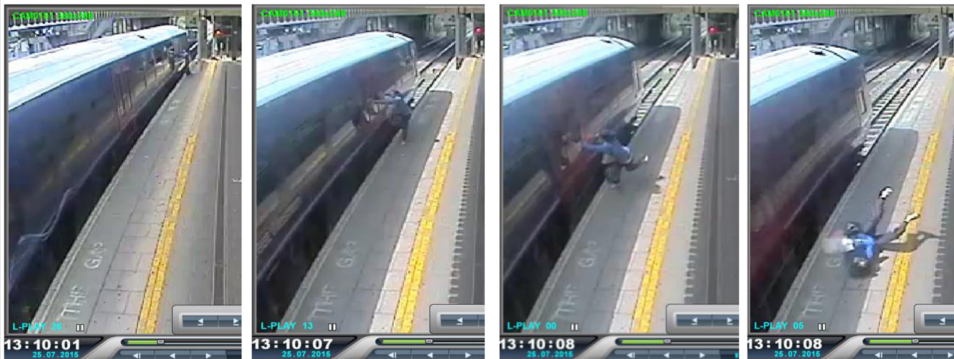
<p>Sequence of four photographs showing train before departure with passenger's hand trapped in the door, the train moving with the passenger's hand still trapped and the passenger falling to the platform, releasing her hand in the process.</p>
